Santa Ana State Building (520)

605 W Santa Ana Boulevard, Santa Ana, CA 92701

Facility Condition Assessment

September 2015

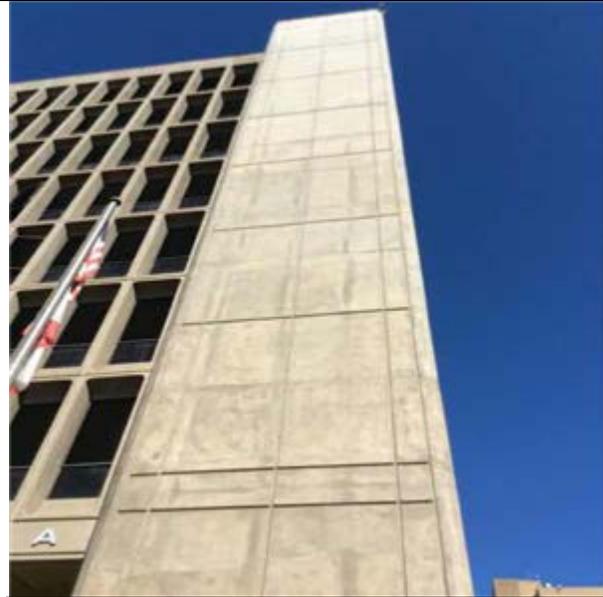
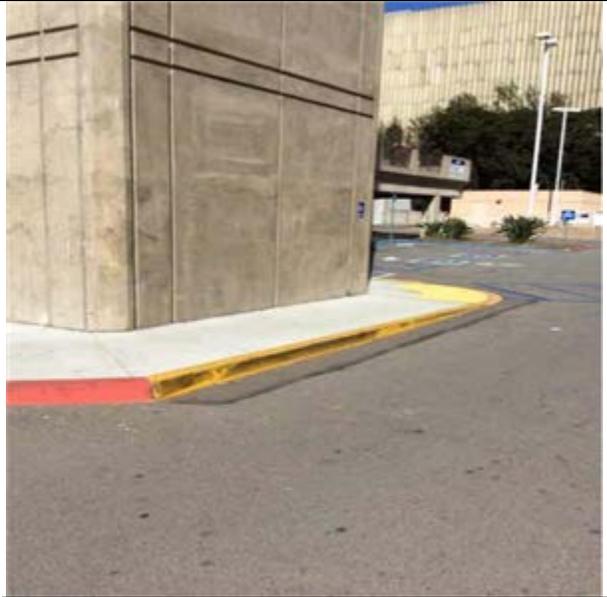
Item	Description
B2011 Exterior Wall Construction	B2011 Exterior Concrete Walls
Condition	Fair
Qty / UOM	92,000 / SF
RUL (years)	15
Location	Exterior Walls

B2011 Exterior Concrete Walls

Based on current condition and RUL, no further action is recommended.

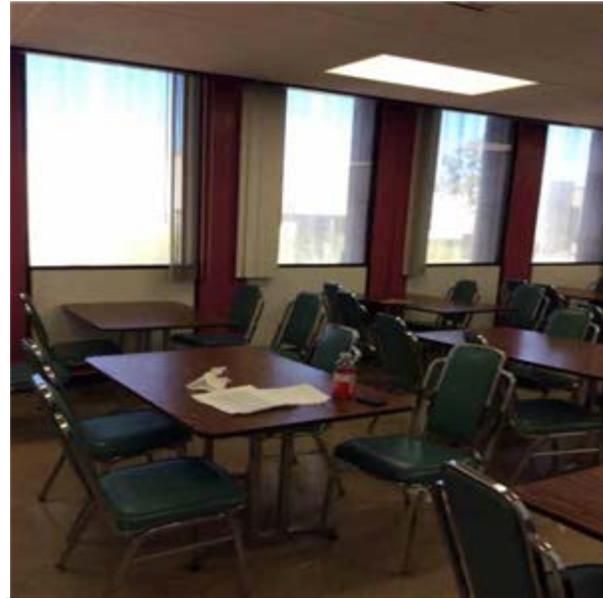
Item	Description
B2021 Windows	B2021 Aluminum Windows
Condition	Fair
Qty / UOM	1,492 / EA
RUL (years)	3
Location	Exterior

B2021 Aluminum Windows

Based on current condition and RUL, replacement is recommended.

Type	Component Description	Qty / UOM	Unit Cost (\$)	Plan Type	Priority	Year	Expenditures (\$)
B2021	Replace B2021 Aluminum Windows	1,492.0 - EA	2652.8	IN - Beyond Rated Life	Priority 2	2018	3,957,971

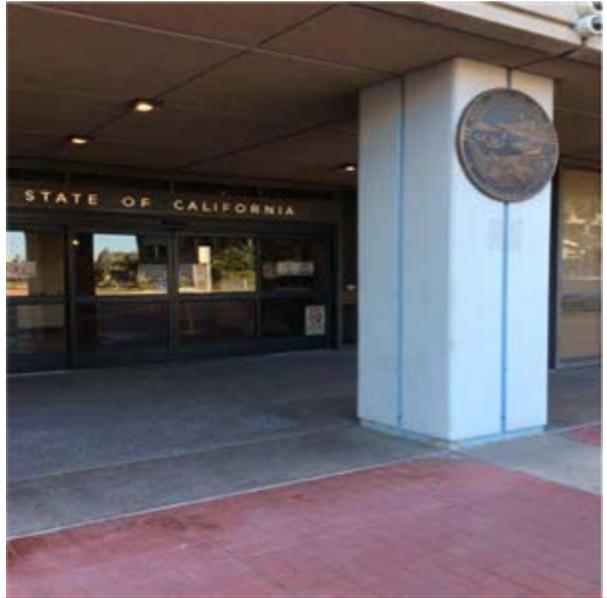
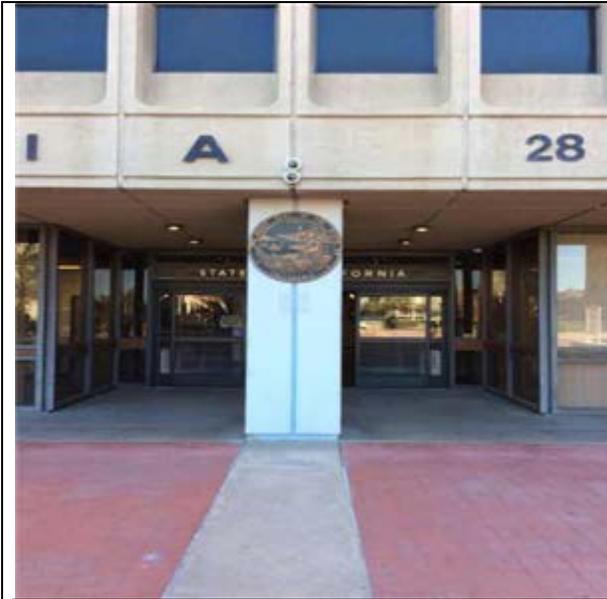
Item	Description
B2031 Glazed Doors & Entrances	B2031 Glazed Entrance Doors
Condition	Fair
Qty / UOM	28 / EA
RUL (years)	5
Location	Entrance Doors

B2031 Glazed Entrance Doors

Based on current condition and RUL, replacement is recommended during the term.

Type	Component Description	Qty / UOM	Unit Cost (\$)	Plan Type	Priority	Year	Expenditures (\$)
B2031	Replace B2031 Glazed Entrance Doors	28.0 - EA	3181.7	IN - Beyond Rated Life	Priority 3	2020	89,088

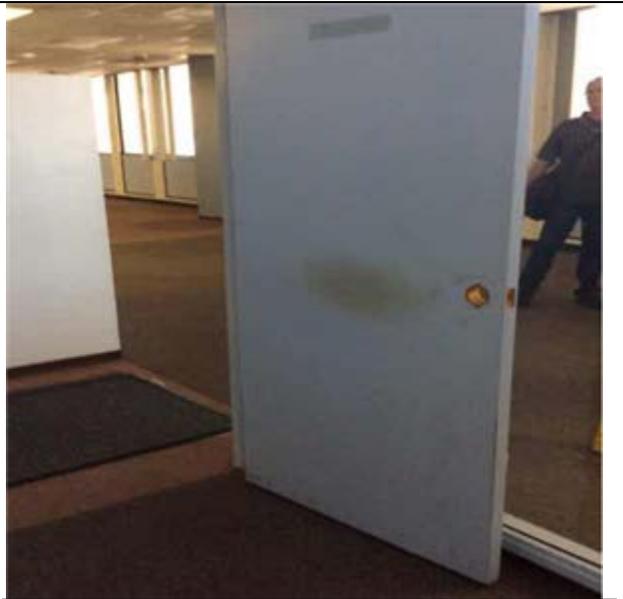
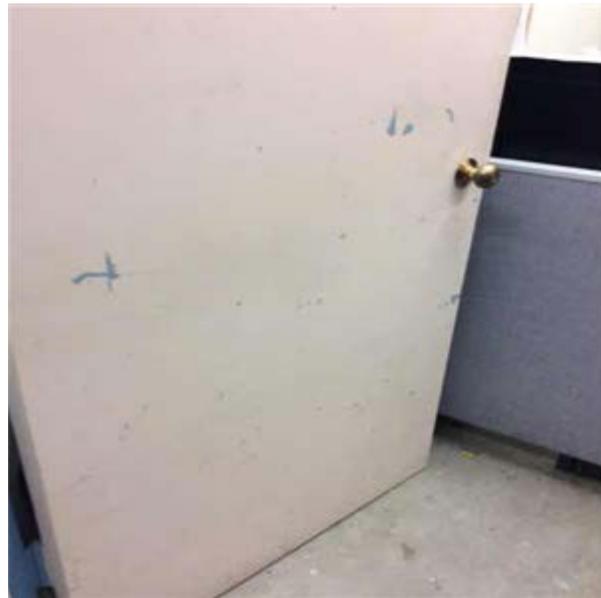
Item	Description
C1021 Interior Doors	C1021 Interior Doors
Condition	Fair
Qty / UOM	655 / EA
RUL (years)	2
Location	Interior Doors

C1021 Interior Doors

Based on current condition and RUL, replacement is recommended.

Type	Component Description	Qty / UOM	Unit Cost (\$)	Plan Type	Priority	Year	Expenditures (\$)
C1021	Replace C1021 Interior Doors	655.0 - EA	2403.1	IN - Beyond Rated Life	Priority 3	2017	1,574,044

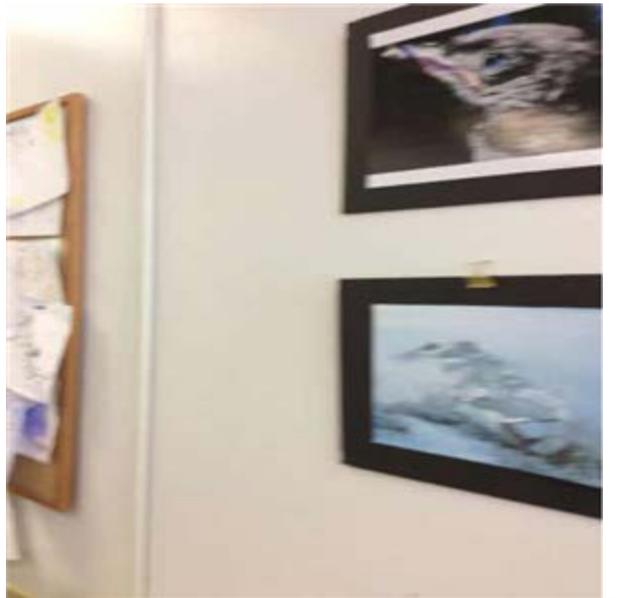
Item	Description
C3012 Wall Finishes to Interior Walls	C3012 Paint Interior Walls, Drywall
Condition	Fair
Qty / UOM	219,892 / SF
RUL (years)	1
Location	Interior Wall Finishes

C3012 Paint Interior Walls, Drywall

Based on current condition and RUL, repainting the interior walls is recommended.

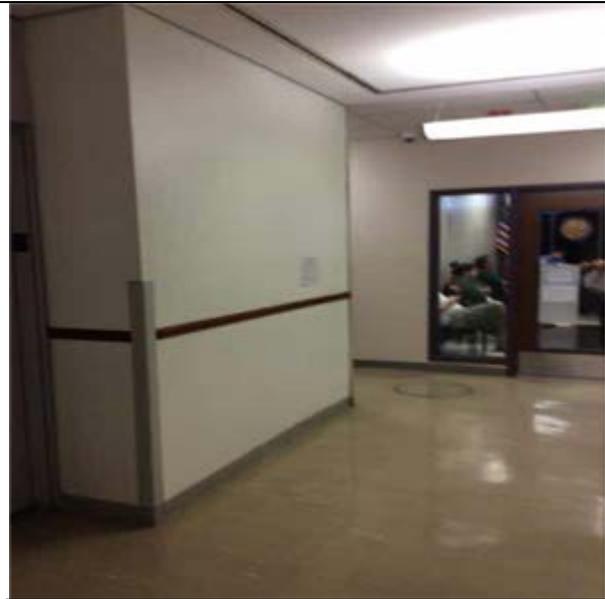
Item	Description
C3024 Flooring	C3024 Terrazzo Flooring
Condition	Fair
Qty / UOM	15,000 / SF
RUL (years)	13
Location	Interior Finishes

C3024 Terrazzo Flooring

Based on current condition and RUL, no further action is recommended.

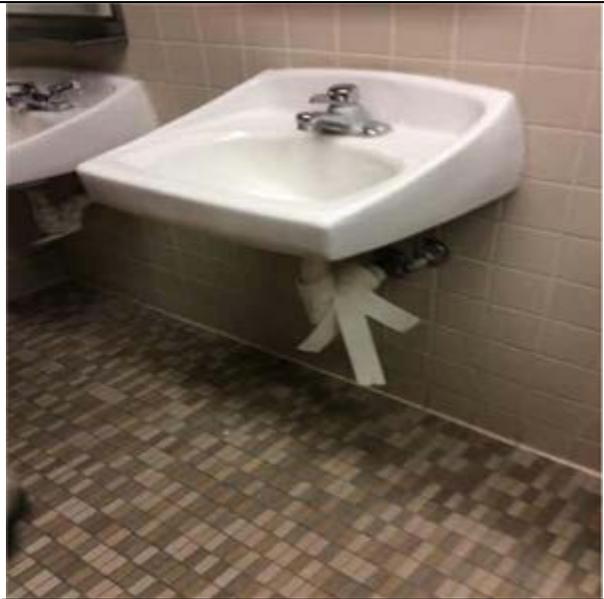
Item	Description
C3024 Flooring	C3024 Ceramic Tile
Condition	Fair
Qty / UOM	4,000 / SF
RUL (years)	13
Location	Interior Flooring

C3024 Ceramic Tile

Based on current condition and RUL, no further action is recommended.

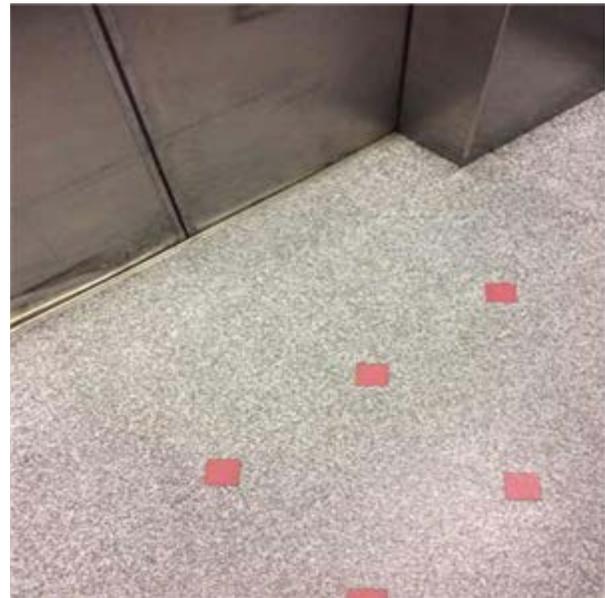
Item	Description
C3024 Flooring	C3024 Vinyl Tile Flooring
Condition	Fair
Qty / UOM	2,200 / SY
RUL (years)	6
Location	Interior Flooring

C3024 Vinyl Tile Flooring

Based on current condition and RUL, replacement is recommended.

Type	Component Description	Qty / UOM	Unit Cost (\$)	Plan Type	Priority	Year	Expenditures (\$)
C3024	Replace C3024 Vinyl Tile Flooring	2,200.0 - SY	163.1	IN - Appearance	Priority 4	2021	358,819

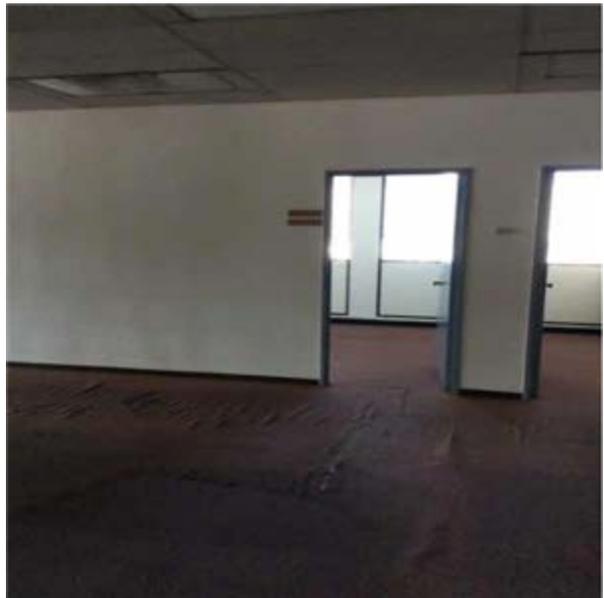
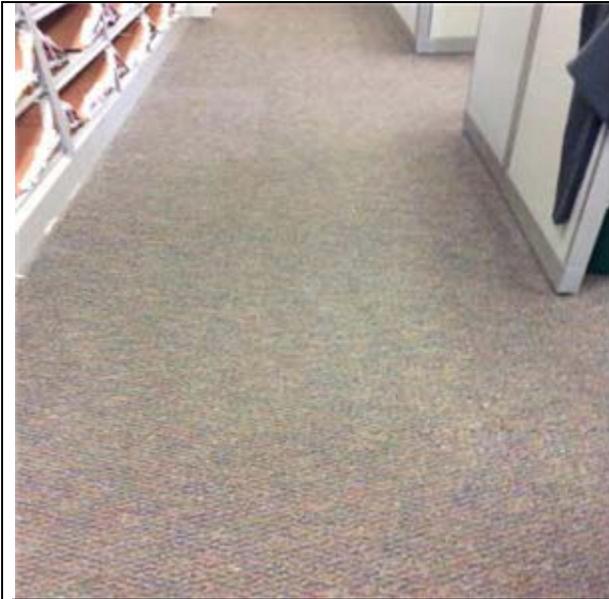
Item	Description
C3025 Carpeting	C3025 Carpet Tiles - Standard
Condition	Fair
Qty / UOM	7,495 / SY
RUL (years)	0
Location	Office areas

C3025 Carpet Tiles - Standard

Based on current condition and RUL, replacement is recommended.

Type	Component Description	Qty / UOM	Unit Cost (\$)	Plan Type	Priority	Year	Expenditures (\$)
C3025	Replace C3025 Carpet Tiles - Standard	7,495.0 - SY	96.6	IN - Beyond Rated Life	Priority 2	2015	724,059

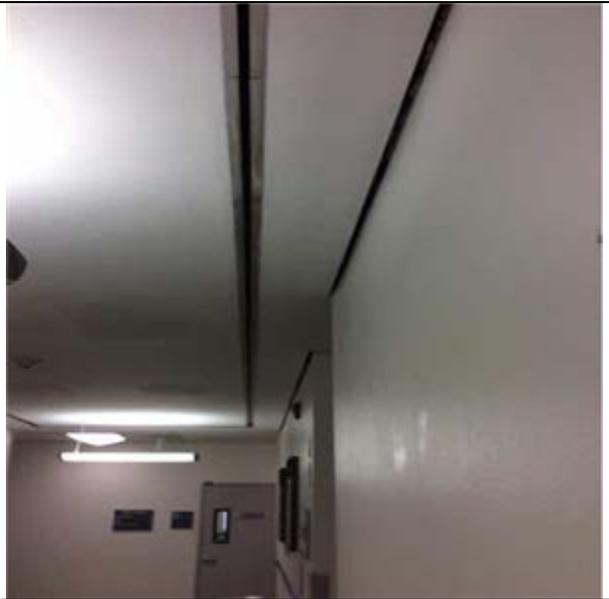
Item	Description
C3031 Ceiling Finishes	C3031 Drywall – Painted Finished Ceilings
Condition	Fair
Qty / UOM	50,222 / SF
RUL (years)	8
Location	Interior Ceilings

C3031 Drywall – Painted Finished Ceilings

Based on current condition and RUL, repainting the interior ceilings is recommended.

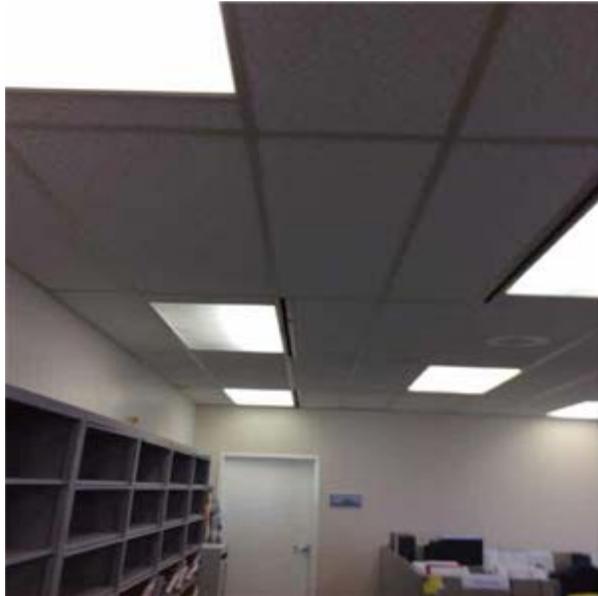
Item	Description
C3032 Suspended Ceilings	C3032 Acoustical Ceiling Tile
Condition	Fair
Qty / UOM	764 / CSF
RUL (years)	8
Location	Interior Ceilings

C3032 Acoustical Ceiling Tile

Based on current condition and RUL, replacement is recommended.

Type	Component Description	Qty / UOM	Unit Cost (\$)	Plan Type	Priority	Year	Expenditures (\$)
C3032	Replace C3032 Acoustical Ceiling Tile	764.0 - CSF	1201.6	IN - Appearance	Priority 4	2023	917,992

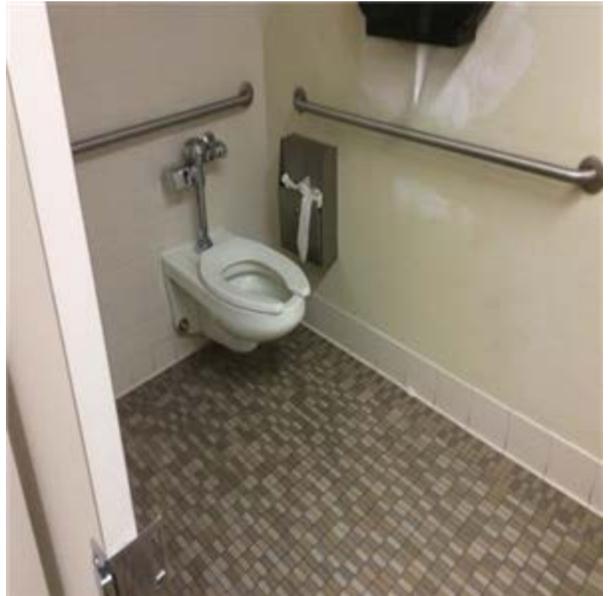
Item	Description
D2011 Water Closets	D2011 Commercial Grade Water Closet, 1.6 GPF Unit
Condition	Fair
Qty / UOM	5 / EA
RUL (years)	5
Location	Restrooms
Low Flow Toilet	Yes
System Grade	Commercial Grade

D2011 Commercial Grade Water Closet, 1.6 GPF Unit

Based on current condition and RUL, replacement is recommended.

Type	Component Description	Qty / UOM	Unit Cost (\$)	Plan Type	Priority	Year	Expenditures (\$)
D2011	Replace D2011 Commercial Grade Water Closet, 1.6 GPF Unit	5.0 - EA	1233.1	IN - Beyond Rated Life	Priority 3	2020	6,166

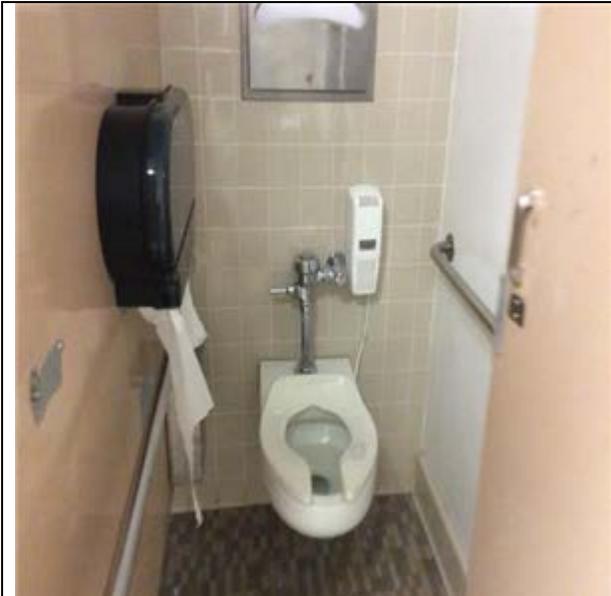
Item	Description
D2011 Water Closets	D2011 Commercial Water Closet - Standard
Condition	Fair
Qty / UOM	39 / EA
RUL (years)	3
Location	Restrooms
Low Flow Toilet	Yes
System Grade	Commercial Grade

D2011 Commercial Water Closet - Standard

Based on current condition and RUL, replacement is recommended.

Type	Component Description	Qty / UOM	Unit Cost (\$)	Plan Type	Priority	Year	Expenditures (\$)
D2011	Replace D2011 Commercial Water Closet - Standard	39.0 - EA	1233.1	IN - Beyond Rated Life	Priority 3	2018	48,093

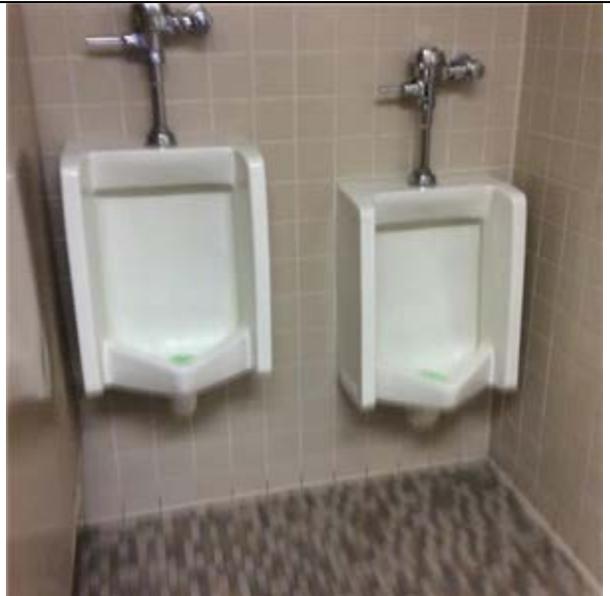
Item	Description
D2012 Urinals	D2012 Urinal - Standard
Condition	Fair
Qty / UOM	16 / EA
RUL (years)	3
Location	Men's Restrooms
Low Flow Toilet	Yes
System Grade	Commercial Grade

D2012 Urinal - Standard

Based on current condition and RUL, replacement is recommended.

Type	Component Description	Qty / UOM	Unit Cost (\$)	Plan Type	Priority	Year	Expenditures (\$)
D2012	Replace D2012 Urinal - Standard	16.0 - EA	2440.7	IN - Beyond Rated Life	Priority 3	2018	39,051

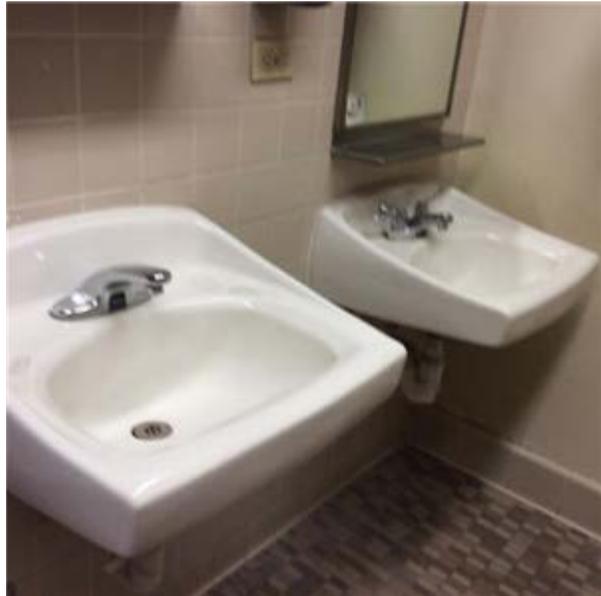
Item	Description
D2013 Lavatories	D2013 China Wall Hung Sink and Faucet - Standard
Condition	Fair
Qty / UOM	38 / EA
RUL (years)	3
Location	Restrooms

D2013 China Wall Hung Sink and Faucet - Standard

Based on current condition and remaining useful life (RUL), replacement is recommended.

Type	Component Description	Qty / UOM	Unit Cost (\$)	Plan Type	Priority	Year	Expenditures (\$)
D2013	Replace D2013 China Wall Hung Sink and Faucet - Standard	38.0 - EA	1542.0	IN - Beyond Rated Life	Priority 3	2018	58,598

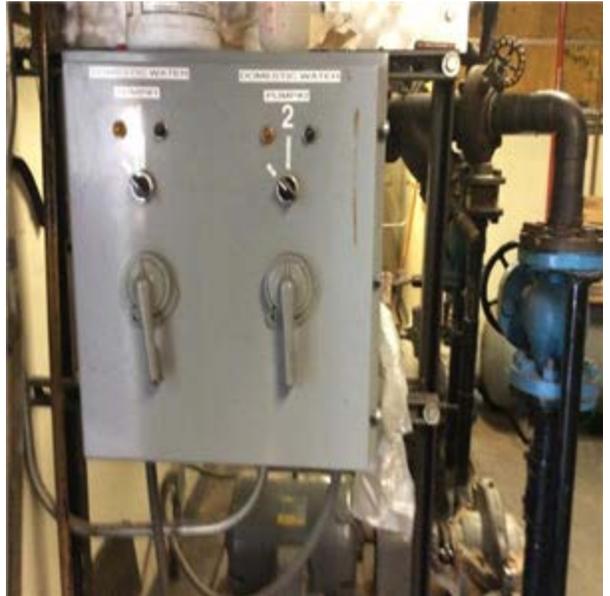
Item	Description
D2023 Domestic Water Supply Equipment	D2023 Domestic Water Distribution
Condition	Fair
Qty / UOM	2 / EA
RUL (years)	5
Location	Boiler Room

D2023 Domestic Water Distribution
