San Diego State Building (801)

1350 Front Street, San Diego, CA 92101

Facility Condition Assessment

September 2015

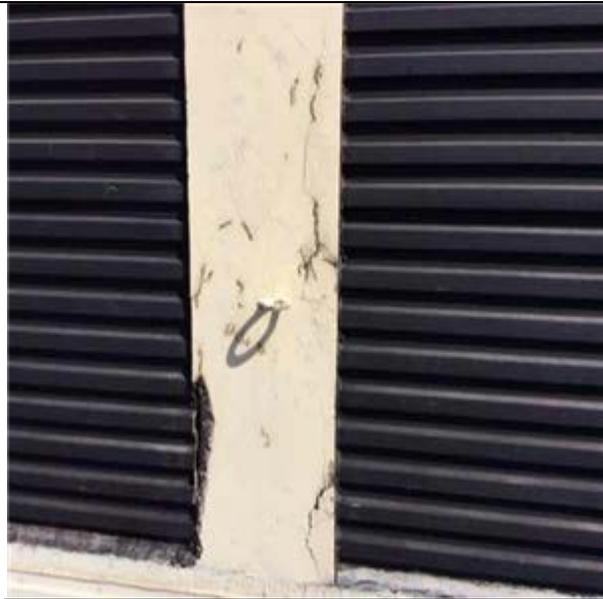
Item	Description
B2011 Exterior Wall Construction	B2011 Penthouse Plaster
Condition	Poor
Qty / UOM	7,560 / SF
RUL (years)	0
Location	Penthouse

There are several cracks in the penthouse walls. Repair and painting of the walls are required.

Type	Component Description	Qty / UOM	Unit Cost (\$)	Plan Type	Priority	Year	Expenditures (\$)
B2011	Replace B2011 Penthouse Plaster	7,560.0 - SF	18.3	IN - Appearance	Priority 1	2015	138,554

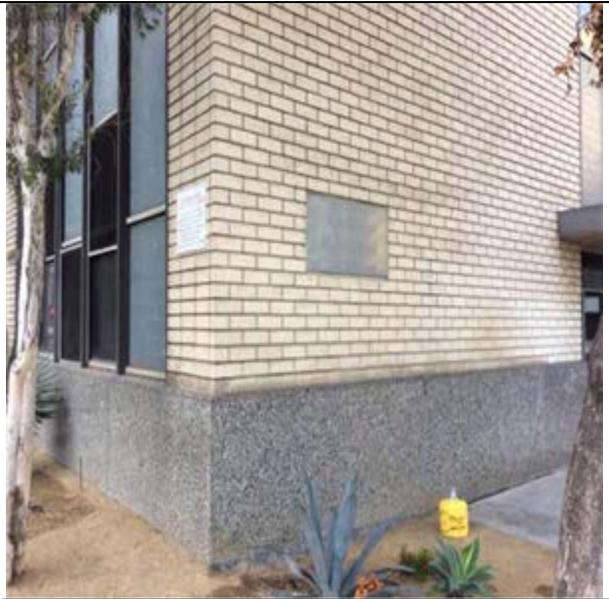
Item	Description
B2011 Exterior Wall Construction	B2011 Pressure Wash Exterior Walls
Condition	Fair
Qty / UOM	32,500 / SF
RUL (years)	0
Location	Stairs
Exterior Wall Construction	Exposed Aggregate Precast Concrete Panels
Parapets	Yes
Balcony Walls and Handrails	Concrete
Exterior Soffits	Concealed
Lintels and Sills	Concrete

The exterior walls are a combination of stone and brick veneer. Based on their condition, pressure washing and repair are anticipated.

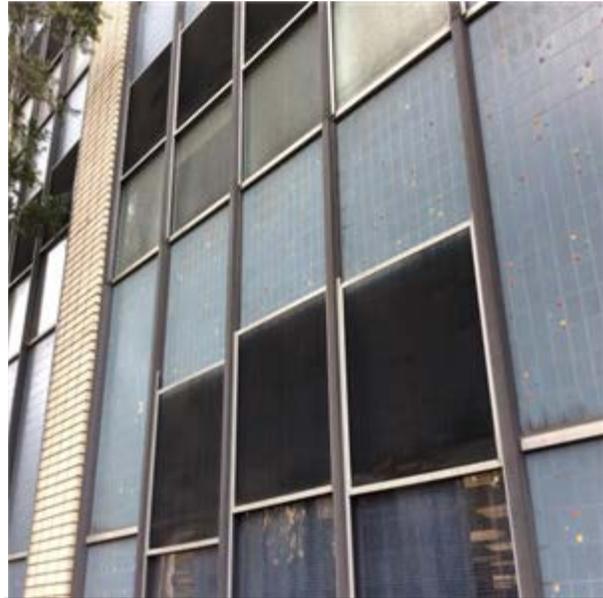
Item	Description
B2021 Windows	B2020 Aluminum Window Caulking
Condition	Poor
Qty / UOM	6,930 / LF
RUL (years)	0
Location	All Floors

Replace sealant and gaskets on the original windows.

Type	Component Description	Qty / UOM	Unit Cost (\$)	Plan Type	Priority	Year	Expenditures (\$)
B2021	Replace B2020 Aluminum Window Caulking	6,930.0 - LF	48.3	IN - Beyond Rated Life	Priority 1	2015	334,963

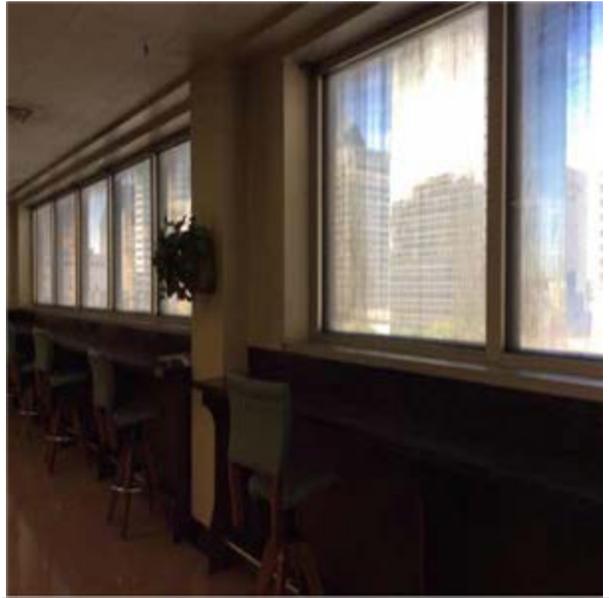
Item	Description
B2021 Windows	B2021 Aluminum Windows
Condition	Fair
Qty / UOM	495 / EA
RUL (years)	0
Location	All upper floors
Window Type	Fixed
Windows Material	Aluminum
Windows Glazing	Single Glazed
Window Operation	Fixed

There are 495 single aluminum windows, which were installed in 1963. Sealant and gasket replacement is required.

Type	Component Description	Qty / UOM	Unit Cost (\$)	Plan Type	Priority	Year	Expenditures (\$)
B2021	Replace B2021 Aluminum Windows	495.0 - EA	2304.5	IN - Beyond Rated Life	Priority 1	2015	1,140,710

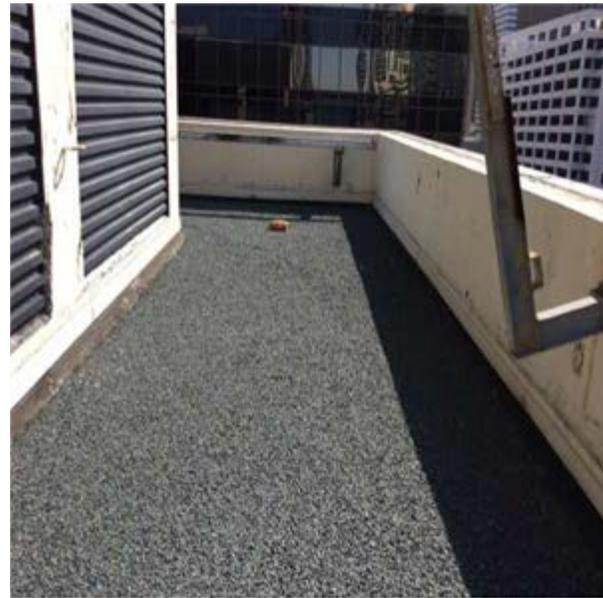
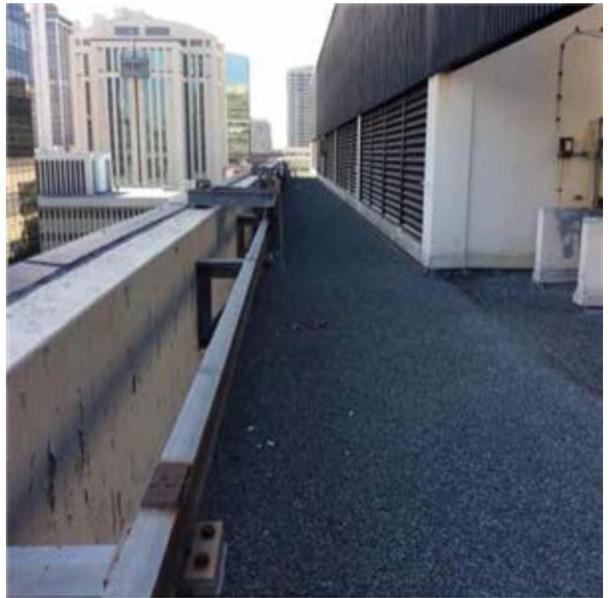
Item	Description
B3011 Roof Finishes	B3011 Built-Up Roof Membrane
Condition	Fair - Good
Qty / UOM	220 / SQ
RUL (years)	10
Location	Roof
Insulation	Rigid
Flashings and Trim	Concrete
Roof Drainage	Internal Building Piping
Roof Warranty	Yes

Per conversation with maintenance staff, the roof was replaced in 2006 and has a 20-year warranty. No action required.

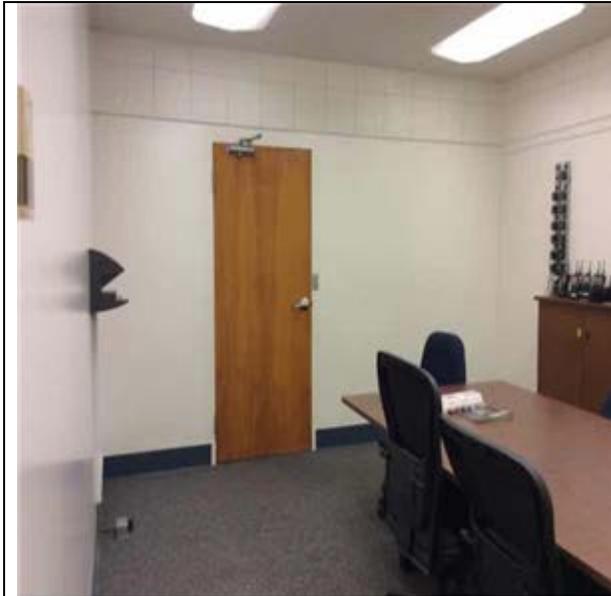
Item	Description
C1021 Interior Doors	C1021 Interior Single Fire Doors
Condition	Poor
Qty / UOM	385 / EA
RUL (years)	0
Location	All Floors

The interior doors do not have fire rating labels. According to the Fire Safety Correction Notice issued in August 2014, the interior fire doors are not in compliance with current codes. Total replacement of doors, frames, and hardware is required.

Type	Component Description	Qty / UOM	Unit Cost (\$)	Plan Type	Priority	Year	Expenditures (\$)
C1021	Replace C1021 Interior Single Fire Doors	385.0 - EA	4203.6	IN - Appearance	Priority 2	2015	1,618,386

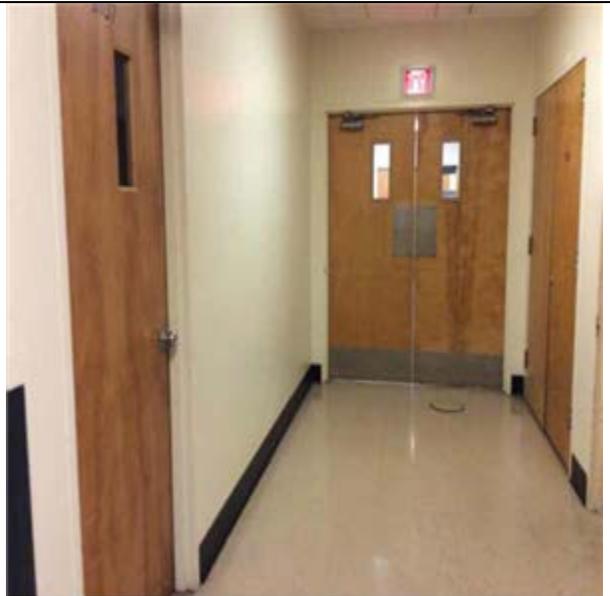
Item	Description
C1021 Interior Doors	C1021 Wood Double Doors and Frames
Condition	Poor
Qty / UOM	15 / EA
RUL (years)	0
Location	First Floor

The double doors do not have fire rating labels. According to the Fire Safety Correction Notice issued in August 2014, the interior fire doors are not in compliance with current codes. Total replacement of doors, frames, and hardware is required.

Type	Component Description	Qty / UOM	Unit Cost (\$)	Plan Type	Priority	Year	Expenditures (\$)
C1021	Replace C1021 Wood Double Doors and Frames	15.0 - EA	8407.2	IN - Appearance	Priority 2	2015	126,108

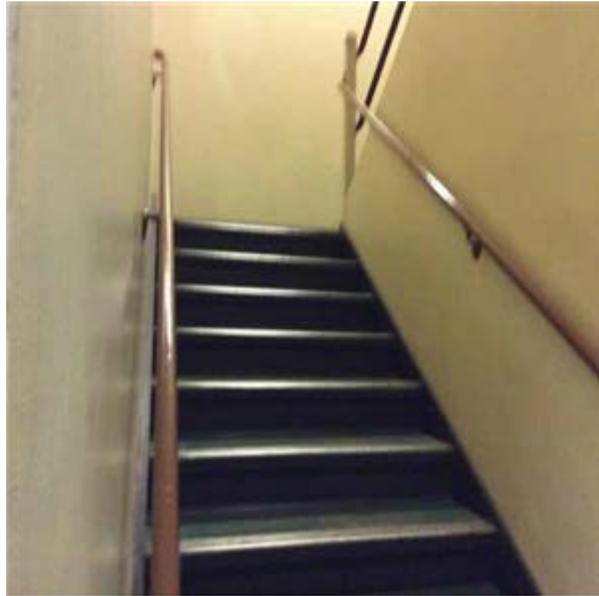
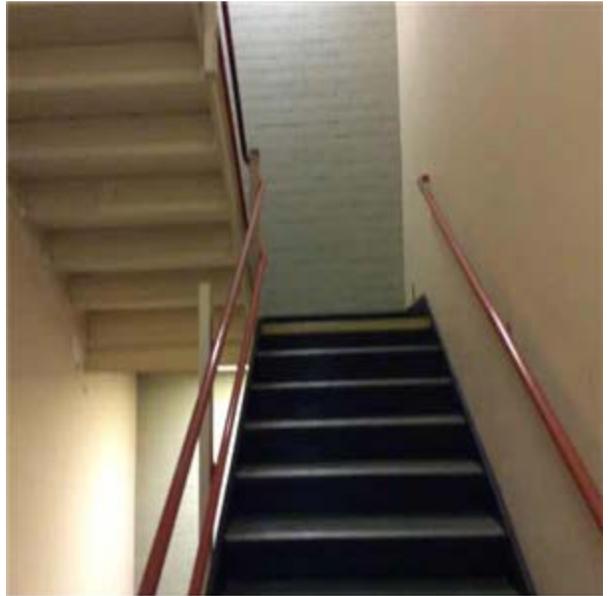
Item	Description
C2011 Regular Stairs	C2011 Fire Exit Stairs
Condition	Fair
Qty / UOM	3,450 / SF
RUL (years)	15
Location	Stairs
Stairs Frame	Steel
Stair Riser	Closed
Stair Treads	Concrete
Stair Railings	Metal
Stair Soffit Finishes	Plaster
Stair Handrail Finishes	Painted

There are two fire exit stairways. Based on their overall condition, repair and painting are required.

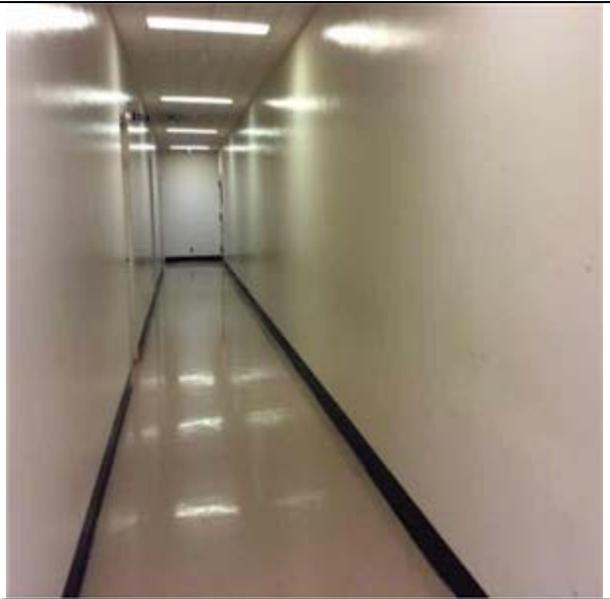
Item	Description
C3012 Wall Finishes to Interior Walls	C3012 Paint Interior Drywall
Condition	Fair
Qty / UOM	141,450 / SF
RUL (years)	0
Location	All Floors

Type	Component Description	Qty / UOM	Unit Cost (\$)	Plan Type	Priority	Year	Expenditures (\$)
C3012	Replace C3012 Paint Interior Drywall	141,450.0 - SF	2.1	IN - Appearance	Priority 2	2015	301,685

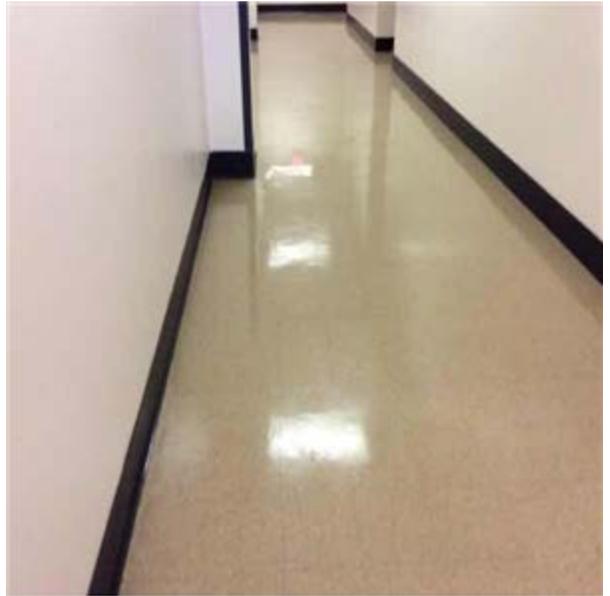
Item	Description
C3024 Flooring	C3024 Vinyl Tile
Condition	Poor
Qty / UOM	1,450 / SY
RUL (years)	0
Location	All Floors
Floor Toppings	Light Weight Concrete

Based on the RUL and condition, vinyl tile replacement is anticipated.

Type	Component Description	Qty / UOM	Unit Cost (\$)	Plan Type	Priority	Year	Expenditures (\$)
C3024	Replace C3024 Vinyl Tile	1,450.0 - SY	125.8	IN - Appearance	Priority 2	2015	182,381

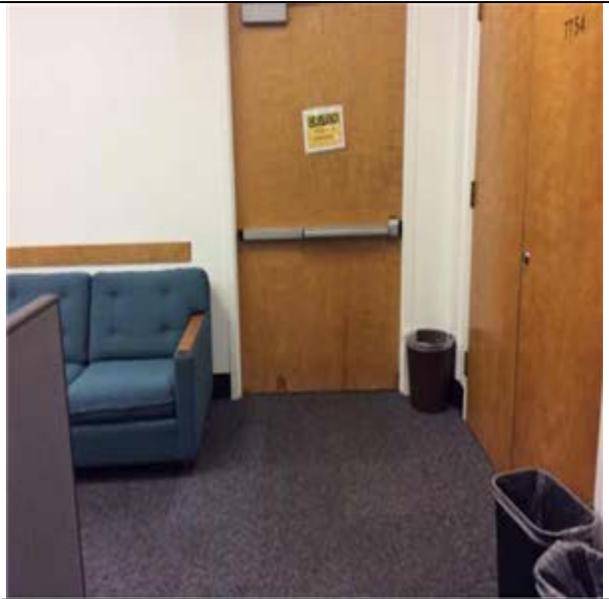
Item	Description
C3025 Carpeting	C3025 Carpet Tiles - Standard
Condition	Fair
Qty / UOM	8,250 / SY
RUL (years)	0
Location	All Floors

Office area carpet flooring shows wear and stains. Based on the RUL and condition, replacement is required.

Type	Component Description	Qty / UOM	Unit Cost (\$)	Plan Type	Priority	Year	Expenditures (\$)
C3025	Replace C3025 Carpet Tiles - Standard	8,250.0 - SY	96.6	IN - Appearance	Priority 2	2015	796,996

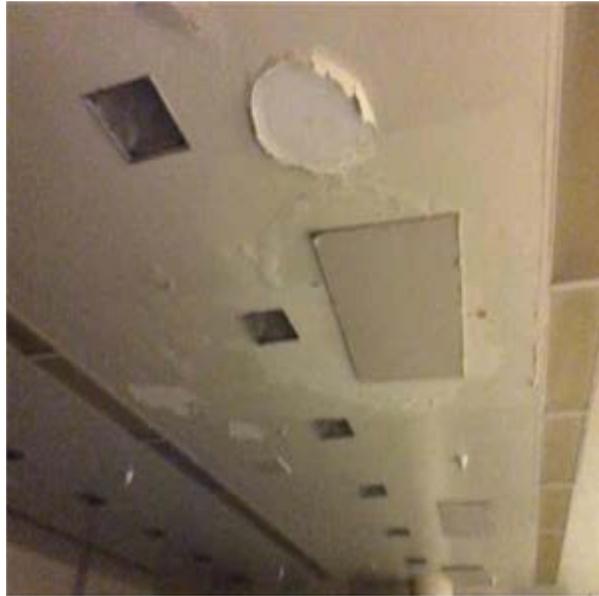
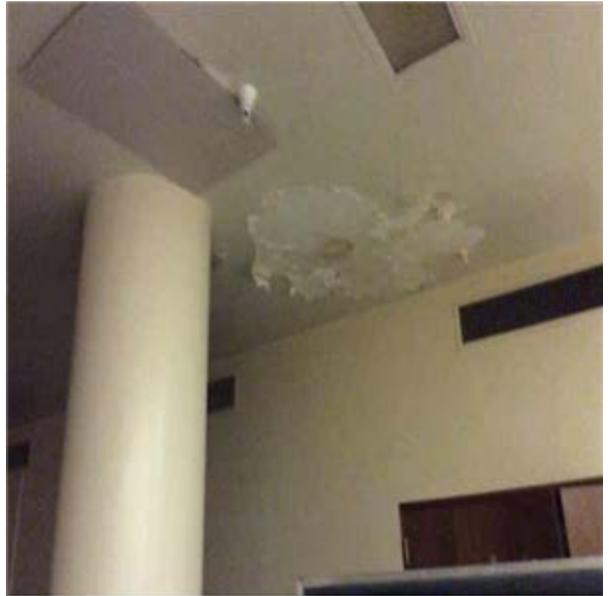
Item	Description
C3031 Ceiling Finishes	C3031 Drywall – Painted Finished Ceilings
Condition	Poor
Qty / UOM	27,450 / SF
RUL (years)	0
Location	All Floors

All common area ceilings are painted drywall. There is water damage on the auditorium ceiling. Recommended installation of a fire sprinkler system necessitates ceiling replacement.
