Subject: Maintenance Monitoring Report #9, prepared by Gerhard Bombe - Sierra Conservation Center Effluent Disposal Project; Vernal Pools, Visual Aesthetics, Oak Tree, and Wetland/Riparian Mitigation Activities

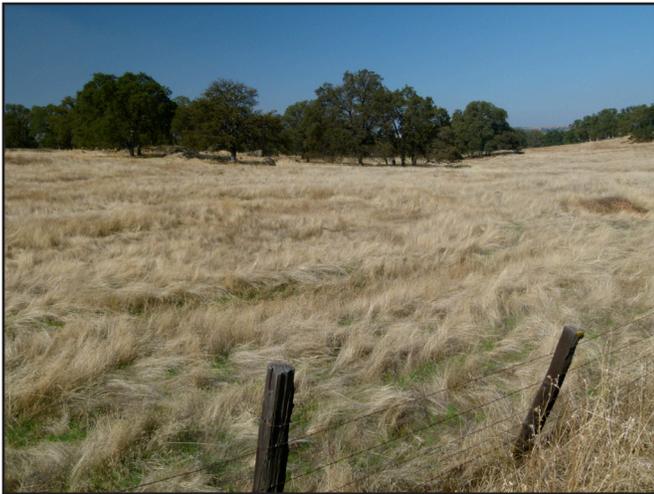
Vernal pool #6 overview. Even after recent rains, pool is still dry.

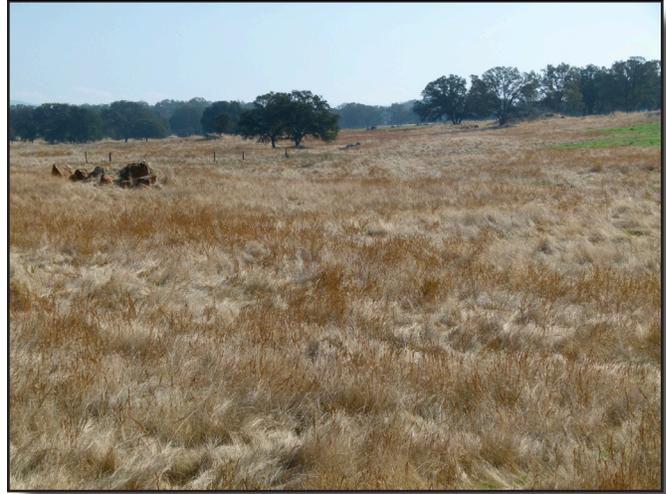
Vernal pool #12 overview. Pool is still dry. Sprayfield is in operation in the background.

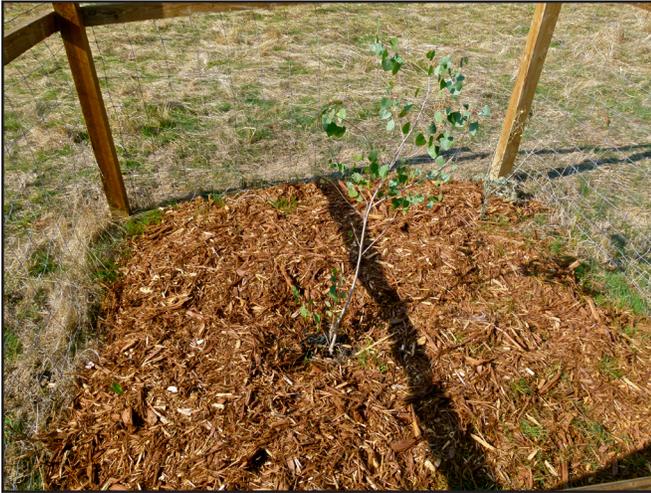
Newly planted replacement Cottonwood. All trees were mulched, as part of the replacement planting.

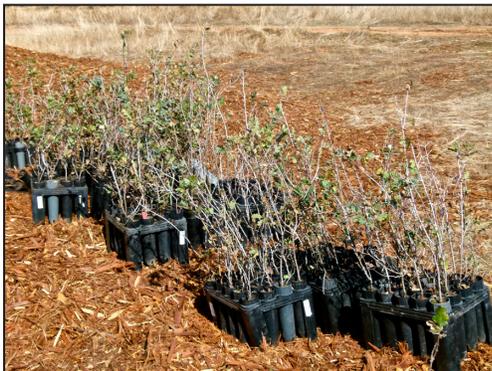
400 new Blue Oaks, in D-40 pots were replanted this month.

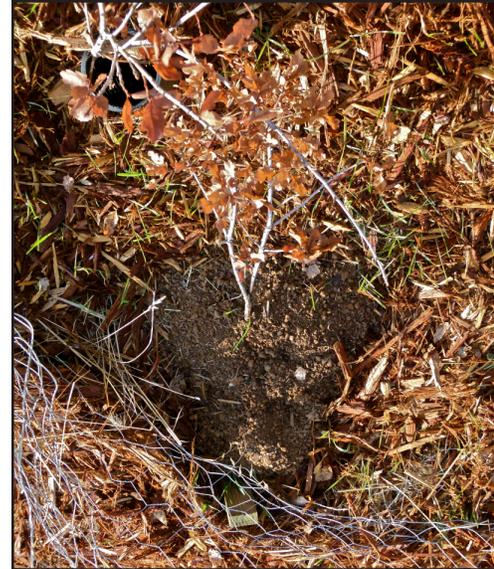
Oak Tree Mitigation Site: Tree mortality has increased due to greater gopher activity, to necessitate replacement planting. Gophers are the main agent responsible for the death of the trees. A close inspection, by scratching the bark and looking for the green cambium, checking for new growth, and gently tugging on the tree trunk, revealed 604 live trees. As this number is below the required 795 survival rate, 400 new oaks were planted from the 19th through the 21st of October by the CCC. All new plantings included a protective wire mesh basket, to keep gophers from attacking the tree root systems. Trees are still being browsed by deer, and insects have also taken a toll on the leaves - all without any apparent ill effects.

A fresh gopher attack, as evidenced by this recently created mound, quickly results in the death of the tree. The trees die so fast that the leaves are still on the tree.

Failed trees have been replaced in this fall's plant material replacement cycle. Photographs of that process are shown below. No other remedial measures are necessary at this time.

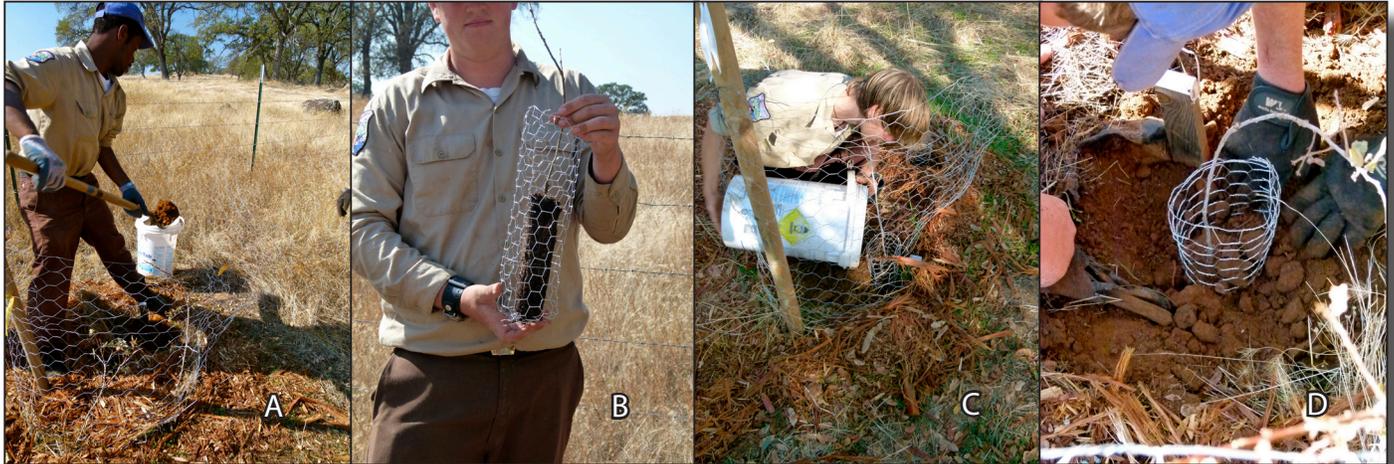
The new trees were planted in the existing cages by (A) loosening the existing wire cage, raking away the mulch from the planting area, removing the dead tree, digging a new planting hole and placing the spoils in a bucket (to backfill the hole), (B) then wrapping the root ball in a precut chickenwire cage, with the bottom end folded over itself and closed, (C) placing the tree with the chickwire cage in the planting hole, then backfilling the hole with the clean soil from the bucket, (D) tamping the backfill firmly against the rootball, to ensure good soil to root contact, and in the end, thoroughly irrigating the newly planted tree, as well as all the other trees in the cage.

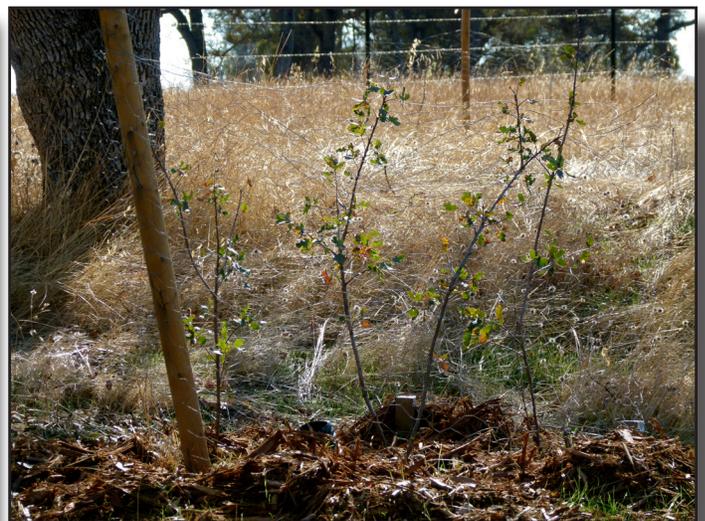
A cage where all four previously planted oak trees survived gopher predation.

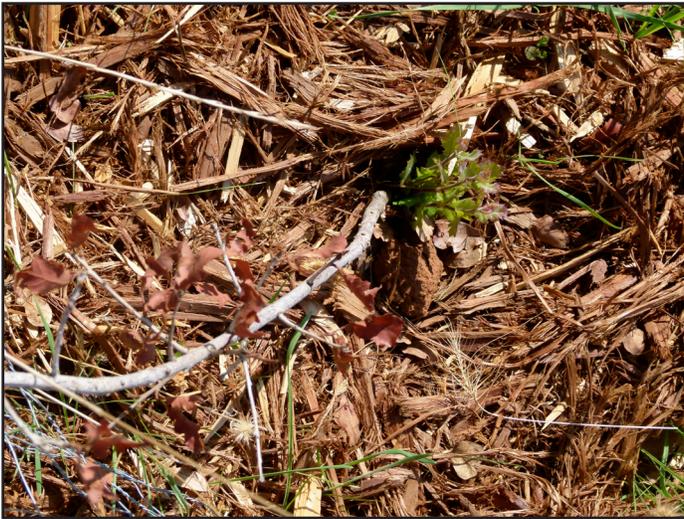
When pulling on the trunk of trees, a gopher cut root system will let the tree come out of the ground with no resistance. If even a slight resistance is felt, that could be indicative that the tree still has some active roots left, and that it may re-grow, as is evident here.

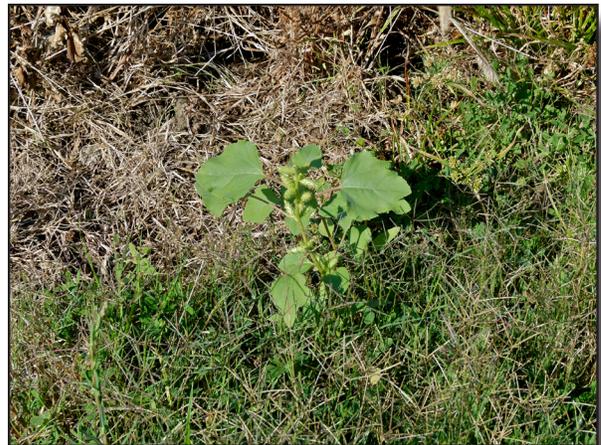
However, despite regular monthly herbicide applications, certain weeds, such as cocklebur persist throughout the wetland sites.

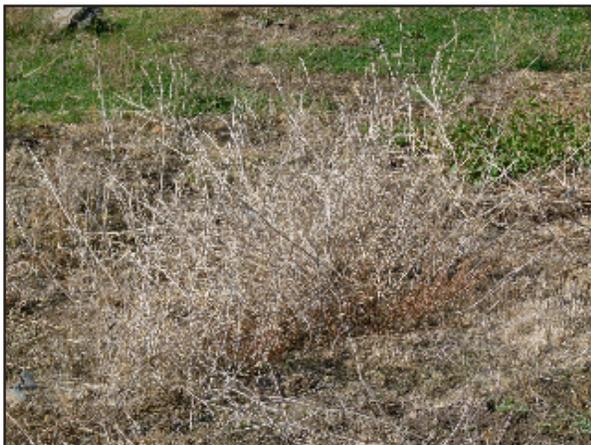
Effective kill of yellow star thistle...which still persists, but is effectively sprayed with herbicide on a monthly basis.

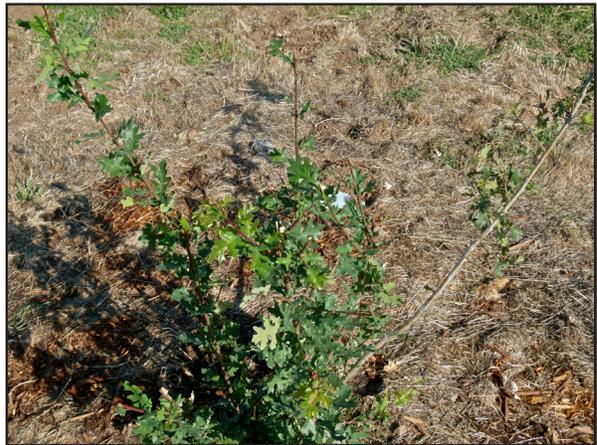
Ongoing browsing on this oak.

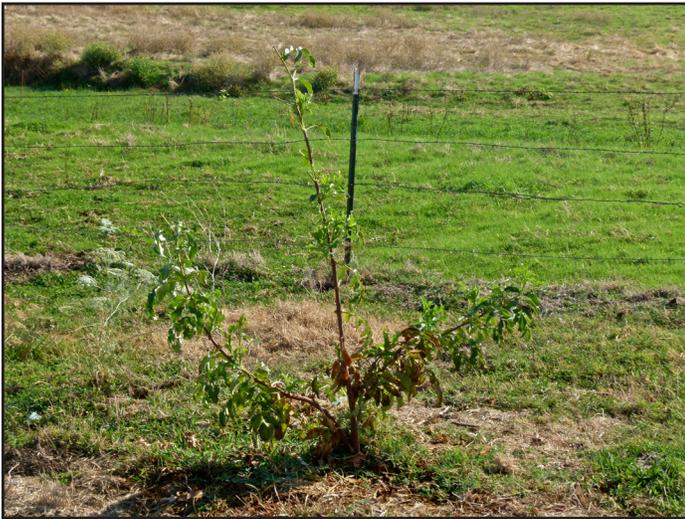
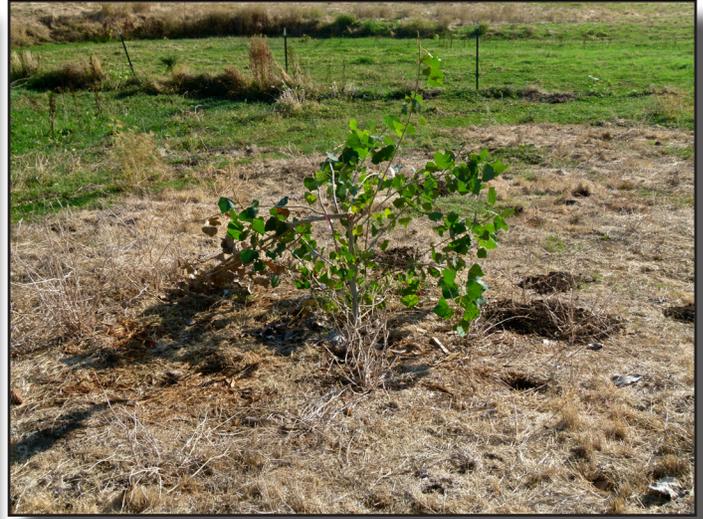
Wetland/Riparian Restoration Site: Upland container plants and riparian cuttings, continue to show excellent new growth. Unfortunately, several cattle were observed in Plot A, and caused some damage, before they could be driven out, back into the pasture. The barbed wire fence will be reinforced to prevent any recurrence of cattle intrusion. The upland plants were checked for moisture and were watered and will continue to be watered at two week intervals until the start of the rainy season. Remnant, emerging star thistle, Bermuda, cocklebur and kikuja grass, as well as many other exotic, invasive weeds were sprayed again with RoundUp herbicide. Previous herbicide applications were very effective against the yellow star thistle, in particular, and other undesirable vegetation, in general. Herbicide applications will continue as necessary.

Cattle related damage to trees and shrubs will stunt their growth, but will not kill them.

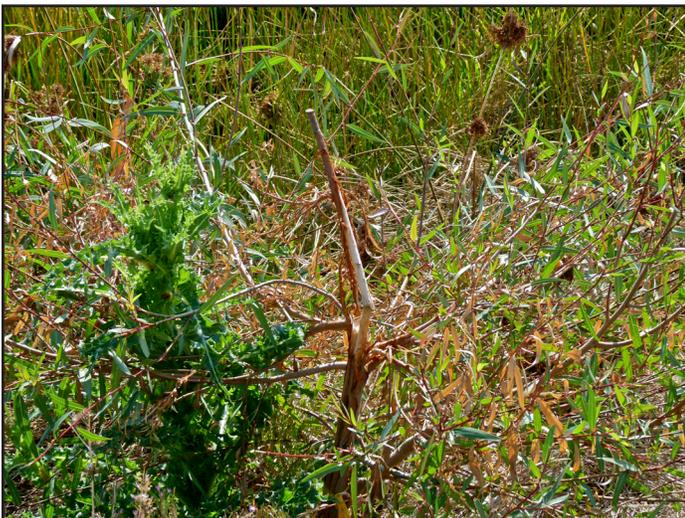
A few well established willow cuttings in Plot C have also been damaged, but by deer, rubbing the fuzz off their antlers.
