Employment Development Department Annex (013)

751"N" Street, Sacramento, CA 95814

Facility Condition Assessment

June 2015

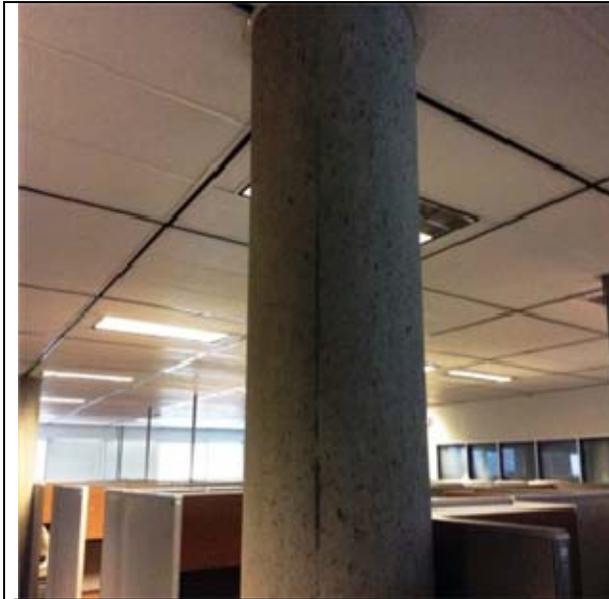
An outdoor park is situated above the Subterranean Building. According to the maintenance staff, the heating and cooling systems are not conditioning effectively in the office area. Adding insulation above suspended ceilings is recommended.

Type	Component Description	Qty / UOM	Unit Cost (\$)	Plan Type	Priority	Year	Expenditures (\$)
B1021	Replace B1021 Batt Insulation, Fiberglass R38	71,250.0 - SF	3.5	OP - Energy	Priority I	2015	250,344

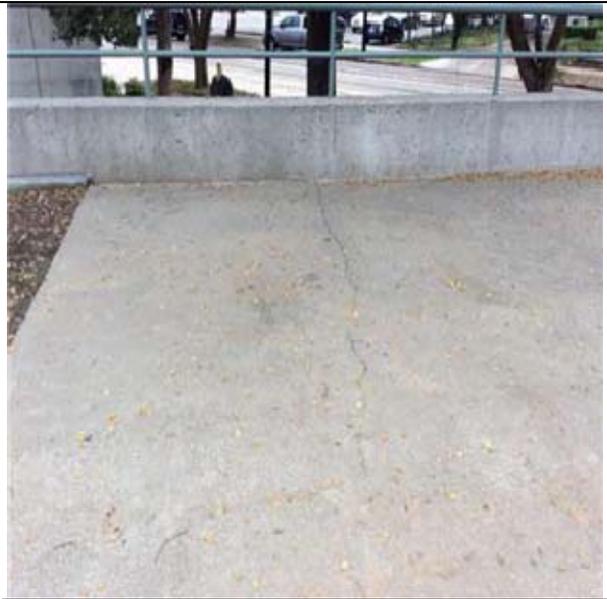
Water is penetrating into the building through the roof membranes from the outdoor park over subterranean space and causing the moisture issues. It is recommended to repair the outdoor park surface with concrete sealant and epoxy injection at the cracks.

Type	Component Description	Qty / UOM	Unit Cost (\$)	Plan Type	Priority	Year	Expenditures (\$)
B1021	Replace B1020 Seal concrete at outdoor park	71,250.0 - SF	11.5	IN - Beyond Rated Life	Priority I	2015	821,655

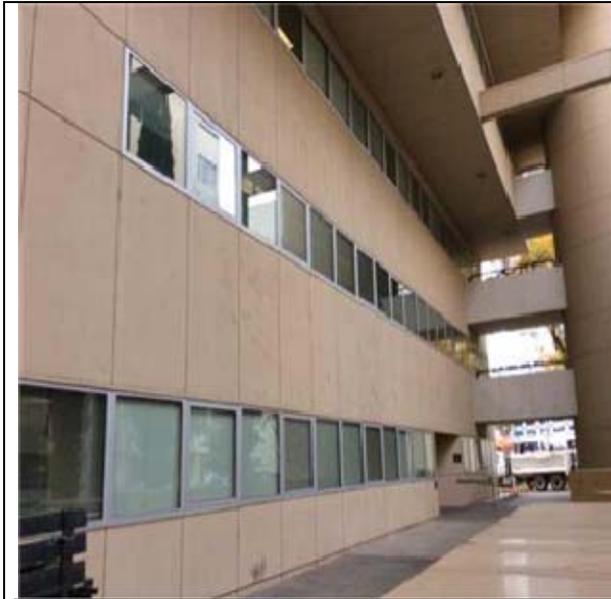
B2010 Stucco and Lath

Based on age and condition, the exterior stucco finish requires crack repair and painting.

Type	Component Description	Qty / UOM	Unit Cost (\$)	Plan Type	Priority	Year	Expenditures (\$)
B2011	B2011 Repair and Paint Exterior Walls	38,250.0 - SF	18.3	IN - Appearance	Priority I	2015	701,015

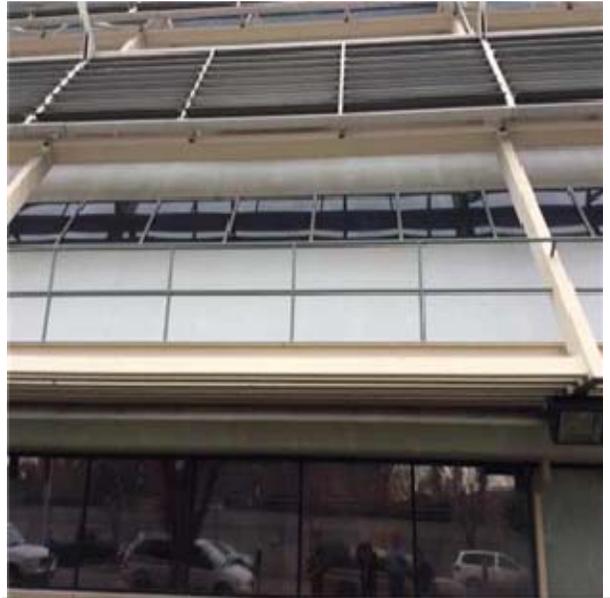
The Solar Building south side has historically had a leaking issue at windows where the solar awnings are attached. Replacement of caulking at the windows is recommended. Based on the estimated RUL, the windows will require eventual replacement.

Type	Component Description	Qty / UOM	Unit Cost (\$)	Plan Type	Priority	Year	Expenditures (\$)
B2021	B2021 - Windows - Recaulking	3,927.0 - LF	38.1	OP - Maintenance	Priority 2	2015	149,493
B2021	B2021 - Windows - Recaulking	3,927.0 - LF	38.1	OP - Maintenance	Priority 2	2020	149,493
B2021	Replace B2021 Windows	231.0 - EA	3614.8	OP - Maintenance	Priority 4	2024	835,018

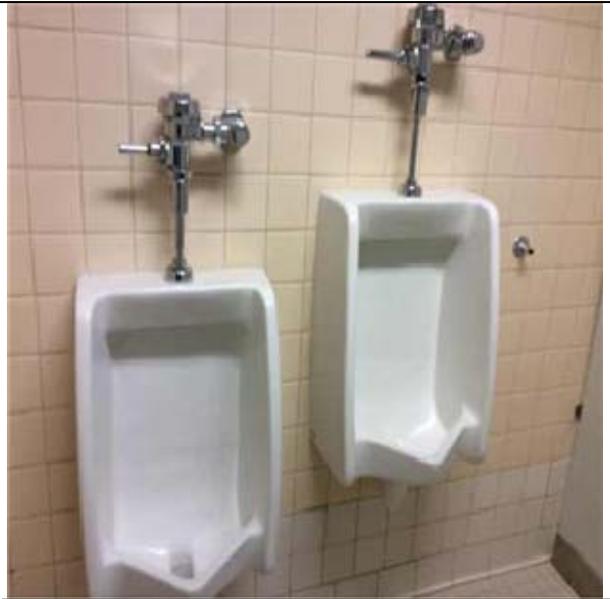
Item	Description
C3005 ADA Renovations	C3005 ADA Restroom Renovations
Condition	Fair - Good
Qty / UOM	20 / EA
RUL (years)	0
Location	All Floors

Type	Component Description	Qty / UOM	Unit Cost (\$)	Plan Type	Priority	Year	Expenditures (\$)
B2031	B2031 Install ADA automatic door openers	25.0 - EA	2159.5	CC - Accessibility	Priority I	2015	53,987
C1035	Replace C1035 Directional Signage	12.0 - EA	316.2	CC - Accessibility	Priority I	2015	3,794
C3005	ADA Restroom Renovation	20.0 - EA	29760.0	CC - Accessibility	Priority I	2015	595,200
D2018	Replace D2018 ADA Drinking Fountain	10.0 - EA	3504.6	CC - Accessibility	Priority I	2015	35,046
G2035	Replace G2030 Pedestrian Paving	1.0 - Lump Sum	500000.0	CC - Accessibility	Priority I	2015	500,000

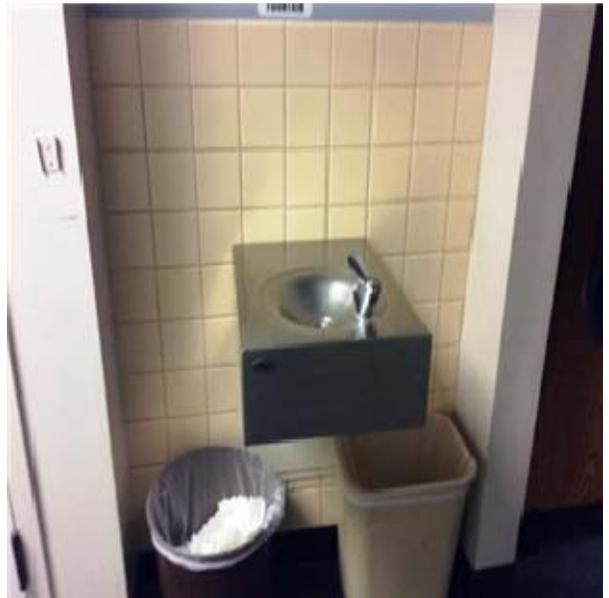
Item	Description
D2018 Drinking Fountains and Coolers	D2018 ADA Drinking Fountain
Condition	Poor
Qty / UOM	10 / EA
RUL (years)	0
Location	All Floors

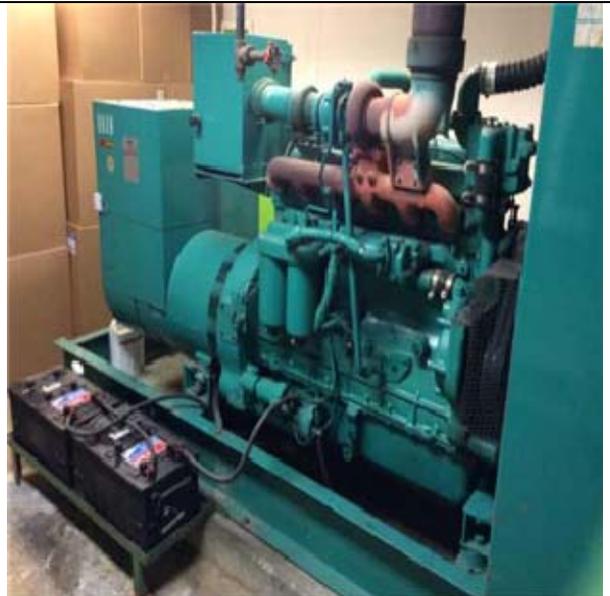
D5092 Diesel Generator 125 kW:- Emergency generator

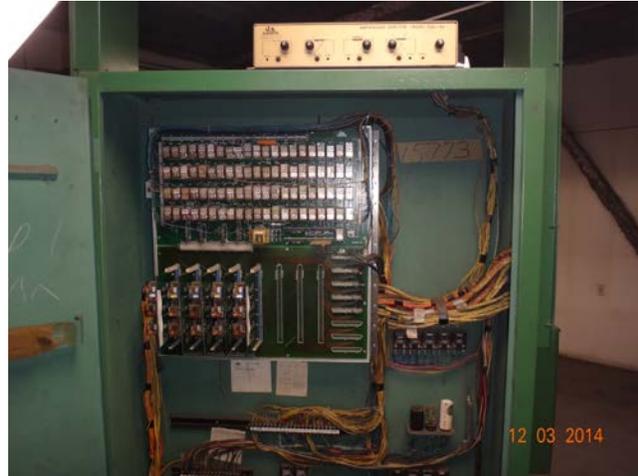
Controllers:

The controllers were manufactured and installed U.S. Elevator when the elevators were installed. The controllers use a combination of relays and solid state boards that are now obsolete and have reached the end of their serviceable life. We recommend new solid state controllers with energy efficient Variable Frequency (VF) drives.

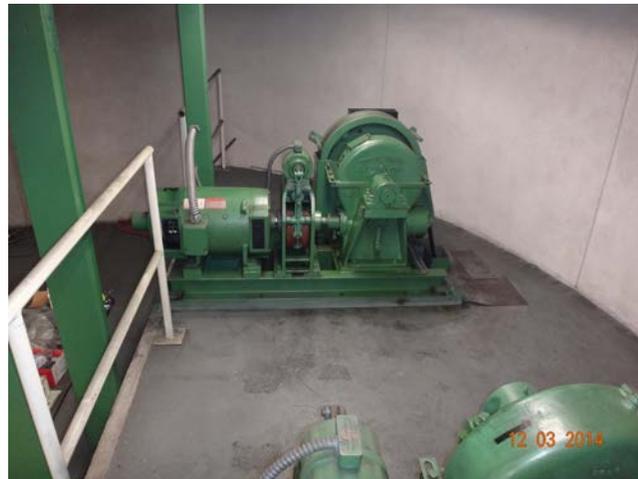
Hoist Machines:

The elevators have geared machines that were manufactured by Hollister Whitney. The machines are in fair condition and have D.C. hoist motors that should be upgraded to A.C. hoist motors when the elevators are modernized.

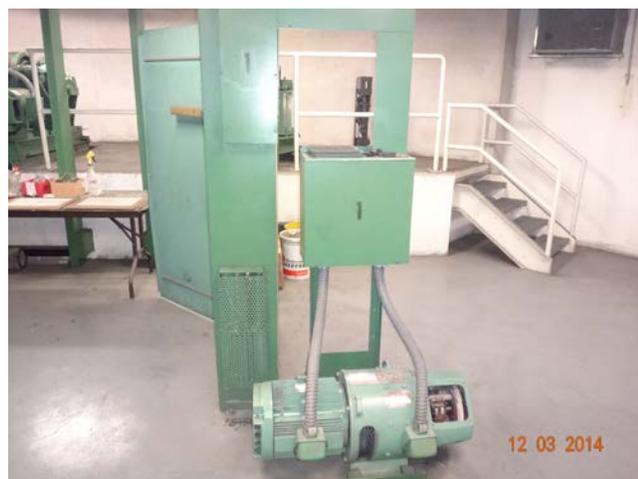
Motor Generator Set:

Both elevators have the original motor generator sets that convert the incoming AC power to DC. We recommend these be removed and new AC hoist motors installed with energy efficient VF drives.

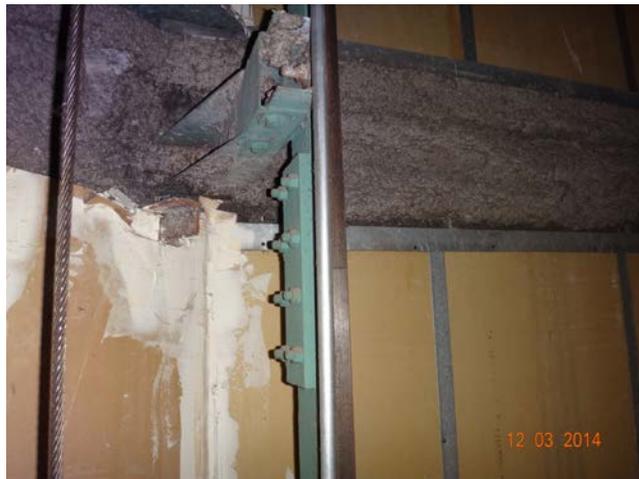
Car Guide Rails:

The car rails are in good condition but do not have seismic fish plates. Upgrading the guide rails to current seismic standards is voluntary.

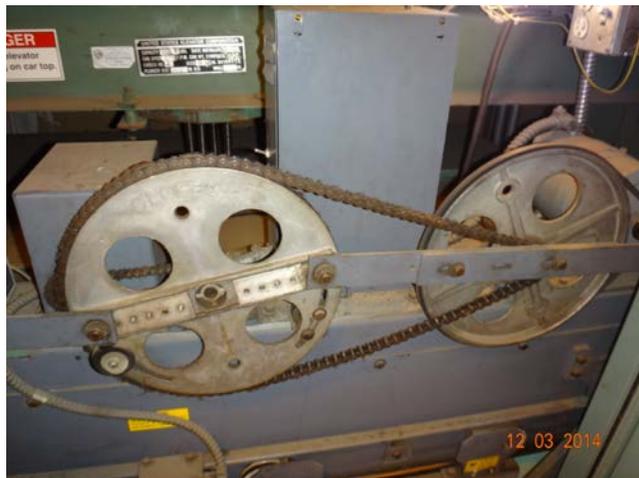
Door Operator:

The door operators are GAL MOML which are known to be high quality but are over 30 years old and worn out. The door operation was noted to be fair with room for improvement. Neither of the elevators had door restrictors. We recommend new GAL MOVFR closed loop door operators on both cars with door restrictors.

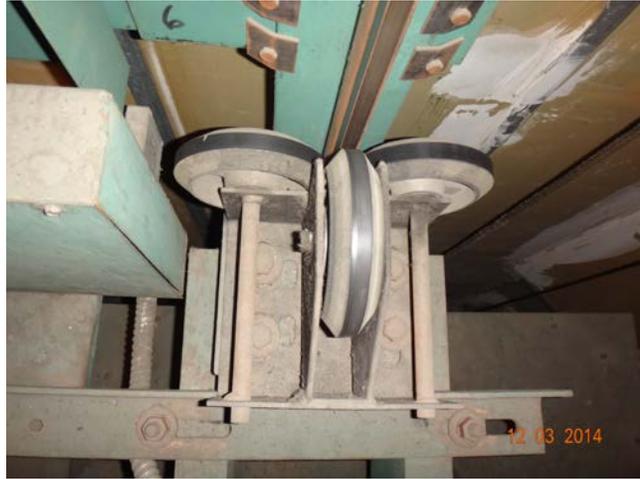
Car Roller/Slide Guides:

On both sides of the elevators and on the top and bottom roller guides keep the elevators riding up and down the steel guide rails. The existing ride quality was noted to be good, but the U.S. rollers have very little adjustments and are not spring loaded. We recommend new spring loaded roller guides when the elevators are modernized.

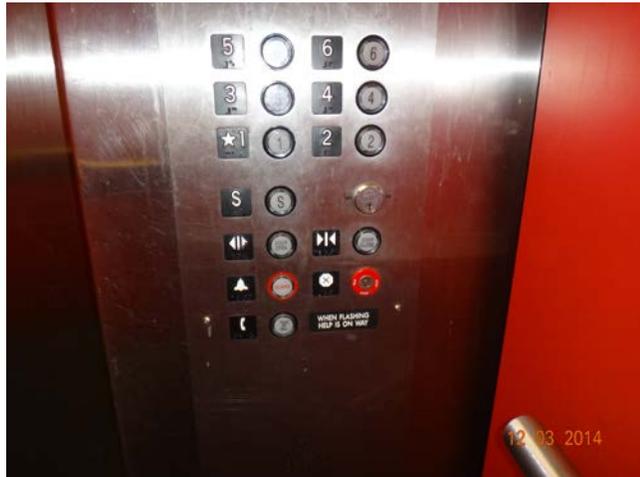
Car Operating Panels:

Both the elevators have the newer Car Operating Panels (COP's) installed in the last 10 to 15 years. The panels are in good condition meet ADA and T24 and do not need any work at this time. When the elevators are modernized it will most likely be more cost effective to replace the panels with new.

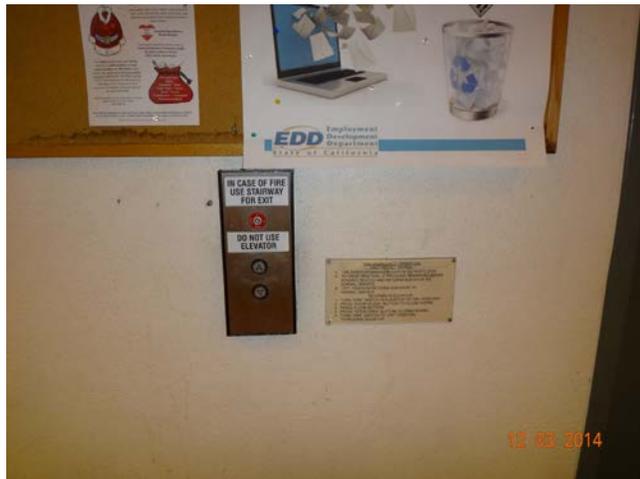
Hall Call Pushbuttons:

At each floor hall call push buttons are located so that users can call the elevator. The hall call stations have raised operation buttons which meet ADA and California Title 24. These were all noted to be in good condition and appear to have been updated 10 to 15 years ago.
