Employment Development Department Headquarters (025)

722/800 Capitol Mall, Sacramento, CA 95814

Facility Condition Assessment

June 2015

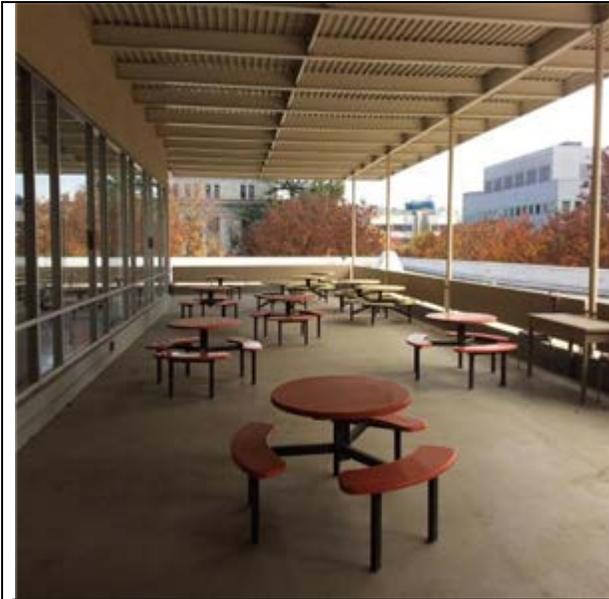
B1020 Steel Joists Supporting Corrugated Metal Roof :- Shade canopy

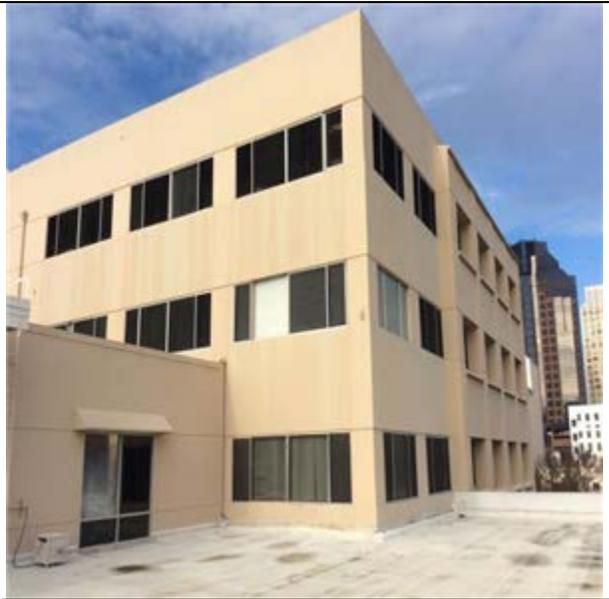
The single glazed steel framed windows are problematic on several fronts. The windows leak air and beginning to leak water. Some frames are showing corrosion. At each end of the approximately 14' x 4' (56 SF each x 245 units) assembly is an operable casement. Occupants of office spaces often open the windows for fresh air, which creates havoc with the heating, ventilation, and air conditioning (HVAC) system.

B2021 Steel framed windows 14' x 4'

Type	Component Description	Qty / UOM	Unit Cost (\$)	Plan Type	Priority	Year	Expenditures (\$)
B2021	Replace B2021 Steel framed windows 14' x 4'	13,720.0 - SF	179.8	IN - Beyond Rated Life	Priority 1	2015	2,466,856

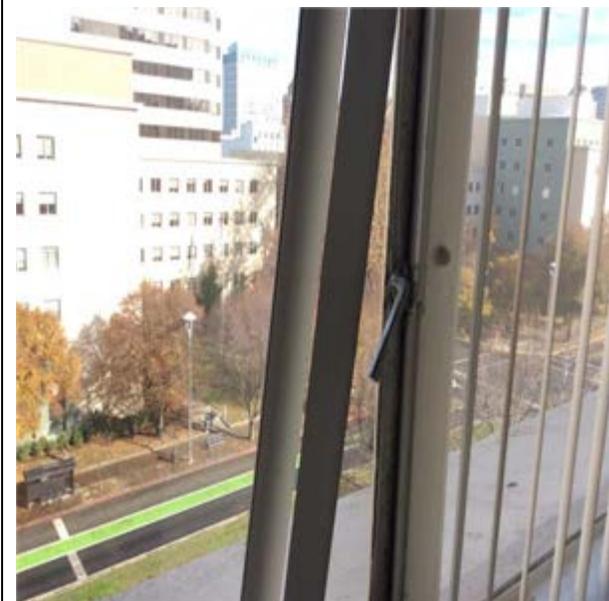
B2021 Steel framed windows 14' x 4' :- Latching mechanism

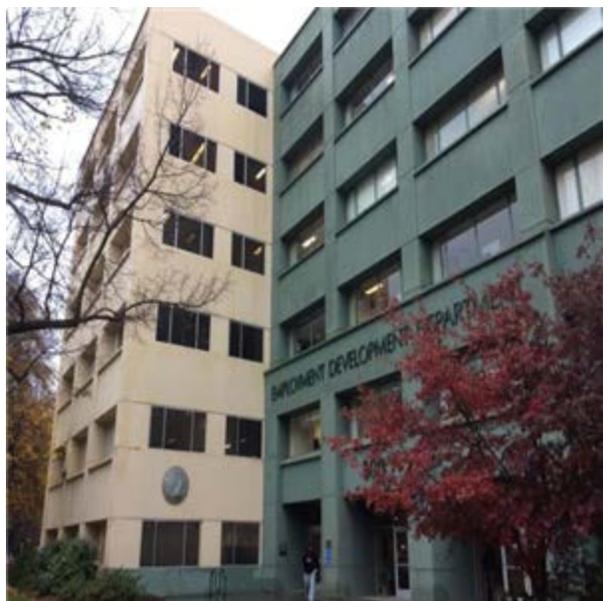
B2021 Steel framed 12 x 4 windows:- Exterior facade

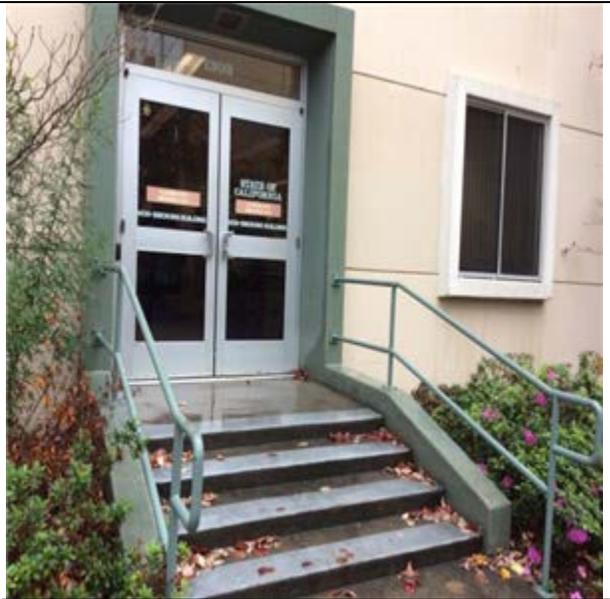
B2030 Aluminum Glazed Doors:- Emergency exit without a ramp

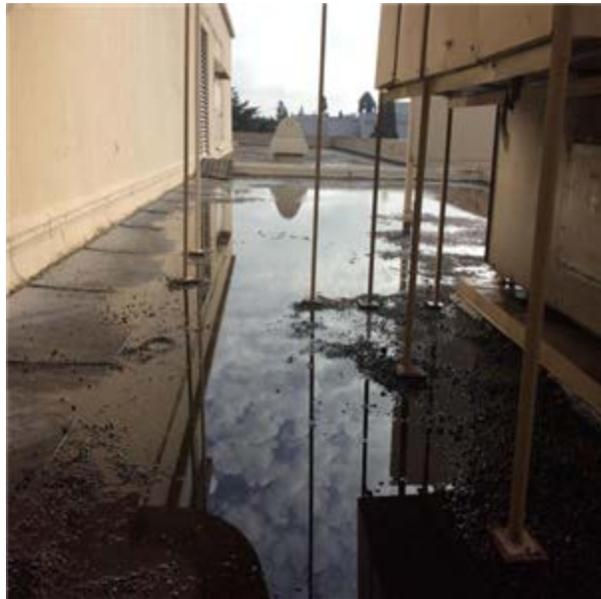
B3010 Built-Up Roofing:- Standing water after mild rainstorm

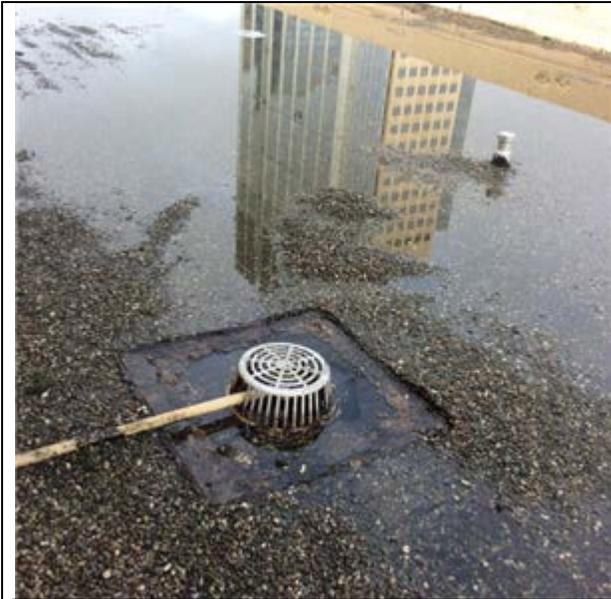
B3010 Built-Up Roofing :- Ineffectiveness of slope to the drain

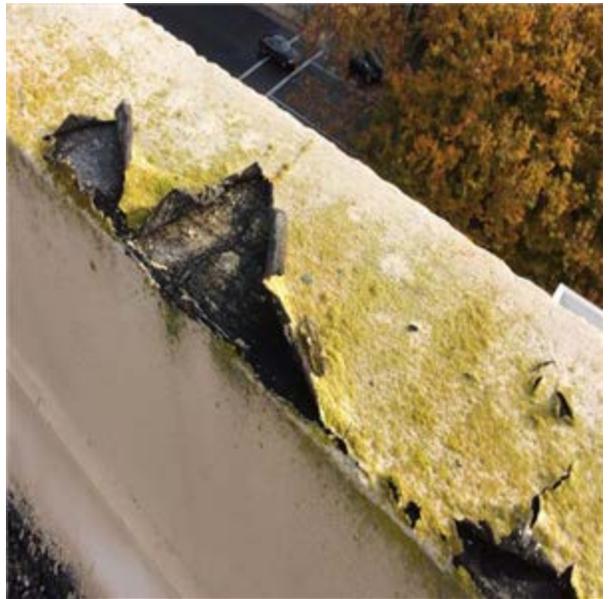
B3010 Coping at Parapets:- Paint or epoxy peeling and leaving parapet cap exposed

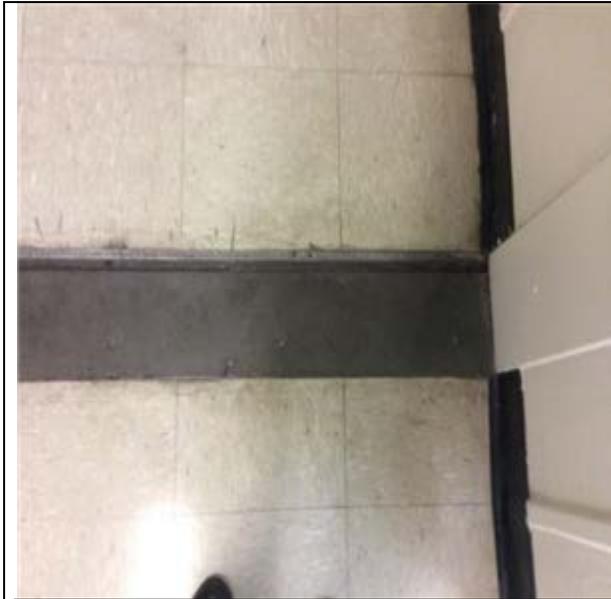
C3020 Vinyl Tile :- Worn tile at a seismic joint

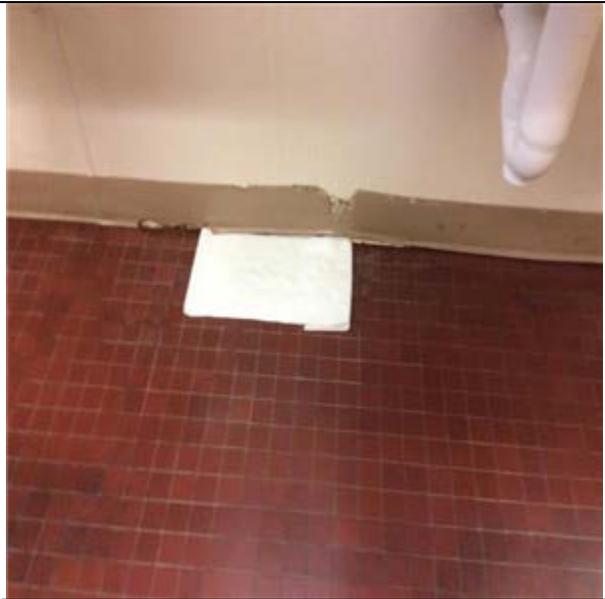
C3020 2X2 Ceramic Floor Tile:- Cove base damaged and tile wear

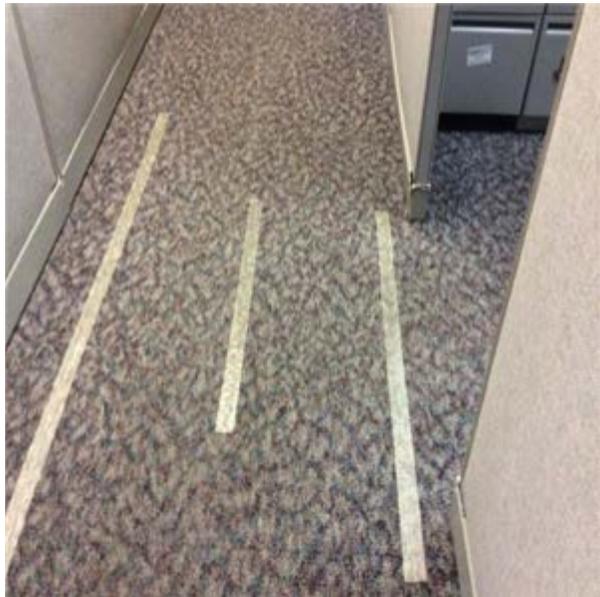
C3020 Carpet Tiles - Standard :- Held together by tape

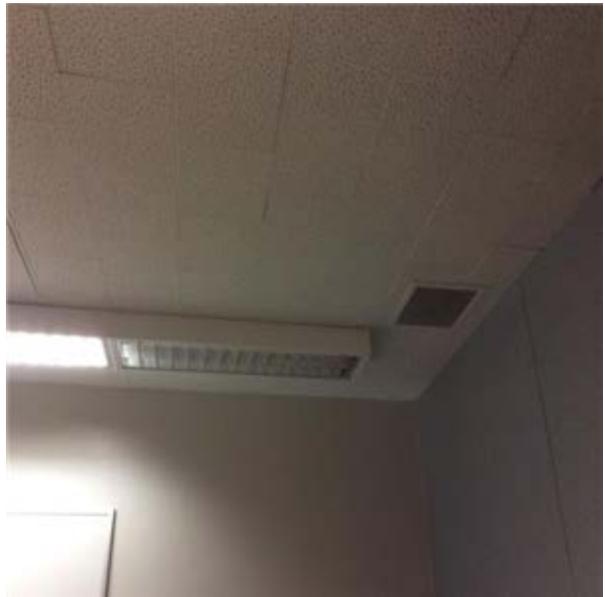
C3030 Ceiling tiles, 12" glued :- Loosening tiles in an office

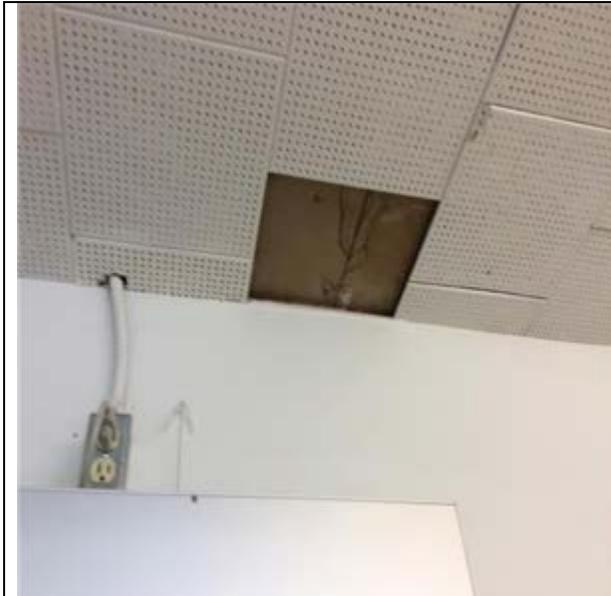
C3030 Ceiling tiles, 12" glued :- Missing and loose tiles

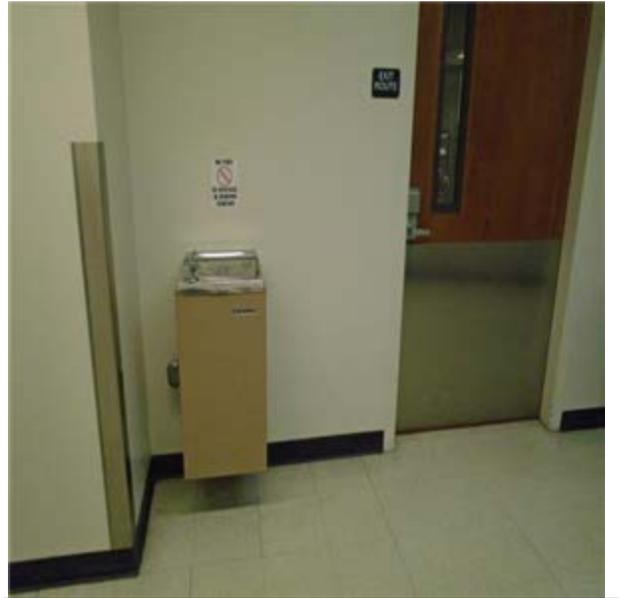
Item	Description
D2018 Drinking Fountains and Coolers	D2018 Drinking Fountains
Condition	Poor - Fair
Qty / UOM	26 / EA
RUL (years)	0
Location	Throughout interior

Type	Component Description	Qty / UOM	Unit Cost (\$)	Plan Type	Priority	Year	Expenditures (\$)
D2018	Replace D2018 Drinking Fountains	26.0 - EA	2876.6	CC - Accessibility	Priority 1	2015	74,792
G2033	G2033 Replace steps with a ramp	72.0 - LF	1641.8	CC - Accessibility	Priority 1	2015	118,207
G2035	Replace G2035 Loading dock ramp	1.0 - EA	34720.0	CC - Accessibility	Priority 1	2015	34,720
G2035	G2035 Repair ramp and add wheel guard	1.0 - LS	17360.0	CC - Accessibility	Priority 1	2016	17,360

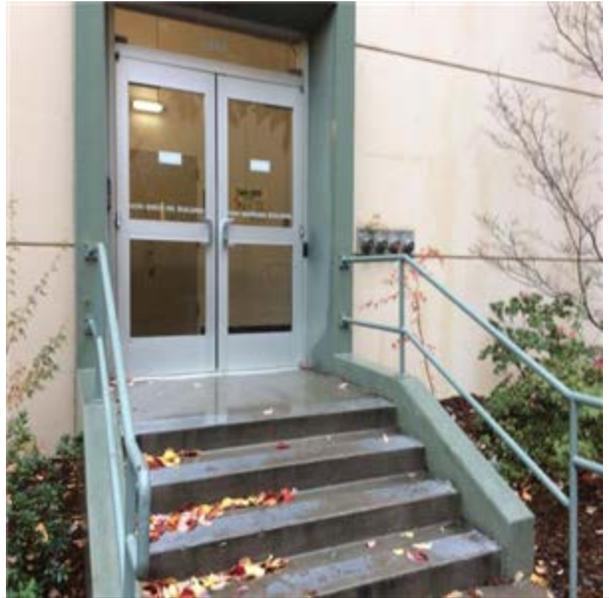
Item	Description
G2033 Exterior Steps	G2033 Concrete Steps
Condition	Poor
Qty / UOM	72 / LF
RUL (years)	0
Location	West side of building

G2033 Concrete Steps:- Emergency exit without a ramp

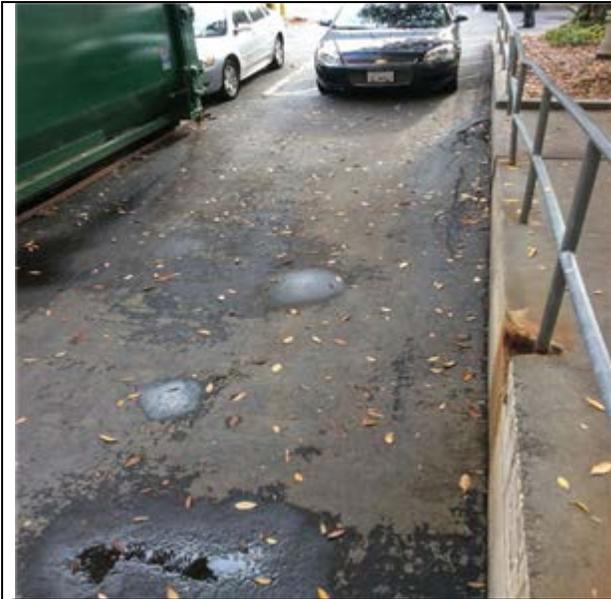
Item	Description
G2035 Exterior Steps & Ramps	G2035 Loading dock ramp
Condition	Poor - Fair
Qty / UOM	1 / EA
RUL (years)	0
Location	Loading dock

G2035 Loading dock ramp :- Edge of ramp without wheel guard and failed concrete at railing post. Note tree root damage at pavement adjacent to ramp

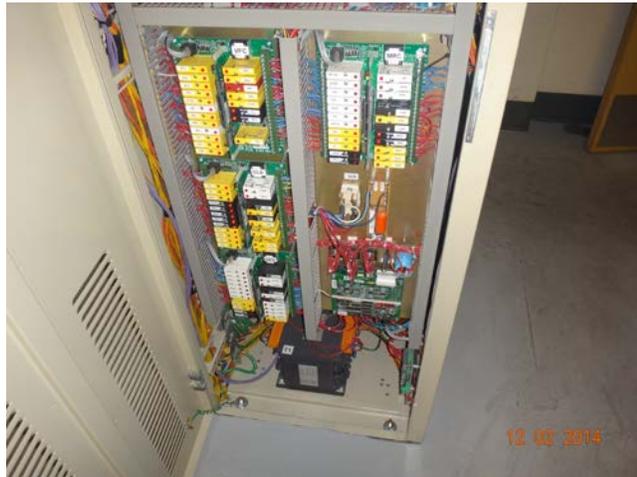
Controllers:

The controllers were manufactured by CEC/Swift and installed locally by TKE when the elevators were recently modernized. The controllers have energy efficient SCR drives made by Magnetec, the world's leading supplier of SCR drives.

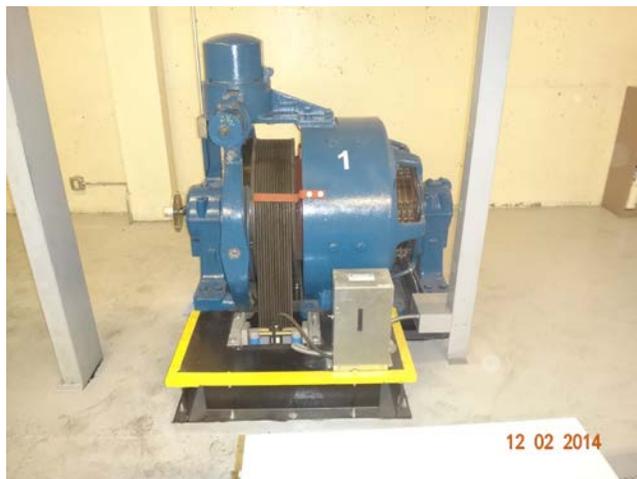
Passenger Machines:

All the passenger elevators have Westinghouse gearless machines. The machines have D.C. hoist motors and appear to have been refurbished when modernized in the last 5 years. All the machines were found to be in good condition. Rope brakes were added. The machines have rope retainers but not all are installed correctly.

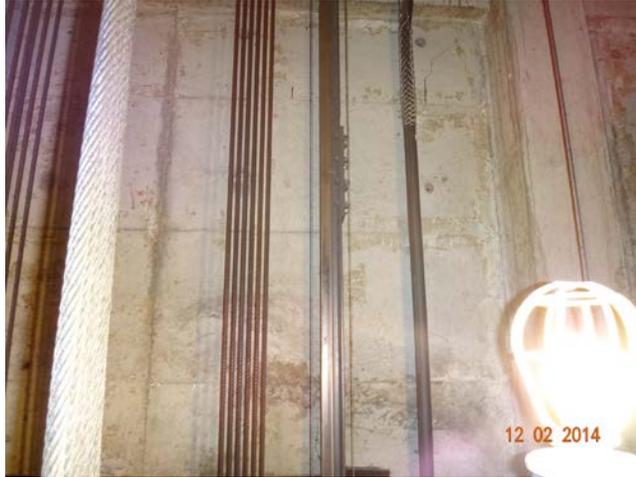
Car Guide Rails:

The car rails are in good condition but do not have seismic fish plates. Upgrading the guide rails to current seismic standards is voluntary.

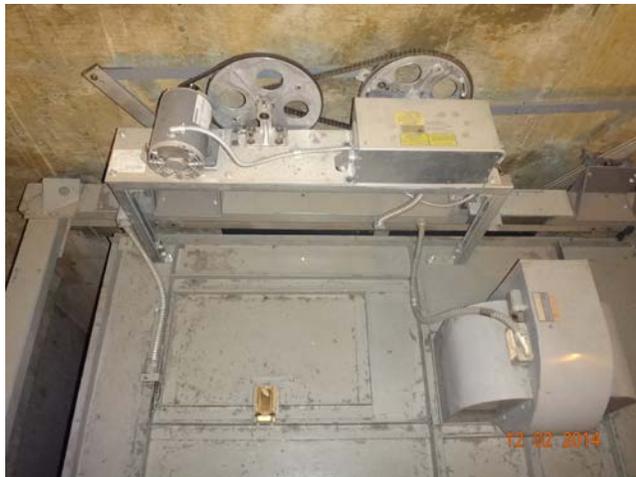
Door Operator:

The door operators are GAL MOVFR and are closed loop. The door operation was noted to be fair with room for improvement. All of the cars are equipped with door restrictors but Car 4 was disabled. The GAL door operators that are installed are known to be reliable and have a long life cycle.

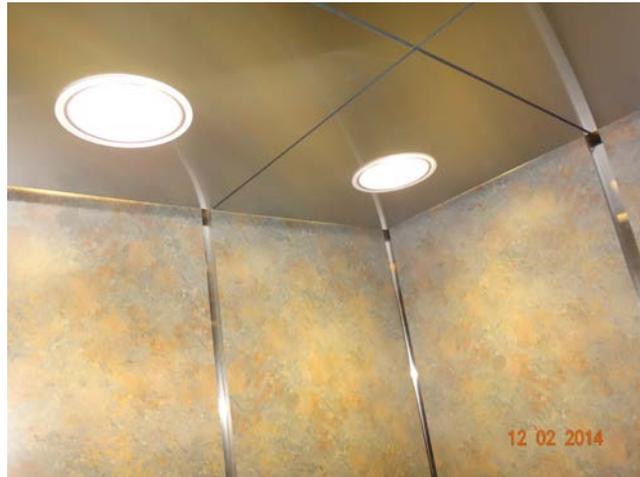
Ceilings:

The cabs have down light ceilings with incandescent light fixtures. The light fixtures could be updated with energy efficient LED's and/or the entire ceiling could be replaced.

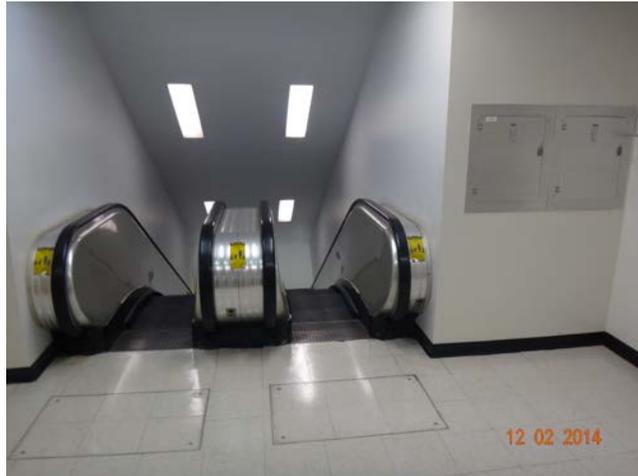
Escalators:

View of upper end of the escalators at the 4th floor with caution signs and proper lighting. Skirt brushes have been installed to reduce the possibility of shoes getting caught between the skirt to step gap. The stop switches are not readily visible.

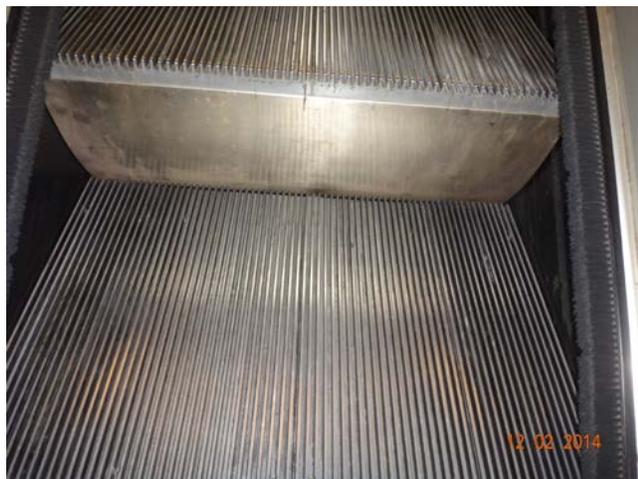
Escalator Steps:

The escalator steps have the original smooth risers. Due to safety concerns these have been outlawed by the National retroactive safety code, A17.3, for over 20 years. While A17.3 is not adopted in California, the importance of having these steps replaced cannot be taken lightly.
