# Gregory Bateson Building (011)

1600 Ninth Street, Sacramento, CA 95814

## Facility Condition Assessment

June 2015

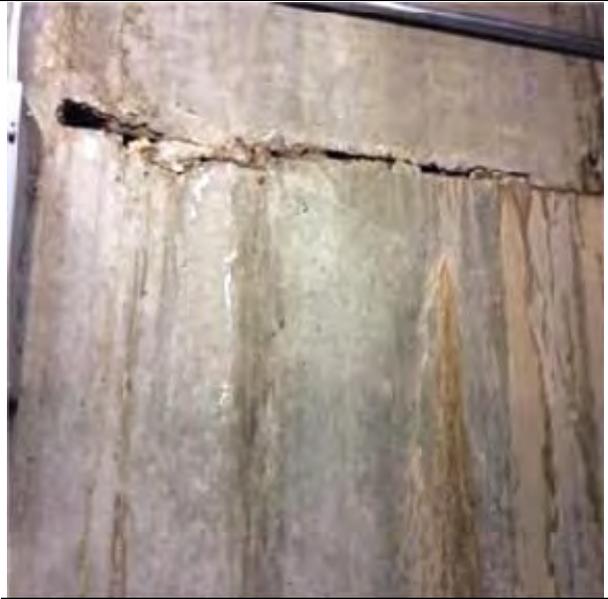
B1010 Floor Construction

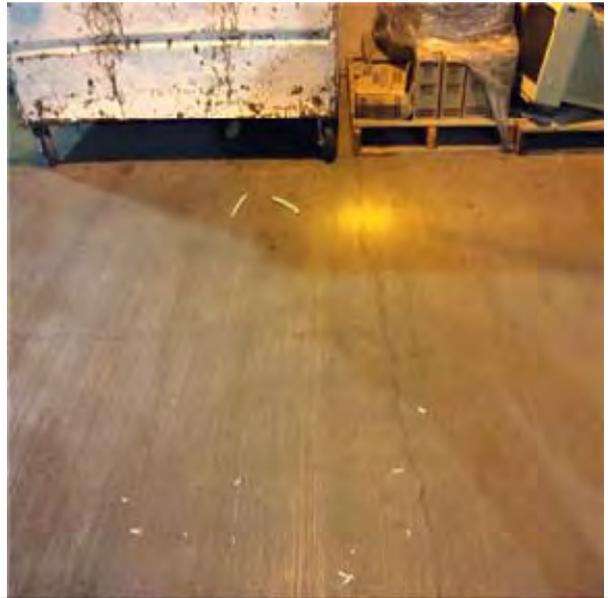
B1012 Concrete Floor Construction

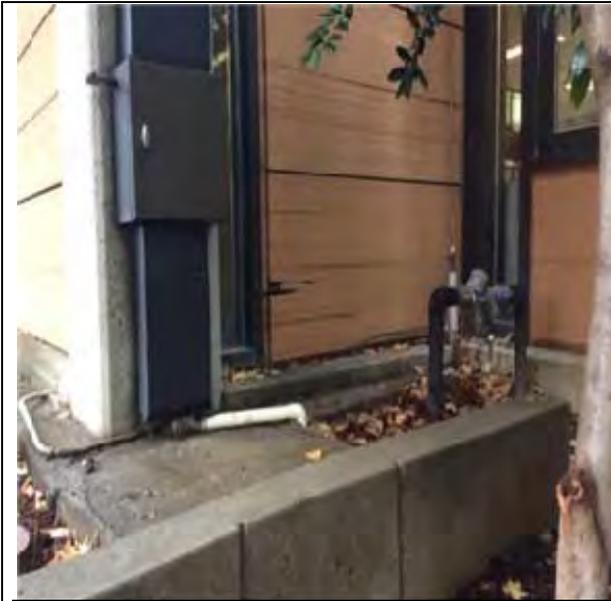
B2010 Glue-lam beam at walls and railings

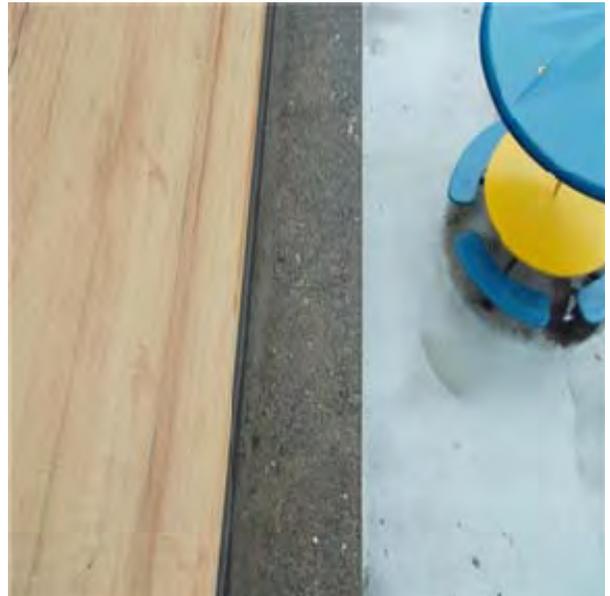
B2010 Glue-lam beam at walls and railings

B2010 Metal deck railings:- View of outside edge of deck/rail

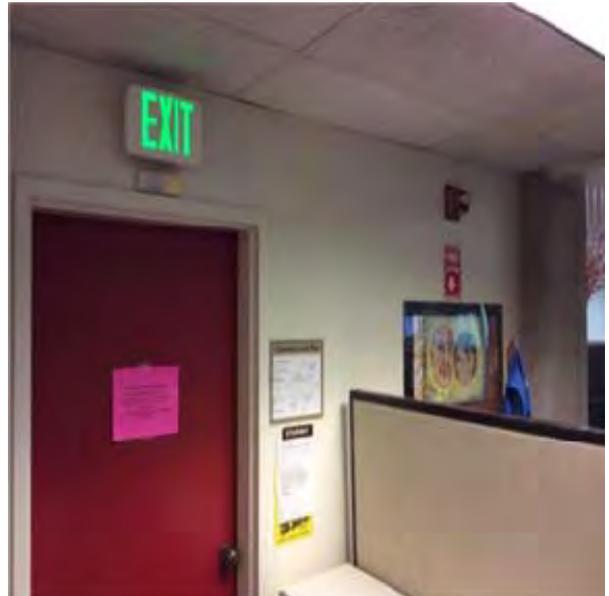
D4010 Fire Sprinkler installation

D4010 Fire Sprinkler installation:- Most areas lack sprinkler protection

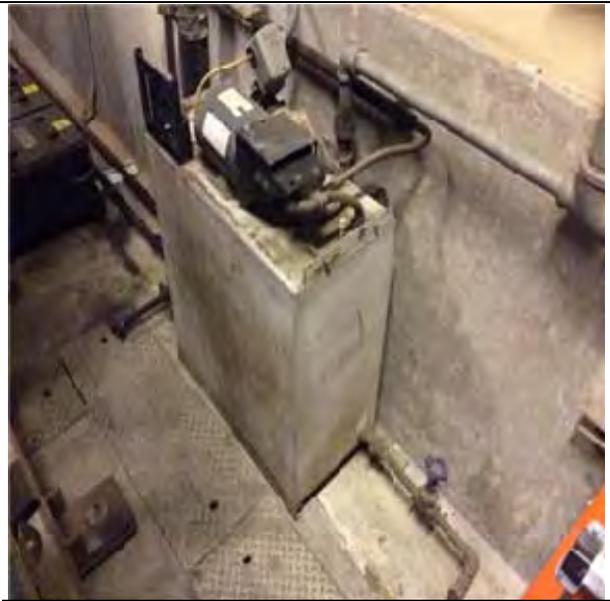
D5090 Diesel Generator 150 kW

D5090 Diesel Generator 150 kW:- Day tank lacking secondary containment

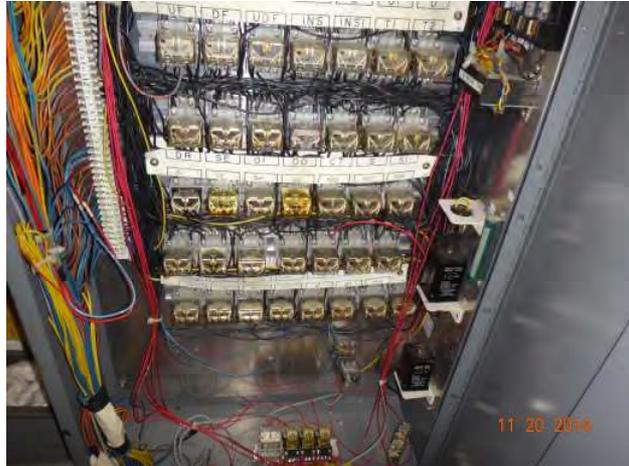
#### **Controllers:**

The controllers were manufactured by ESCO and installed by Otis Elevator company as part of a modernization in 1981. The controllers utilize old relay logic that is known to be reliable but have reached the end of their useful lives. If properly maintained the controllers should last another 3 to 5 years with no major updates.

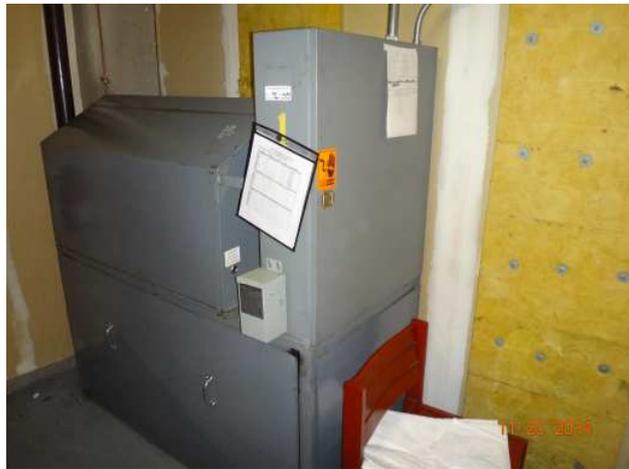
#### **Hydraulic Power Units:**

All the elevators have ESCO power units equipped with Maxton valves and IMO pumps. The machines were installed by Otis Elevator in 1981 when the building was erected. The machines are in relatively good condition considering their age. Full modernization is recommended in 3 to 5 years.

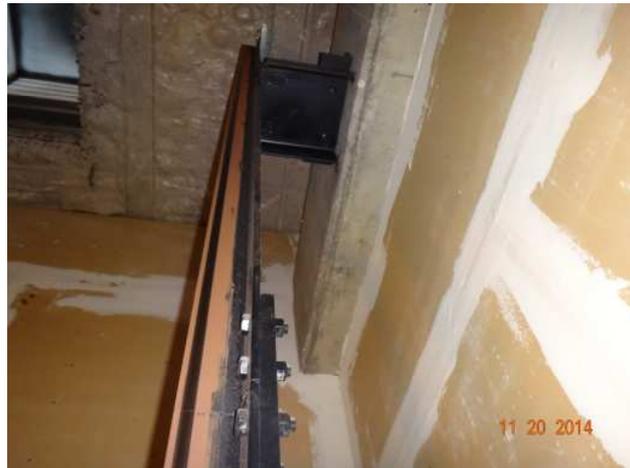
**Hoistway Construction:**

The hoistway (elevator shaft) is the main area where the elevators go up and down. The hoistways are mostly built of drywall and some concrete beams. These vents at the top of the shafts are fixed open. These could be replaced with motorized vents that are normally closed to reduce energy loss.

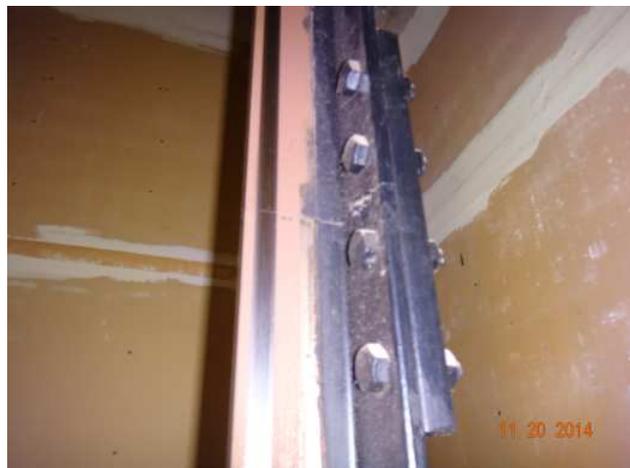
**Car Guide Rails:**

The car rails are in good condition. There is light rust on the machined surfaces. During the proposed modernization this should be remedied.

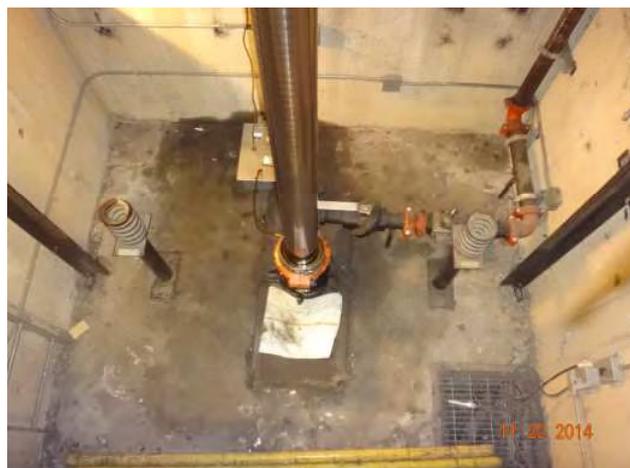
**Pits:**

The pits for are poured concrete with sump areas and metal grating. The pits were found to be dirty and the jack seals need to be fixed. The pits are equipped with seismic rupture valves and manual shut off valves.

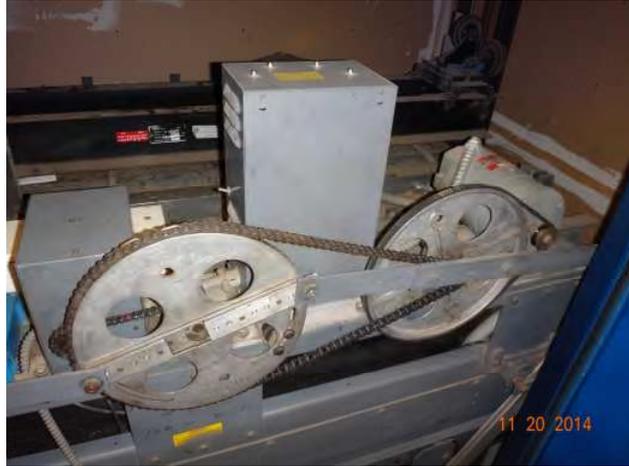
### Door Operator:

The door operators are GAL MOML. The door operation was noted to be good with room for improvement. None of the cars are equipped with door restrictors. Immediate installation is highly recommended, at a minimum during the proposed modernization.

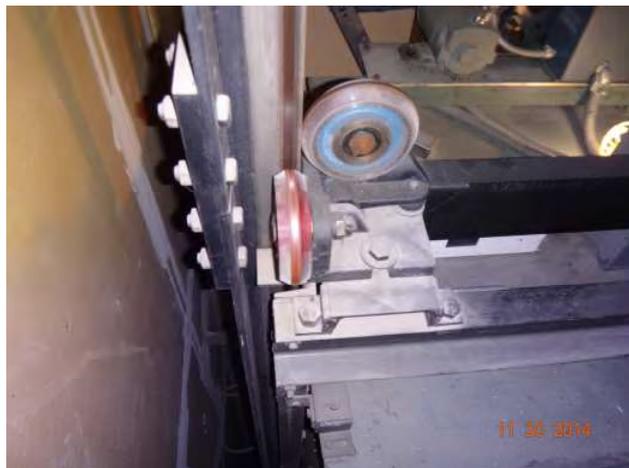
### Car Roller/Slide Guides:

On both sides of the elevators and on the top and bottom roller guides keep the elevators riding up and down the steel guide rails. The existing ride quality was good. These are likely the original equipment but are equipped with seismic retainer plates. The guide rollers or entire assemblies could be replaced during modernization.

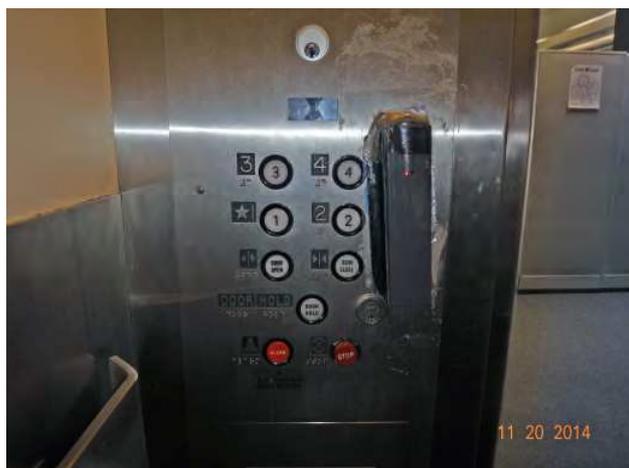
### Car Operating Panels:

All the elevators have the original equipment Car Operating Panels (COP's). These would be replaced during the proposed modernization. The panels are in good condition; the buttons had proper braille and are at the proper height for ADA. The aesthetic is poor and the stop switch is not keyed as required by code.

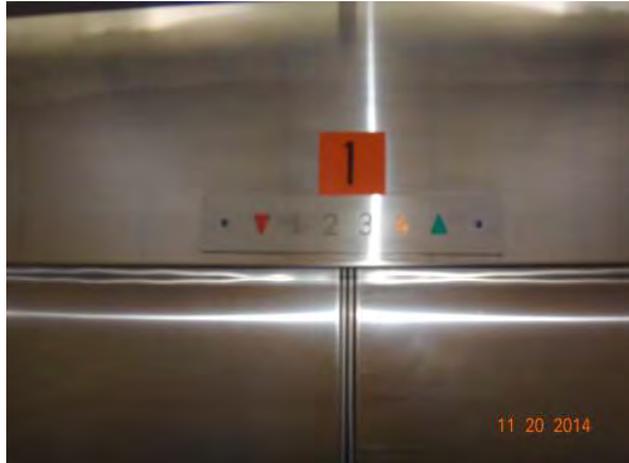
**Hall Lanterns:**

Car lanterns inform persons waiting in the hall of which direction the elevator is about to travel in next. ADA requires that the hall lanterns illuminate and sound for the waiting passengers. The existing elevators have car lanterns on each car. The lanterns have the proper gong for up and down. Some of the gongs and lantern were inoperative during out survey. The cars were all equipped with in-car position indicators mounted above the door.

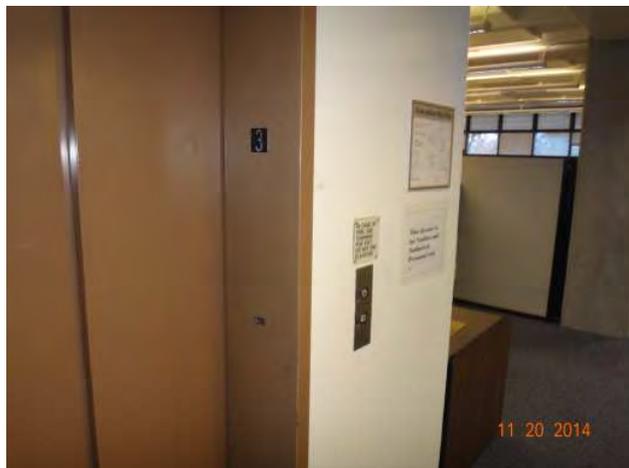
**Hall Call Pushbuttons:**

At each floor hall call push buttons are located so that users can call the elevator. The hall call stations have flush operation buttons which are not ADA compliant. During a modernization the fixture and fire exit sign will be replaced.

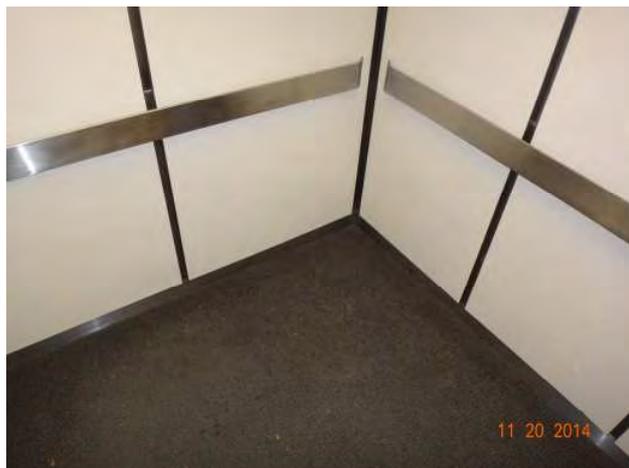
**Wall Finish:**

The existing cab interiors are possibly original and looked to be in fair condition. All sides have the code required handrails. No code required work in needed.

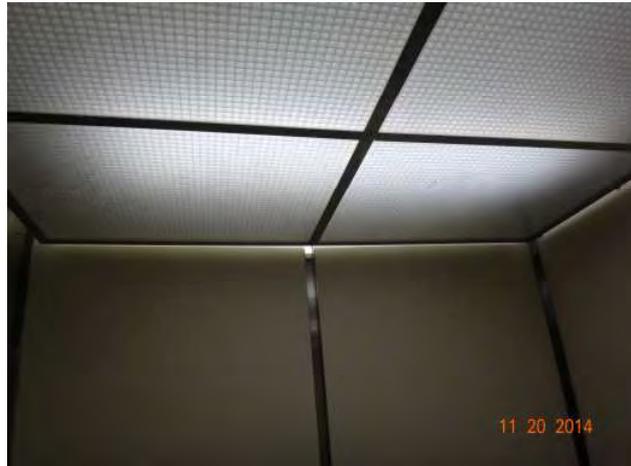
**Ceilings:**

The cabs interiors are dated. The drop ceiling and diffused fluorescent lighting is not aesthetically pleasing but is in fair condition. A complete cab upgrade is recommended during the proposed modernization.
