Resources Building (018)

1416 Ninth Street, Sacramento, CA 95814

Facility Condition Assessment

June 2015

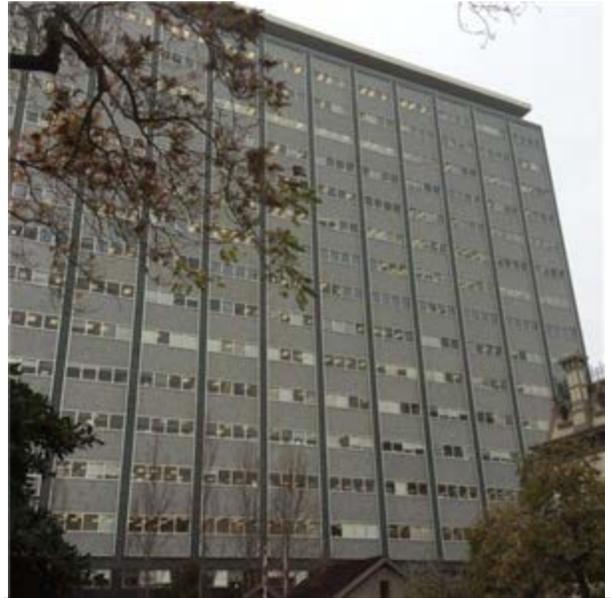
Item	Description
B1029 Other Roof Systems	B1029 Guard rail at roof edge
Condition	Poor
Qty / UOM	900 / LF
RUL (years)	0
Location	Edge of roof

B1029 Guard rail at roof edge :- No railing

Type	Component Description	Qty / UOM	Unit Cost (\$)	Plan Type	Priority	Year	Expenditures (\$)
B1029	Replace B1029 Guard rail at roof edge	900.0 - LF	421.6	CC - Life Safety	Priority 1	2015	379,440

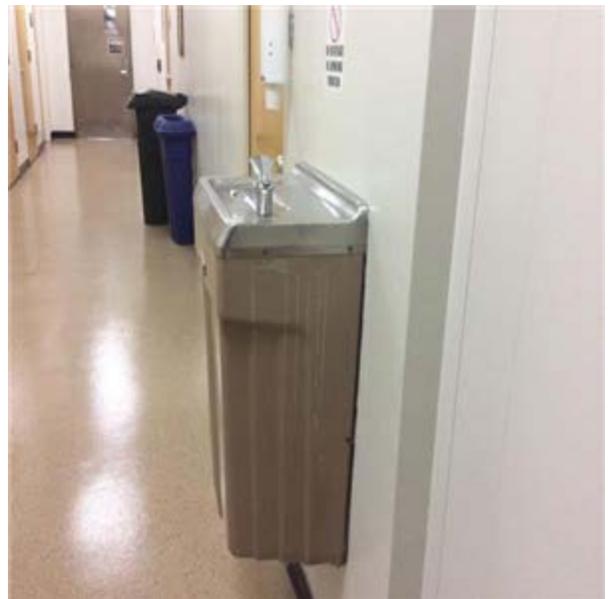
Item	Description
D2018 Drinking Fountains and Coolers	D2010 Drinking Fountains
Condition	Poor
Qty / UOM	10 / EA
RUL (years)	0
Location	Corridors

D2010 Drinking Fountains:- Not ADA accessible

Type	Component Description	Qty / UOM	Unit Cost (\$)	Plan Type	Priority	Year	Expenditures (\$)
D2011	Bring toilet seat heights in the accessible compartments into compliance with ADA	10.0 - EA	590.0	CC - Accessibility	Priority 1	2015	5,900
D2013	D2013 Wrap exposed drain lines at restroom lavatories	96.0 - EA	59.0	CC - Accessibility	Priority 1	2015	5,664
D2018	Replace D2010 Drinking Fountains	10.0 - EA	2874.5	CC - Accessibility	Priority 1	2015	28,745

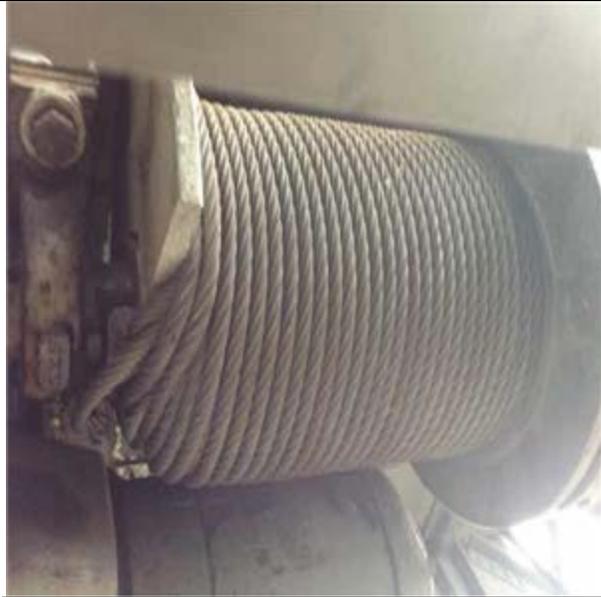
E1097 Roof carriage with suspended scaffold:- broken winding

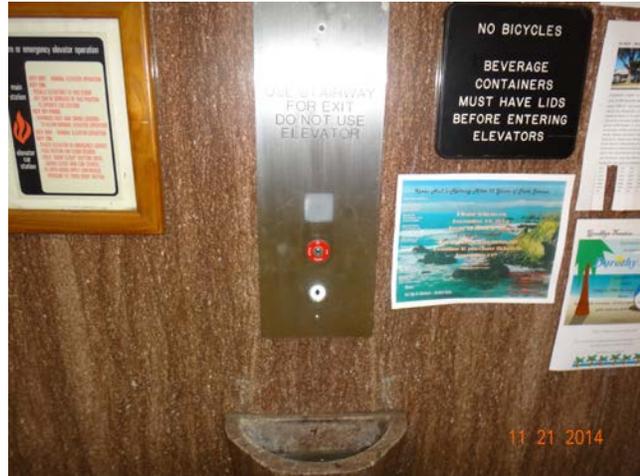
Hall Call Pushbuttons:

At each floor hall call push buttons are located so that users can call the elevator. The hall call stations have raised operation buttons which meet ADA and California Title 24. These were all noted to be in good condition. However at the main lobby there are ashtrays that protrude and are in the way. These should be removed.

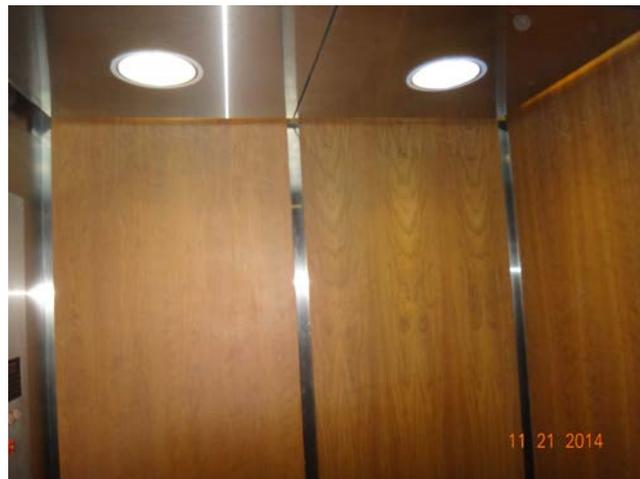
Ceilings:

The cabs have down light ceilings with incandescent light fixtures. The light fixtures could be updated with energy efficient LED's and/or the entire ceiling could be replaced.
