## Agriculture Building (006)

1220 "N" Street, Sacramento, CA 95814

### Facility Condition Assessment

June 2015

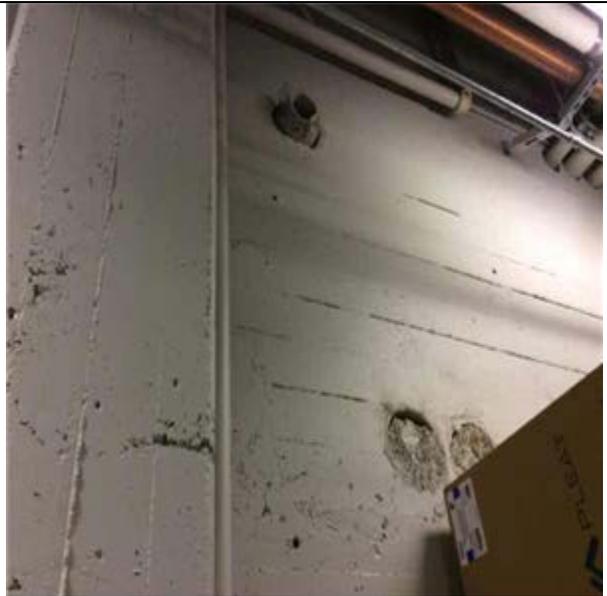
There are numerous small holes on the walls and ceiling in the basement. It is recommended that the holes be patched and surface repainted.

B1012 Concrete Beams and Floor Slab:- B1012 Deteriorated patch at old wall penetrations

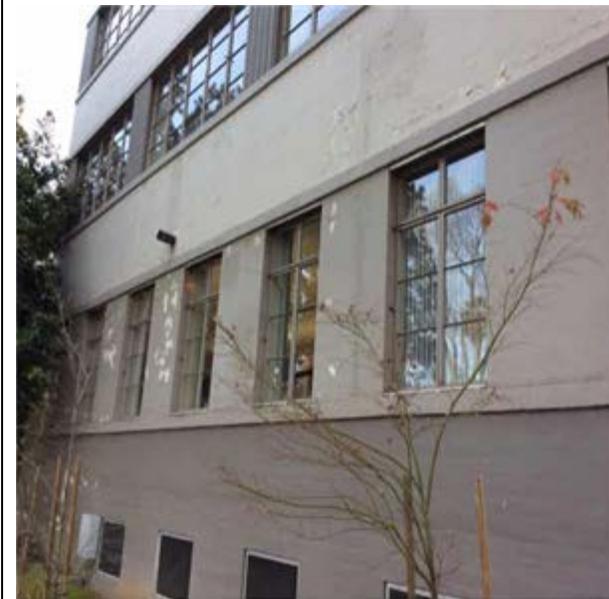
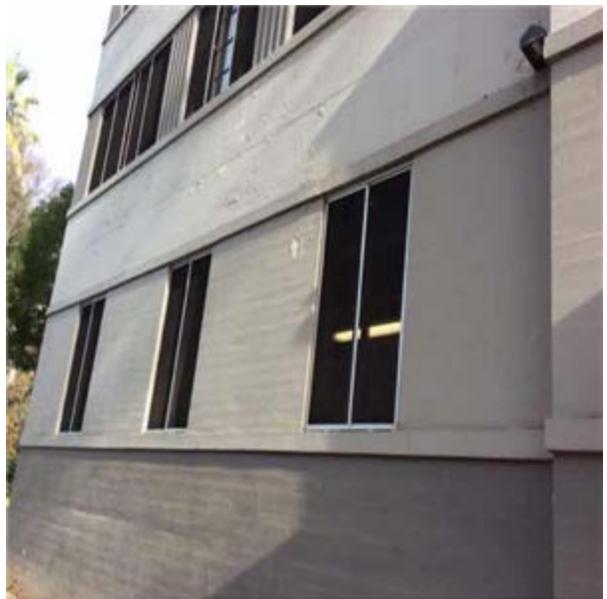
Item	Description
B2011 Exterior Wall Construction	B2011 Exterior Wall Painted Concrete Parging Finish
Condition	Poor - Fair
Qty / UOM	38700 / SF
RUL (years)	0
Location	Throughout exterior

Type	Component Description	Qty / UOM	Unit Cost (\$)	Plan Type	Priority	Year	Expenditures (\$)
B2011	Replace B2011 Exterior Wall Painted Concrete Parging Finish	38,700.0 - SF	14.3	IN - Appearance	Priority 1	2015	552,822

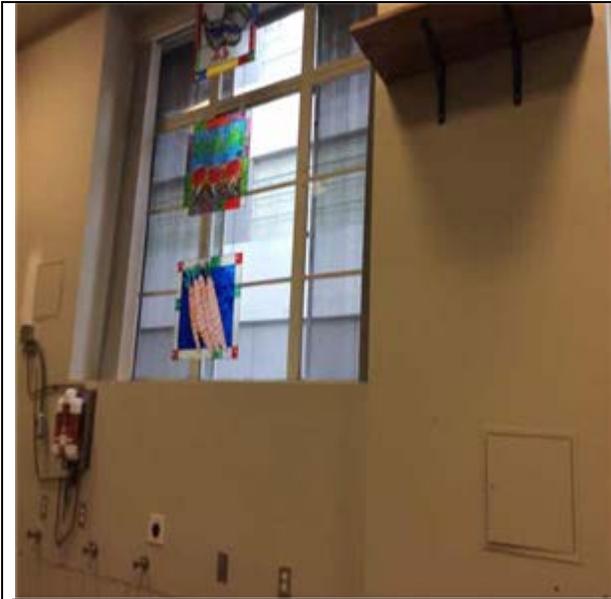
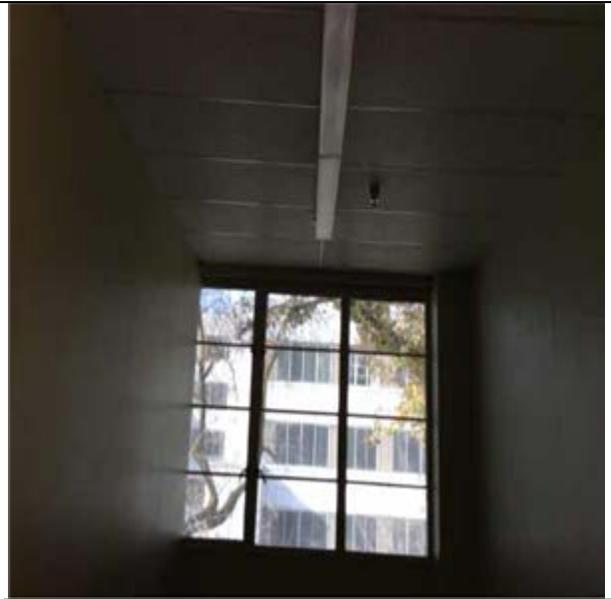
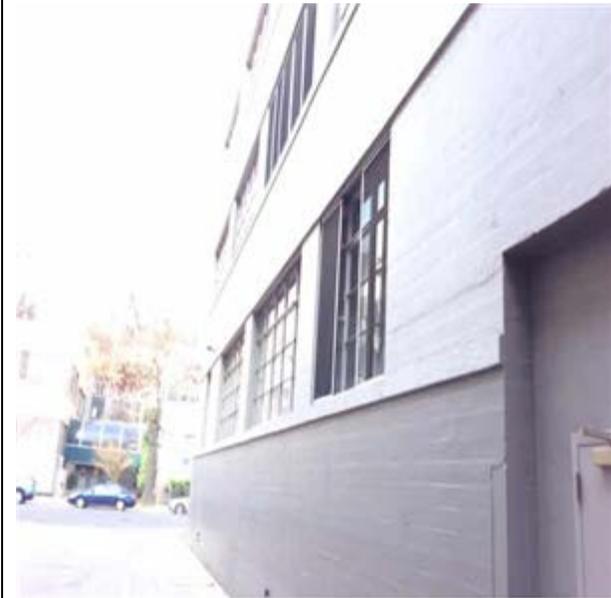
B2021 Windows, single pane

The single pane aluminum windows were installed in 1936. Based on conversation with the building staff they are considered historical assets. It is recommended to reseal windows and replace gaskets rather than complete replacement.

Type	Component Description	Qty / UOM	Unit Cost (\$)	Plan Type	Priority	Year	Expenditures (\$)
B2021	B2021 Repair and reseal exterior windows	1,976.0 - LF	38.1	OP - Maintenance	Priority 2	2015	75,226

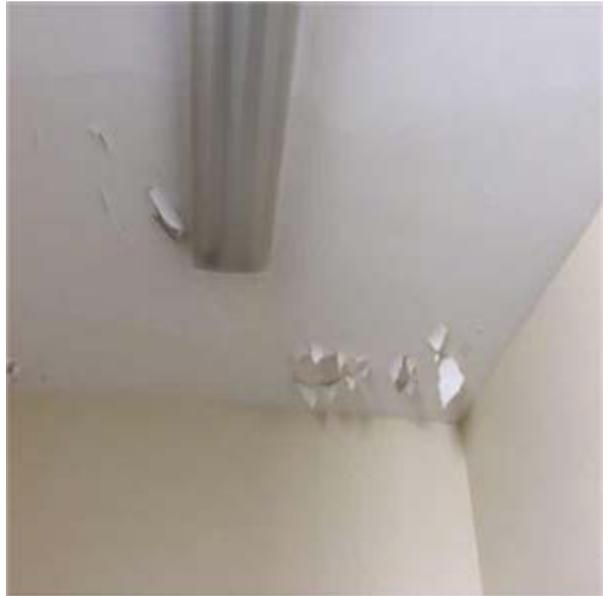
C3012 Paint Interior Walls, Drywall:- C3012 Ceiling with damage

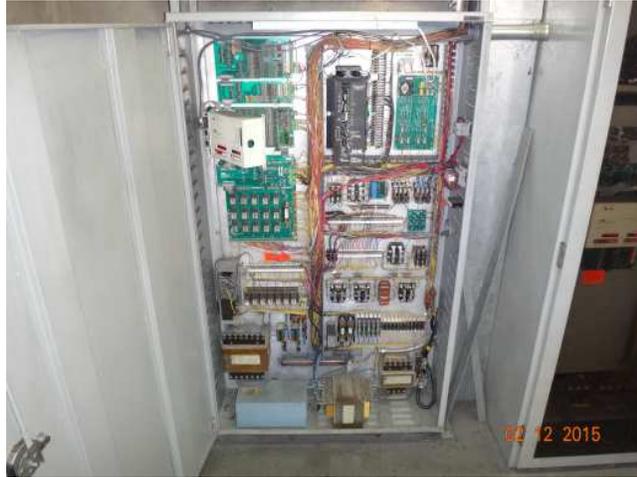
#### **Controllers:**

The controllers were manufactured by MCE and installed locally when the elevators were modernized in 1990. The controllers utilize antiquated motor generator sets. We recommend the elevators be modernized with new controllers.

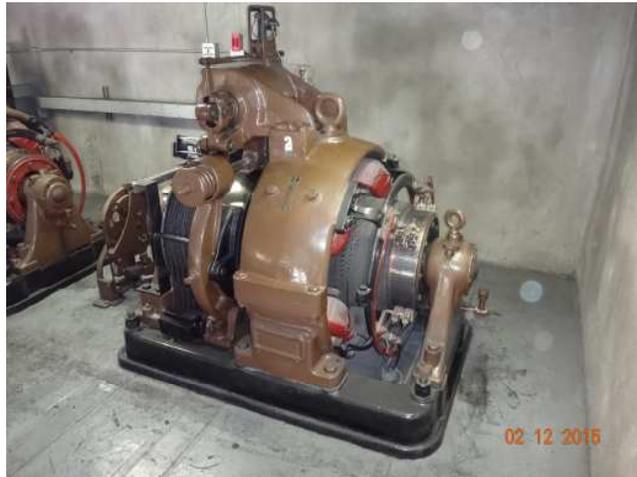
#### **Gearless Machines:**

Both of the traction elevators have Otis gearless machines that were most likely installed in the 1950's when the elevators were new. These appeared to be in good condition and do not need any major work.

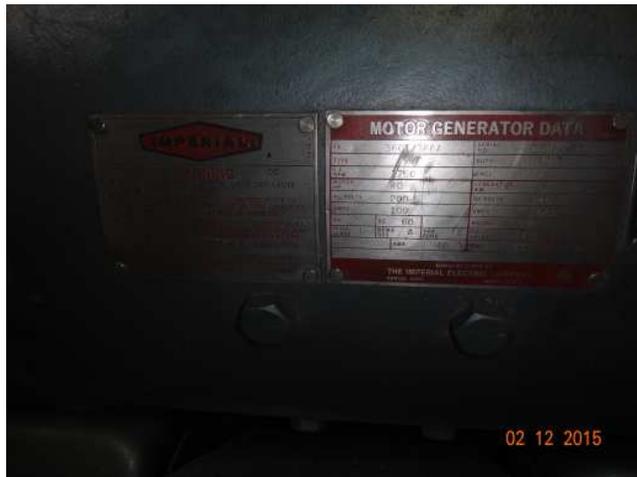
#### **Motor Generator Sets:**

Both of the traction elevators have inefficient motor generator sets that convert the incoming AC power to DC. We recommend these be replaced with solid state drives that are energy efficient.

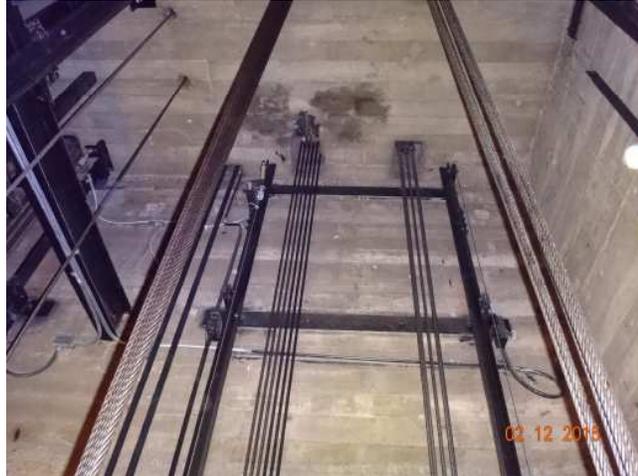
### Pits:

The pits were found to be dry with minor dust. They should be cleaned.

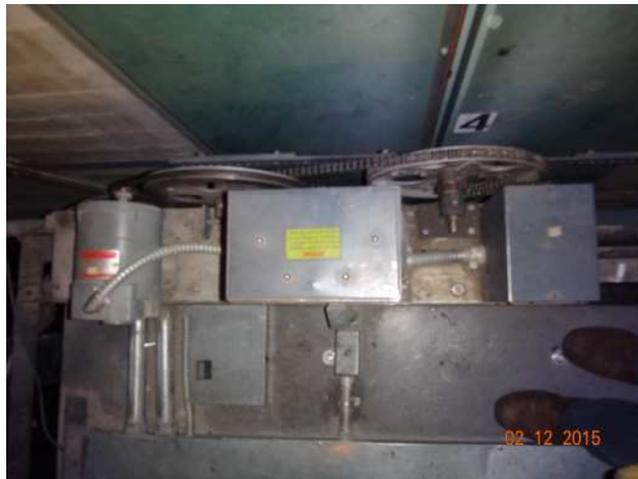
### Door Operator:

The operators were upgraded in 1990 with GAL door operators that are known to be of high quality. They have door restrictors and are in reasonable good condition. We recommend new closed loop operators when they are modernized.

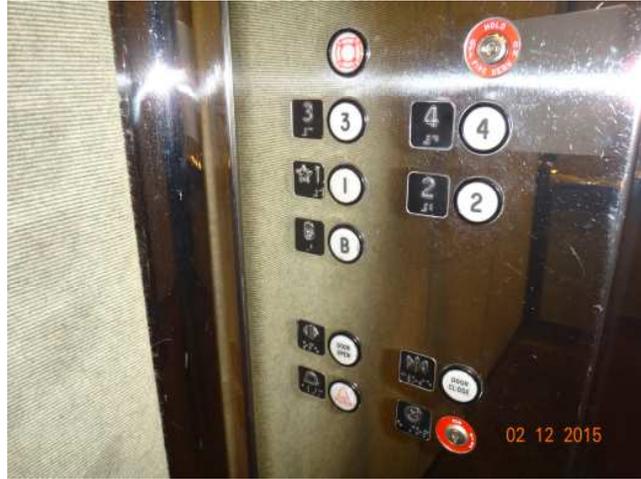
**Car Operating Panels:**

Both the passenger elevators have newer Car Operating Panels (COP's) that were installed during the elevator modernizations. The panels are in good condition and meet all ADA and T24 but are starting to look dated.

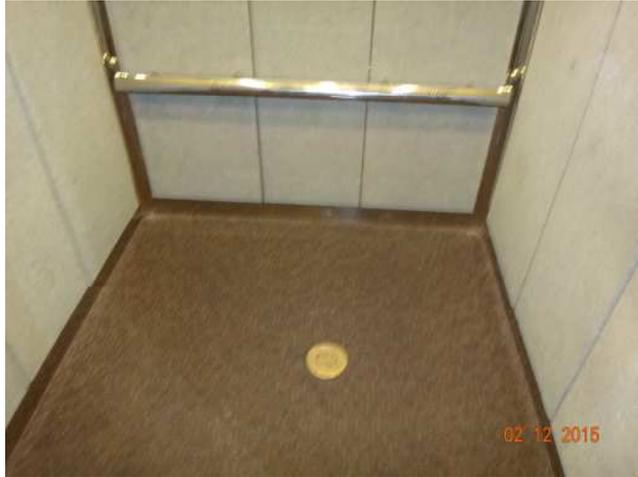
**Wall Finish:**

The existing cab interiors were most likely updated when the elevators were modernized and now look dated. The back wall has the code required handrail. The railing heights are in compliance with Title 24 California code.

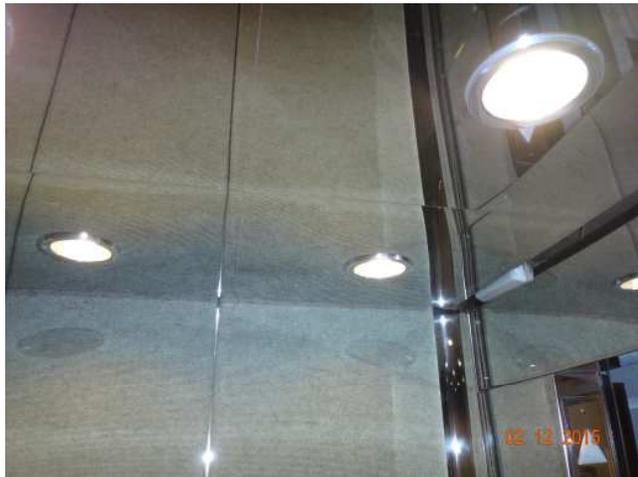
**Ceilings:**

The passenger elevators have down-light ceilings with incandescent light fixtures. The light fixtures could be updated with energy efficient LED's and/or the entire ceiling could be replaced.

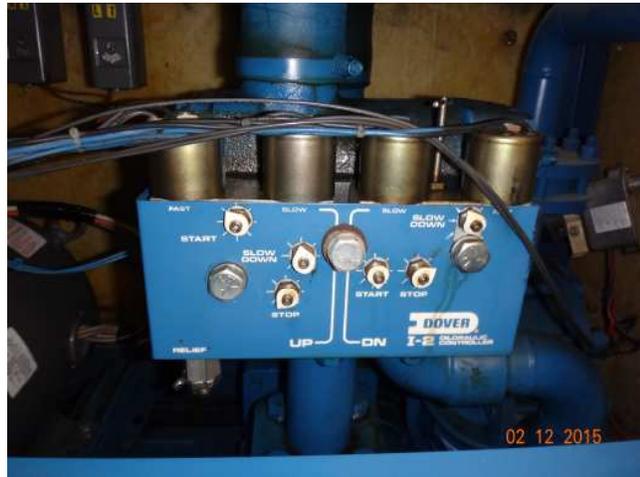
**Valve:**

The hydraulic freight elevator has a high quality Dover I2 valve that was noted to be in good condition.

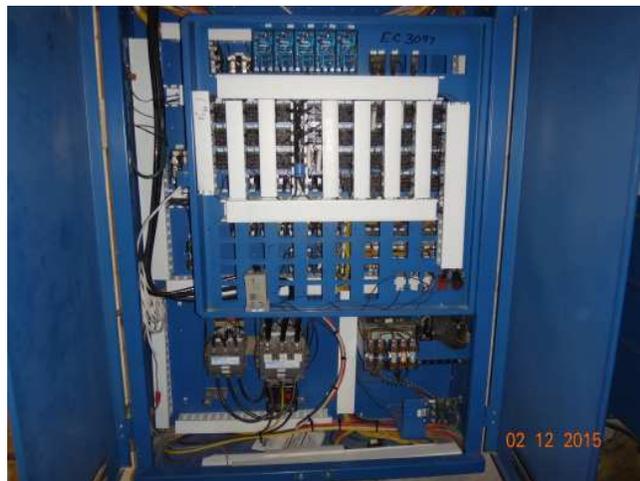
**Controller:**

The hydraulic freight controller was made by Dover and is in good maintainable condition.

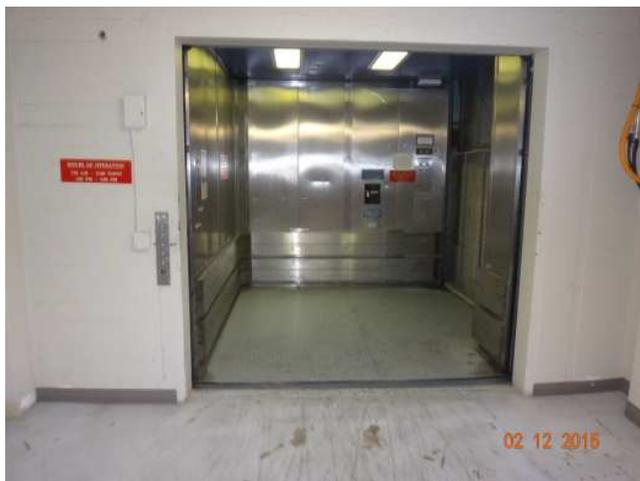
**Freight Cab:**

The hydraulic freight elevator has vertical bi-parting doors that are in good condition.
