## Franchise Tax Board Los Angeles Building (084)

9645 Butterfield Way, Rancho Cordova, CA 95827

### Facility Condition Assessment

June 2015

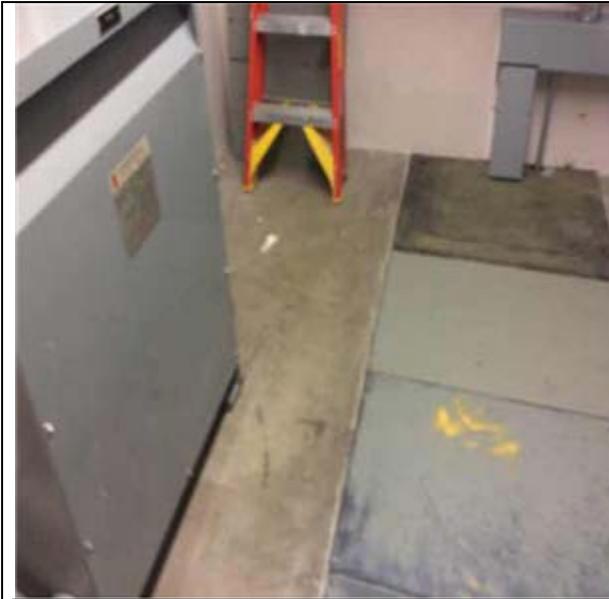
A1030 Standard Concrete Slab

The concrete slabs on grade were observed to be in good condition.

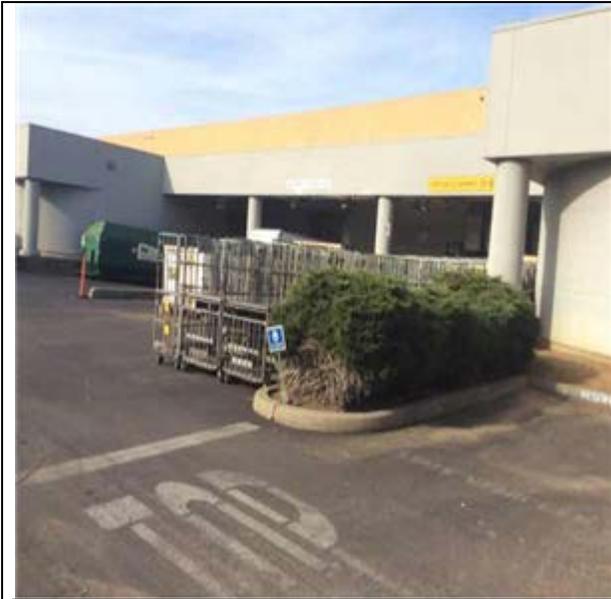
B2011 Paint Exterior Walls

Based on its estimated RUL and condition, exterior painting will be required.

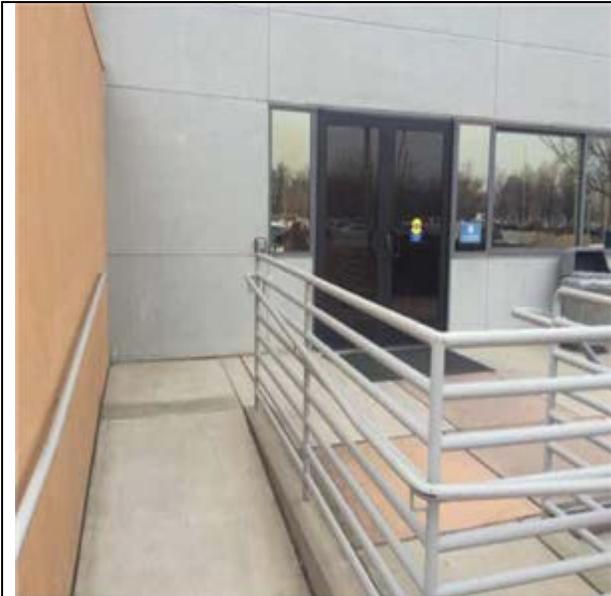
B2031 Glazed Entrance Doors

The storefront type aluminum entrance doors were recently replaced and in good condition.

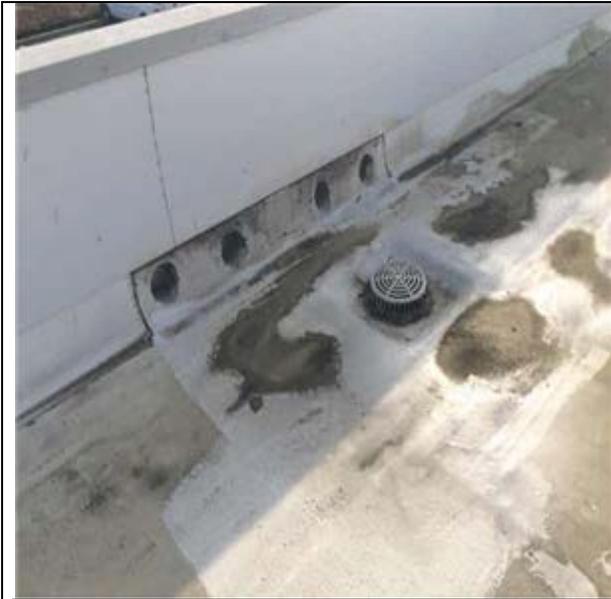
The roof has a history of leaks throughout the building. Replacement is recommended.

Type	Component Description	Qty / UOM	Unit Cost (\$)	Plan Type	Priority	Year	Expenditures (\$)
B3011	Replace B3011 Built-Up Roofing	2,325.0 - SQ	1861.5	IN - Beyond Rated Life	Priority 1	2015	4,327,902

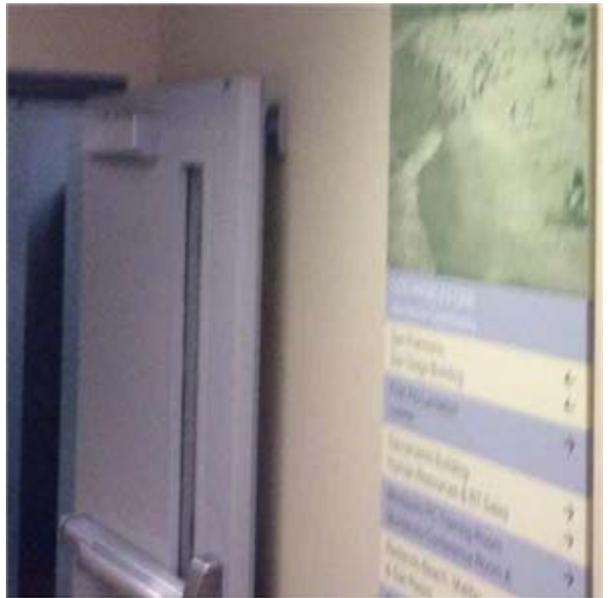
Based on their estimated RUL, the corridor fire doors will require replacement.

Type	Component Description	Qty / UOM	Unit Cost (\$)	Plan Type	Priority	Year	Expenditures (\$)
C1021	Replace C1021 Interior Doors	10.0 - EA	3809.4	IN - Beyond Rated Life	Priority 4	2022	38,094

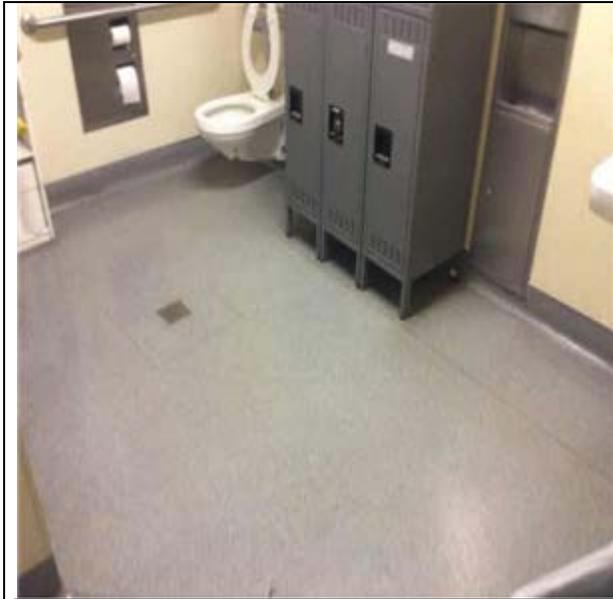
C3024 Vinyl Tile :- central plant

Tiles in lower pedestrian traffic areas are in good condition, but will need to be replaced in higher traffic areas.

Type	Component Description	Qty / UOM	Unit Cost (\$)	Plan Type	Priority	Year	Expenditures (\$)
C3024	Replace C3024 Vinyl Tile	8,000.0 - SY	125.8	IN - Appearance	Priority 4	2021	1,006,242

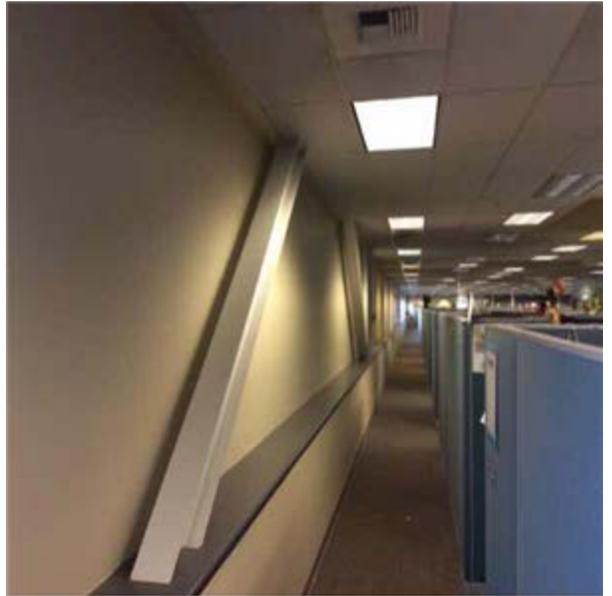
Carpet tiles are located throughout the building. Based on the RUL and observed conditions, replacement of the older carpet tiles is recommended.

Type	Component Description	Qty / UOM	Unit Cost (\$)	Plan Type	Priority	Year	Expenditures (\$)
C3025	Replace C3025 Carpet Tiles - Older	17,500.0 - SY	96.6	IN - Appearance	Priority 2	2015	1,690,598

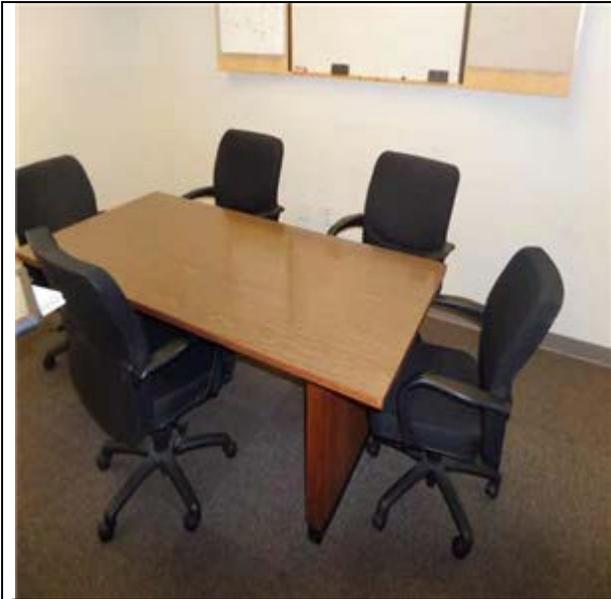
Carpet tiles are located throughout the building. Based on the RUL and observed conditions, replacement of the older carpet tiles is recommended.

Type	Component Description	Qty / UOM	Unit Cost (\$)	Plan Type	Priority	Year	Expenditures (\$)
C3025	Replace C3025 Carpet Tiles - Newer	17,500.0 - SY	96.6	IN - Appearance	Priority 3	2019	1,690,598
