Jesse M. Unruh Building (002)

915 Capitol Mall, Sacramento, CA 95814

Facility Condition Assessment

June 2015

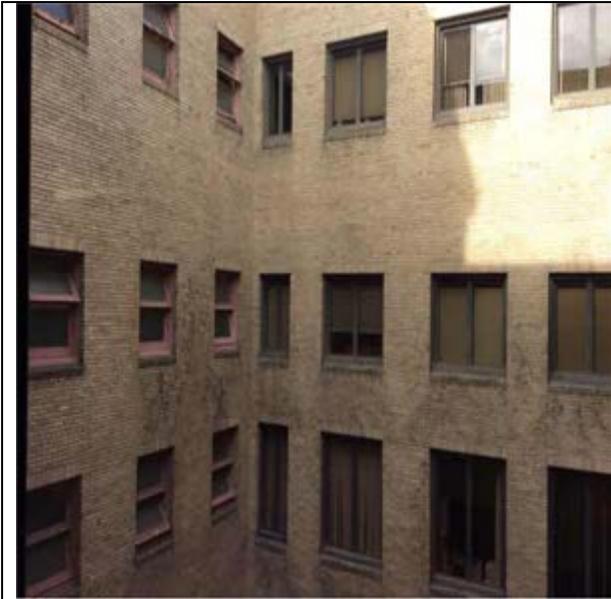
B2011 Brick Veneer-point

There are four light courts whose exterior walls are brick veneer. They should be repaired and repointed.

Type	Component Description	Qty / UOM	Unit Cost (\$)	Plan Type	Priority	Year	Expenditures (\$)
B2011	B2011 Repair Veneer Repair and Repoint	1,014.0 - CSF	1880.1	IN - Beyond Rated Life	Priority 1	2016	1,906,381

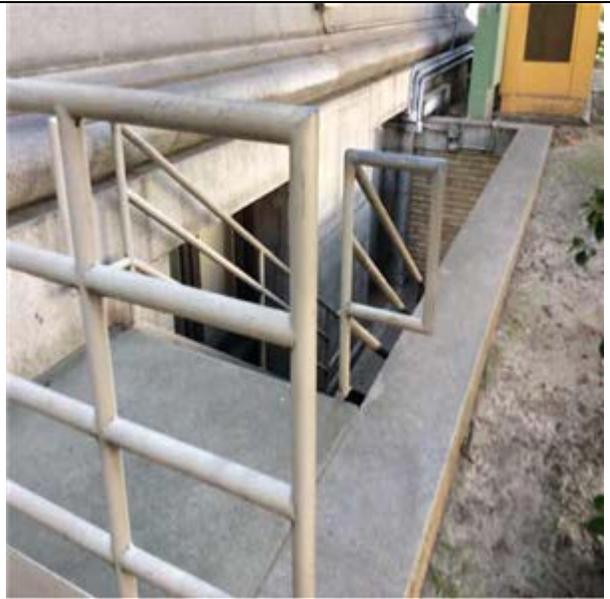
There are open area access wells for the basement, located at east and west sides of the building. Installation of metal grates is recommended to prevent falling hazard.

Type	Component Description	Qty / UOM	Unit Cost (\$)	Plan Type	Priority	Year	Expenditures (\$)
B2013	Replace B2013 Metal Grate	1,020.0 - SF	103.2	CC - Life Safety	Priority 1	2015	105,258

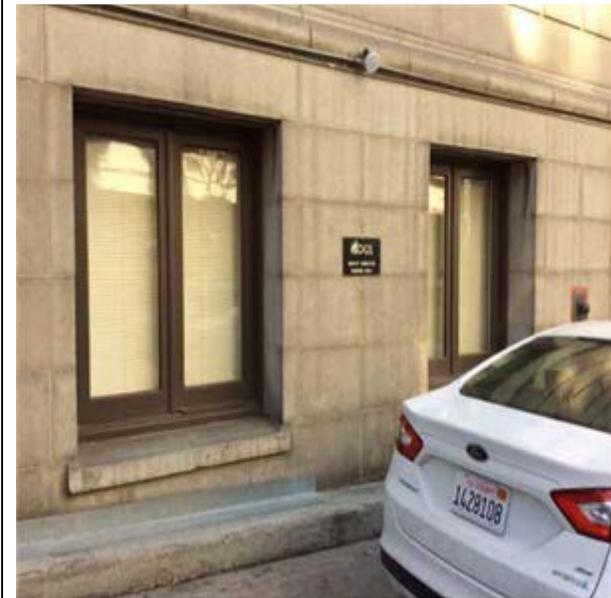
There are historical wooden windows that were installed in 1929 as part of the original construction. Based on conversation with the building staff, re-caulking and painting the frames is recommended.

Type	Component Description	Qty / UOM	Unit Cost (\$)	Plan Type	Priority	Year	Expenditures (\$)
B2021	Replace B2021 Repair and Paint Wood Windows	25.0 - EA	1205.3	OP - Maintenance	Priority 1	2015	30,132

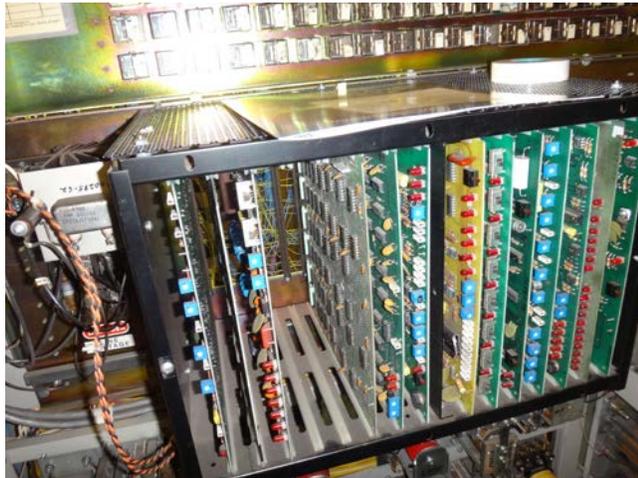
Controllers:

The controllers for Cars 1-3 were manufactured by Schindler/Haughton and installed in 1989 during the 2nd modernization. The controllers utilize motor generator sets. The boards are obsolete and support for service is diminishing. We recommend these be replaced with new solid state controllers and SCR drives.

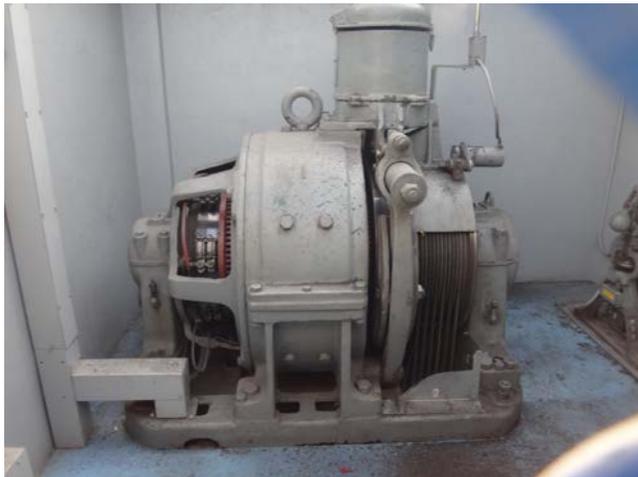
Gearless Machines:

Cars 1 and 2 have Gearless machines that appear to have been installed when the elevators were 1st modernized in 1961. Car 3 has a newer Hollister Whitney machine that was installed when Car 3 was replaced in 1991.

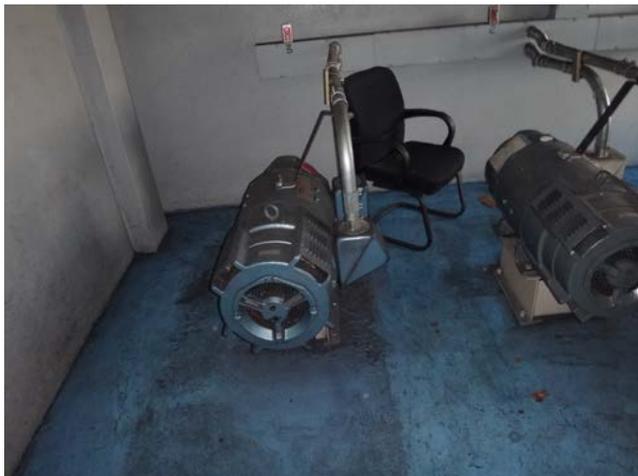
Motor Generator Sets:

Cars 1 and 2 had motor generators installed when last modernized in 1989. Newer Car 3 also has a motor generator set. These are worn out, noisy and not very energy efficient. We recommend these be removed as part of the modernization.

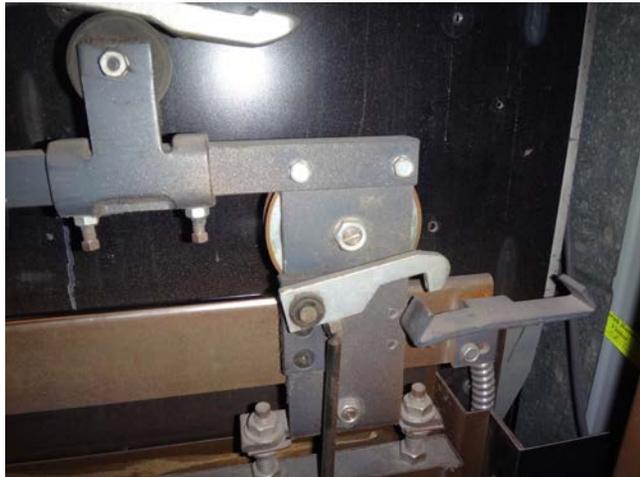
Door Operator:

The door operators for Cars 1-3 are MAC type that have been installed during the modernization in 1989. They were provided with door restrictors. Car 2 door restrictor is shown at right and is not adjusted properly. This should be repaired immediately.

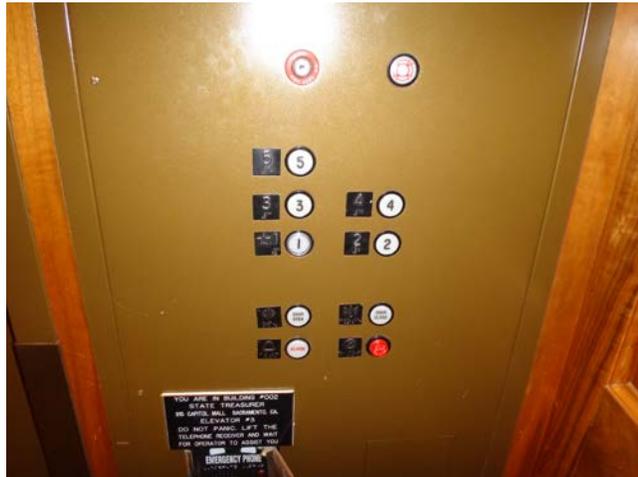
Car Operating Panels:

All the elevators have newer Car Operating Panels (COP's) that were installed during the elevator modernizations. The panels are in good condition and meet most ADA and T24 but the buttons are not raised. We recommend the buttons be replaced with raised caps.

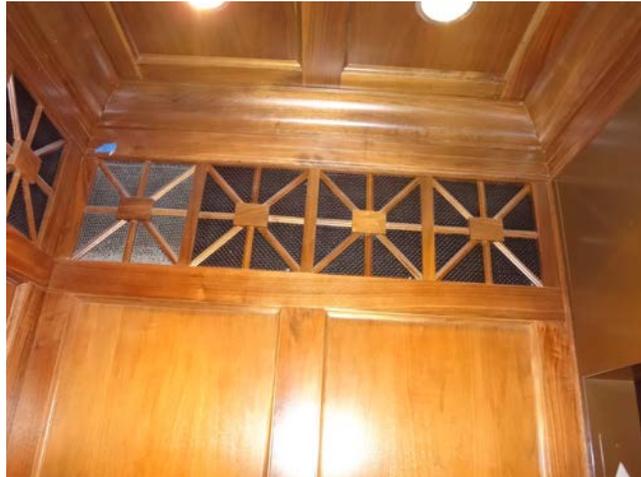
Ceilings:

The passenger elevators have down light ceilings with incandescent light fixtures. The light fixtures could be updated with energy efficient LED's and/or the entire ceiling could be replaced.
