Library and Courts II Building (038)

900 "N" Street, Sacramento, CA 95814

Facility Condition Assessment

June 2015

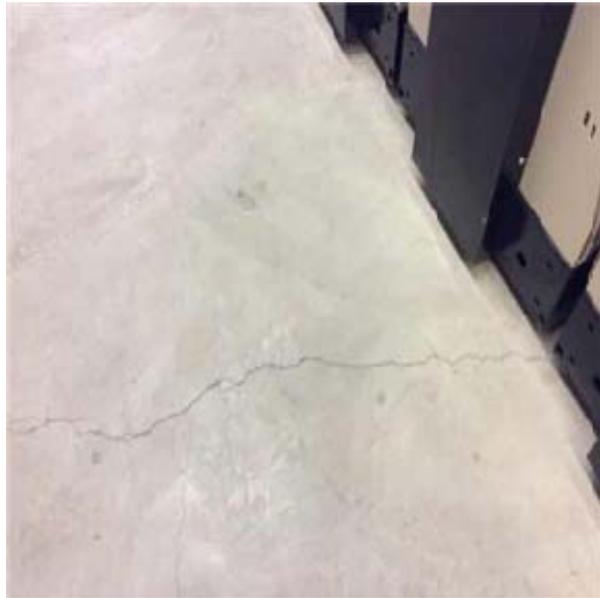
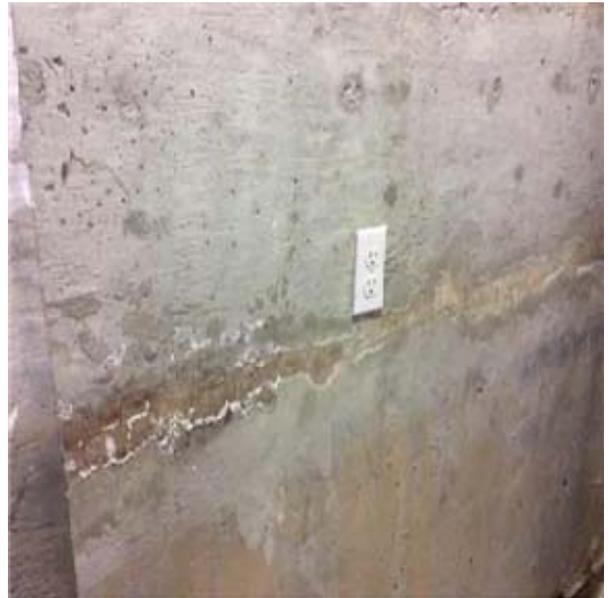
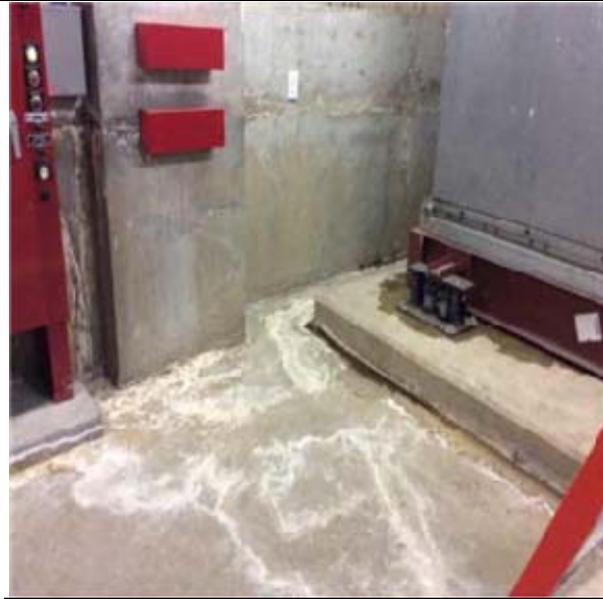
Item	Description
A2022 Moisture Protection	A2022 Crack Repair
Condition	Poor
Qty / UOM	350 / LF
RUL (years)	0
Location	Basement walls

Cracks in the basement walls and concrete slab require repair with concrete epoxy injection.

Type	Component Description	Qty / UOM	Unit Cost (\$)	Plan Type	Priority	Year	Expenditures (\$)
A2022	A2022 Repair Crack	350.0 - LF	121.5	OP - Maintenance	Priority I	2015	42,541

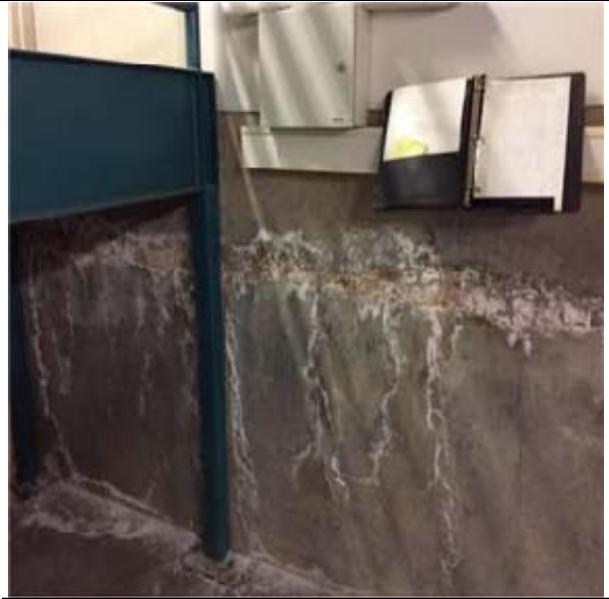
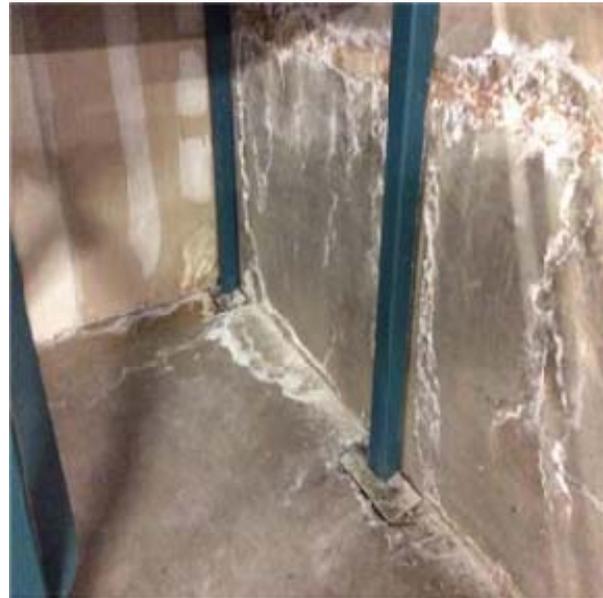
Item	Description
A2022 Moisture Protection	A2022 Waterproof Coating
Condition	Poor
Qty / UOM	1 / LS
RUL (years)	0
Location	Basement

There are signs of water intrusion on the basement walls at the west elevation. The application of an elastomeric waterproof coating to the exterior walls of the basement is recommended.

Type	Component Description	Qty / UOM	Unit Cost (\$)	Plan Type	Priority	Year	Expenditures (\$)
A2022	Replace A2022 Waterproof Coating	1.0 - LS	74400.0	OP - Maintenance	Priority I	2015	74,400

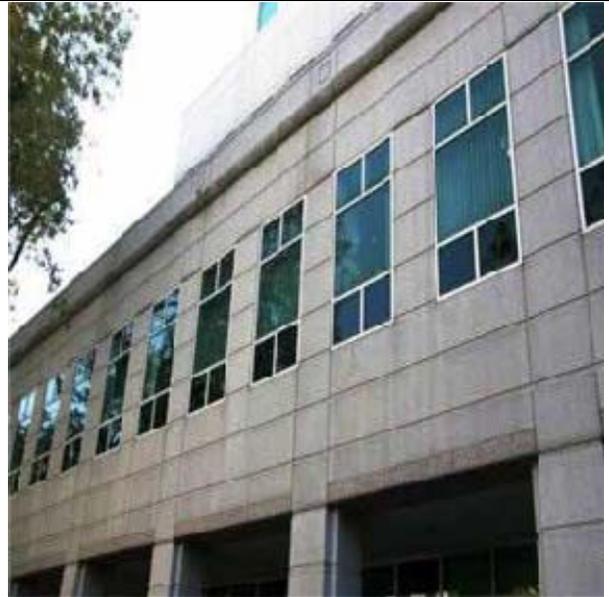
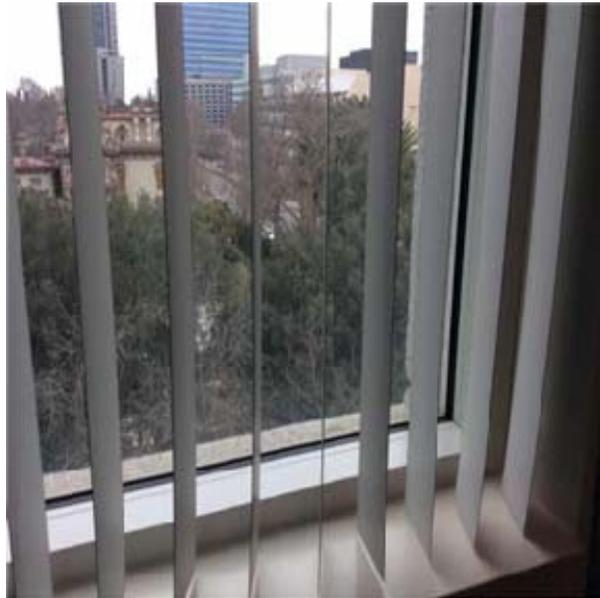
B202 | Windows, Single Pane Aluminum

Item	Description
B202I Windows	B202I Windows, Single Pane Aluminum
Condition	Fair - Good
Qty / UOM	103 / EA
RUL (years)	10
Location	Throughout exterior
Window Type	Fixed
Windows Material	Steel
Windows Glazing	Double Glazed
Window Operation	Manual

Type	Component Description	Qty / UOM	Unit Cost (\$)	Plan Type	Priority	Year	Expenditures (\$)
B202I	B202I Replace sealant and gasket throughout building	3,950.0 - LF	15.4	OP - Maintenance	Priority 2	2016	60,633

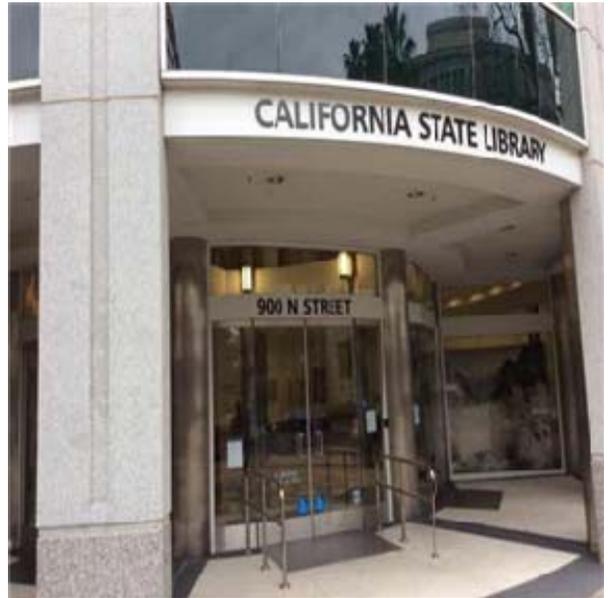
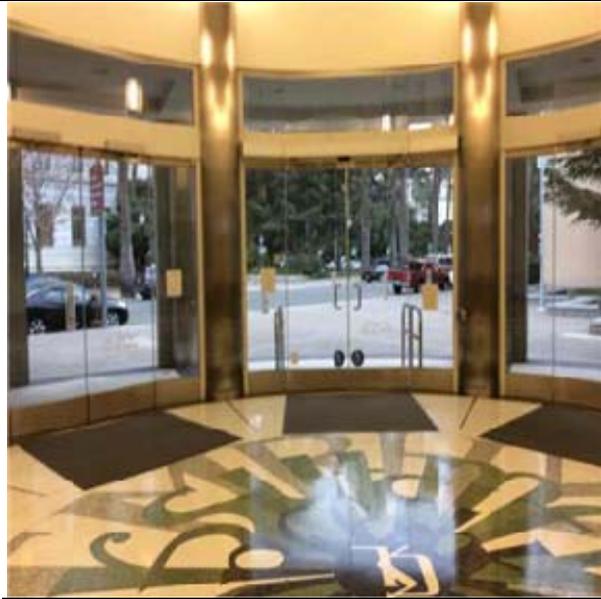
B203 | Main Entrance doors

Item	Description
B203I Glazed Doors & Entrances	B203I Main Entrance doors
Condition	Good
Qty / UOM	3 / EA
RUL (years)	8
Location	First floor exterior
Door Hardware	Push Plate
Door Operation	Manual
Glass Type	Tempered Glass
Door Frame	Metal Framed
Door Use	Entrance

Based on their estimated RUL, the lobby entrance doors will require replacement toward the end of the ten-year study period.

Type	Component Description	Qty / UOM	Unit Cost (\$)	Plan Type	Priority	Year	Expenditures (\$)
B2031	Replace B2031 Main Entrance doors	3.0 - EA	4335.5	OP - Maintenance	Priority 4	2023	13,007

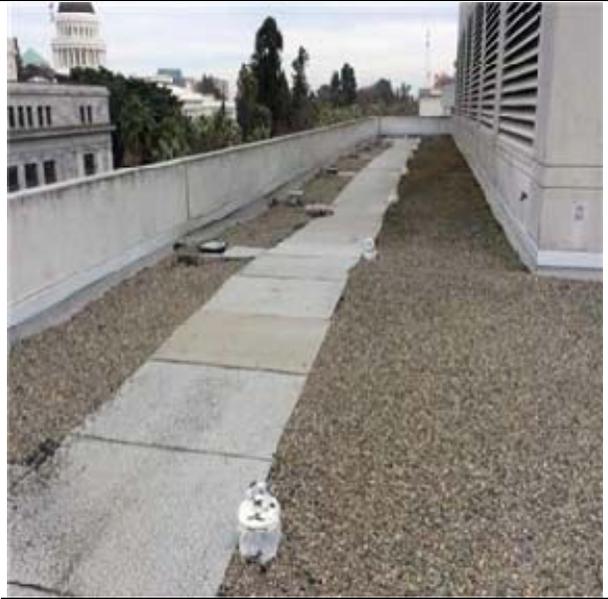
Item	Description
B3011 Roof Finishes	B3011 Built-up Roof
Condition	Poor
Qty / UOM	425 / SQ
RUL (years)	0
Location	Roof
Insulation	None
Flashings and Trim	Metal
Roof Eaves and Soffits	No
Roof Drainage	Internal Building Piping
Roof Warranty	No

The built-up roof system is the original installation and has reached the end of its expected life. There is reported moisture intrusion occurring on the south side. Replacement is recommended.

Type	Component Description	Qty / UOM	Unit Cost (\$)	Plan Type	Priority	Year	Expenditures (\$)
B3011	Replace B3011 Built-up Roof	425.0 - SQ	1861.5	IN - Beyond Rated Life	Priority I	2015	791,122

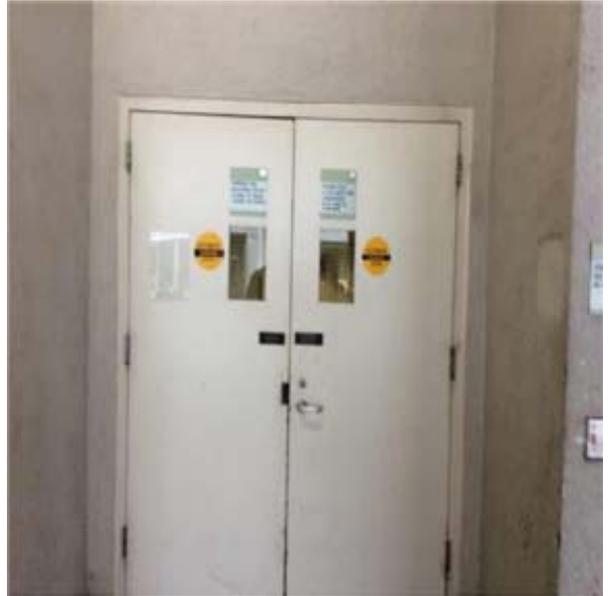
CI021 Double Doors, Wood with Vision Lites

Item	Description
C1021 Interior Doors	C1021 Double Doors, Wood with Vision Lites
Condition	Fair
Qty / UOM	22 / EA
RUL (years)	4
Location	Throughout interior

Based on current condition, door repainting is anticipated.

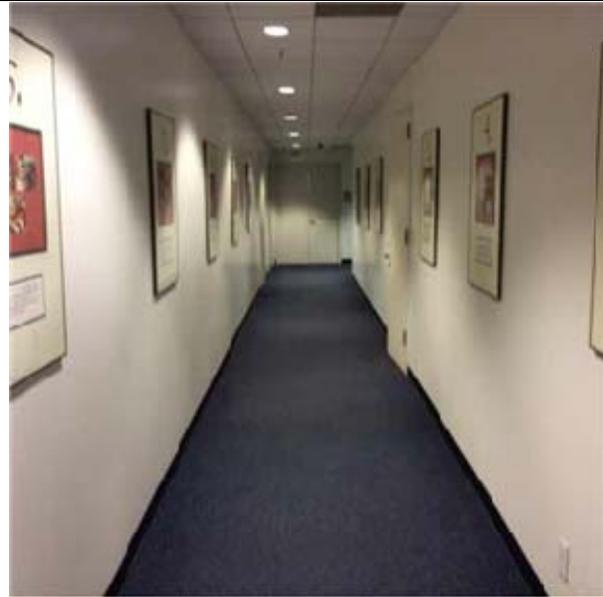
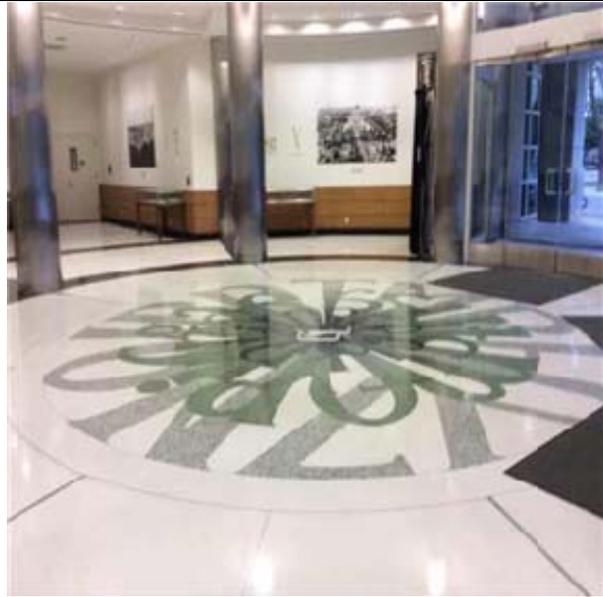
Item	Description
C3012 Wall Finishes to Interior Walls	C3012 Paint Interior Walls, Drywall
Condition	Fair
Qty / UOM	124500 / SF
RUL (years)	0
Location	Throughout interior

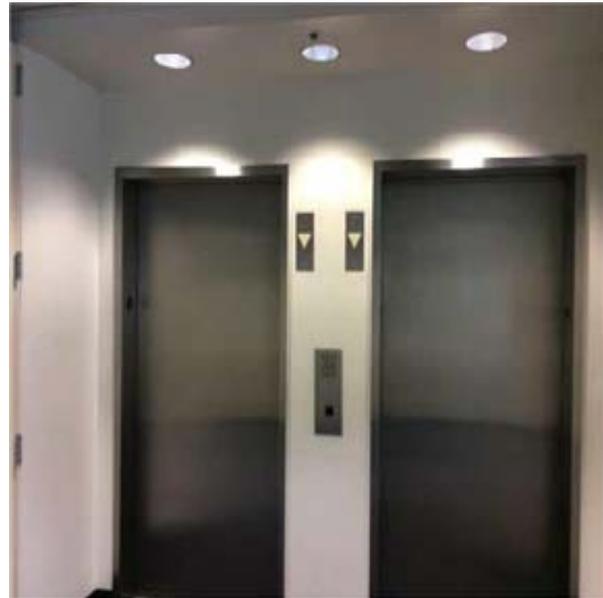
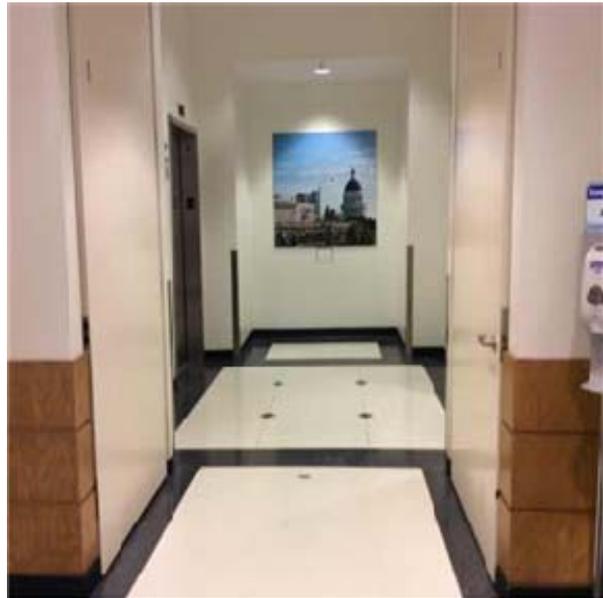
Item	Description
C3012 Wall Finishes to Interior Walls	C3012 Wall Finishes - Elevator Lobby
Condition	Fair
Qty / UOM	4580 / SF
RUL (years)	0
Location	Throughout interior

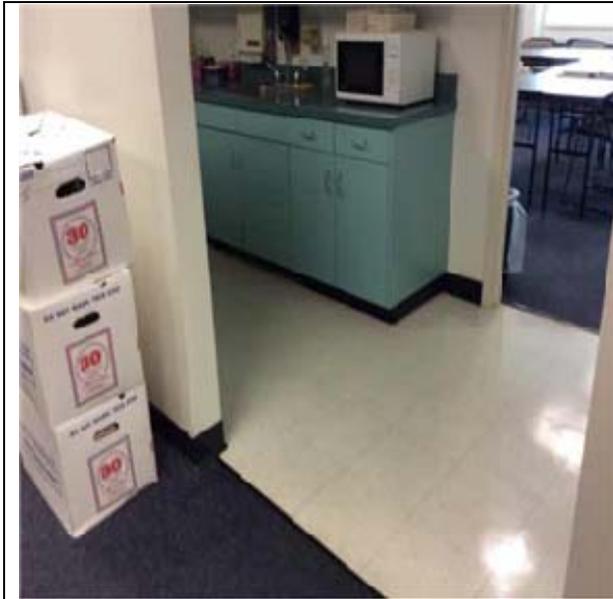
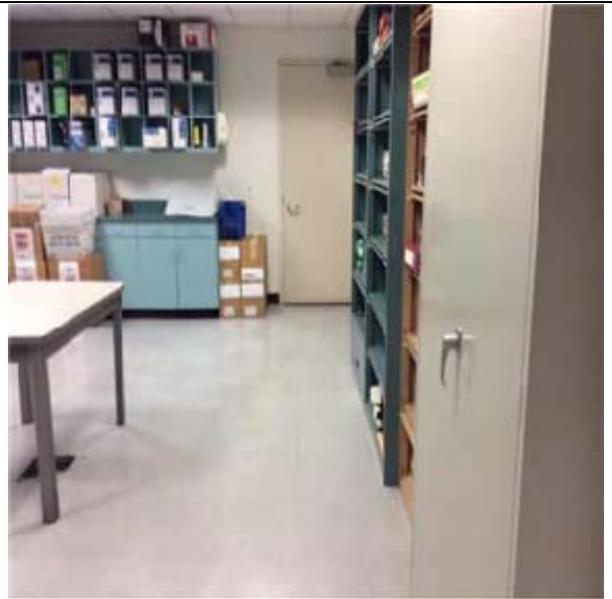
Item	Description
C3024 Flooring	C3024 Vinyl Tile
Condition	Fair
Qty / UOM	250 / SY
RUL (years)	0
Location	Throughout interior
Floor Toppings	Light Weight Concrete

Based on the RUL, vinyl tile replacement is anticipated during the reserve term.

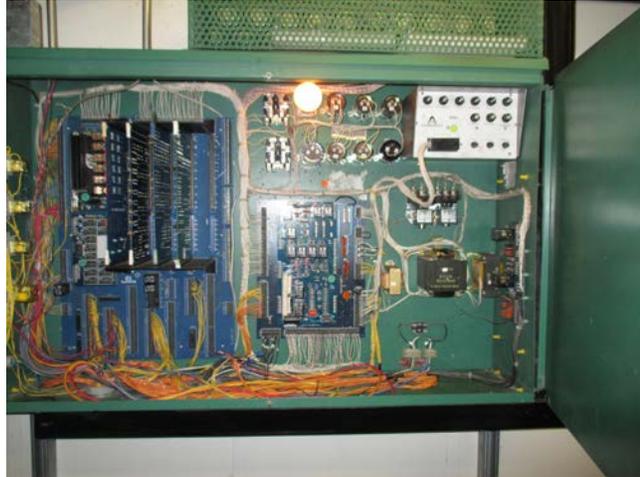
Controllers:

The controllers were manufactured and installed by U.S. Elevator. The traction cars use MP 1220 controllers. Parts support and reliability of these controllers is of concern.

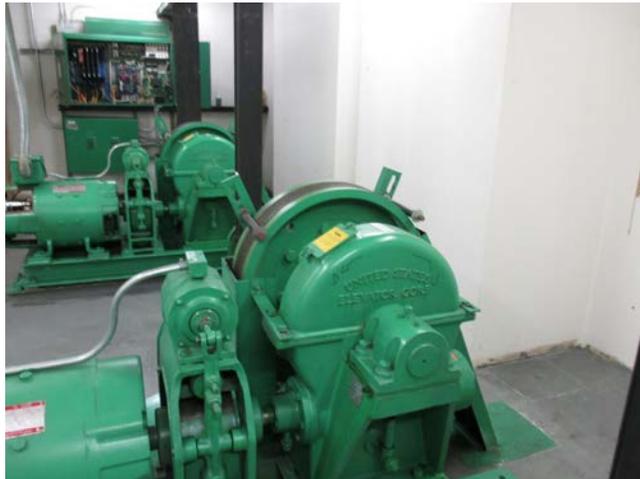
Machines:

All the geared traction elevators have high-quality Hollister Whitney machines. The machines were found to be well maintained. These machines are generally in good condition and can be retained during the modernization.

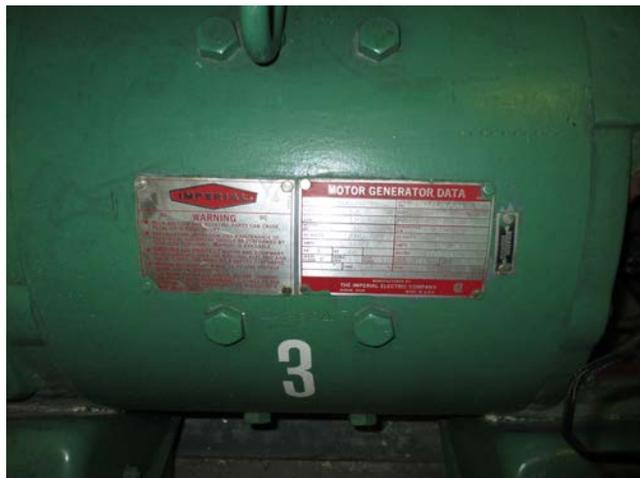
Motor Generator Sets:

All the traction elevators have motor generator sets. They were all found to be in fairly good condition but antiquated technology. We recommend these be removed when the elevators are modernized.

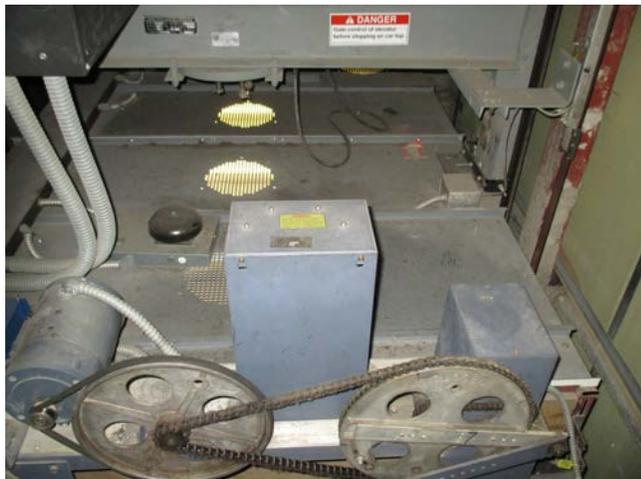
Door Operator:

The door operators are GAL which are known to be reliable, however, they are starting to show their age. We recommend new closed loop door operators when the elevators are modernized.

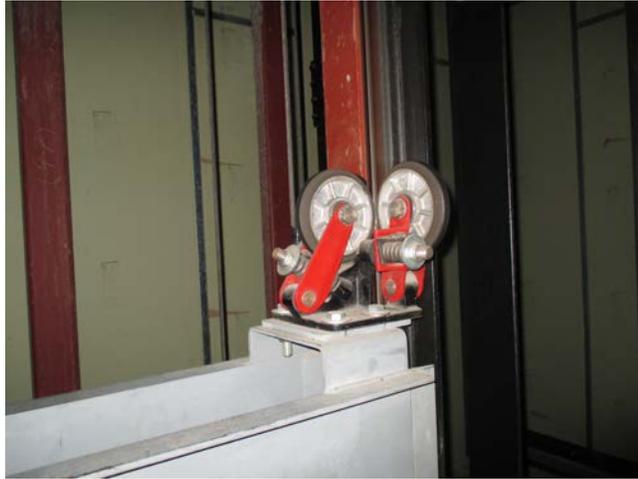
Car Roller/Slide Guides:

On both sides of the elevators and on the top and bottom roller guides keep the elevators riding up and down the steel guide rails. All the cars and counterweights have high quality ELSCO roller guides that were in good condition.

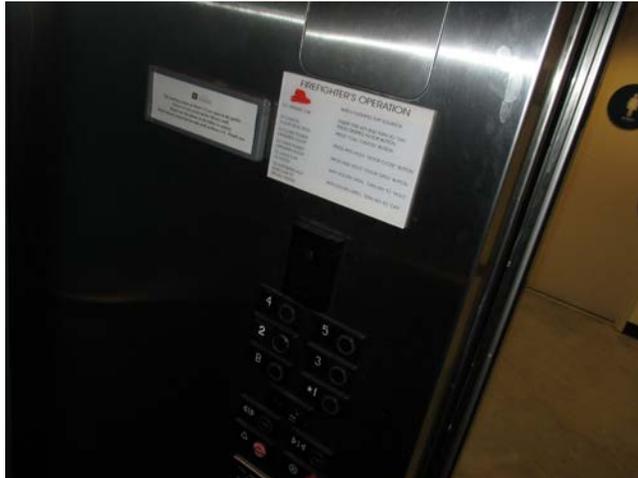
Car Operating Panels:

All the Car Operating Panels (COP's) are in fair condition and meet all ADA and T24. However, this style of U.S. button is known to be problematic and not very durable.

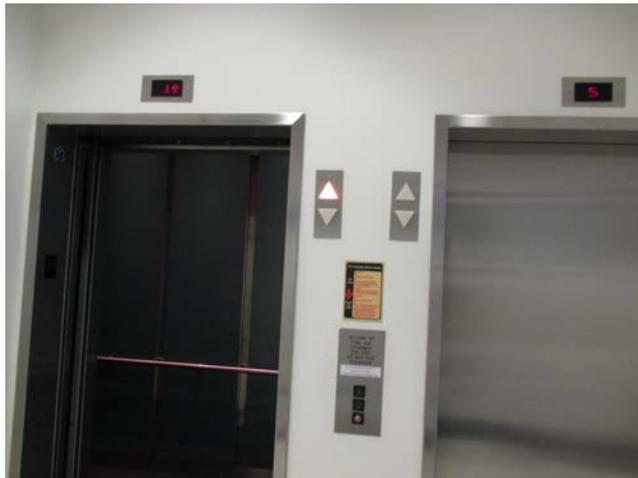
Hall Lanterns:

Hall lanterns inform persons waiting in the hall of which direction the elevator is about to travel in next. ADA requires that the hall lanterns illuminate and sound for the waiting passengers. The existing passenger elevators have hall lanterns for each car and are in good condition.

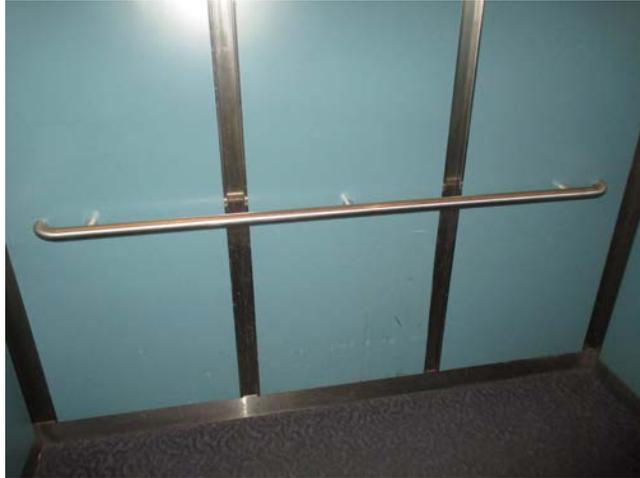
Wall Finish:

The existing cab interiors for the passenger cars are in good condition but dated. When the elevators are modernized consideration should be given to upgrade the cabs. The service car had pads and appeared to be in good condition.

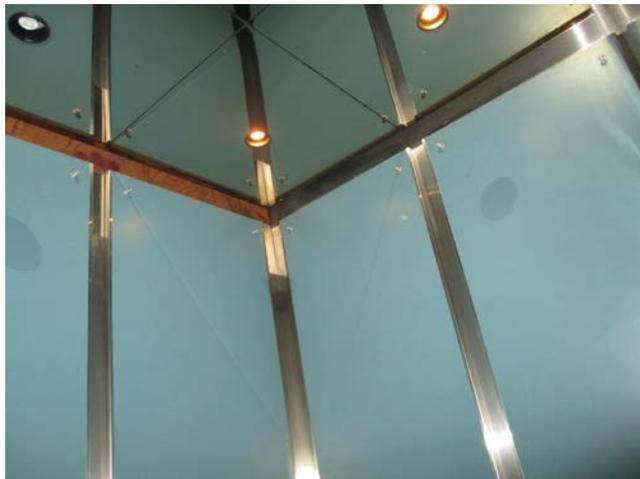
Ceilings:

The passenger elevators have down light ceilings with incandescent light fixtures. Most of the lighting in the passenger cabs was noted to be dim. We recommend new lights that are brighter and have energy savings LED's.

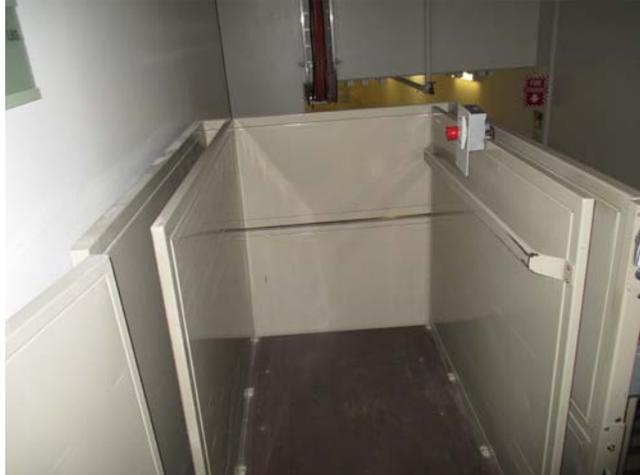
Platform Lift:

There is one platform lift that provides service from the street level to the lobby. It appears to be in good condition.
