Paul Bonderson Building (016)

901 "P" Street, Sacramento, CA 95814

Facility Condition Assessment

June 2015

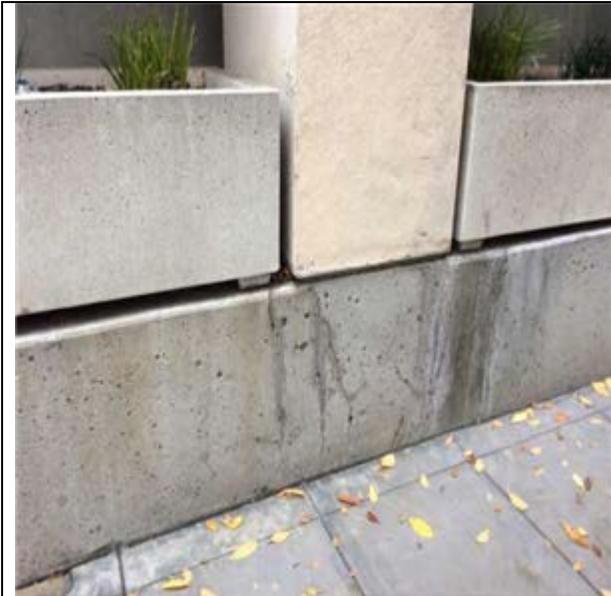
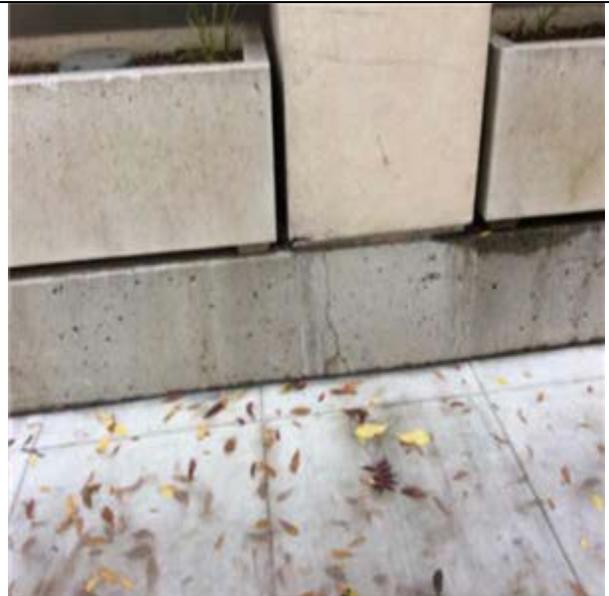
There are several cracks on the perimeter exposed concrete base that require epoxy injection repair.

A1027 Concrete Crack Repair

Type	Component Description	Qty / UOM	Unit Cost (\$)	Plan Type	Priority	Year	Expenditures (\$)
A1013	Replace A1027 Concrete Crack Repair	150.0 - LF	49.1	IN - Beyond Rated Life	Priority 1	2015	7,362

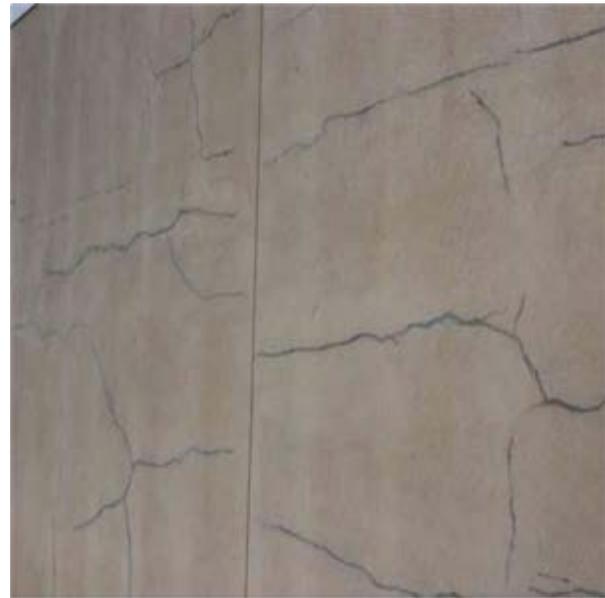
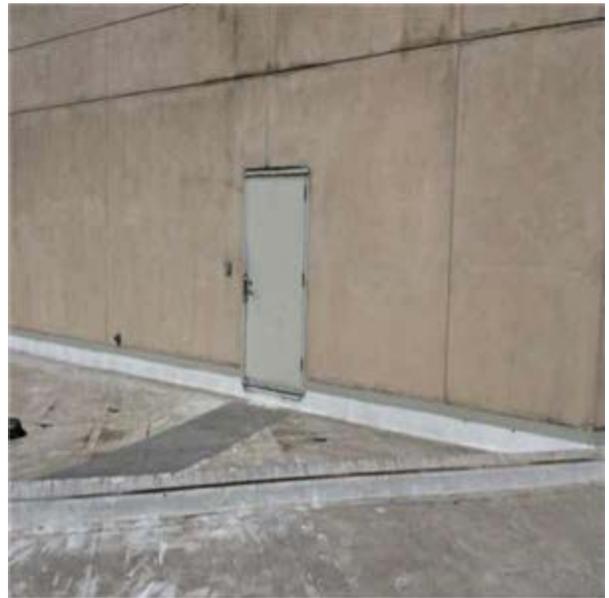
Excessive vertical and horizontal cracks in the stucco finish throughout the exterior walls and soffits require repairs.

B2011 Stucco and Lath

Type	Component Description	Qty / UOM	Unit Cost (\$)	Plan Type	Priority	Year	Expenditures (\$)
B2011	Replace B2011 Stucco and Lath	98,750.0 - SF	18.3	IN - Appearance	Priority 1	2015	1,809,811

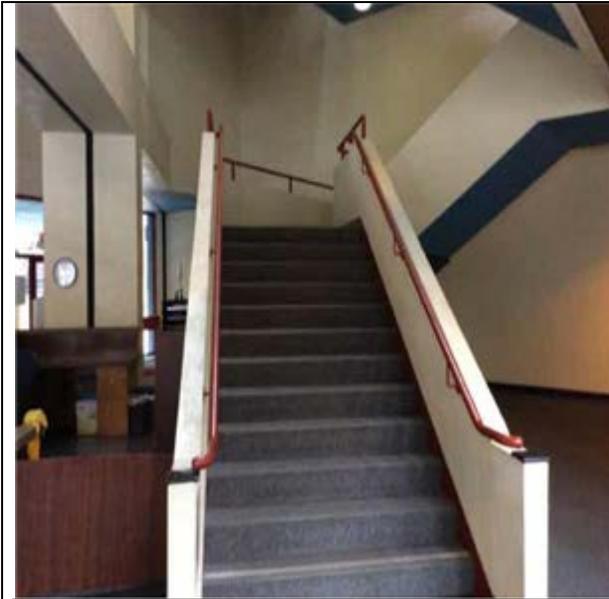
Item	Description
C2011 Regular Stairs	C2011 Cane Rail Below Stair
Condition	Poor
Qty / UOM	320 / SF
RUL (years)	0
Location	First Floor
Stairs Frame	Steel
Stair Riser	Closed
Stair Soffit Finishes	Drywall
Stair Handrail Finishes	Polished Metal

C2011 Cane Rail Below Stair :- First floor interior Stair

Type	Component Description	Qty / UOM	Unit Cost (\$)	Plan Type	Priority	Year	Expenditures (\$)
B2031	Replace B2031 ADA 12V DC Actuator Buttons	6.0 - EA	2507.8	CC - Accessibility	Priority 1	2015	15,047
C2011	Adding Guard Rail	320.0 - SF	182.4	CC - Accessibility	Priority 1	2015	58,361

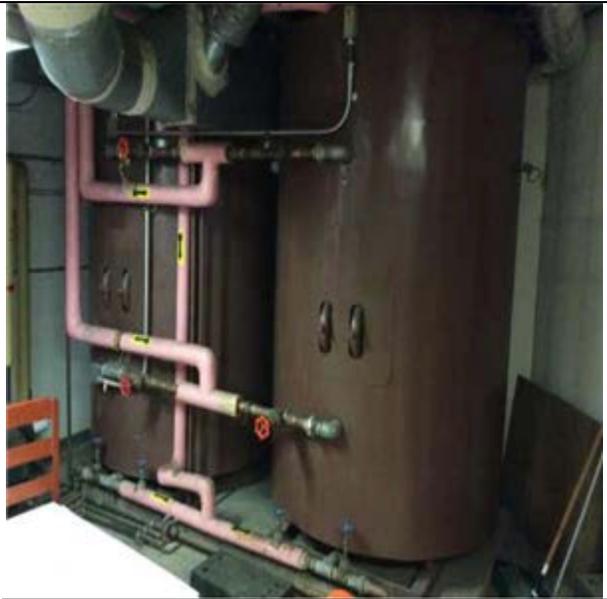
D2023 Solar Water Storage Tanks 500 Gallon:-
Abandoned solar storage tanks

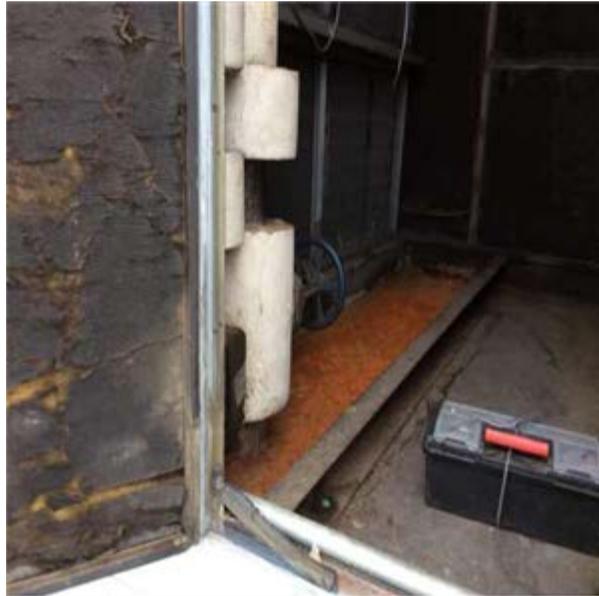
D3041 Air Handler 18,000-20,000 CFM (Original) :-
Rusting condensate pan and deteriorated insulation

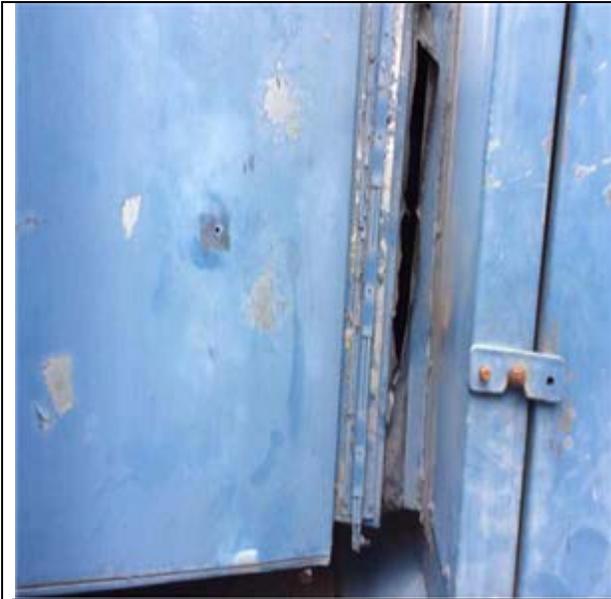
D3041 Air Handler 18,000-20,000 CFM (Original) :- Large air leak gap

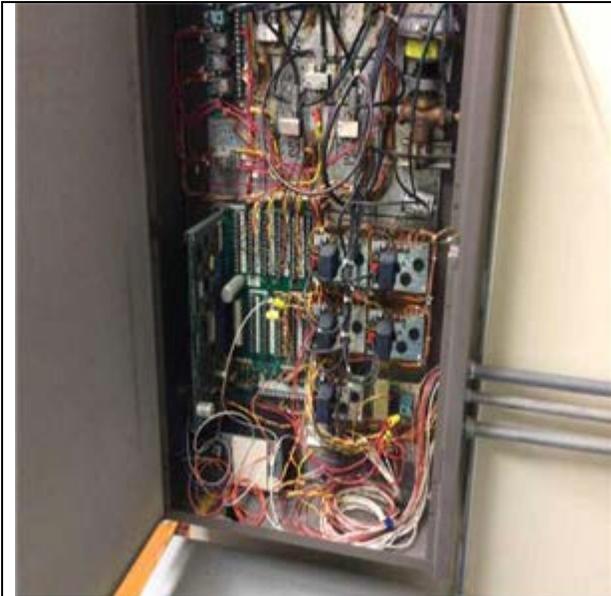
D3068 Pneumatic HVAC Controls :- Early/failed attempt at digital revision

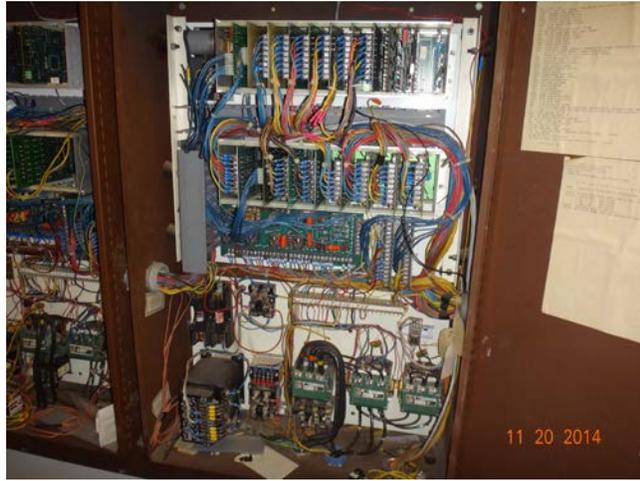
The Miprom controllers for were manufactured and installed by Montgomery Elevator company during original building construction in 1982. The controllers utilize digital board technology that is known to be reliable but have reached the end of their useful lives. If properly maintained the controllers should last another 3 to 5 years with no major updates.

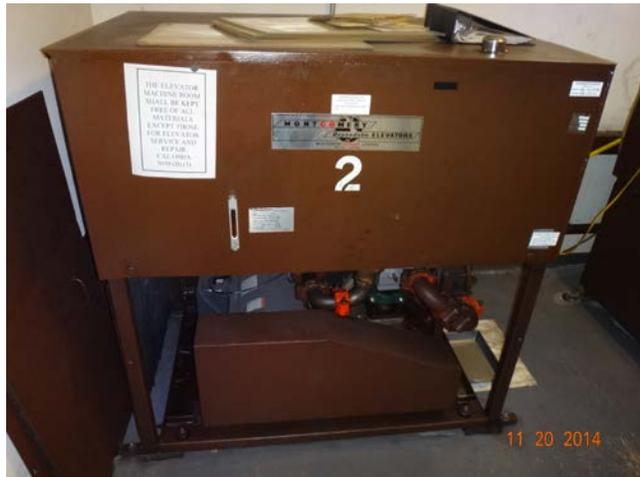
All the elevators have Montgomery power units equipped with Maxton valves and IMO pumps. The machines were installed in 1982 when the building was erected. The machines are in relatively good condition considering their age. Full modernization is recommended in 3 to 5 years

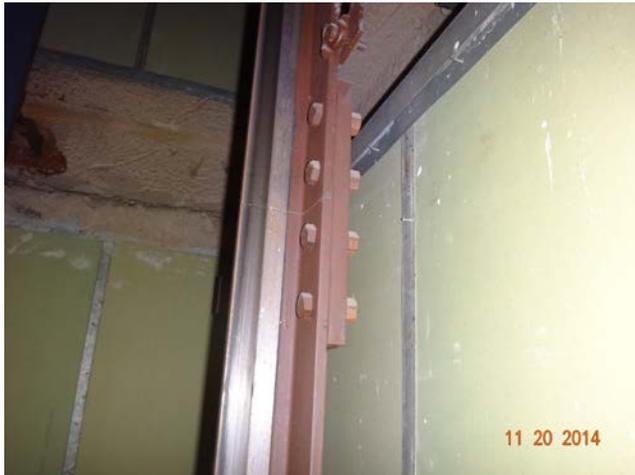
The car rails are in good condition but do not have seismic fish plates. During the proposed modernization, these could be installed. This is recommended as an option but is rarely cost effective.

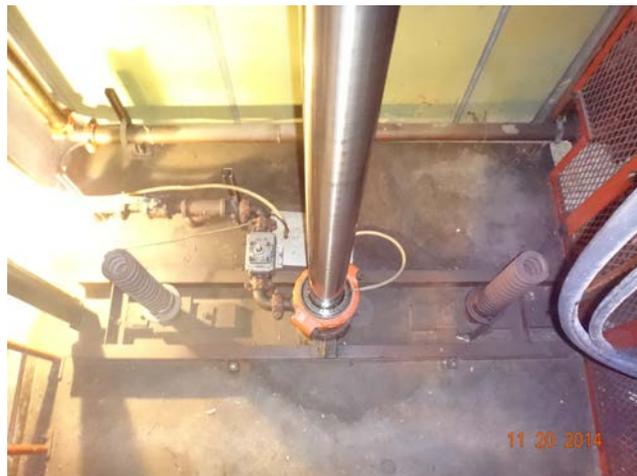
The pits for are poured concrete with sump areas and metal grating. The pits were found to be clean and dry. Some of the jack seals need to be fixed. The pits are equipped with seismic rupture valves and manual shut off valves.

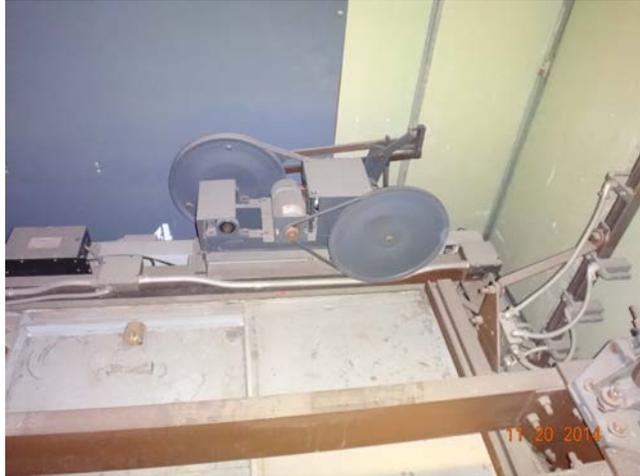
The door operators are MAC made by Montgomery Elevator Company. The door operation was noted to be fair with room for improvement. None of the cars are equipped with door restrictors. Immediate installation is highly recommended, at a minimum during the proposed modernization.

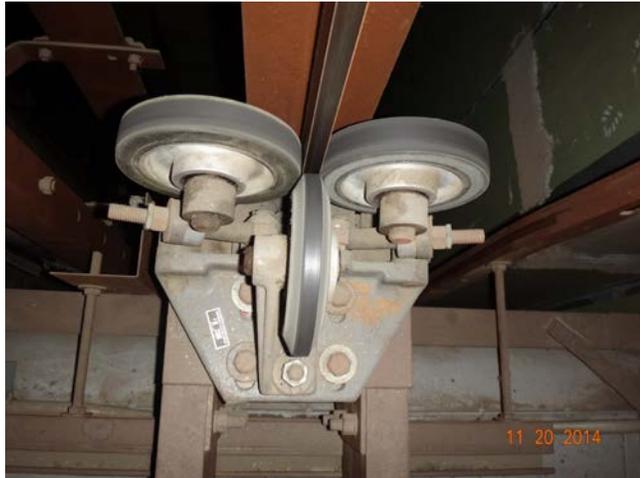
On both sides of the elevators and on the top and bottom roller guides keep the elevators riding up and down the steel guide rails. The existing ride quality was fair to poor. These are likely the original equipment but are equipped with seismic retainer plates. The guide rollers or entire assemblies could be replaced during modernization to improve ride quality.

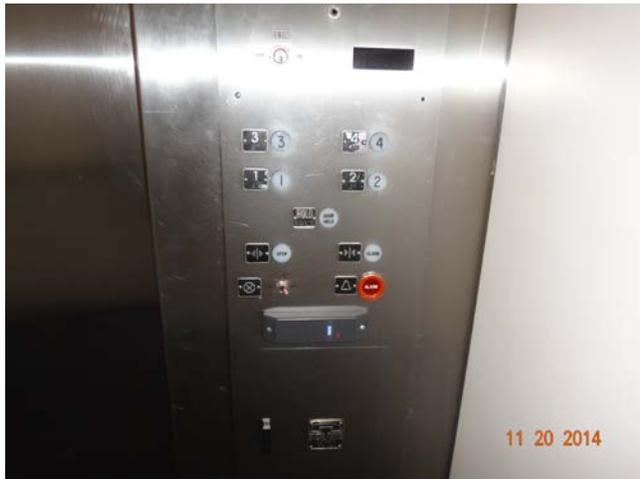
All the elevators have the original equipment Car Operating Panels (COP's). These would be replaced during the proposed modernization. The panels are in good condition; the buttons had proper braille and are at the proper height for ADA. The aesthetic is poor and the stop switch is not keyed as required by code.

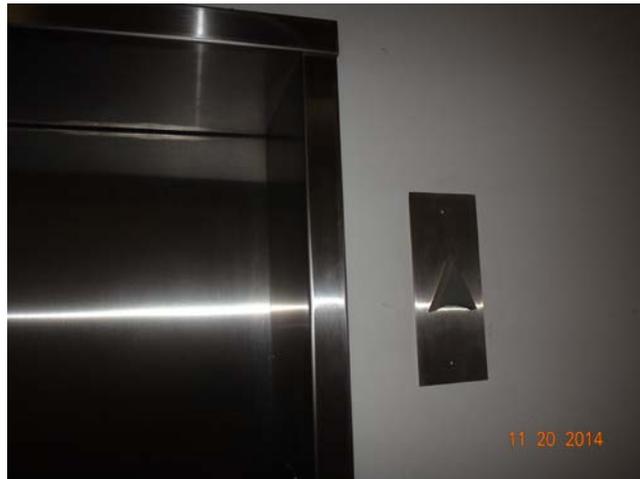
Hall lanterns inform persons waiting in the hall of which direction the elevator is about to travel in next. ADA requires that the hall lanterns illuminate and sound for the waiting passengers. The existing elevators have hall and car lanterns for each car. The lanterns have the proper gong for up and down. Some of the gongs and lantern were inoperative during our survey. The cars were all equipped with in-car position indicators mounted above the door.

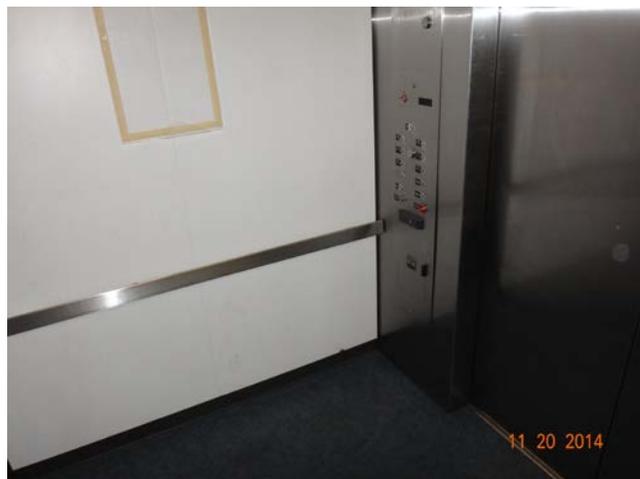
The existing cab interiors are likely original and looked are in fair condition. All sides have the code required handrails. The railing heights are not in compliance with Title 24 California code. The railings would either need to be replaced or relocated to proper height.

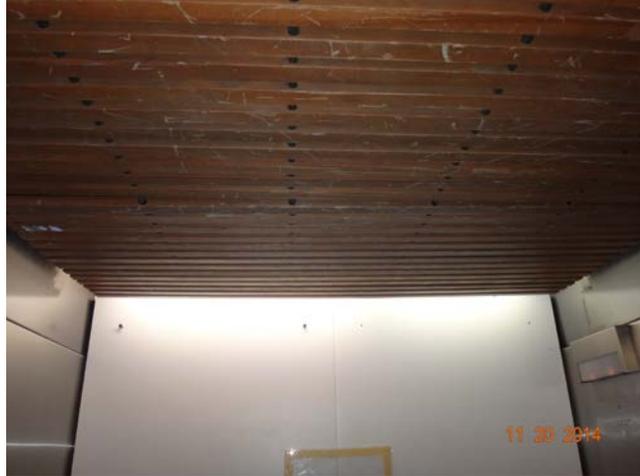
The cabs interiors are dated. The drop ceiling are wood and the lighting is indirect fluorescent that is not aesthetically pleasing but in fair condition. A complete cab upgrade is recommended during the proposed modernization.
