East End Complex Block 172 (052)

1500 Capitol Avenue, Sacramento, CA 95814

Facility Condition Assessment

June 2015

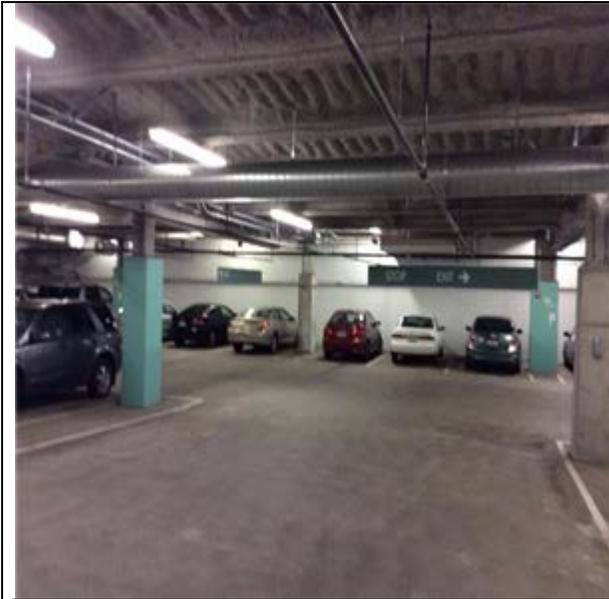
Item	Description
B10 Superstructure	B1032 Concrete Frame Structure, slab
Condition	Good
Qty / UOM	91610 / SF
RUL (years)	47
Location	Subterranean Parking Garage

Recommendations regarding the parking garage are under Block 171.

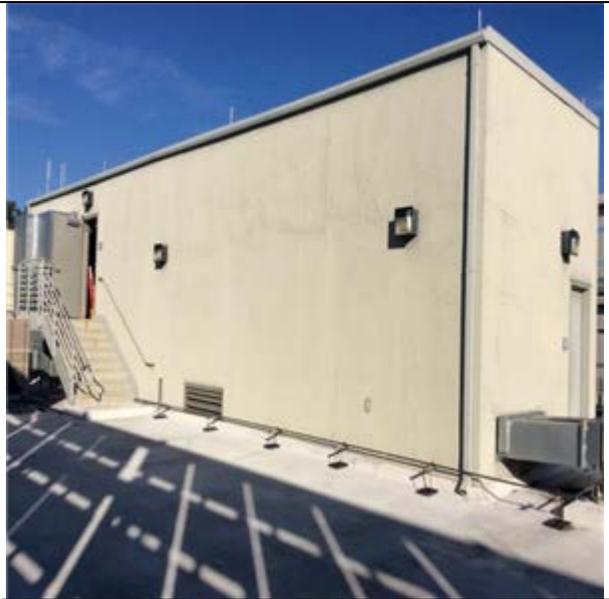
Item	Description
B2011 Exterior Wall Construction	B2011 Stucco and Lath
Condition	Fair
Qty / UOM	1000 / SF
RUL (years)	0
Location	Elevator machine room

The stucco is developing cracks and leaks. Removing the existing stucco and installing new is recommended.

Type	Component Description	Qty / UOM	Unit Cost (\$)	Plan Type	Priority	Year	Expenditures (\$)
B2011	Replace B2011 Stucco and Lath	1,000.0 - SF	18.3	IN - Reliability	Priority 1	2015	18,327

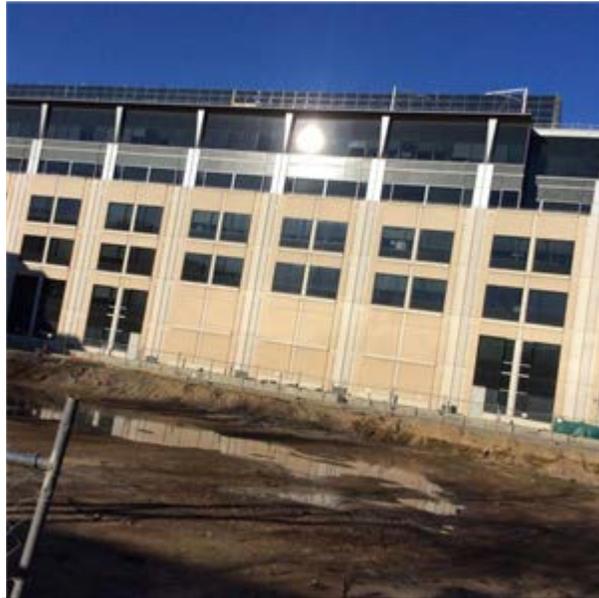
Item	Description
B2011 Exterior Wall Construction	B2011 Granite Veneer
Condition	Good
Qty / UOM	5000 / SF
RUL (years)	28
Location	Exteriors

Based on normal deterioration, sealant replacement will be required in the reserve term.

Type	Component Description	Qty / UOM	Unit Cost (\$)	Plan Type	Priority	Year	Expenditures (\$)
B2011	Replace exterior sealant	1,000.0 - LF	15.7	OP - Maintenance	Priority 3	2018	15,650

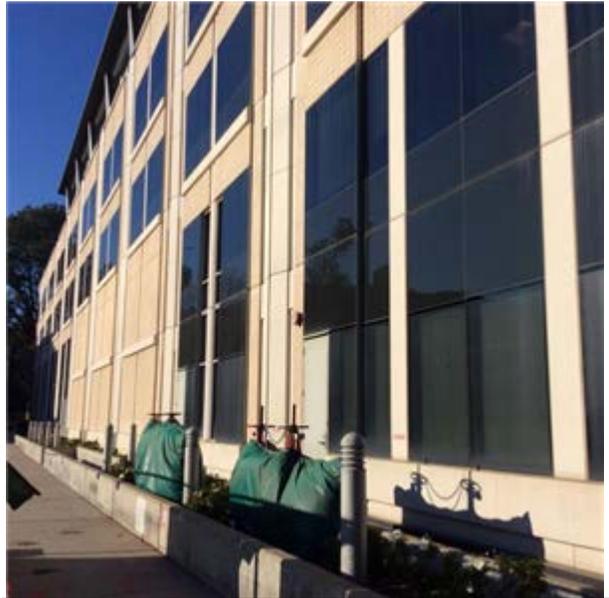
Item	Description
B2011 Exterior Wall Construction	B2011 Precast veneer panels
Condition	Good
Qty / UOM	16500 / SF
RUL (years)	25
Location	First through sixth floors

Based on normal deterioration, sealant replacement will be required during the reserve term.

Type	Component Description	Qty / UOM	Unit Cost (\$)	Plan Type	Priority	Year	Expenditures (\$)
B2011	Replace exterior sealant	4,000.0 - LF	15.7	OP - Maintenance	Priority 3	2018	62,600

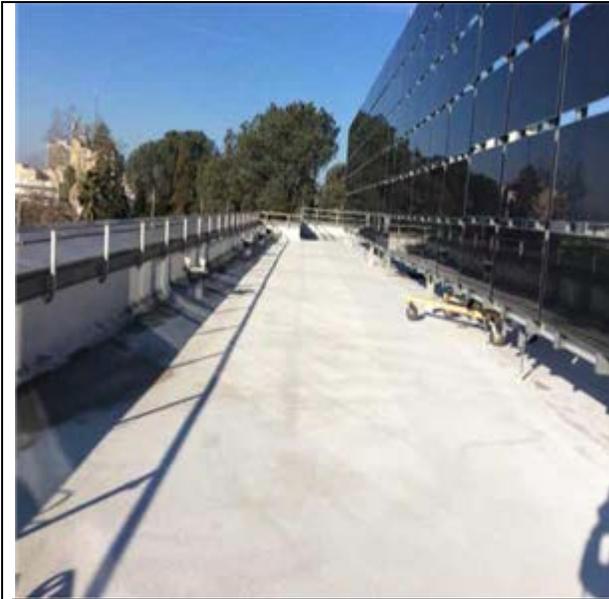
B301 | Liquid Applied Waterproofing :- Overview of roof

Item	Description
B3010 Roof Coverings	B301 I Liquid Applied Waterproofing
Condition	Fair
Qty / UOM	358 / SQ
RUL (years)	8
Location	Roof

Based on its condition and RUL, roof replacement is anticipated during the reserve term.

Type	Component Description	Qty / UOM	Unit Cost (\$)	Plan Type	Priority	Year	Expenditures (\$)
B3010	Replace B301 I Liquid Applied Waterproofing	358.0 - SQ	1806.4	IN - Beyond Rated Life	Priority 4	2023	646,676
B3010	Pressure wash roof	35,844.0 - SF	1.5	IN - Reliability	Priority 4	2023	53,766

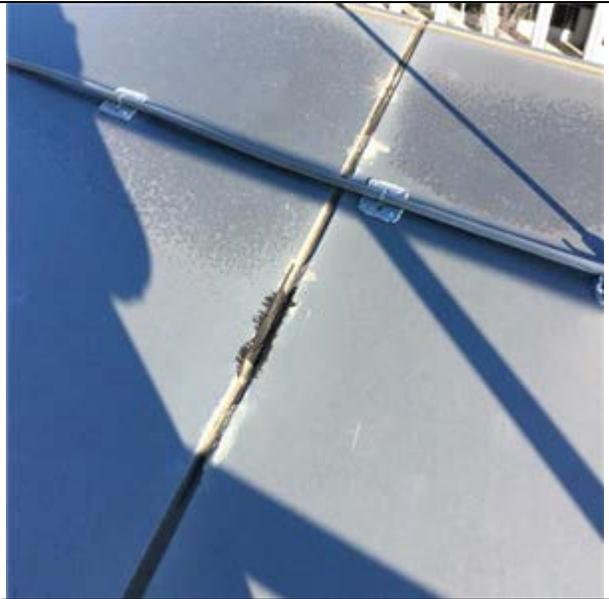
Item	Description
B3014 Flashings & Trim	B3014 Coping
Condition	Good
Qty / UOM	10000 / LF
RUL (years)	37
Location	Coping at parapets

The sealant between the coping is failing due to birds pecking at it. Patching the sealant will remain a constant maintenance item, until the sealant is replaced by a material that is not attractive to birds. Replacement is required during the reserve term.

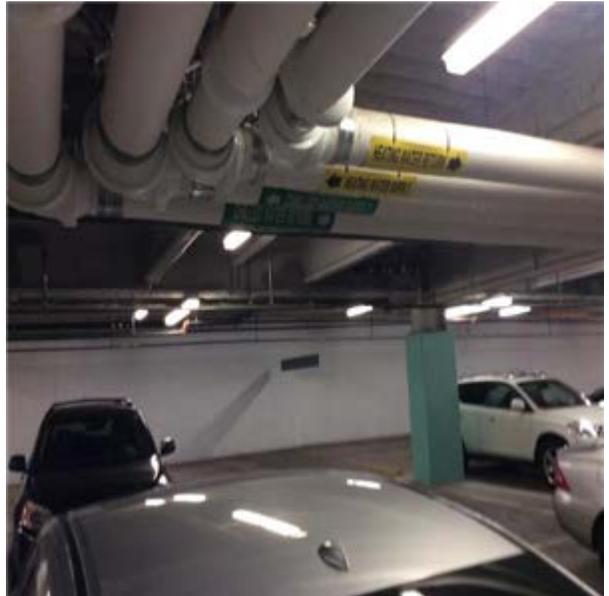
D3044 Isolation Valve HVAC Water Supply

- The stucco on the elevator equipment room and mechanical penthouse is developing cracks, causing leaks. Repairs are recommended.
- There are no isolation valves on the heating and cooling system to allow maintenance to be performed in one area, without shutting down the whole system. Installation of isolation valves is recommended.
- Repair and replace non-working panels in the rooftop photovoltaic system.
- A full infrared scan, cleaning, and tightening of wire attachments is recommended for the electrical switchgear and distribution panels.

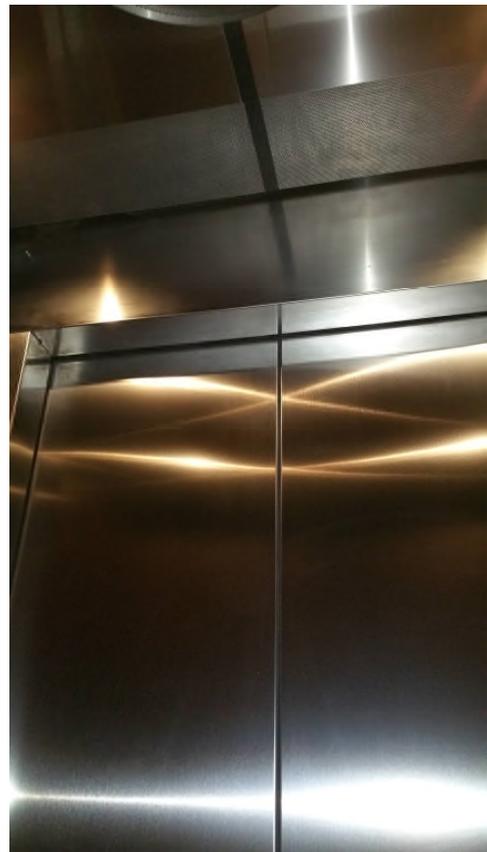
The passenger elevators have decorative stainless steel ceilings with incandescent light fixtures. The light fixtures could be updated with energy efficient LED's and/or the entire ceiling could be replaced.
