Personnel Building (021)

801 Capitol Mall, Sacramento, CA 95814

Facility Condition Assessment

June 2015

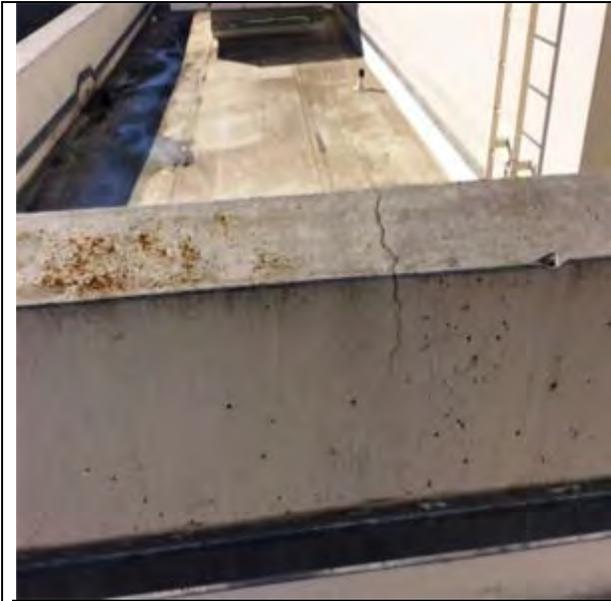
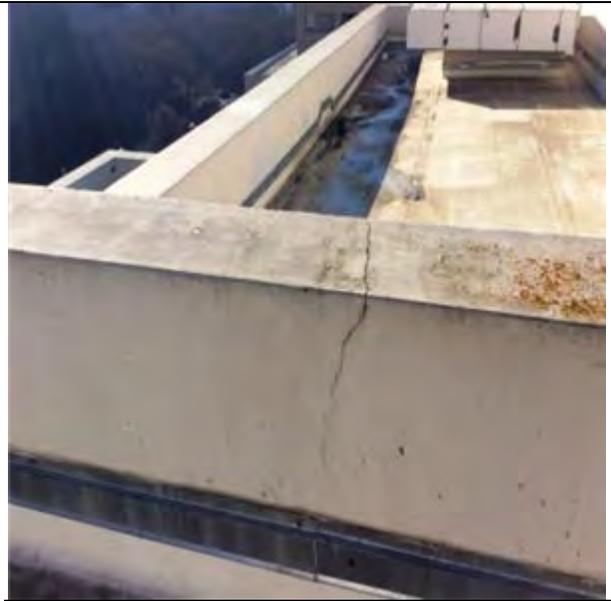
Item	Description
B1021 Flat Roof Construction	B1021 Roof Concrete Parapet
Condition	Poor - Fair
Qty / UOM	150 / LF
RUL (years)	0
Location	Roof

Repair cracks in concrete parapet wall next to penthouse, using epoxy injection.

Type	Component Description	Qty / UOM	Unit Cost (\$)	Plan Type	Priority	Year	Expenditures (\$)
B1021	Repair	150.0 - LF	138.3	CC - Life Safety	Priority 1	2015	20,750

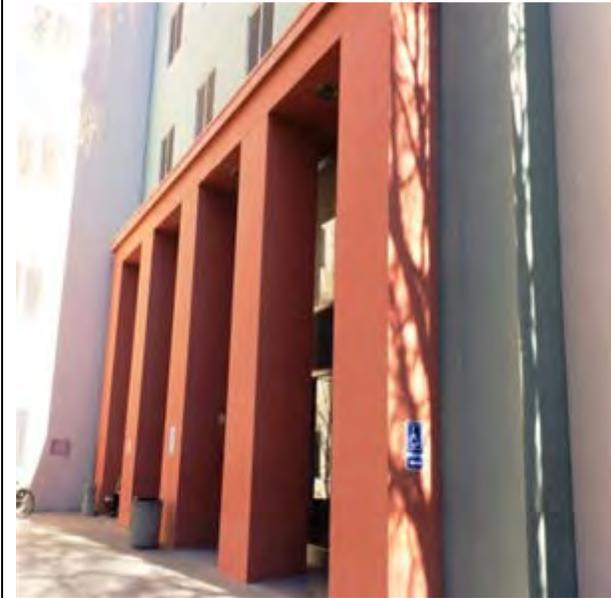
Item	Description
B2011 Exterior Wall Construction	B2011 Exterior Concrete Walls
Condition	Fair - Good
Qty / UOM	38520 / SF
RUL (years)	15
Location	Exterior walls

Exterior walls are cast-in-place concrete with painted finish. Pressure washing and painting is recommended.

B2011 Exterior Concrete Walls :- Painted finishes

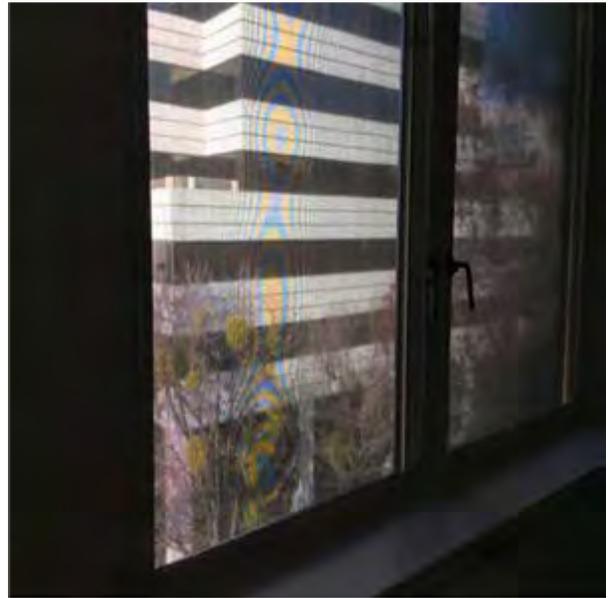
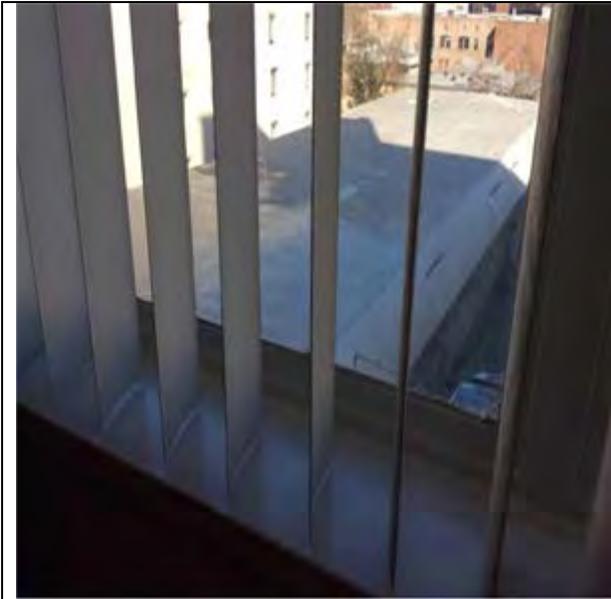
Item	Description
B2021 Windows	B2021 Windows, Single Pane Metal
Condition	Poor - Fair
Qty / UOM	207 / EA
RUL (years)	0
Location	Exterior elevations
Window Type	Fixed
Windows Material	Steel
Windows Glazing	Double Glazed
Window Operation	Manual

Single pane windows are original equipment and not energy efficient. Replacement is recommended.

Type	Component Description	Qty / UOM	Unit Cost (\$)	Plan Type	Priority	Year	Expenditures (\$)
B2021	Replace Windows	207.0 - EA	1987.3	IN - Beyond Rated Life	Priority 1	2015	411,381

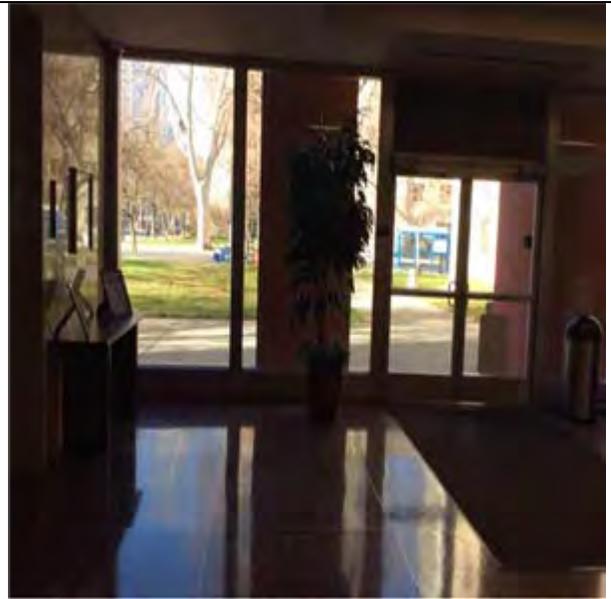
Item	Description
B2031 Glazed Doors & Entrances	B2031 Entrance double doors to office area
Condition	Good
Qty / UOM	2 / EA
RUL (years)	18
Location	Main entrance
Door Hardware	Push Plate
Door Operation	Automatic
Glass Type	Tempered Glass
Door Frame	Metal Framed
Door Use	Entrance

Main entrance aluminum framed glass doors are in good condition and functioning adequately.

B2031 Entrance double doors to office area

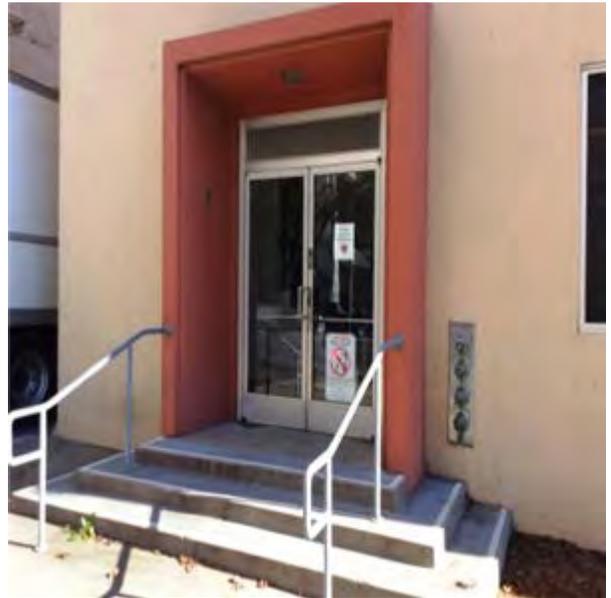
Item	Description
B2031 Glazed Doors & Entrances	B2031 Glazed Doors & Entrances 6' x 7'
Condition	Fair
Qty / UOM	1 / EA
RUL (years)	5
Location	West end

The aluminum full-vision double doors with transom at the west end, are showing signs of aging, and will require replacement.

B2031 Glazed Doors & Entrances 6' x 7':- West end

Type	Component Description	Qty / UOM	Unit Cost (\$)	Plan Type	Priority	Year	Expenditures (\$)
B2031	Replace B2031 Glazed Doors & Entrances 6' x 7'	1.0 - EA	12400.0	IN - Beyond Rated Life	Priority 3	2020	12,400

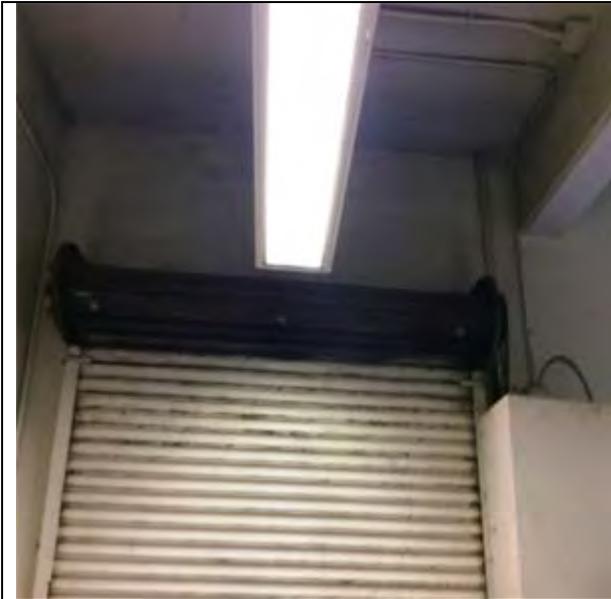
Item	Description
B2034 Overhead Doors	B2034 Steel Rolling Overhead Door, Manual - 8' to 12'
Condition	Poor - Fair
Qty / UOM	1 / EA
RUL (years)	0
Location	Rear loading dock

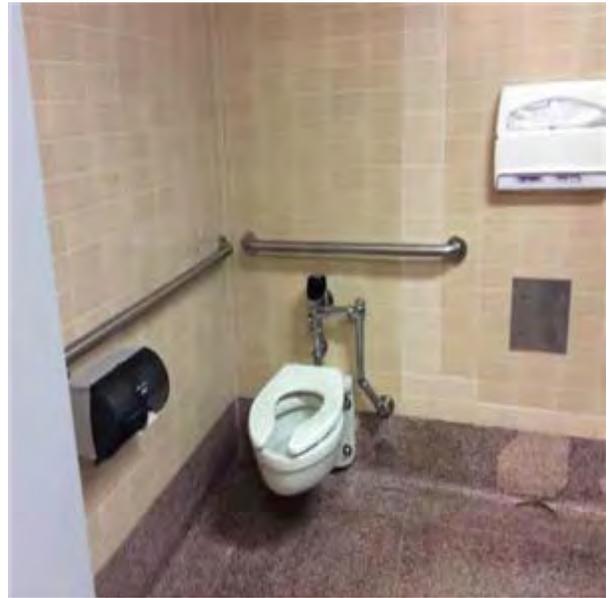
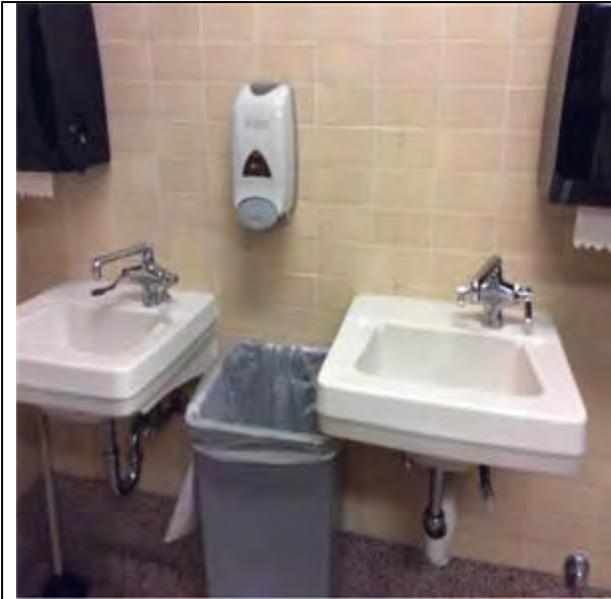
Item	Description
C3005 ADA Renovations	C3005 - ADA Restroom Renovations
Condition	Fair
Qty / UOM	6 / EA
RUL (years)	0
Location	All Floors

Type	Component Description	Qty / UOM	Unit Cost (\$)	Plan Type	Priority	Year	Expenditures (\$)
C3005	Replace C3005 - ADA Restroom Renovations	6.0 - EA	29760.0	CC - Accessibility	Priority 1	2015	178,560
G2033	Replace G2030 Accessible Ramp	25.0 - LF	1438.4	CC - Accessibility	Priority 1	2015	35,960
G2033	G2035 Modify concrete steps at entrance for accessible ramp	1.0 - EA	11829.0	CC - Accessibility	Priority 1	2015	11,829

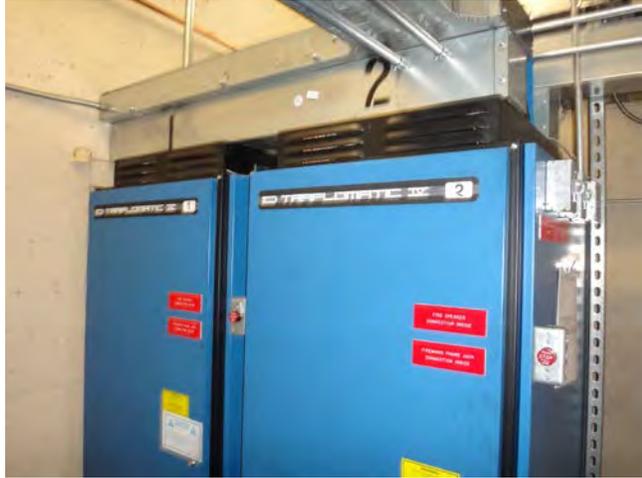
Controllers:

The controllers were manufactured and installed by Dover when the elevators were modernized in 1997. The controllers utilize motor generator sets. These controllers can last another 4 to 6 years.

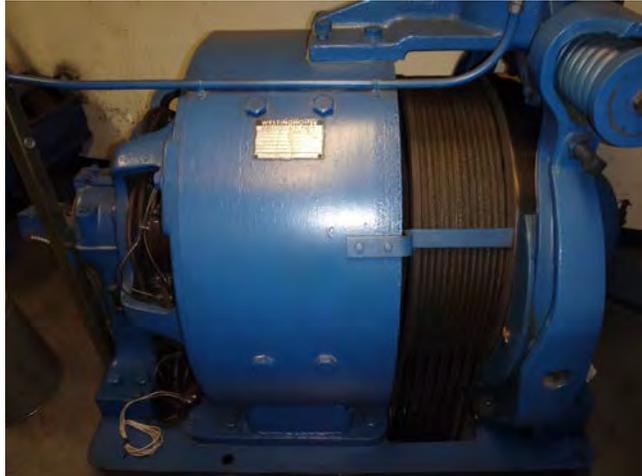
Gearless Machines:

Both the passenger and service cars have Westinghouse gearless machines that were installed in 1955 when the elevators were new. They appeared to be in good condition and operating at full speed.

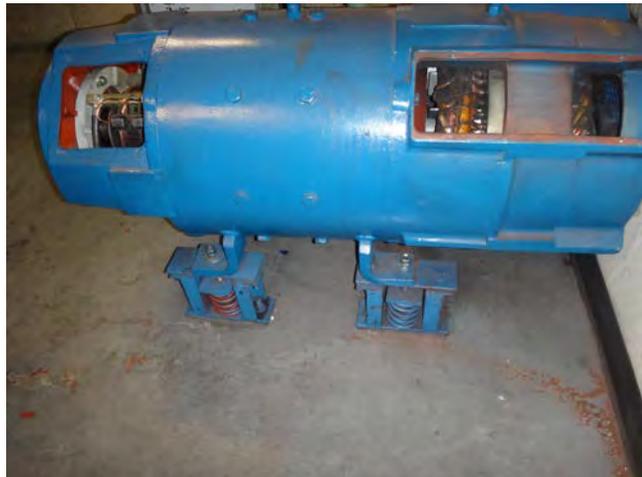
Motor Generator Sets:

All the elevators had motor generators installed when last modernized in 1997. These are worn out, noisy and not very energy efficient. We recommend these be removed as part of the modernization.

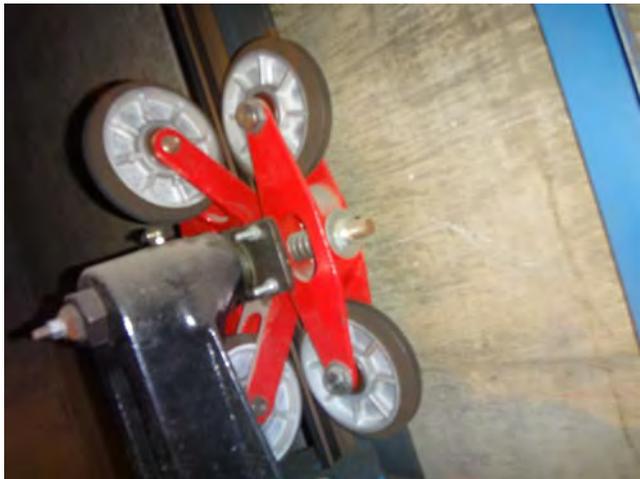
Car Roller/Slide Guides:

On both sides of the elevators and on the top and bottom roller guides keep the elevators riding up and down the steel guide rails. The existing ride quality was noted to be good on all the cars. High quality ELSCO rollers were installed on the cars when last modernized.

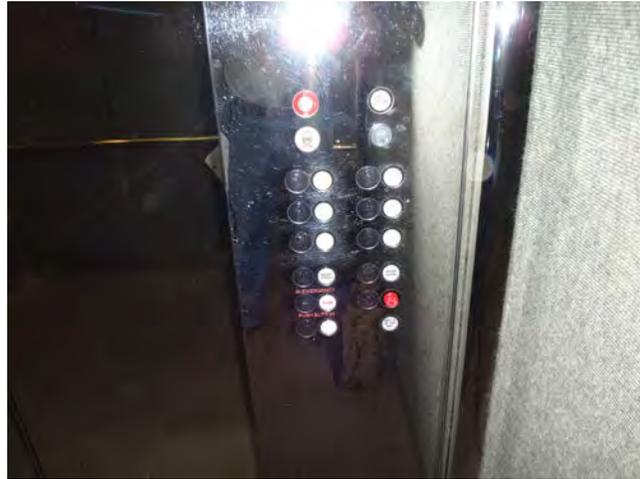
Car Operating Panels:

All the elevators have newer Car Operating Panels (COP's) that were installed during the elevator modernization. The panels are in good condition and meet ADA and T24. The panels are made of stainless steel with polished finish and are in good condition but have a few scratches.

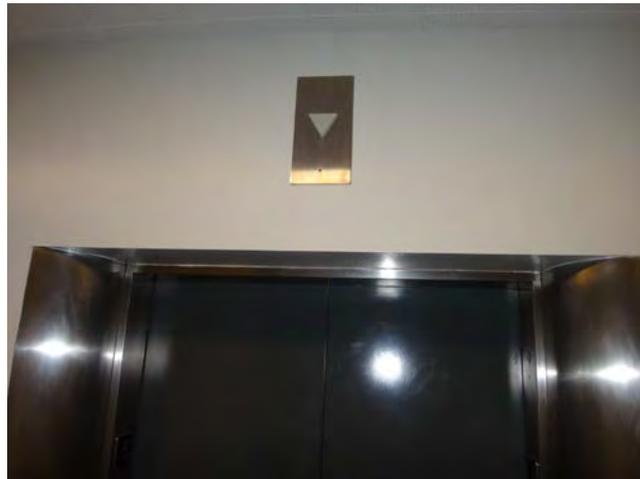
Hall Lanterns:

Hall lanterns inform persons waiting in the hall of which direction the elevator is about to travel in next. ADA requires that the hall lanterns illuminate and sound for the waiting passengers. The existing passenger elevators have hall lanterns for each car. The lanterns have the proper gong for up and down. The service car has a car riding lantern.

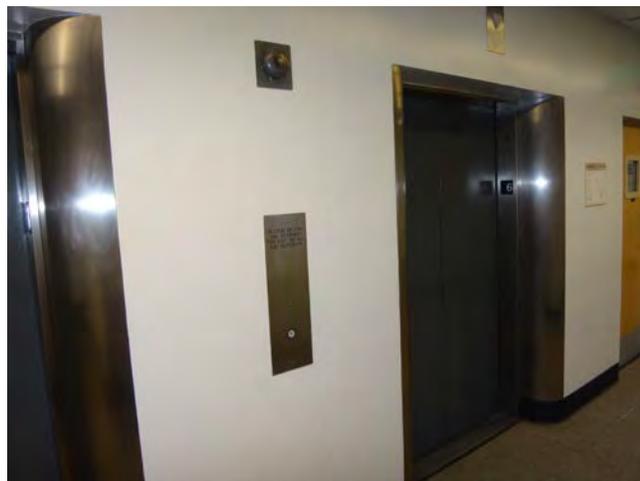
Hall Call Pushbuttons:

At each floor hall call push buttons are located so that users can call the elevator. The hall call stations have raised operation buttons which meet ADA and California Title 24. These were all noted to be in good condition.

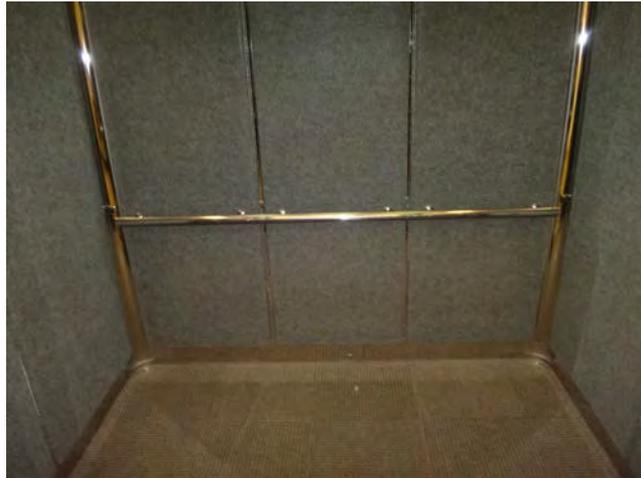
Wall Finish:

The existing cab interiors were updated with carpet walls in 1997 and now look dated. The back wall has the code required handrail. The railing heights are in compliance with Title 24 California code. We recommend new cab interiors when they are modernized.

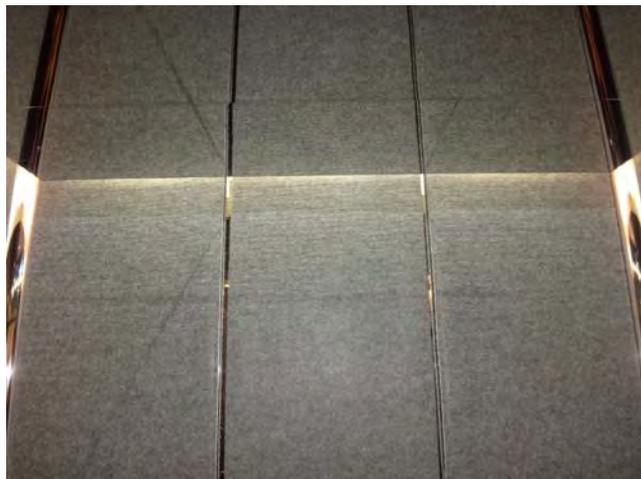
Ceilings:

The passenger elevators have islands with perimeter lighting with incandescent light fixtures. The light fixtures could be updated with energy efficient LED's and/or the entire ceiling could be replaced.
