Secretary of State / Archives Building (036)

1500 11th Street, Sacramento, CA 95814

Facility Condition Assessment

June 2015

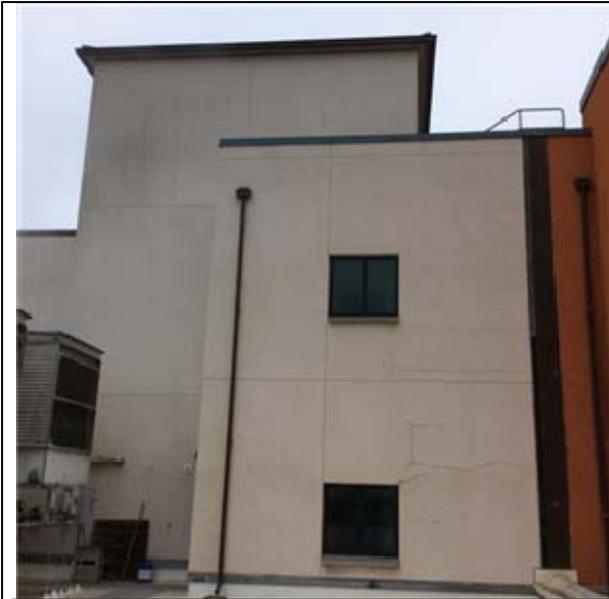
B2011 Stucco and Lath

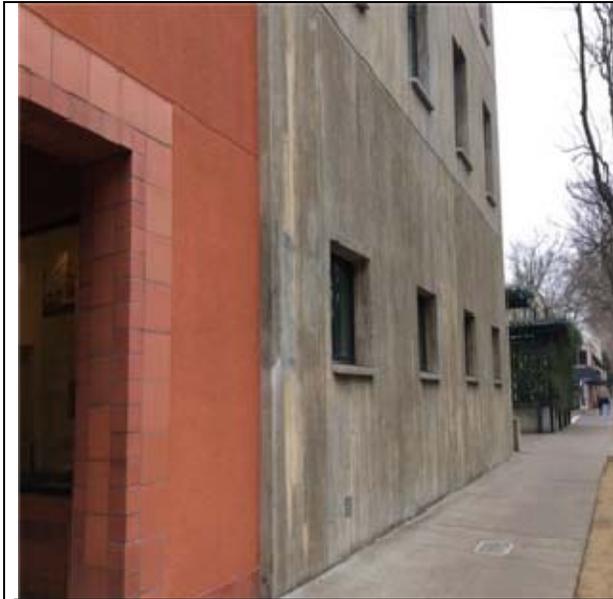
B2011 2 foot thick poured concrete

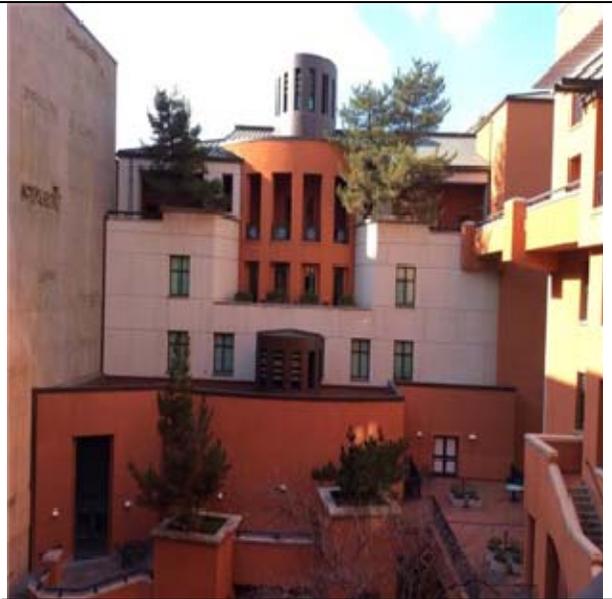
B2011 Stucco and Lath:- Partial view of courtyard

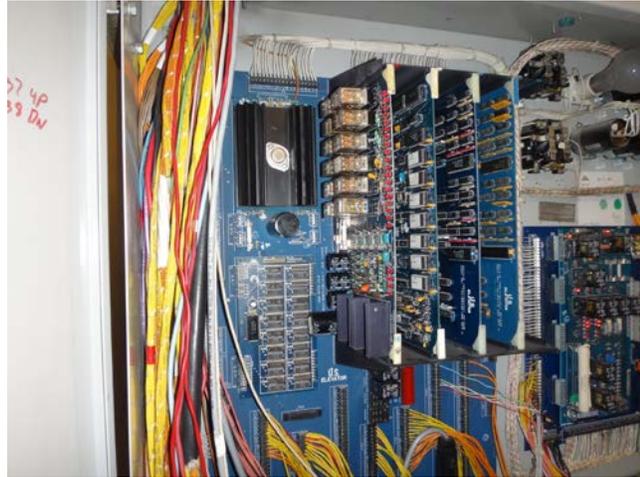
Controllers:

The controllers were manufactured and installed by U.S. Elevator. The traction cars use MP 1220 controllers and the hydraulic elevators use MP 1230 controllers. Parts support and reliability of these controllers is of concern.

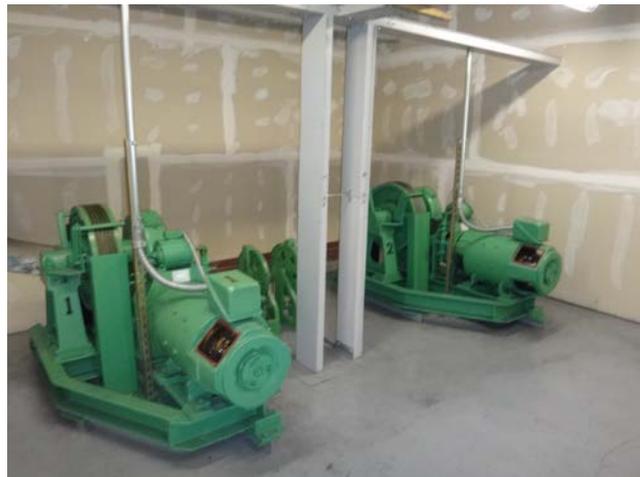
Machines:

All the geared traction elevators have high-quality Hollister Whitney machines. A few of the machines had minor oil leaks and some had enough that warrant changing the seals. These machines are generally in good condition and can be retained during the modernization.

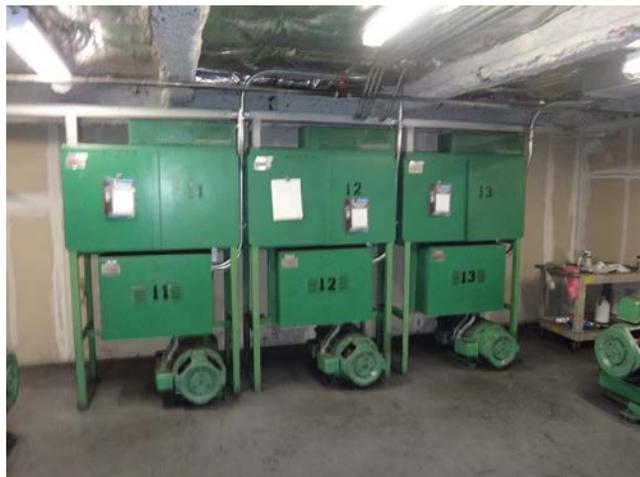
Motor Generator Sets:

All the traction elevators have motor generator sets. Some were in pretty good condition and quiet while others were loud and had arching. We recommend these be removed when the elevators are modernized.

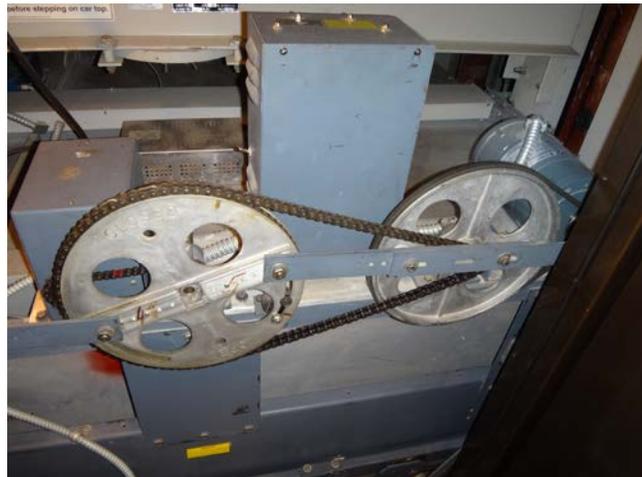
Door Operator:

The door operators are GAL which are known to be reliable, however, they are starting to show their age. We recommend new closed loop door operators when the elevators are modernized.

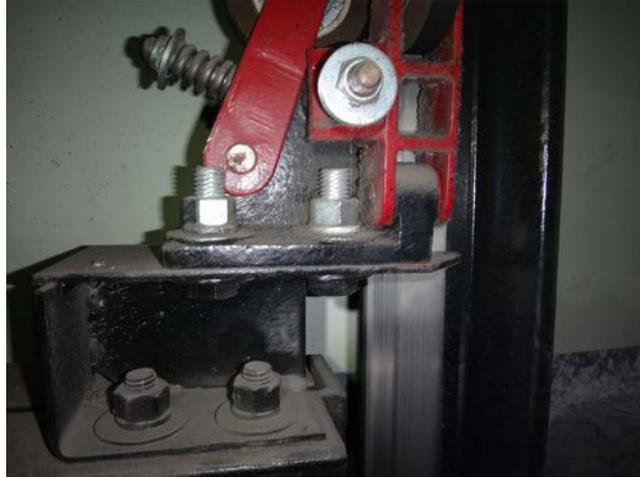
Car Roller/Slide Guides:

On both sides of the elevators and on the top and bottom roller guides keep the elevators riding up and down the steel guide rails. All the cars and counterweights have high quality ELSCO roller guides that were in good condition.

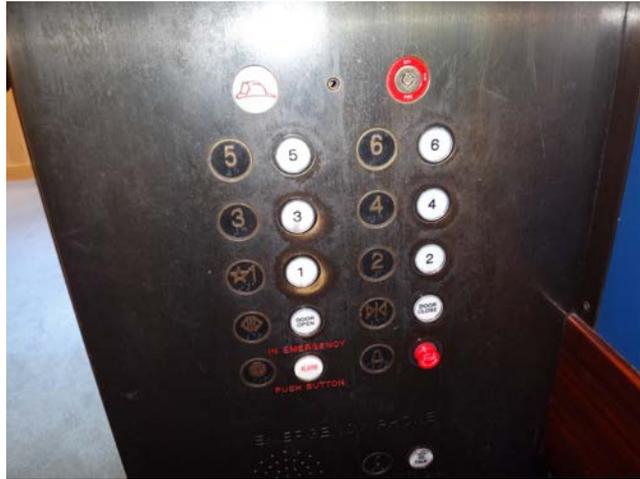
Car Operating Panels:

All the Car Operating Panels (COP's) are in good condition and meet all ADA and T24. Some of the car button panels were starting to look dated, but overall they were found to be in good condition.

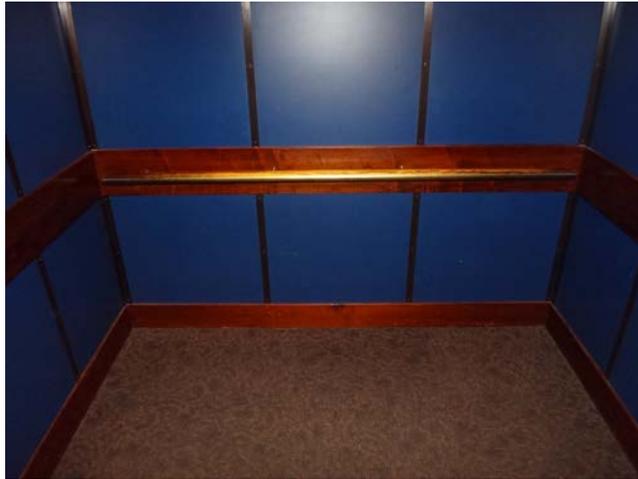
Wall Finish:

The existing cab interiors for the passenger cars are in good condition but dated. When the elevators are modernized consideration should be given to upgrade the cabs.

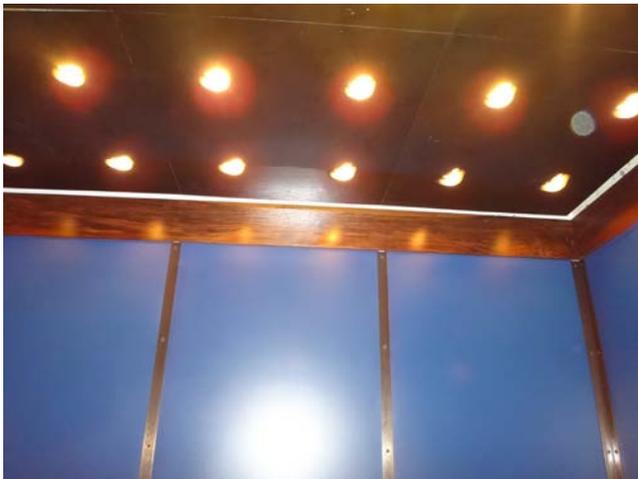
Ceilings:

The passenger elevators have down light ceilings with incandescent light fixtures. Most of the lighting in the passenger cabs was noted to be dim. We recommend new lights that are brighter and have energy savings LED's.

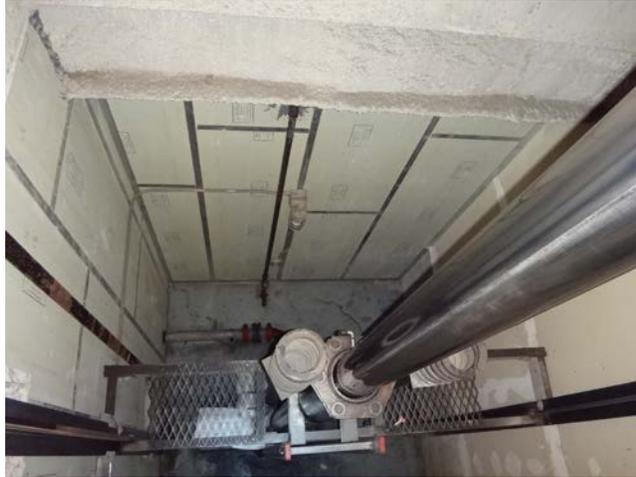
Hydraulic Elevators:

All the hydraulic elevators have in-ground jacks. The pistons and jack heads appeared to be in good condition.

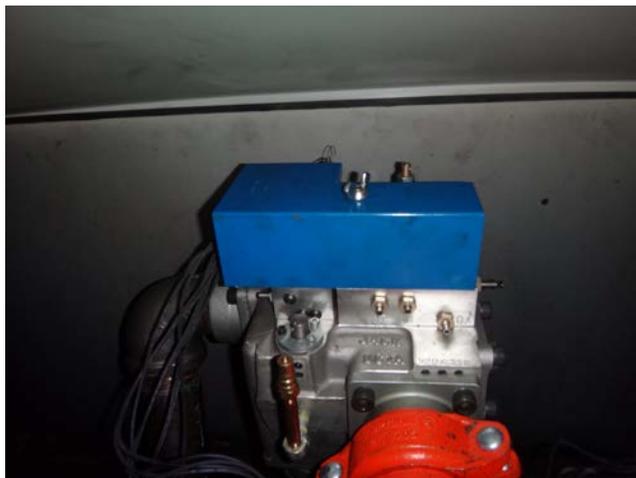
Power Unit:

Each hydraulic elevator has a power unit that consists of a valve, pump, motor and tank. The power units were submersible type and found to be in good condition.
