## Office Building 8 (039)

714 "P" Street, Sacramento, CA 95814

### Facility Condition Assessment

June 2015

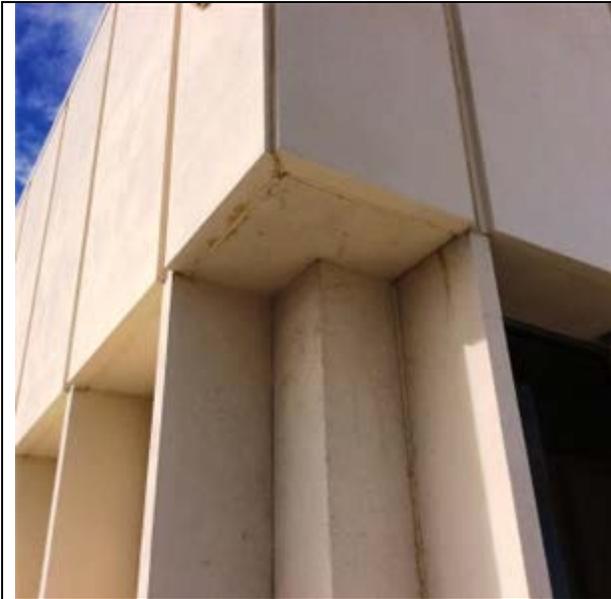
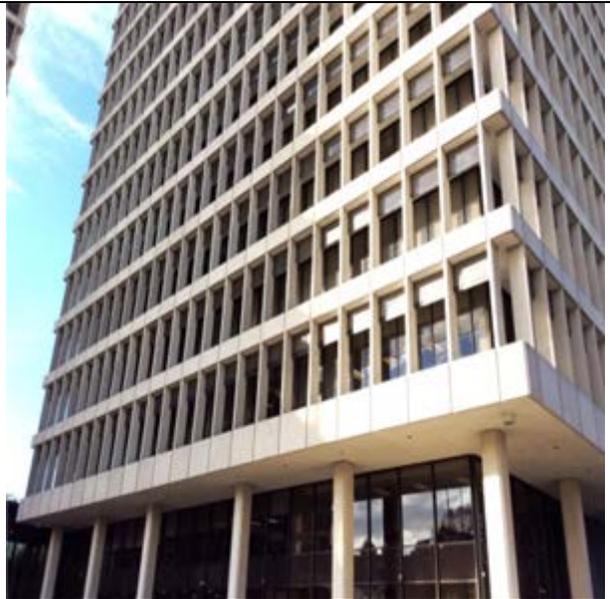
The exterior walls were power-washed and repaired in 2008. Routine maintenance is required.

B2011 Exterior Walls

Type	Component Description	Qty / UOM	Unit Cost (\$)	Plan Type	Priority	Year	Expenditures (\$)
B2011	Repair 10% of stucco	12,391.0 - SF	18.3	OP - Maintenance	Priority 2	2015	227,092
B2011	Repair 10% of stucco	12,391.0 - SF	18.3	OP - Maintenance	Priority 2	2020	227,092

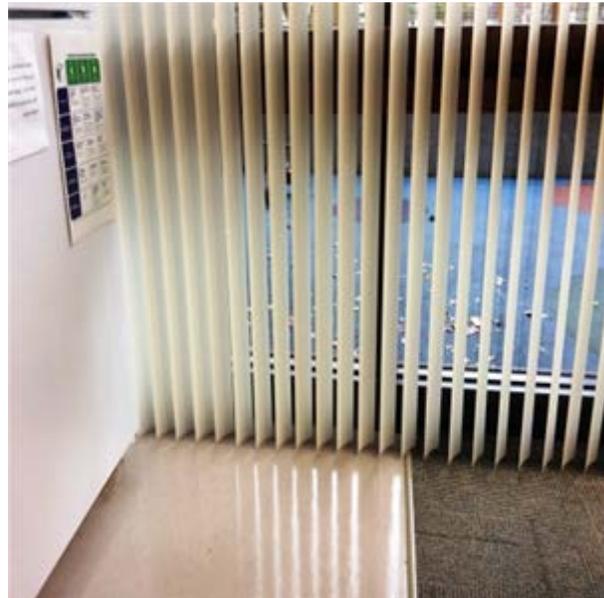
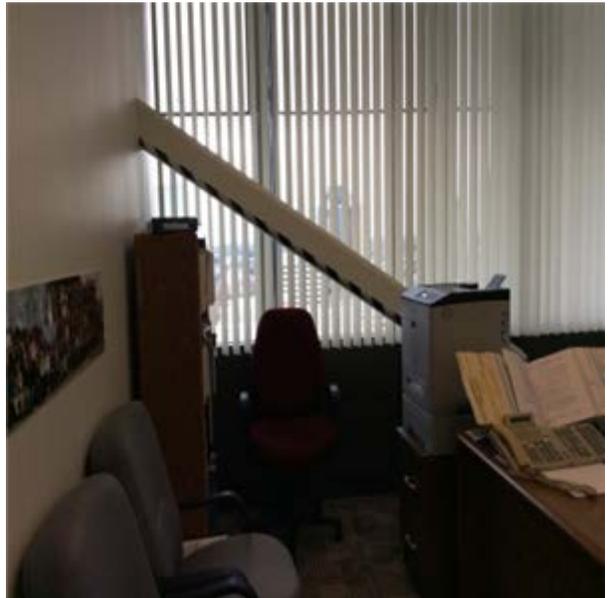
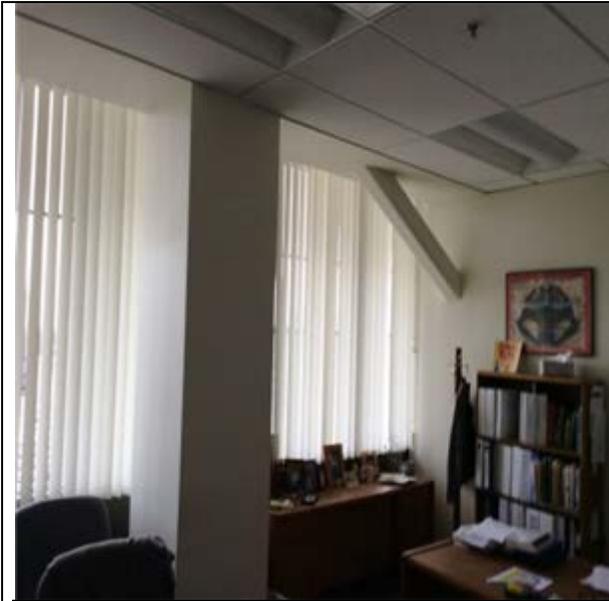
The curtain walls at the main lobby were installed in 2010 and some of windows were replaced during seismic renovation. Re-sealing windows and replacing gaskets in near term are recommended.

B2021 Windows /Curtain Walls

Type	Component Description	Qty / UOM	Unit Cost (\$)	Plan Type	Priority	Year	Expenditures (\$)
B2021	Re-seal windows and replace gaskets	3,950.0 - LF	38.1	OP - Maintenance	Priority 2	2017	150,369
B2021	Re-seal windows and replace gaskets	3,950.0 - LF	38.1	OP - Maintenance	Priority 2	2024	150,369

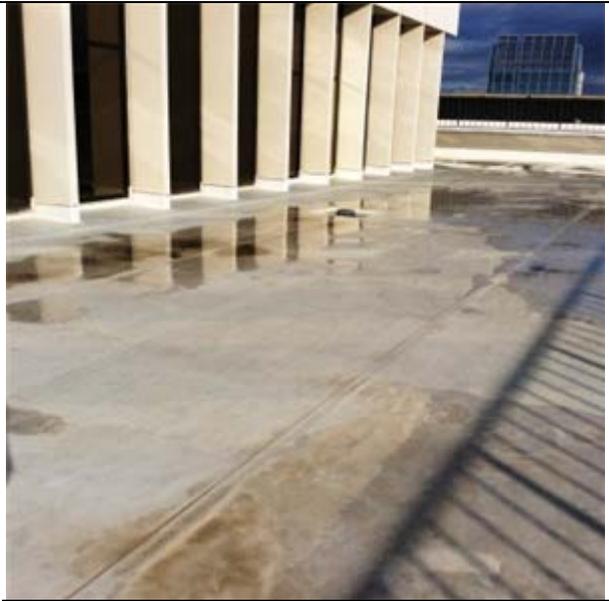
The building roof is PVC single-ply membrane, replaced in 2008. There were some water puddles observed during roof inspection. Re-sloping these areas is recommended.

B3011 Building Roof:- Roof water

Type	Component Description	Qty / UOM	Unit Cost (\$)	Plan Type	Priority	Year	Expenditures (\$)
B3011	Repair 20% of roof due to excessive ponding	34.0 - SQ	1861.5	OP - Maintenance	Priority 2	2015	63,290
B3011	Install roof walk pads per building plans	8.0 - EA	487.5	CC - Life Safety	Priority 1	2015	3,900

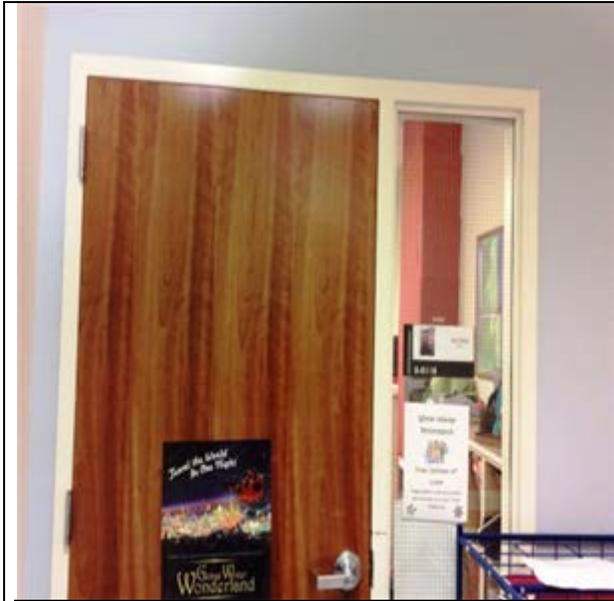
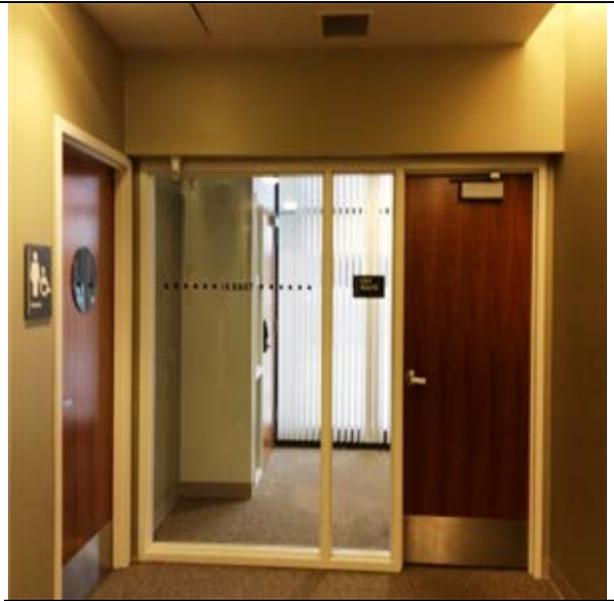
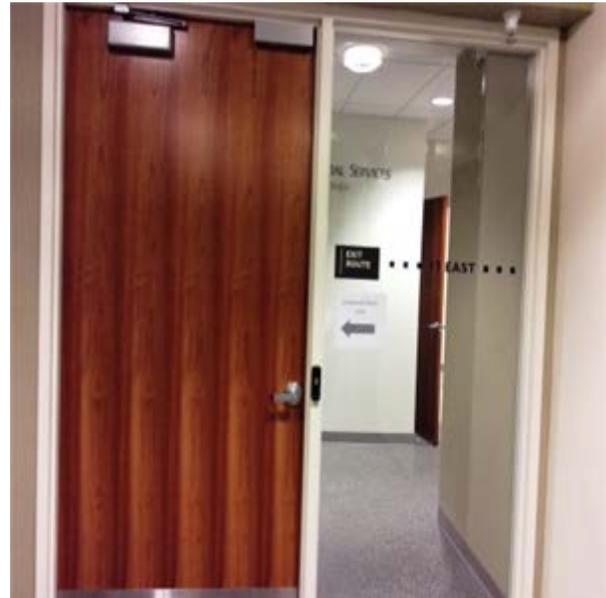
B2031 Solid Wood Door

As part of 2009 DGS ADA Accessibility Survey, Adding automatic door openers with DC actuators at all floor entrance doors was recommended.

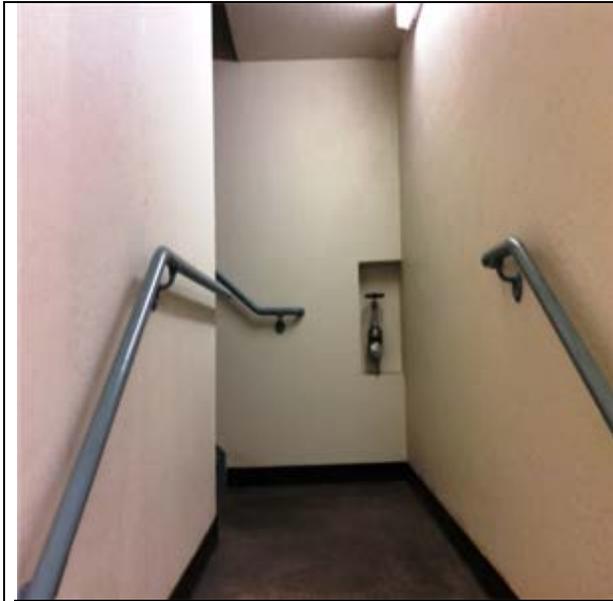
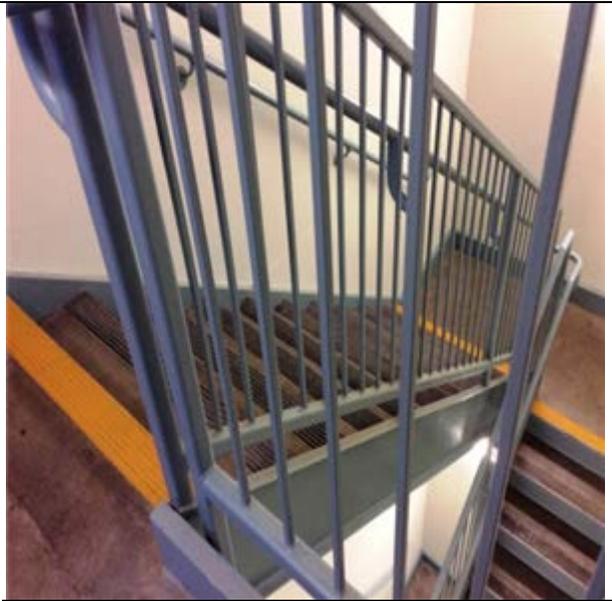
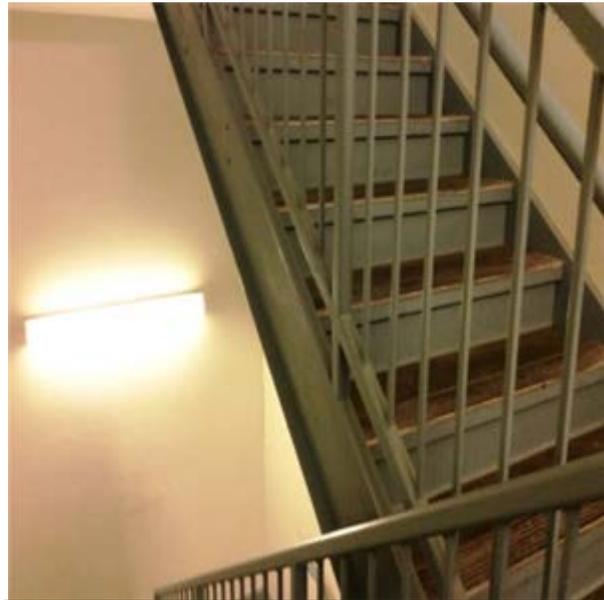
C2011 Fire exit stairs

There are two fire exit stairs built in 1969. An additional fire exit stairway was added in 2010. Painting and floor cover replacements during the term are recommended.

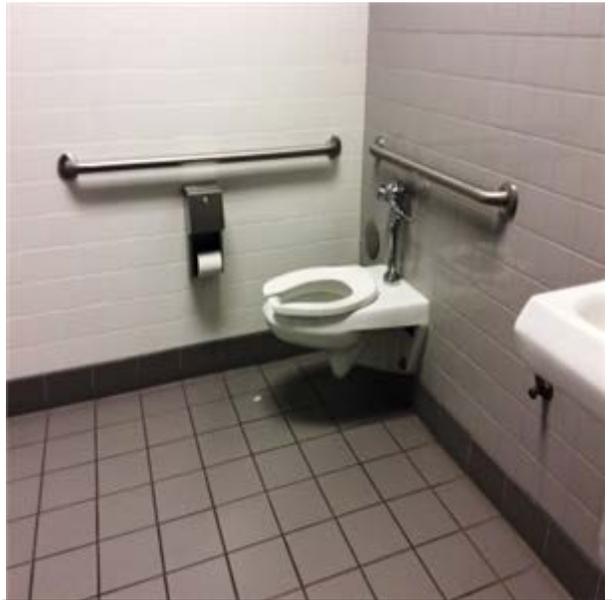
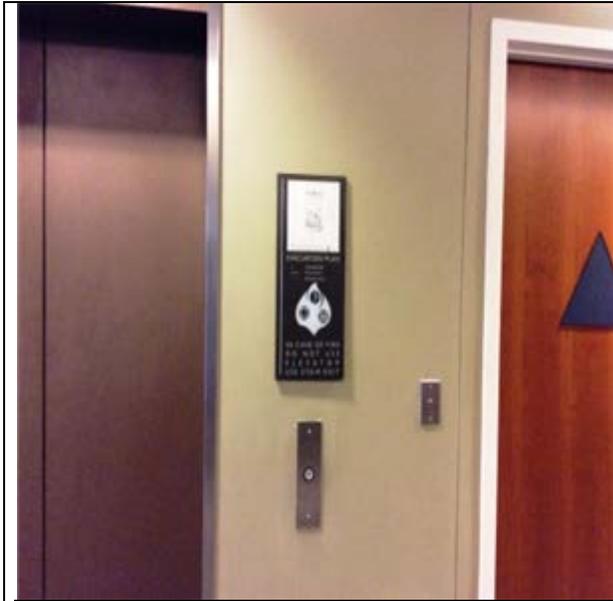
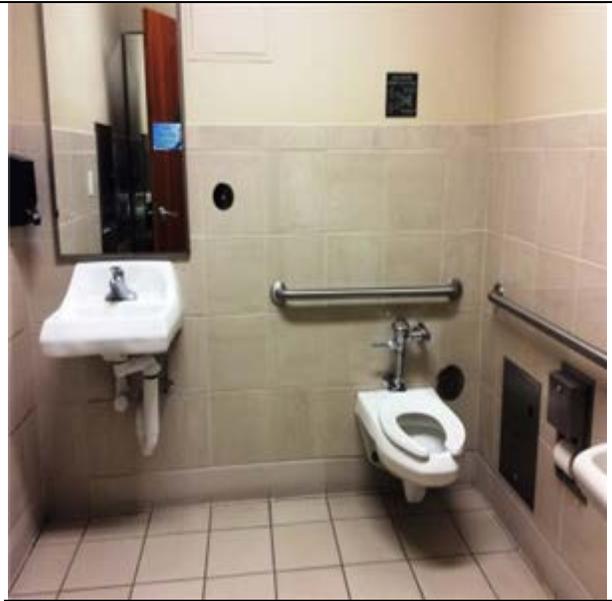
Item	Description
<b>C3005 ADA Renovations</b>	C3005 ADA door signage / Restrooms
Condition	Fair
Qty / UOM	21 / EA
RUL (years)	0
Location	All upper floors

Type	Component Description	Qty / UOM	Unit Cost (\$)	Plan Type	Priority	Year	Expenditures (\$)
C1021	Add ADA automatic door opener	12.0 - EA	2159.5	CC - Accessibility	Priority 2	2015	25,914
C1035	Replace C1035 Directional Signage	12.0 - EA	316.2	CC - Accessibility	Priority 1	2015	3,794
C3005	Replace C3005 ADA door signage / Restrooms	21.0 - EA	372.0	CC - Accessibility	Priority 1	2015	7,812
D1011	Re-order the car push buttons in the high-rise cars so they meet ADA requirements	3.0 - EA	2000.0	CC - Accessibility	Priority 1	2015	6,000

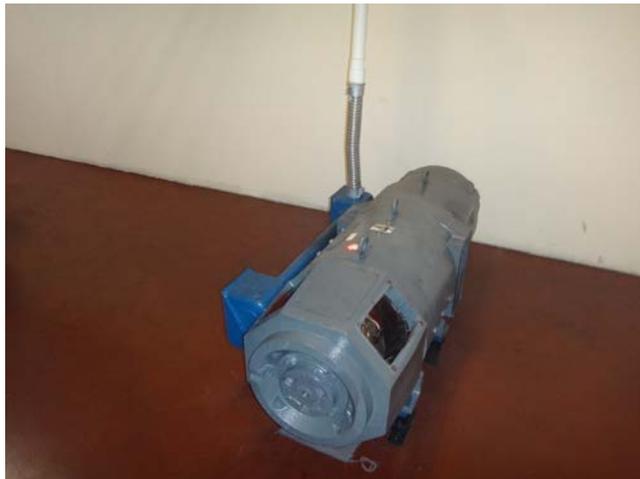
#### **Motor Generator Sets:**

All the passenger elevators, Cars 1-6, had motor generators installed when last modernized in 1997. These are worn out, noisy and not very energy efficient. We recommend these be removed as part of the modernization.

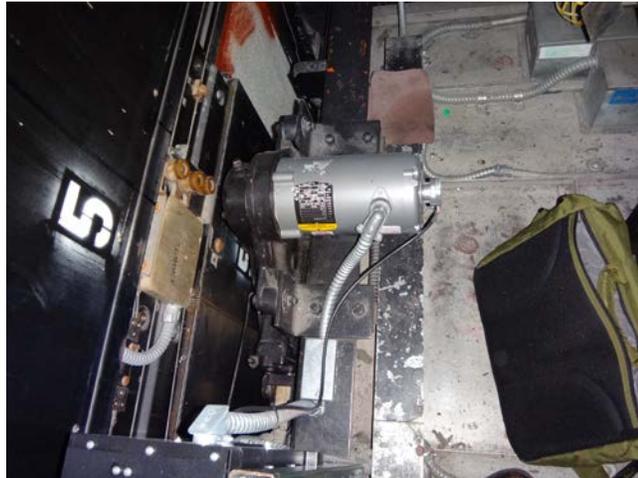
### **Door Operator:**

The door operators for Cars 1-6 are the original Otis 6970 that have been recently updated with closed loop kits by TKE. The door operators for the service and shuttle elevators were upgraded with GAL and are closed loop and known to be of high quality. The only work on the door operators is to add door restrictors which are not present on any of the elevators.

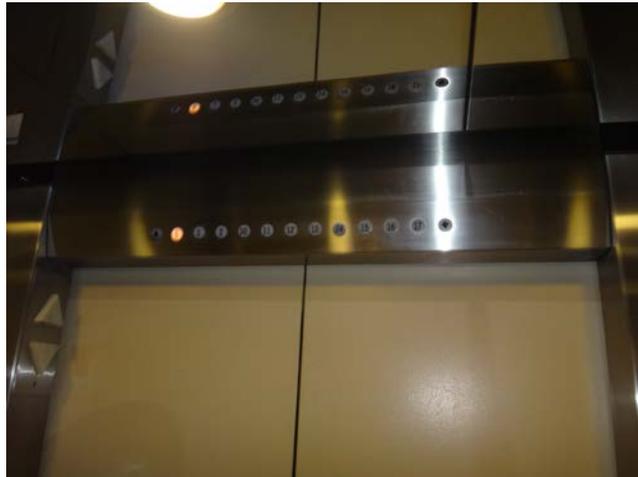
**Ceilings:**

The passenger elevators have down light ceilings with incandescent light fixtures. The light fixtures could be updated with energy efficient LED's and/or the entire ceiling could be replaced.

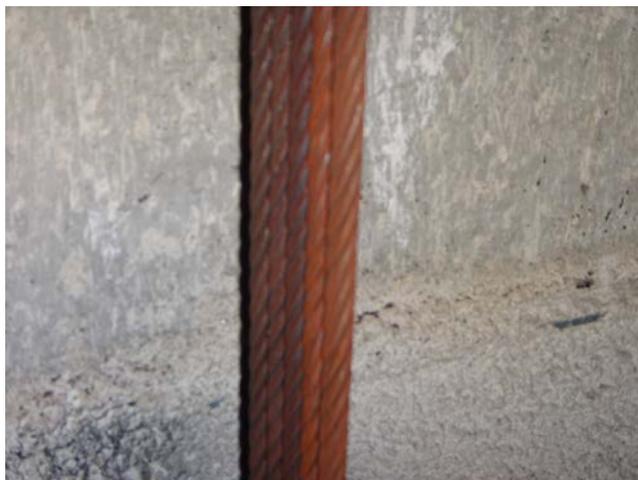
**F. Miscellaneous:**

The hoist ropes for Car 2 in OB 9 failed to meet minimum size requirements and should be replaced immediately.
