California Tower (330)

3737 Main Street, Riverside, CA 92501

Facility Condition Assessment

September 2015

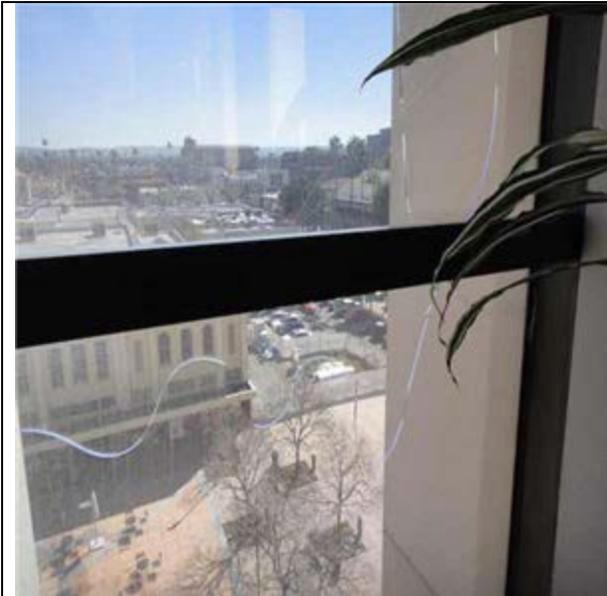
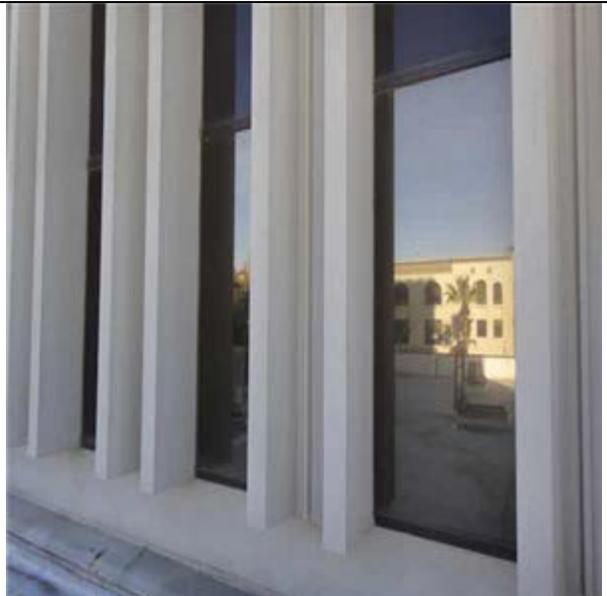
The exterior curtain wall glazings were replaced in 1995, however, single-pane glazing was utilized. Damaged and leaking panels were noted throughout the exterior curtain walls at isolated corner locations. Based on current condition and RUL, no further action is required.

B2011 - Curtain Wall Glazing

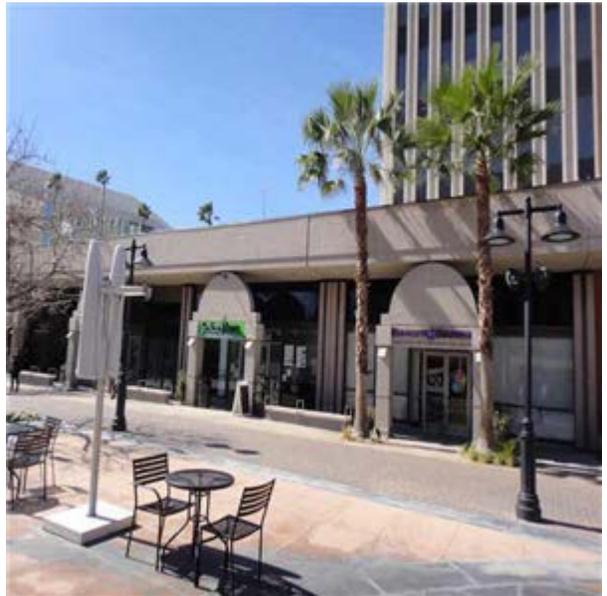
B2010 Stucco Painting

Based on current condition and RUL, repainting is recommended during the assessment term.

Type	Component Description	Qty / UOM	Unit Cost (\$)	Plan Type	Priority	Year	Expenditures (\$)
B2011	Replace B2010 Stucco Painting	1.0 - EA	145600.0	IN - Appearance	Priority 2	2017	145,600

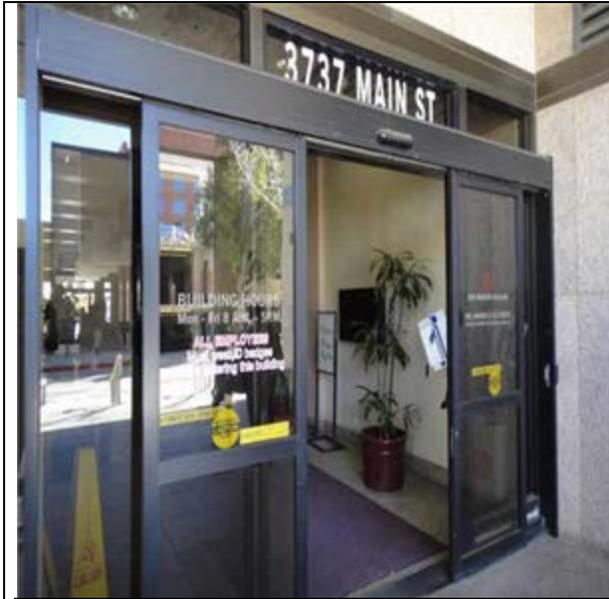
Based on current condition and RUL, no further action is recommended.

B2031 Glazed Entrance Doors

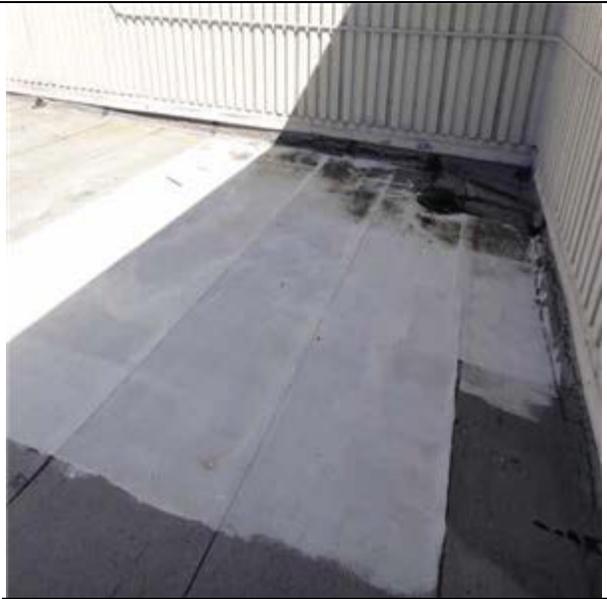
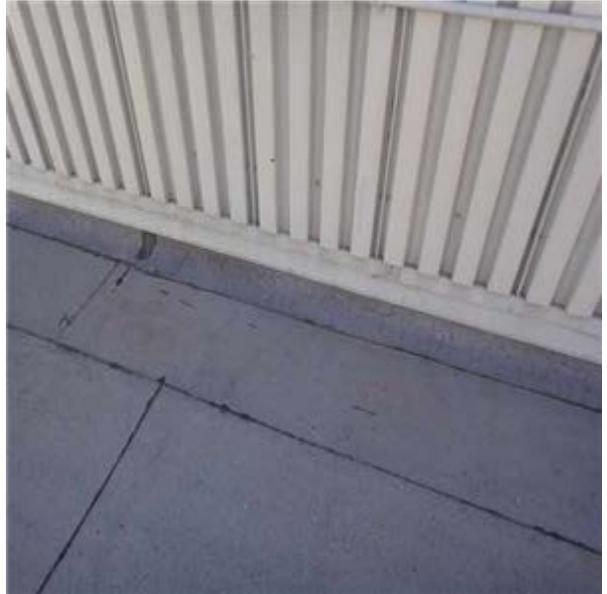
B3011 Built-Up Roofing

Based on current condition and RUL, replacement is recommended during the assessment term.

Type	Component Description	Qty / UOM	Unit Cost (\$)	Plan Type	Priority	Year	Expenditures (\$)
B3011	Replace B3011 Built-Up Roofing	127.0 - SQ	1366.1	IN - Beyond Rated Life	Priority 2	2018	173,491

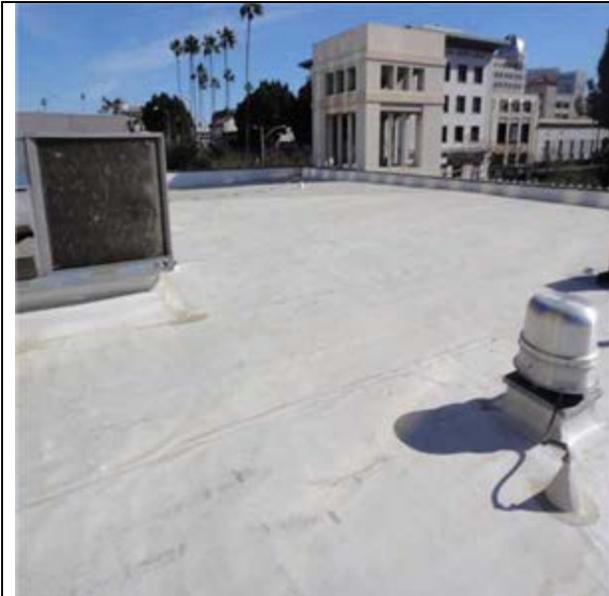
Based on current condition and RUL, no further action is recommended.

B3010 TPO, Roof 45 Mills

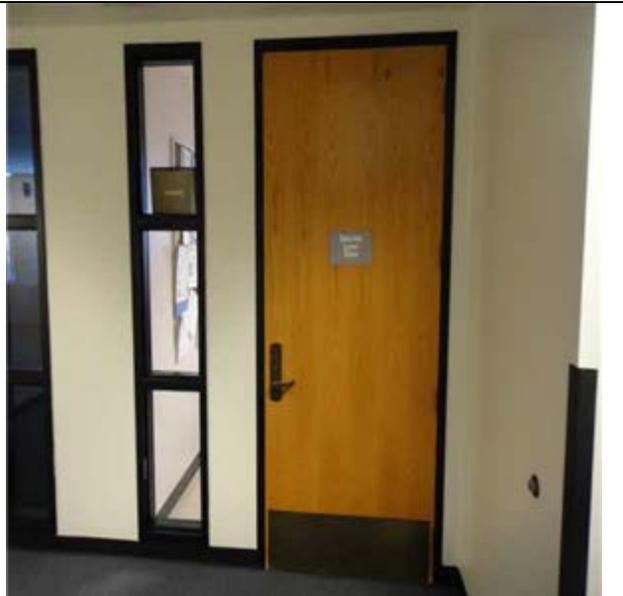
Based on current condition and RUL, no further action is recommended.

C1021 Interior Doors

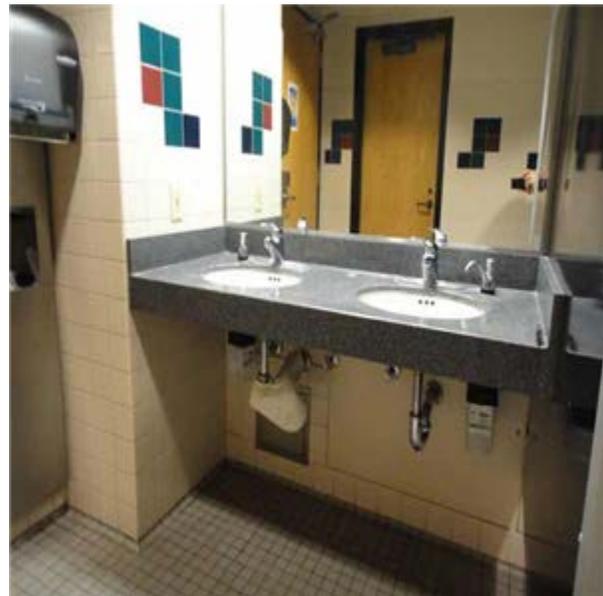
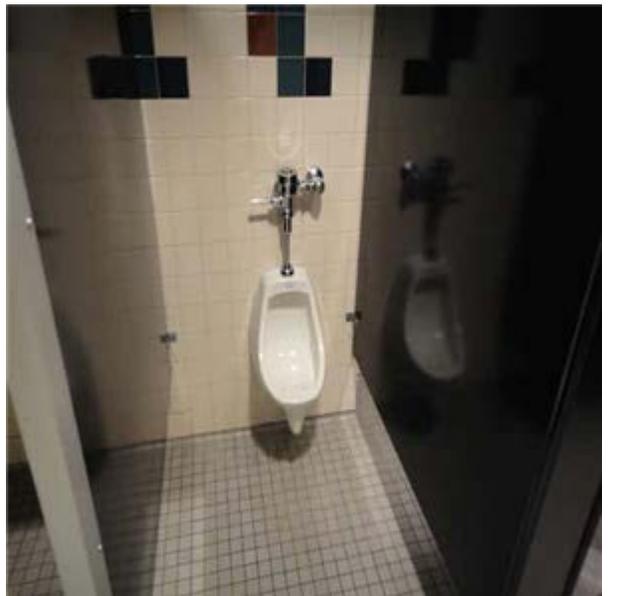
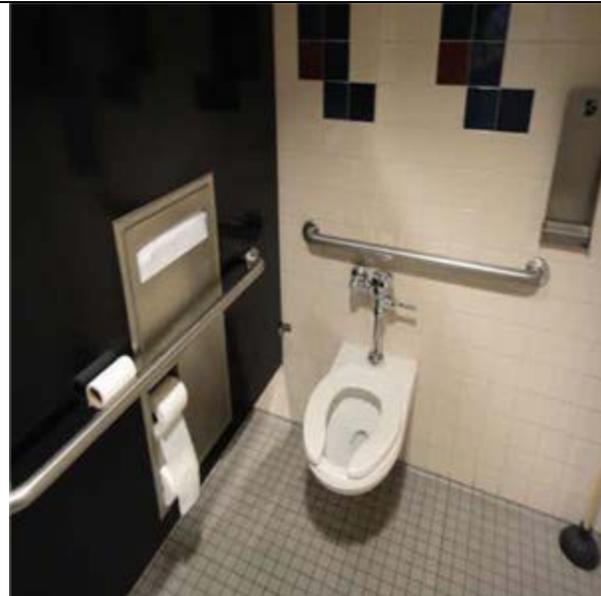
Each level contains at least two common area restrooms. The main level has four common area restrooms. ADA accessibility modifications are recommended for the facility in the near term. Cost for these modifications have been provided via a client-obtained bid. This bid includes all restrooms except for the eighth floor restrooms, which have been incorporated into that floor's tenant space, and have been recently remodeled/modified.

C3005 Restroom ADA Upgrades and Remodel

Type	Component Description	Qty / UOM	Unit Cost (\$)	Plan Type	Priority	Year	Expenditures (\$)
C3005	Replace C3005 Restroom ADA Upgrades and Remodel	1.0 - EA	1488000.0	CC - Accessibility	Priority 2	2017	1,488,000

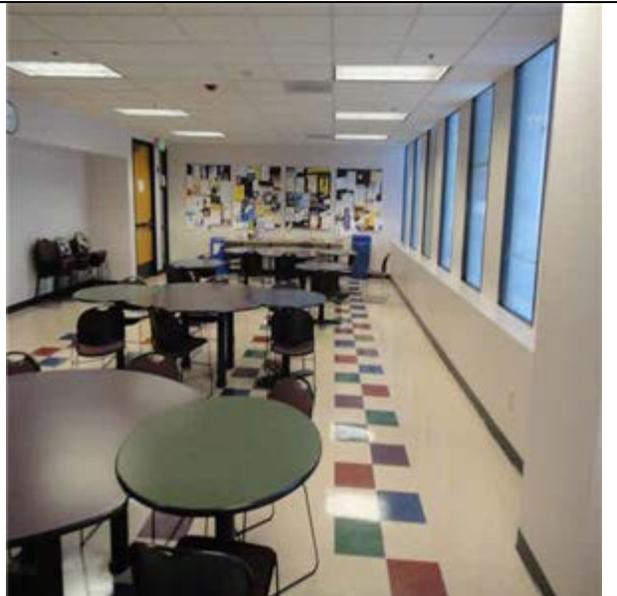
C3024 Vinyl Tile

Based on current condition and RUL, replacement is recommended during the assessment term.

Type	Component Description	Qty / UOM	Unit Cost (\$)	Plan Type	Priority	Year	Expenditures (\$)
C3024	Replace C3024 Vinyl Tile	5,500.0 - SY	163.1	IN - Appearance	Priority 3	2018	897,048

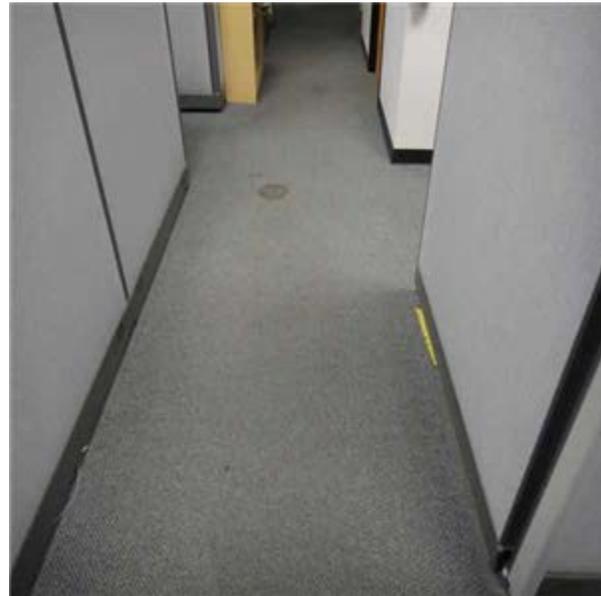
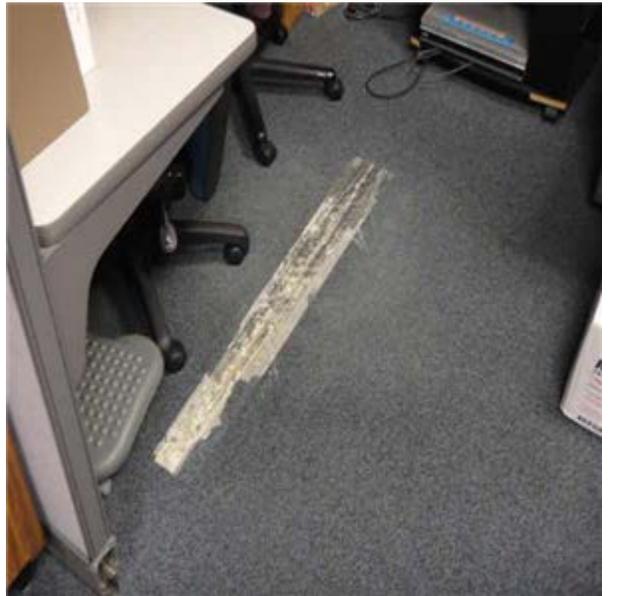
C3025 Carpeting

Based on current condition and RUL, replacement is recommended during the assessment term.

Type	Component Description	Qty / UOM	Unit Cost (\$)	Plan Type	Priority	Year	Expenditures (\$)
C3025	Replace C3025 Carpeting	8,000.0 - SY	96.6	IN - Appearance	Priority 3	2017	772,845

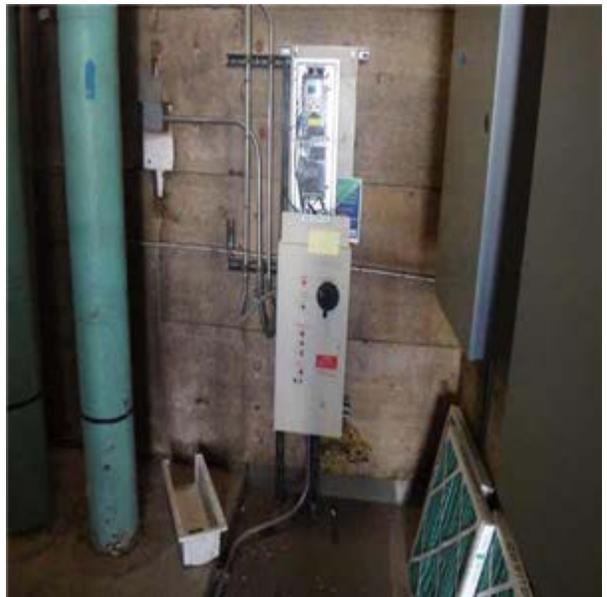
D3042 Make-up Building Air Fan 22500 CFM:- Make-up air unit VFD Not Operational

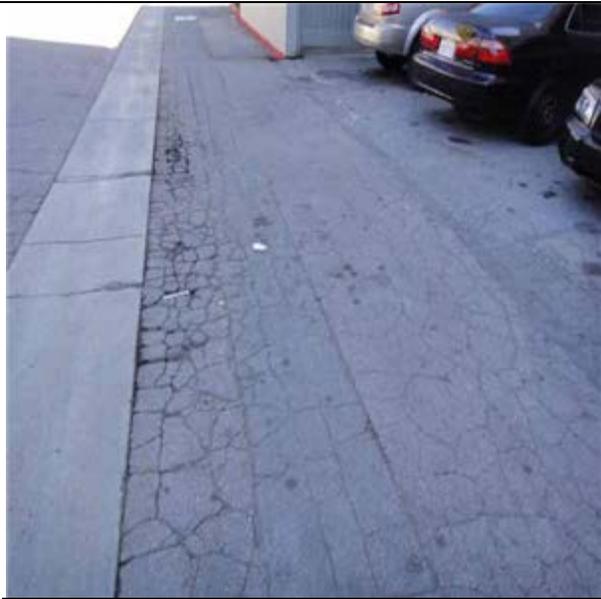
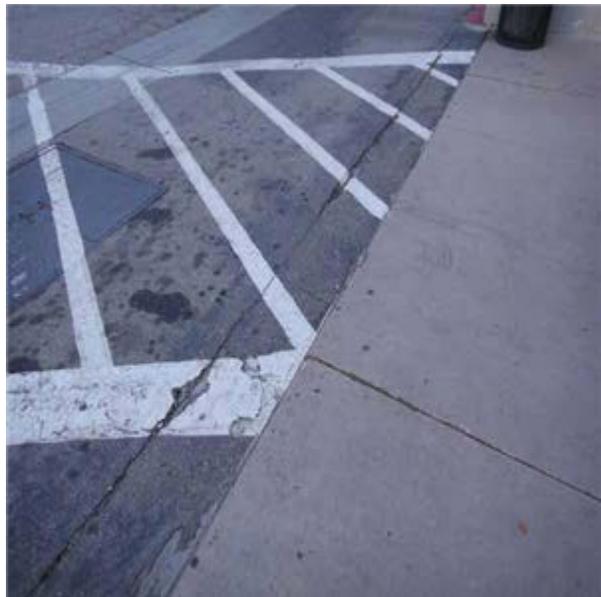
G2012 Asphalt Cut and Resurface 2.0'' - Roadways
