# Ronald M. George State Office Complex/ Earl Warren Building (402)

350 MacAllister Street, San Francisco, CA 94104

## Facility Condition Assessment

September 2015

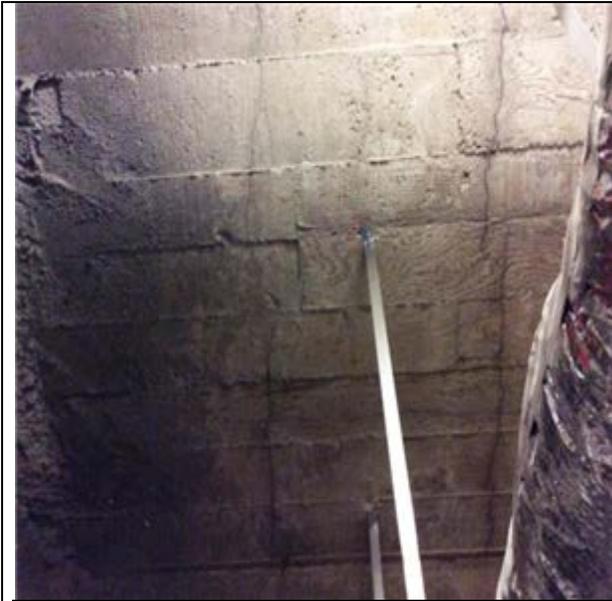
Item	Description
B1012 Upper Floors Construction	B1012 Crack Repair Epoxy Injection
Condition	Poor
Qty / UOM	250 / LF
RUL (years)	0
Location	Roof Attic

Several concrete floor cracks are noted in the attic. Repair is recommended by the use of epoxy injections.

Type	Component Description	Qty / UOM	Unit Cost (\$)	Plan Type	Priority	Year	Expenditures (\$)
B1012	B1019 Repair Crack Epoxy Injection	250.0 - LF	101.5	OP - Maintenance	Priority 1	2015	25,366

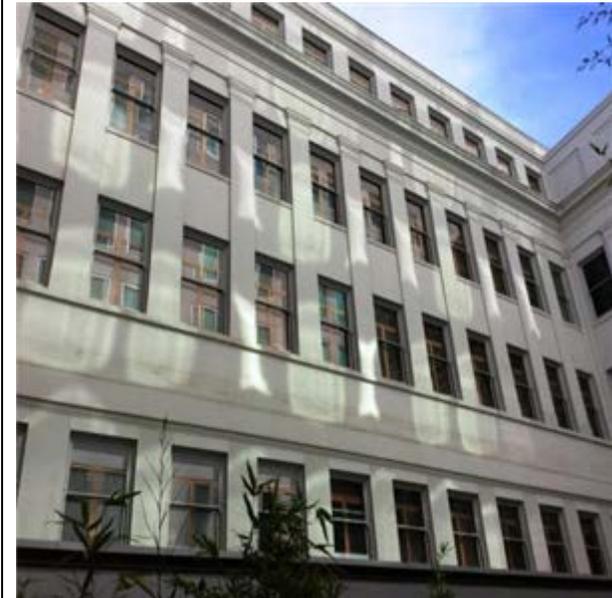
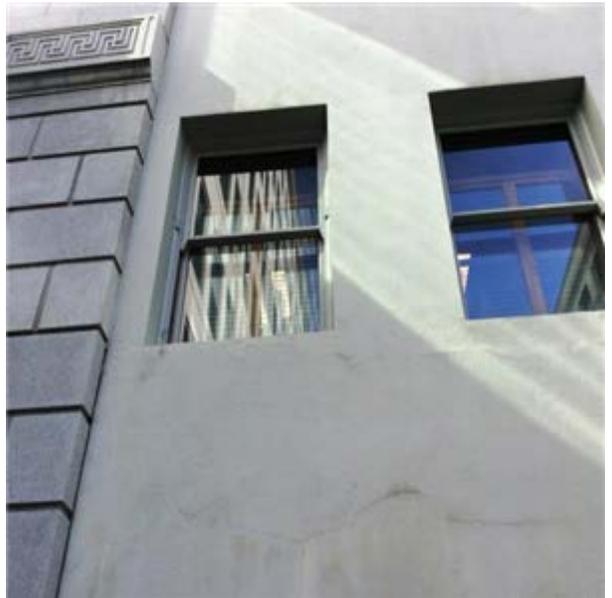
Item	Description
<b>B2021 Windows</b>	B2021 Historic Wood Windows
Condition	Fair
Qty / UOM	500 / EA
RUL (years)	0
Location	All Floors
Window Type	Double Hung
Windows Material	Wood
Windows Glazing	Single Glazed
Window Operation	Manual

There are approximately 500 historical wooden windows from the original construction, according to management staff. Windows require caulk sealant and painting due to normal deterioration.

Type	Component Description	Qty / UOM	Unit Cost (\$)	Plan Type	Priority	Year	Expenditures (\$)
B2021	Replace B2021 Historic Wood Windows	500.0 - EA	604.3	OP - Maintenance	Priority 1	2015	302,126

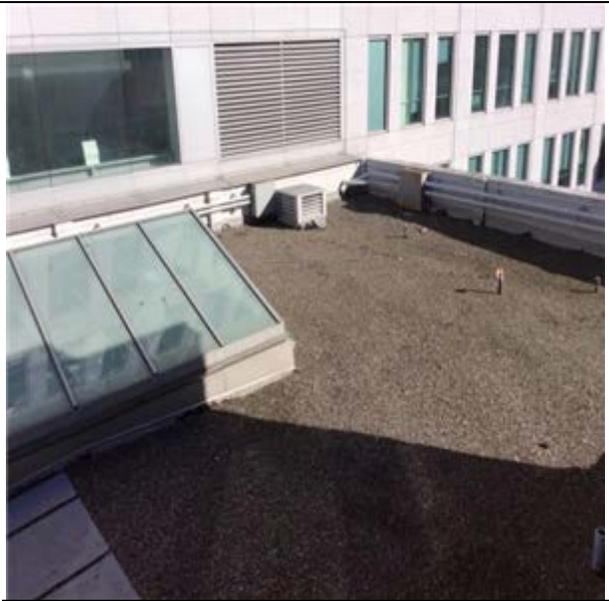
Item	Description
B3011 Roof Finishes	B3011 Built-Up Roofing
Condition	Fair
Qty / UOM	90 / SQ
RUL (years)	3
Location	Rear Wings

The flat roof sections at the rear wings are traditional built-up systems with gravel slag. Based on RUL (RUL) and condition, replacement is anticipated during the term.

Type	Component Description	Qty / UOM	Unit Cost (\$)	Plan Type	Priority	Year	Expenditures (\$)
B3011	Replace B3011 Built-Up Roofing	90.0 - SQ	1861.5	IN - Beyond Rated Life	Priority 2	2018	167,532

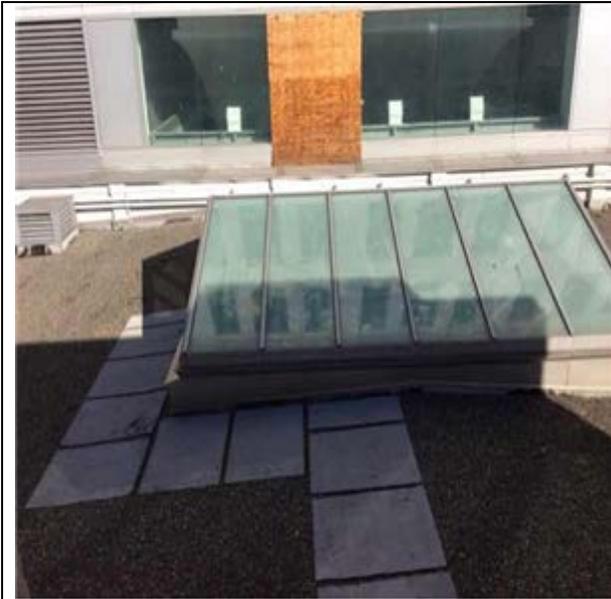
Item	Description
<b>B3021 Glazed Roof Openings</b>	B3021 Glass Skylights
<b>Condition</b>	Fair
<b>Qty / UOM</b>	85 / SF
<b>RUL (years)</b>	0
<b>Location</b>	Roof
<b>Roof Opening Operation</b>	Fixed

There are two skylights on the north side adjacent to the light court. Based on RUL and condition, repair of the skylights is recommended in the reserve term.

Type	Component Description	Qty / UOM	Unit Cost (\$)	Plan Type	Priority	Year	Expenditures (\$)
B3021	B3021 Repair Glass Skylights	85.0 - SF	66.0	IN - Beyond Rated Life	Priority 1	2015	5,614

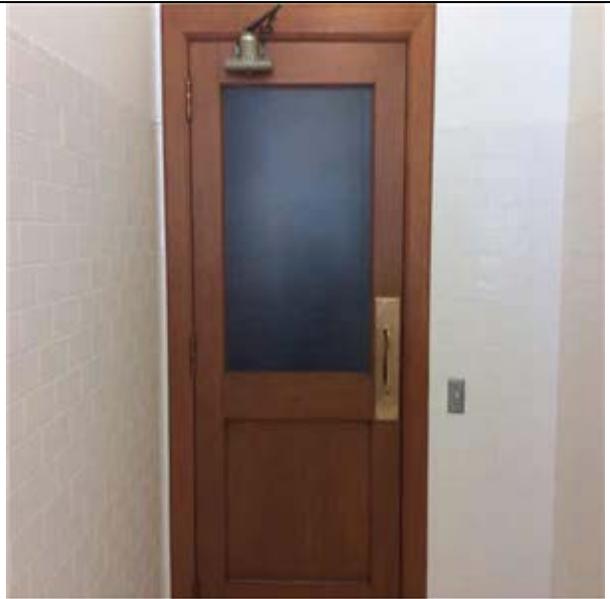
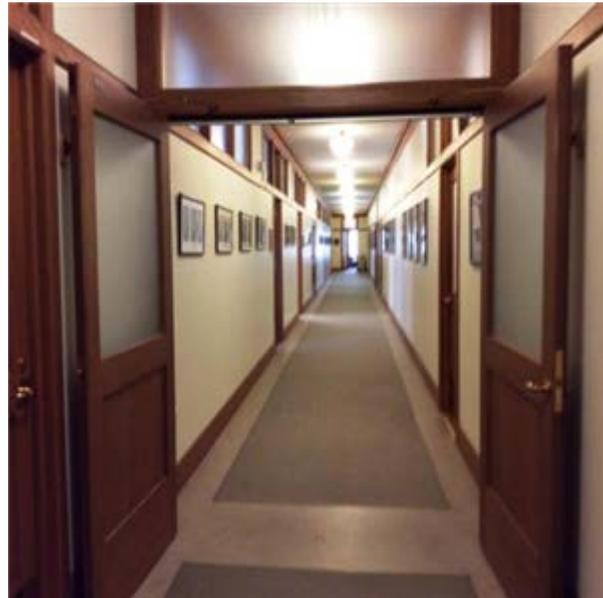
Item	Description
<b>C1021 Interior Doors</b>	C1021 Interior Doors Refinish
<b>Condition</b>	Fair
<b>Qty / UOM</b>	252 / EA
<b>RUL (years)</b>	0
<b>Location</b>	All Floors

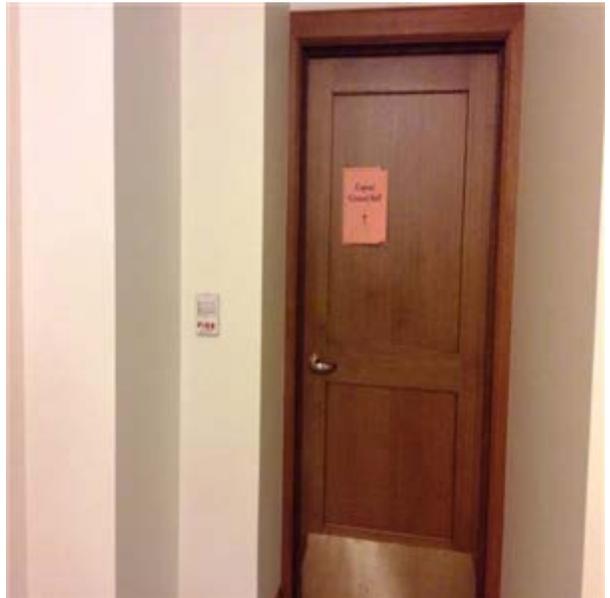
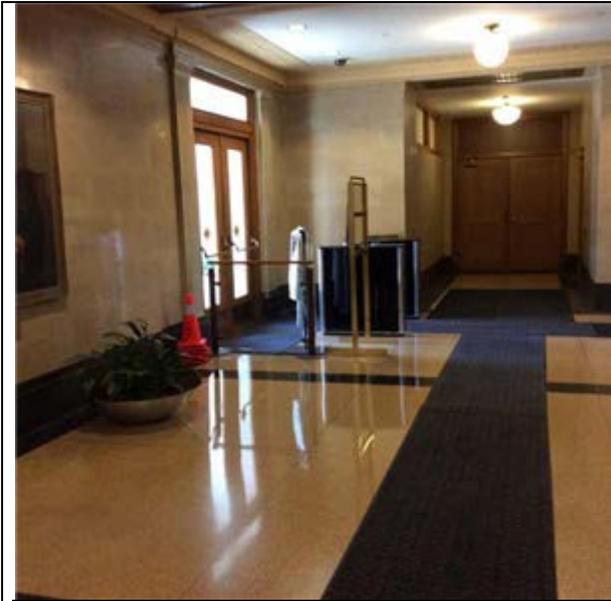
Item	Description
<b>C1035 Identifying Devices</b>	C1035 Directional Signage
<b>Condition</b>	Fair
<b>Qty / UOM</b>	12 / EA
<b>RUL (years)</b>	0
<b>Location</b>	All Floors

Type	Component Description	Qty / UOM	Unit Cost (\$)	Plan Type	Priority	Year	Expenditures (\$)
C1035	Replace C1035 Directional Signage	12.0 - EA	316.2	CC - Life Safety	Priority 1	2015	3,794

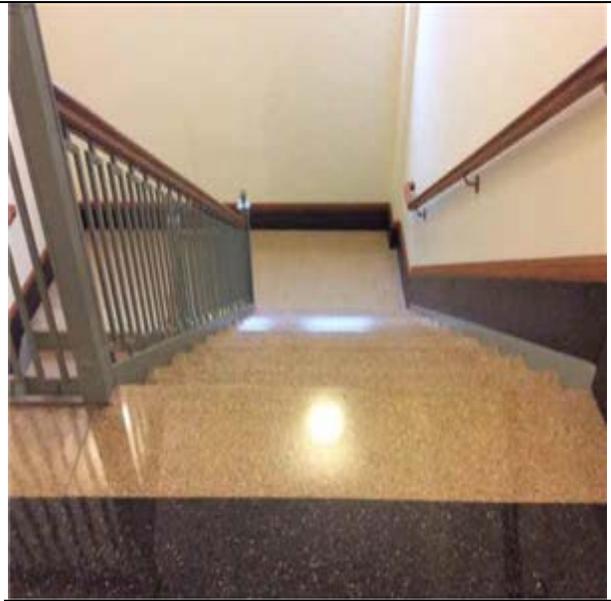
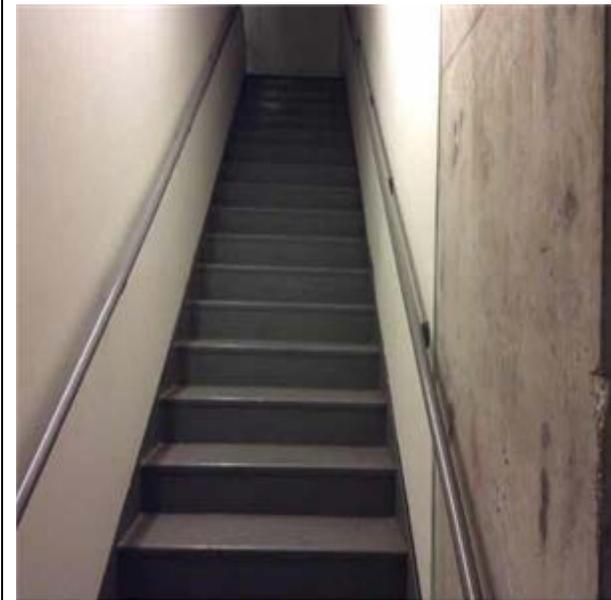
Item	Description
<b>C2011 Regular Stairs</b>	C2011 Fire Exit Stairs
Condition	Good
Qty / UOM	4,150 / SF
RUL (years)	13
Location	Stairs
Stairs Frame	Concrete
Stair Riser	Closed
Stair Treads	Concrete-Filled/Metal Pan
Stair Railings	Metal
Stair Soffit Finishes	Plaster
Stair Handrail Finishes	Painted

There are two fire exit stairs with concrete flooring which were renovated in 1998. Two additional stairs are located adjacent to the elevators with terrazzo flooring. The stairs were constructed in 1922 and renovated in 1998. Repair of the stair treads is anticipated in the reserve term.

Type	Component Description	Qty / UOM	Unit Cost (\$)	Plan Type	Priority	Year	Expenditures (\$)
C2011	C2011 Repair fire exit stairs floor	992.0 - SF	63.1	OP - Maintenance	Priority 3	2017	62,615

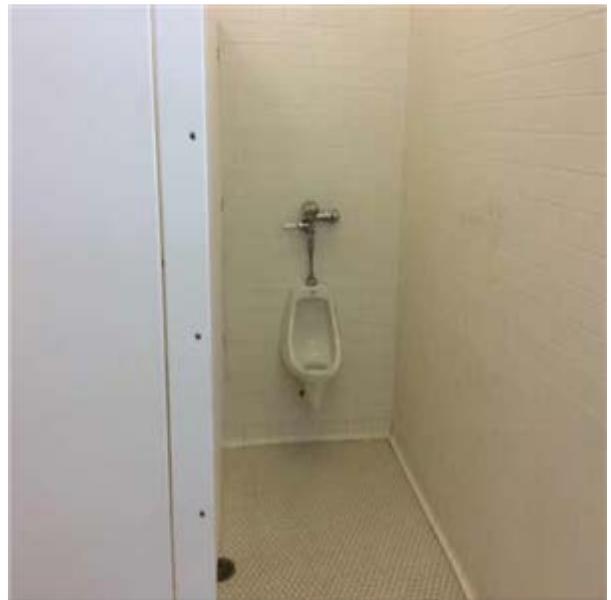
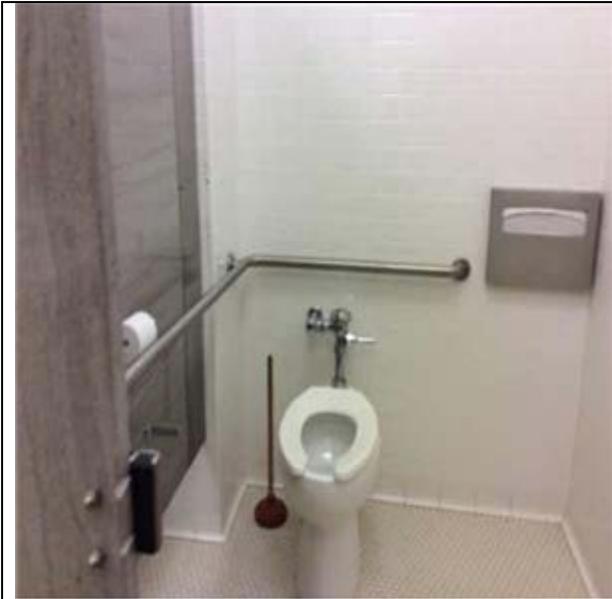
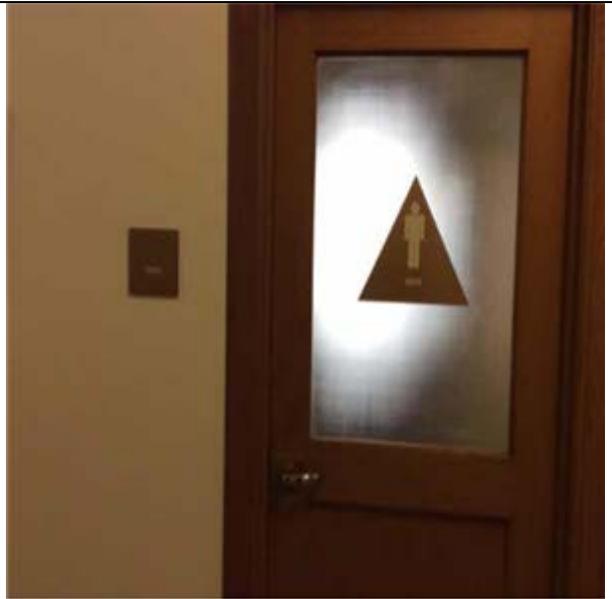
Item	Description
<b>C3005 ADA Renovations</b>	C3005 ADA Renovations
<b>Condition</b>	Fair
<b>Qty / UOM</b>	24 / EA
<b>RUL (years)</b>	1
<b>Location</b>	All restrooms

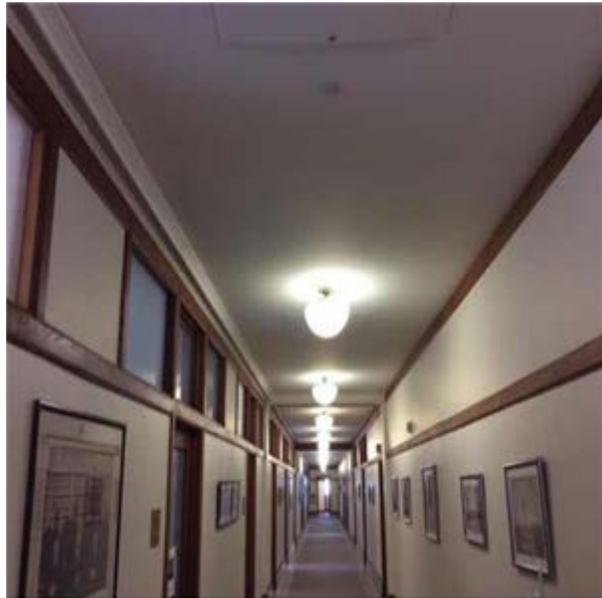
Item	Description
<b>C3012 Wall Finishes to Interior Walls</b>	C3012 Paint Interior Walls, Drywall
<b>Condition</b>	Fair
<b>Qty / UOM</b>	156,580 / SF
<b>RUL (years)</b>	1
<b>Location</b>	All Floors

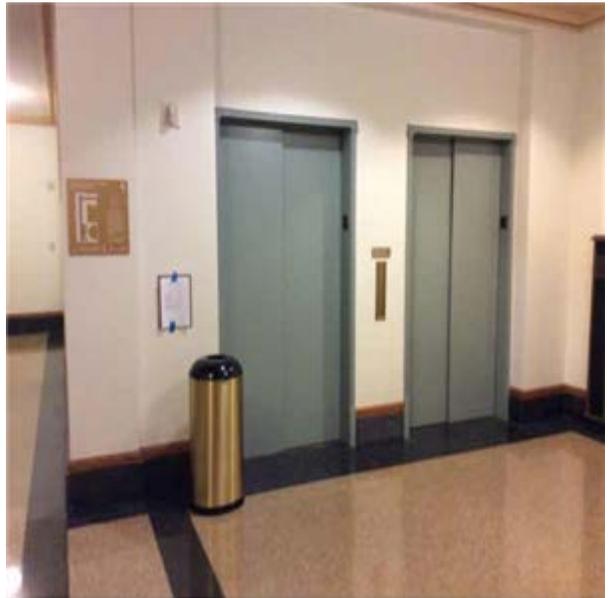
Item	Description
<b>C3012 Wall Finishes to Interior Walls</b>	C3012 Wall Finishes - Elevator Lobby
<b>Condition</b>	Fair
<b>Qty / UOM</b>	8,250 / SF
<b>RUL (years)</b>	1
<b>Location</b>	All Floors

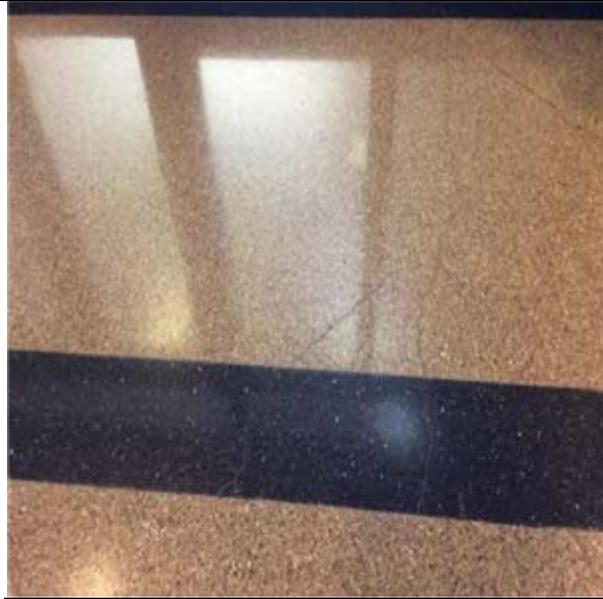
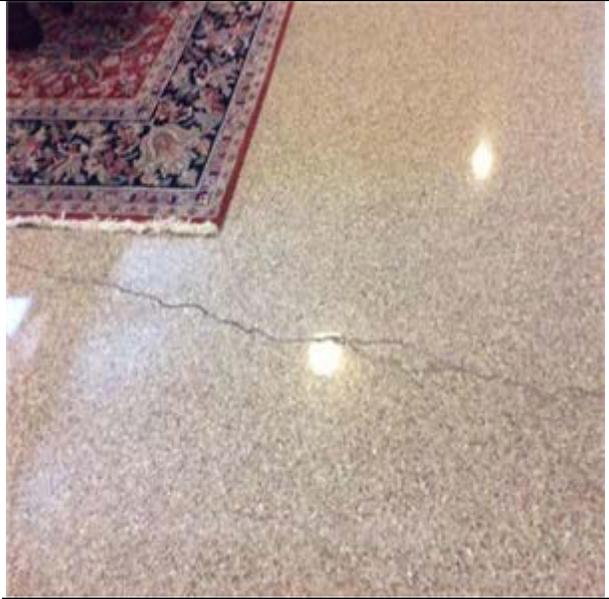
Item	Description
C3024 Flooring	C3024 Terrazzo Flooring
Condition	Fair
Qty / UOM	12,650 / SF
RUL (years)	1
Location	Lobby
Floor Toppings	Light Weight Concrete

The south portion of the building is dated and the terrazzo flooring has many cracks. Based on RUL, replacement of the terrazzo flooring is anticipated.

Type	Component Description	Qty / UOM	Unit Cost (\$)	Plan Type	Priority	Year	Expenditures (\$)
C3024	Replace C3024 Terrazzo Flooring	12,650.0 - SF	36.1	IN - Appearance	Priority 3	2016	456,546

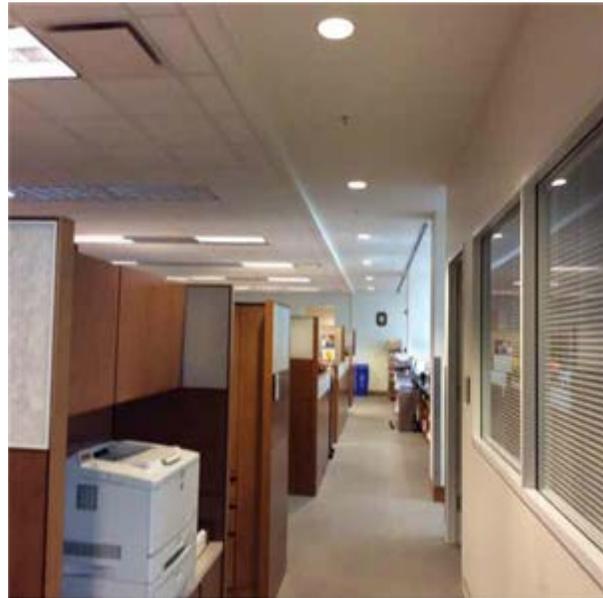
Item	Description
<b>C3025 Carpeting</b>	C3225 Carpet Tiles
<b>Condition</b>	Fair
<b>Qty / UOM</b>	1,905 / SY
<b>RUL (years)</b>	1
<b>Location</b>	All Floors
<b>Floor Toppings</b>	Light Weight Concrete

Various office area floors are covered with carpet tiles. Replacement in the reserve term is anticipated.
