Hugh Burns State Building (701)

2550 Mariposa Street, Fresno, CA 93721

Facility Condition Assessment

September 2015

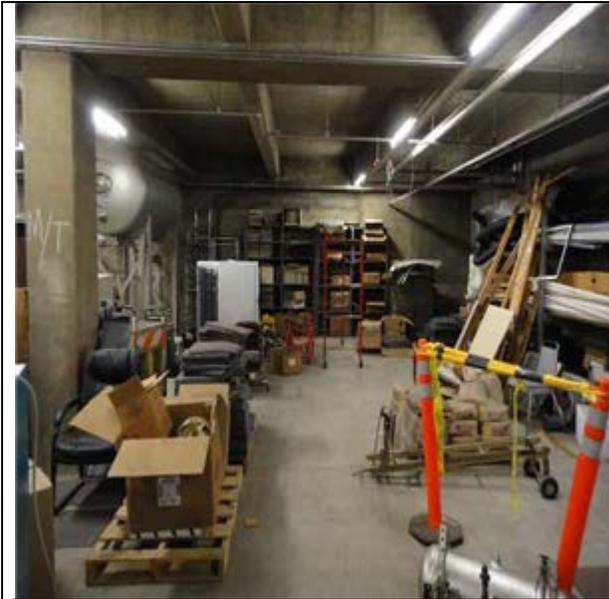
Item	Description
B1012 Upper Floors Construction	B1012 - Cast-in-place Concrete Beams and Floor Slab
Condition	Fair
Qty / UOM	109,780 / SF
RUL (years)	10
Location	Structural Component

Based on current condition and remaining useful life (RUL), no further action is recommended.

B1012 - Cast-in-place Concrete Beams and Floor Slab

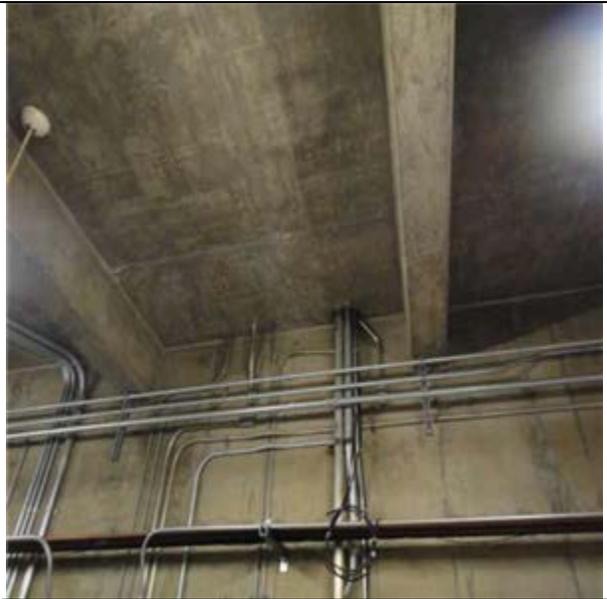
Item	Description
B1021 Flat Roof Construction	B1021 - Cast-in-Place Reinforced Concrete Roof Deck
Condition	Fair
Qty / UOM	36,090 / SF
RUL (years)	10
Location	Structural Component

Based on current condition and RUL, no further action is recommended.

B1021 - Cast-in-Place Reinforced Concrete Roof Deck

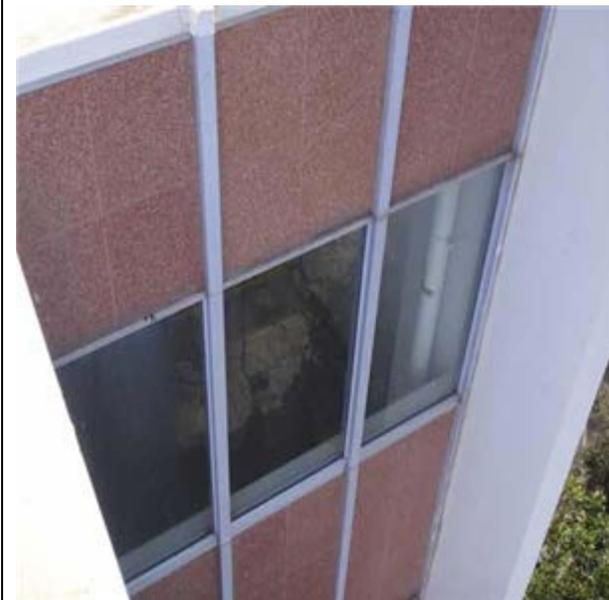
Item	Description
B2011 Exterior Wall Construction	B2011 Curtain Walls
Condition	Fair
Qty / UOM	1,500 / SF
RUL (years)	5
Location	Exterior Walls

Based on current condition and RUL, replacement is recommended during the assessment term.

B2011 Curtain Walls

Type	Component Description	Qty / UOM	Unit Cost (\$)	Plan Type	Priority	Year	Expenditures (\$)
B2011	Replace B2011 Curtain Walls	1,500.0 - SF	227.5	IN - Beyond Rated Life	Priority 3	2020	341,250

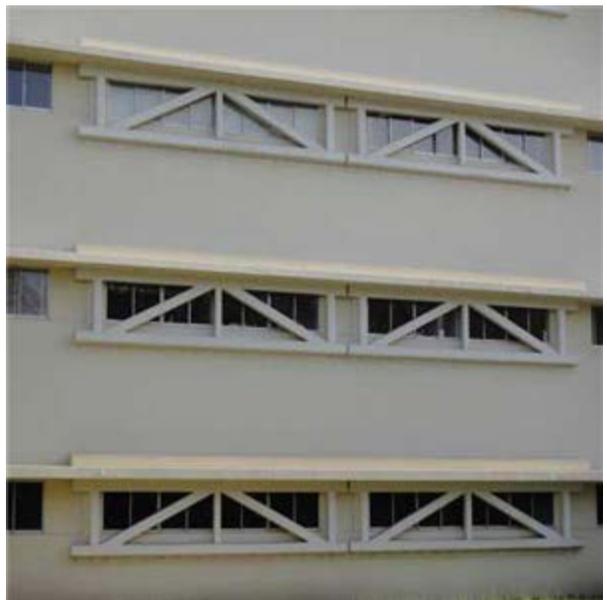
Item	Description
B2011 Exterior Wall Construction	B2011 Stucco Exterior Walls
Condition	Fair
Qty / UOM	56,200 / SF
RUL (years)	15
Location	Exterior Walls
Exterior Wall Construction	Stucco
Parapets	Yes

Based on current condition and RUL, exterior painting will be required within the term.

B2011 Stucco Exterior Walls

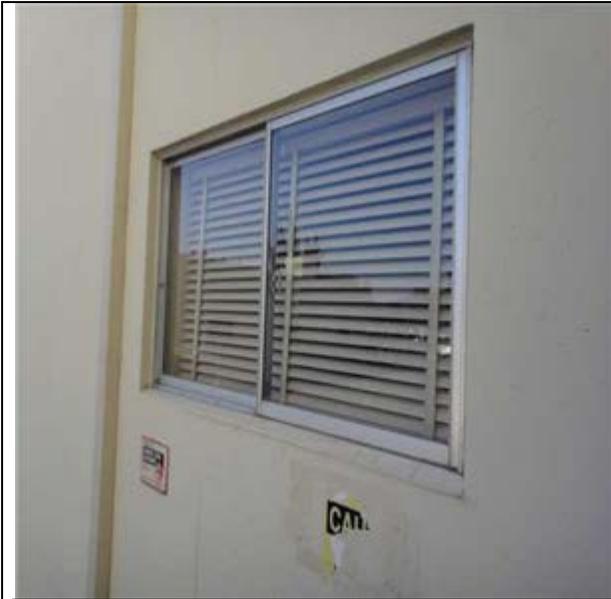
Item	Description
B2021 Windows	B2021 Aluminum Windows
Condition	Poor
Qty / UOM	644 / EA
RUL (years)	0
Location	Windows

Based on current condition and RUL, replacement is recommended at this time.

B2021 Aluminum Windows

Type	Component Description	Qty / UOM	Unit Cost (\$)	Plan Type	Priority	Year	Expenditures (\$)
B2021	Replace B2021 Aluminum Windows	644.0 - EA	2652.8	IN - Beyond Rated Life	Priority 1	2015	1,708,400

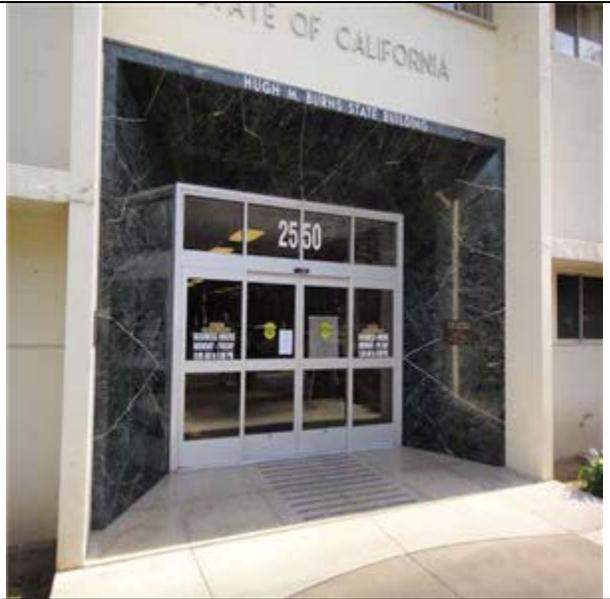
Item	Description
B2031 Glazed Doors & Entrances	B2031 Glazed Entrance Doors
Condition	Fair
Qty / UOM	6 / EA
RUL (years)	5
Location	Entrance Doors

Based on current condition and RUL, replacement is recommended during the assessment term.

B2031 Glazed Entrance Doors

Type	Component Description	Qty / UOM	Unit Cost (\$)	Plan Type	Priority	Year	Expenditures (\$)
B2031	Replace B2031 Glazed Entrance Doors	6.0 - EA	3181.7	IN - Beyond Rated Life	Priority 3	2020	19,090

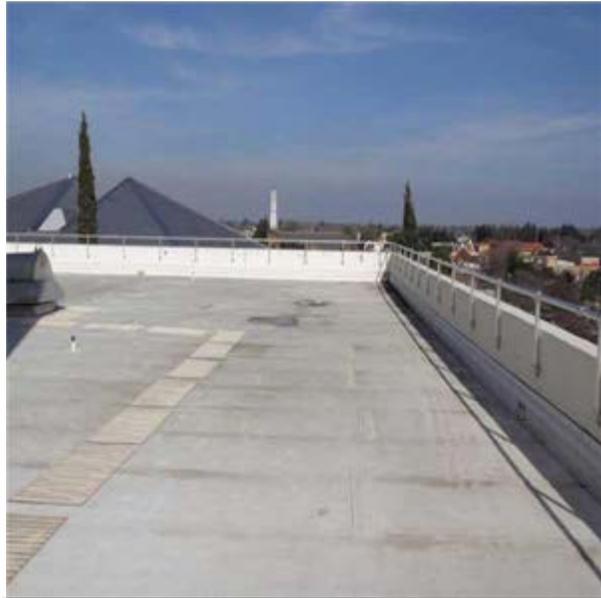
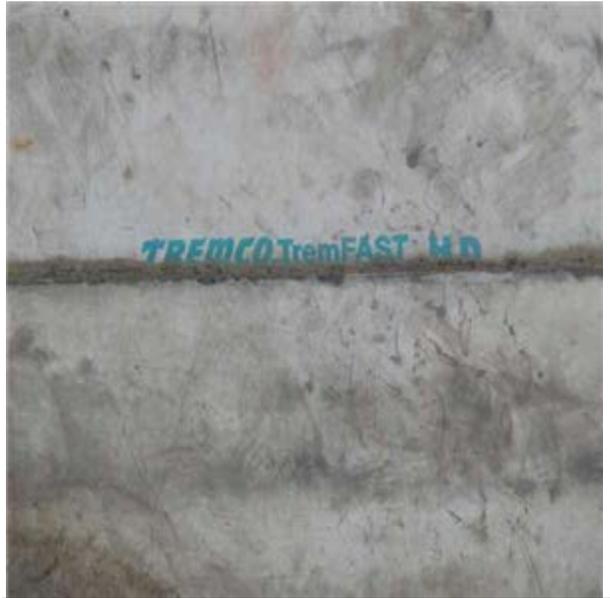
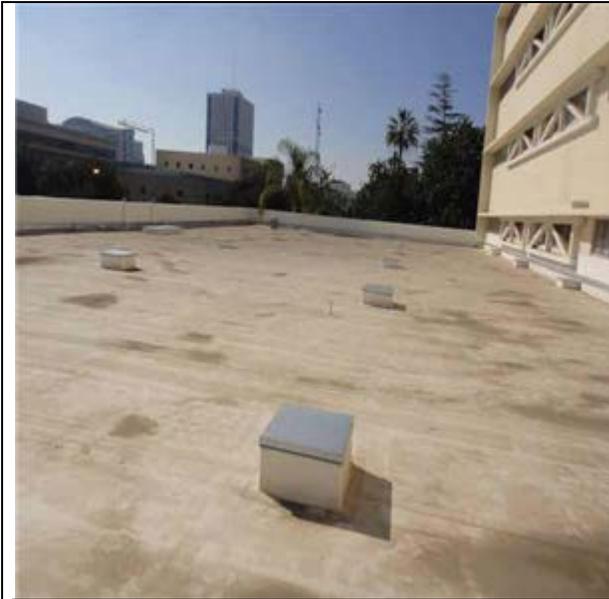
Item	Description
B3011 Roof Finishes	B3011 - TPO, Roof 45 Mills
Condition	Fair
Qty / UOM	135 / SQ
RUL (years)	13
Location	Lower Roof

Based on current condition and RUL, no further action is recommended.

Item	Description
B3011 Roof Finishes	B3011 - TPO, Roof 45 Mills
Condition	Fair
Qty / UOM	200 / SQ
RUL (years)	5
Location	Upper Roof (main roof)

Based on current condition and RUL, replacement is recommended during the assessment term.

B3011 - TPO, Roof 45 Mills

Type	Component Description	Qty / UOM	Unit Cost (\$)	Plan Type	Priority	Year	Expenditures (\$)
B3011	Replace B3011 - TPO, Roof 45 Mills	200.0 - SQ	1729.0	IN - Beyond Rated Life	Priority 3	2020	345,800

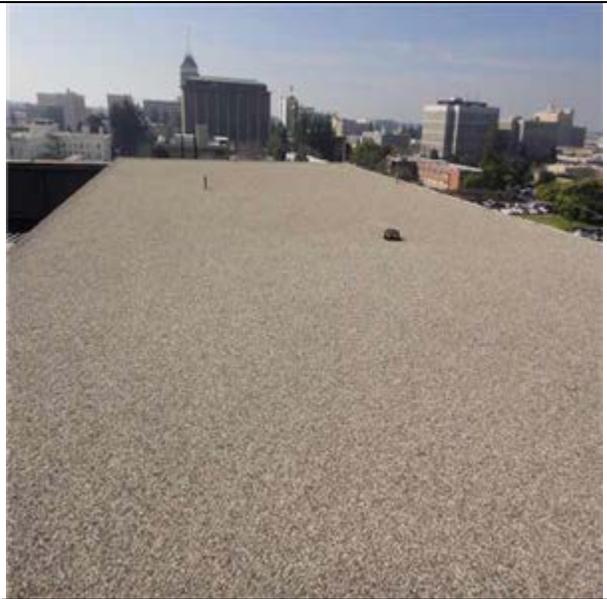
Item	Description
B3011 Roof Finishes	B3011 Built-Up Roofing with Stone Ballast
Condition	Fair
Qty / UOM	90 / SQ
RUL (years)	5
Location	Penthouse Roof

Based on current condition and RUL, replacement is recommended during the assessment term.

B3011 Built-Up Roofing with Stone Ballast

Type	Component Description	Qty / UOM	Unit Cost (\$)	Plan Type	Priority	Year	Expenditures (\$)
B3011	Replace B3011 Built-Up Roofing with Stone Ballast	90.0 - SQ	1366.1	IN - Beyond Rated Life	Priority 3	2020	122,947

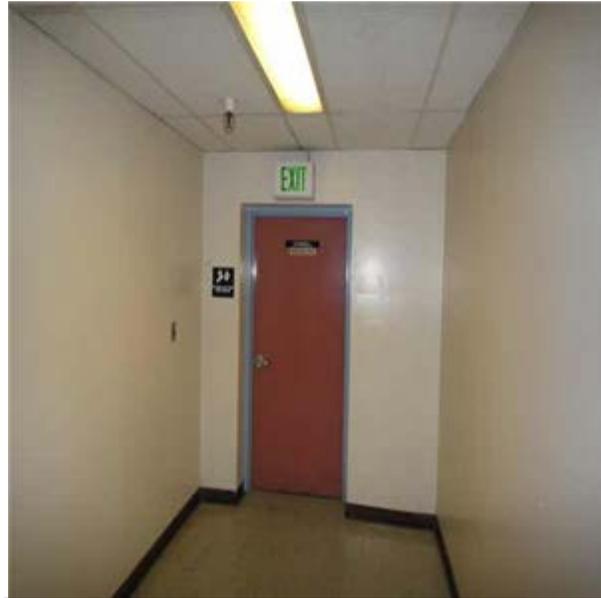
Item	Description
C1021 Interior Doors	C1021 Interior Fire Doors
Condition	Fair
Qty / UOM	36 / EA
RUL (years)	5
Location	Interior Fire Doors

Based on current condition and RUL, replacement is recommended during the assessment term.

C1021 Interior Fire Doors

Type	Component Description	Qty / UOM	Unit Cost (\$)	Plan Type	Priority	Year	Expenditures (\$)
C1021	Replace C1021 Interior Fire Doors	36.0 - EA	2707.9	CC - Life Safety	Priority 3	2020	97,486

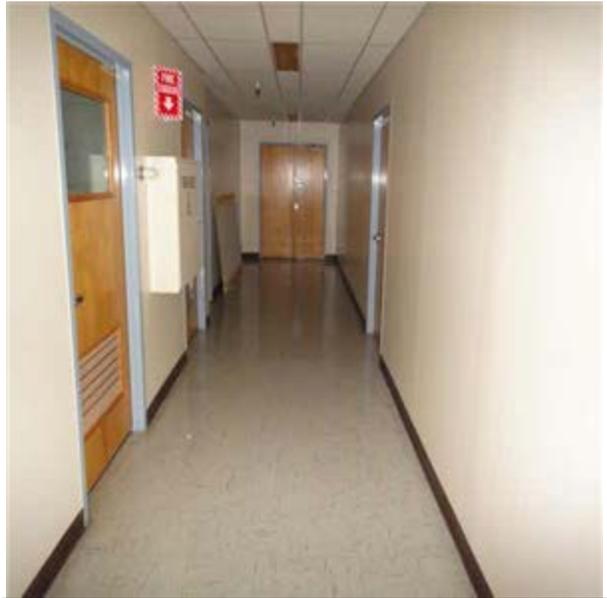
Item	Description
C1021 Interior Doors	C1021 Interior Wood Doors
Condition	Fair
Qty / UOM	424 / EA
RUL (years)	5
Location	Interior Doors

Based on current condition and RUL, replacement is recommended during the assessment term.

C1021 Interior Wood Doors

Type	Component Description	Qty / UOM	Unit Cost (\$)	Plan Type	Priority	Year	Expenditures (\$)
C1021	Replace C1021 Interior Wood Doors	424.0 - EA	1280.0	IN - Beyond Rated Life	Priority 4	2020	542,711

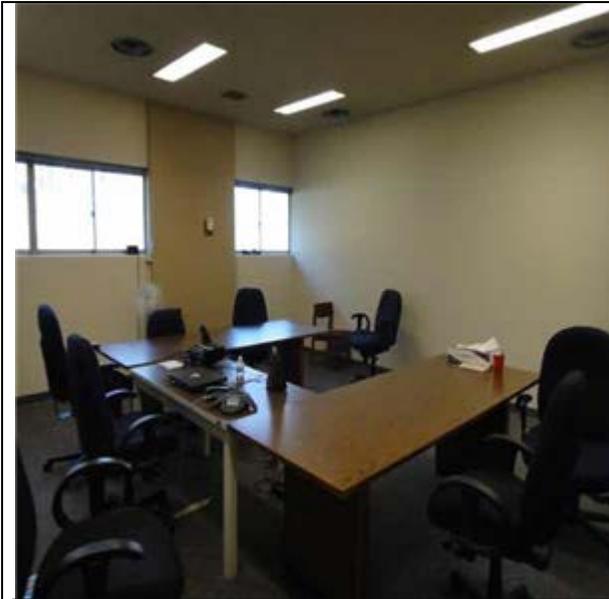
Item	Description
C3012 Wall Finishes to Interior Walls	C3012 Paint Interior Walls, Drywall
Condition	Fair
Qty / UOM	571,700 / SF
RUL (years)	3
Location	Interior Walls

Based on current condition and RUL, repainting is recommended during the assessment term.

C3012 Paint Interior Walls, Drywall

Type	Component Description	Qty / UOM	Unit Cost (\$)	Plan Type	Priority	Year	Expenditures (\$)
C3012	Replace C3012 Paint Interior Walls, Drywall	571,700.0 - SF	2.1	IN - Appearance	Priority 3	2018	1,219,322

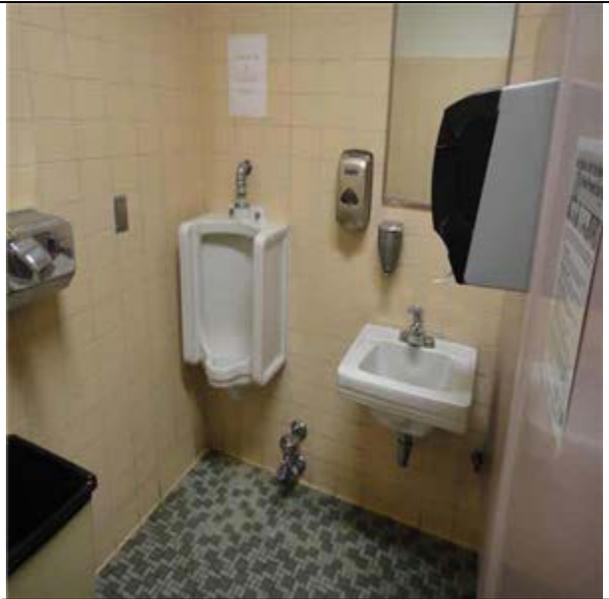
Item	Description
C3024 Flooring	C3024 - Ceramic Tile
Condition	Fair
Qty / UOM	3,000 / SF
RUL (years)	2
Location	Interior Flooring

Based on current condition and RUL, replacement is recommended during the assessment term.

C3024 - Ceramic Tile

Type	Component Description	Qty / UOM	Unit Cost (\$)	Plan Type	Priority	Year	Expenditures (\$)
C3024	Replace C3024 - Ceramic Tile	3,000.0 - SF	40.9	IN - Appearance	Priority 3	2017	122,767

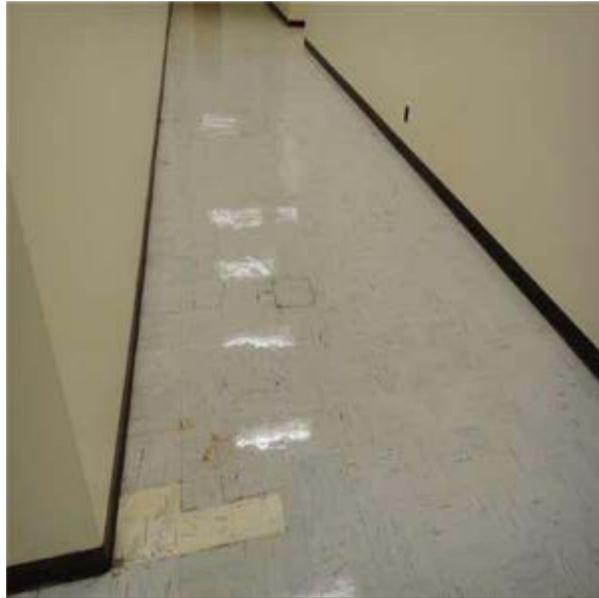
Item	Description
C3024 Flooring	C3024 Asbestos Vinyl Tile
Condition	Fair
Qty / UOM	11,110 / SY
RUL (years)	2
Location	Interior Flooring

Based on current condition and RUL, replacement is recommended during the assessment term.

C3024 Asbestos Vinyl Tile

Type	Component Description	Qty / UOM	Unit Cost (\$)	Plan Type	Priority	Year	Expenditures (\$)
C3024	Replace C3024 Asbestos Vinyl Tile	11,110.0 - SY	125.8	IN - Appearance	Priority 3	2017	1,397,418

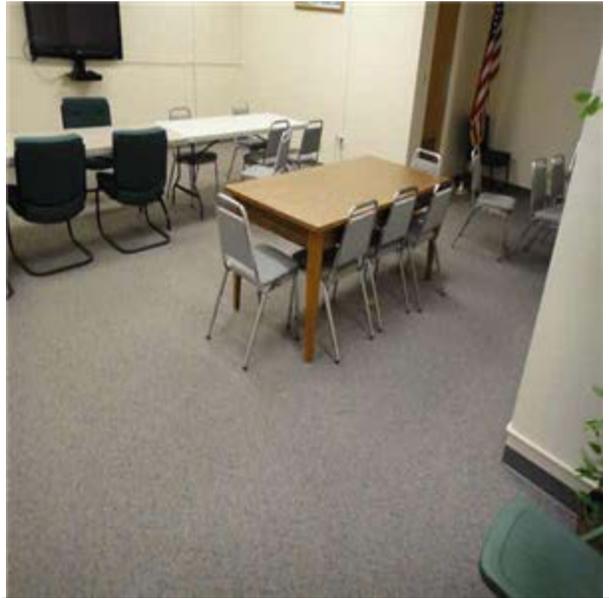
Item	Description
C3025 Carpeting	C3025 Carpet
Condition	Fair
Qty / UOM	2,722 / SY
RUL (years)	2
Location	Interior Flooring

Based on current condition and RUL, replacement is recommended during the assessment term.

C3025 Carpet

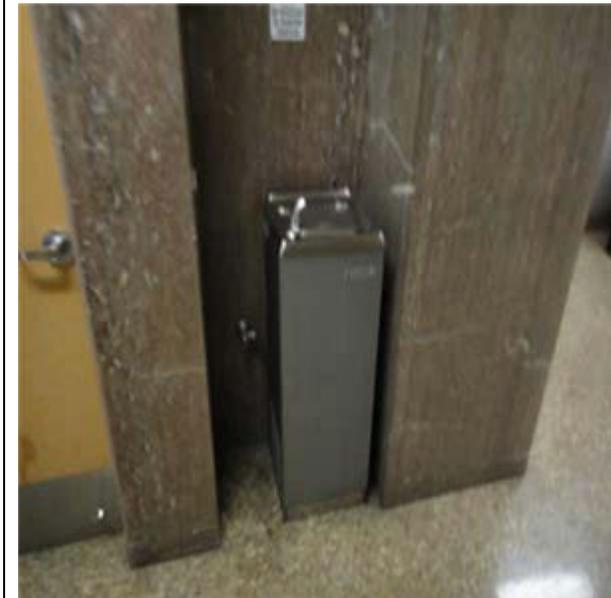
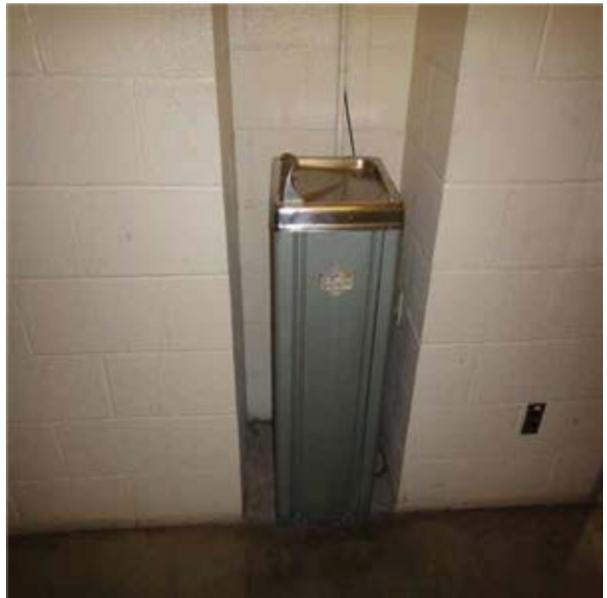
Item	Description
D2018 Drinking Fountains and Coolers	D2018 Drinking Fountain
Condition	Fair
Qty / UOM	5 / EA
RUL (years)	3
Location	Interior Hallways

D2018 Drinking Fountain

Type	Component Description	Qty / UOM	Unit Cost (\$)	Plan Type	Priority	Year	Expenditures (\$)
D2018	Replace D2018 Drinking Fountain	5.0 - EA	2876.6	CC - Accessibility	Priority 2	2018	14,383
