Fresno Water Resources Building (753)

3374 East Shields Avenue, Fresno, CA 93726

Facility Condition Assessment

September 2015

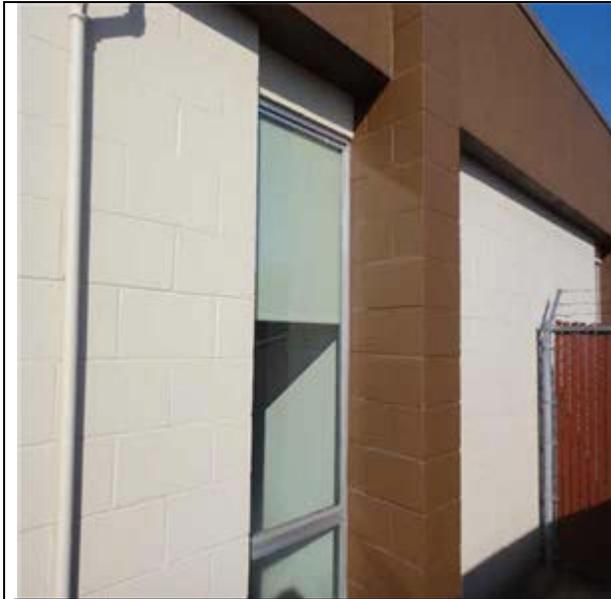
The exterior masonry block walls will require painting during the assessment term due to normal deterioration.

B2011 Painted Masonry Exterior Walls

Type	Component Description	Qty / UOM	Unit Cost (\$)	Plan Type	Priority	Year	Expenditures (\$)
B2011	Replace B2011 Painted Masonry Exterior Walls	13,788.0 - SF	4.6	IN - Appearance	Priority 3	2020	62,917

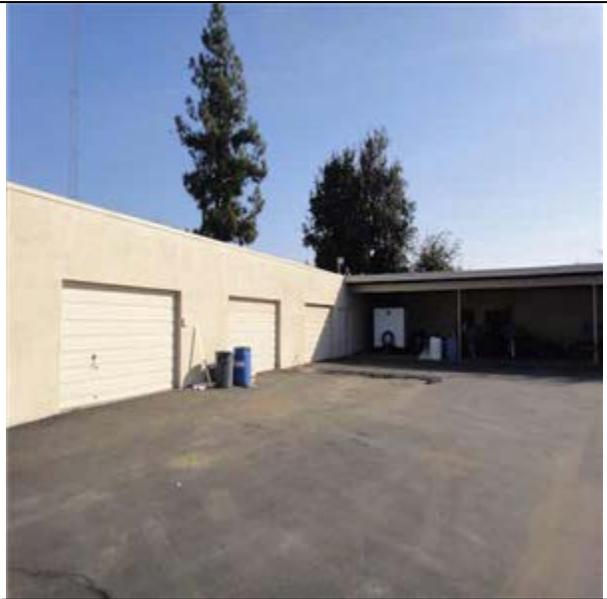
The exterior stucco walls will require painting during the assessment term due to normal deterioration.

B2011 Painted Exterior Wall Stucco and Lath

Type	Component Description	Qty / UOM	Unit Cost (\$)	Plan Type	Priority	Year	Expenditures (\$)
B2011	Replace B2011 Painted Exterior Wall Stucco and Lath	5,100.0 - SF	4.6	IN - Appearance	Priority 4	2022	23,272

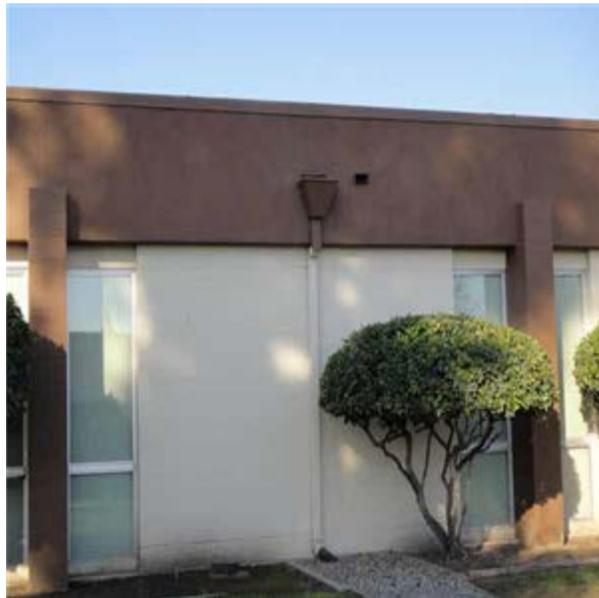
The single pane aluminum windows appear to be original to the building construction. Replacement of all windows with energy efficient dual pane units is recommended.

B2021 Aluminum Windows

Type	Component Description	Qty / UOM	Unit Cost (\$)	Plan Type	Priority	Year	Expenditures (\$)
B2021	Replace B2021 Aluminum Windows	44.0 - EA	3614.8	IN - Beyond Rated Life	Priority 1	2016	159,051

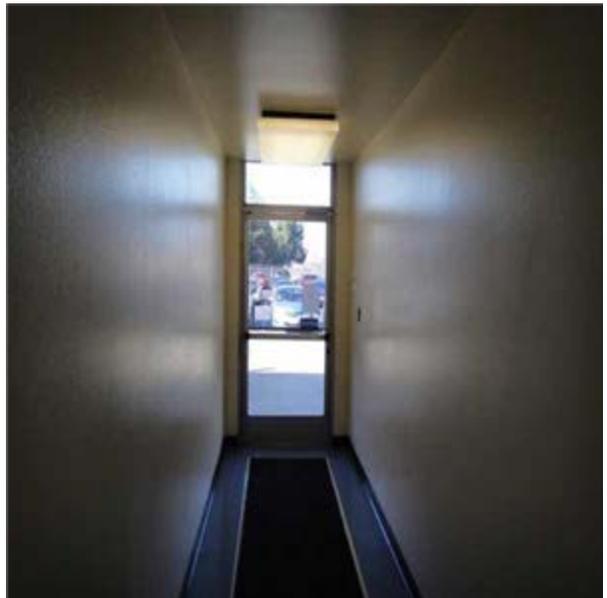
The entry doors are aluminum storefront systems with fully glazed doors and side panels. Based on RUL, replacement is anticipated during the assessment term.

B2031 Glazed Entrance Doors

Type	Component Description	Qty / UOM	Unit Cost (\$)	Plan Type	Priority	Year	Expenditures (\$)
B2031	Replace B2031 Glazed Entrance Doors	5.0 - EA	4335.5	IN - Appearance	Priority 4	2022	21,678

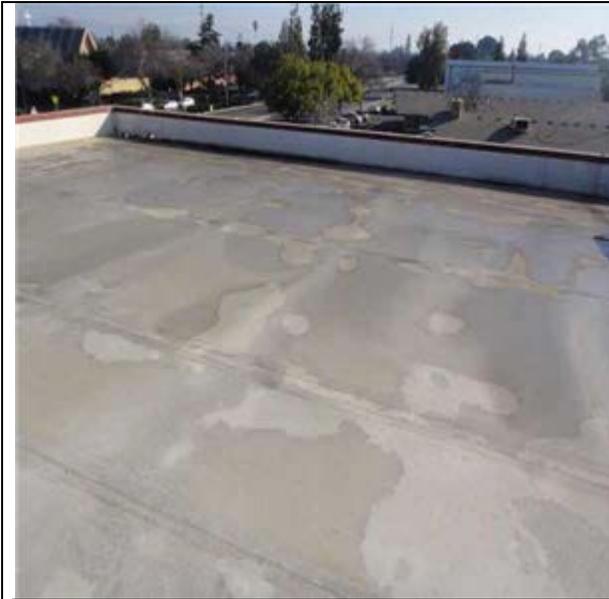
Based on RUL and current condition, roof membrane replacement is anticipated during the reserve period.

B3011 TPO Membrane Roofing

Type	Component Description	Qty / UOM	Unit Cost (\$)	Plan Type	Priority	Year	Expenditures (\$)
B3011	Replace B3011 TPO Membrane Roofing	400.0 - SQ	1566.5	IN - Beyond Rated Life	Priority 3	2019	626,587

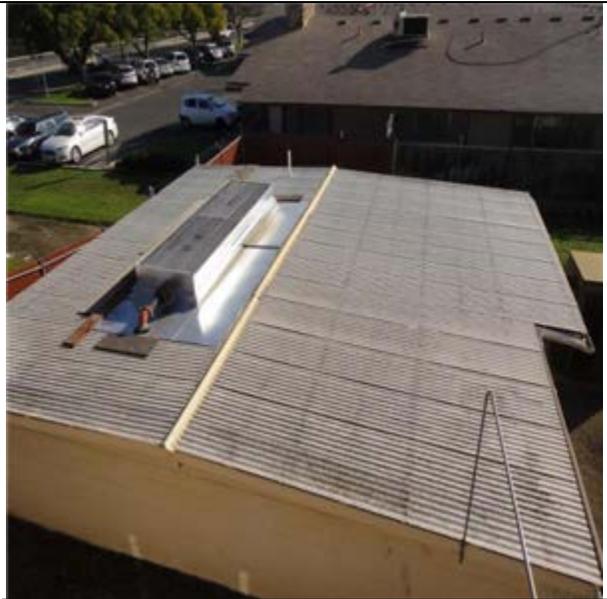
The corrugated fiberglass translucent roof on the east side of mechanical building shows aging and exposed fibers. Replacement is recommended during the assessment term.

B3011 Translucent Fiberglass Roof

Type	Component Description	Qty / UOM	Unit Cost (\$)	Plan Type	Priority	Year	Expenditures (\$)
B3011	Replace B3011 Translucent Fiberglass Roof	900.0 - SF	9.7	IN - Beyond Rated Life	Priority 3	2020	8,772

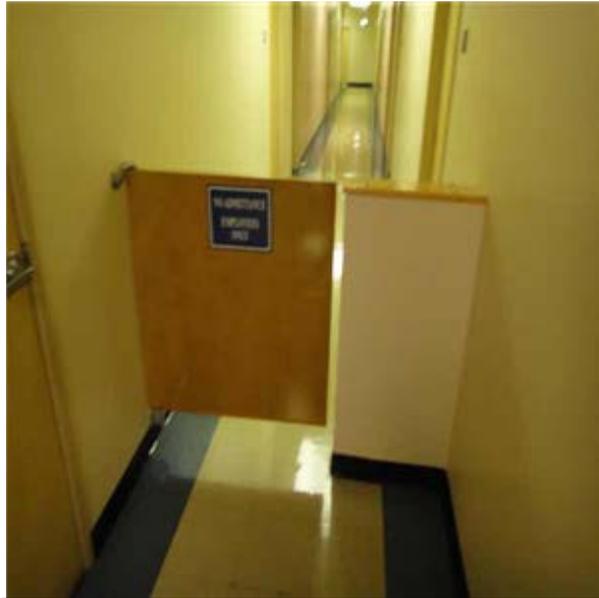
Partial height walls with swing doors were observed in some of the common corridors. The walls present an ADA barrier, as the clear openings were 30 inches or less. A cost is included to remove the walls and refinish the adjacent surfaces.

C1011 Wood Stud and Drywall half wall partition

Type	Component Description	Qty / UOM	Unit Cost (\$)	Plan Type	Priority	Year	Expenditures (\$)
C1011	Replace C1011 Wood Stud and Drywall half wall partition	64.0 - SF	17.0	CC - Accessibility	Priority 1	2015	1,087

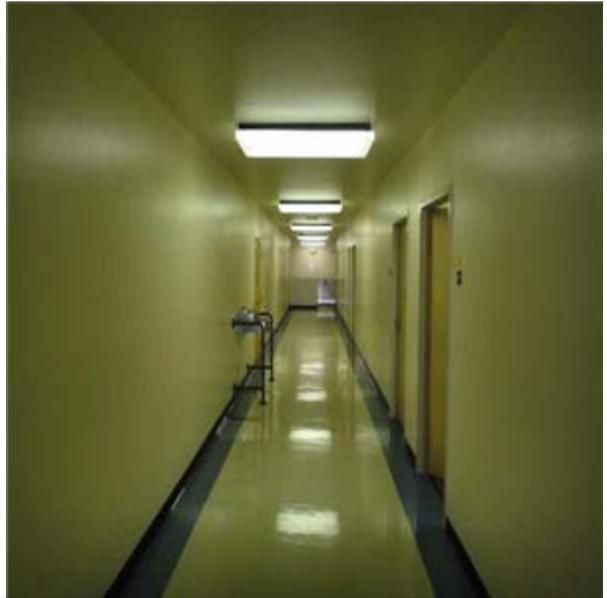
C3012 Paint Interior Walls, Drywall

Type	Component Description	Qty / UOM	Unit Cost (\$)	Plan Type	Priority	Year	Expenditures (\$)
C3012	Replace C3012 Paint Interior Walls, Drywall	58,000.0 - SF	2.1	IN - Appearance	Priority 3	2018	123,702

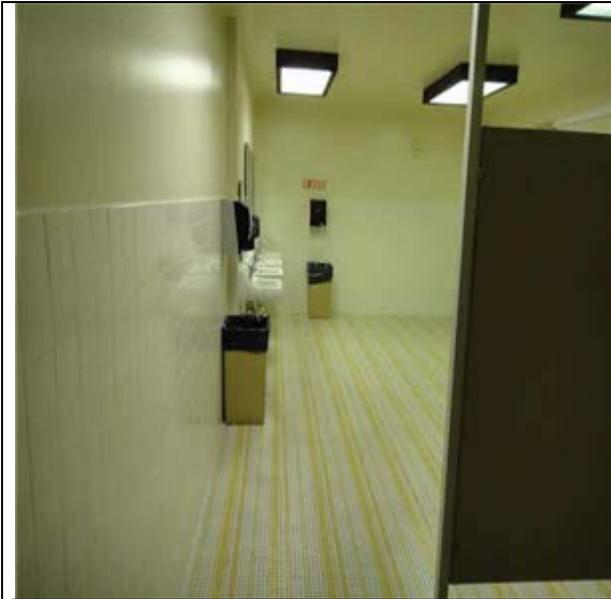
Based on the estimated useful life and observed condition, ceramic tile replacement is anticipated during the assessment period.

C3024 2X2 Ceramic Tile

Type	Component Description	Qty / UOM	Unit Cost (\$)	Plan Type	Priority	Year	Expenditures (\$)
C3024	Replace C3024 2X2 Ceramic Tile	8.0 - CSF	3155.9	IN - Appearance	Priority 3	2018	25,247

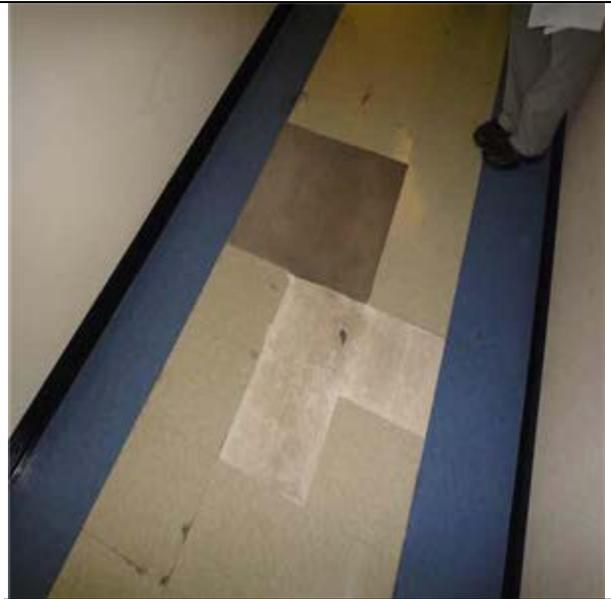
Based on RUL, vinyl tile replacement is anticipated during the assessment period.

C3024 Vinyl Tile

Type	Component Description	Qty / UOM	Unit Cost (\$)	Plan Type	Priority	Year	Expenditures (\$)
C3024	Replace C3024 Vinyl Tile	860.0 - SY	125.8	IN - Appearance	Priority 3	2017	108,171

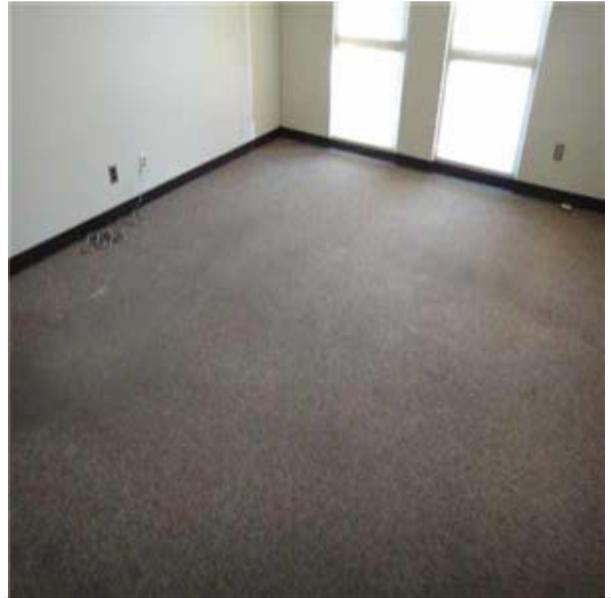
Based on RUL, carpet tile replacement is anticipated during the assessment period.

C3025 Carpet Commercial Medium Grade

Type	Component Description	Qty / UOM	Unit Cost (\$)	Plan Type	Priority	Year	Expenditures (\$)
C3025	Replace C3025 Carpet Commercial Medium Grade	3,330.0 - SY	96.6	IN - Appearance	Priority 3	2016	321,697
C3025	Replace C3025 Carpet Commercial Medium Grade	3,330.0 - SY	96.6	IN - Appearance	Priority 3	2024	321,697

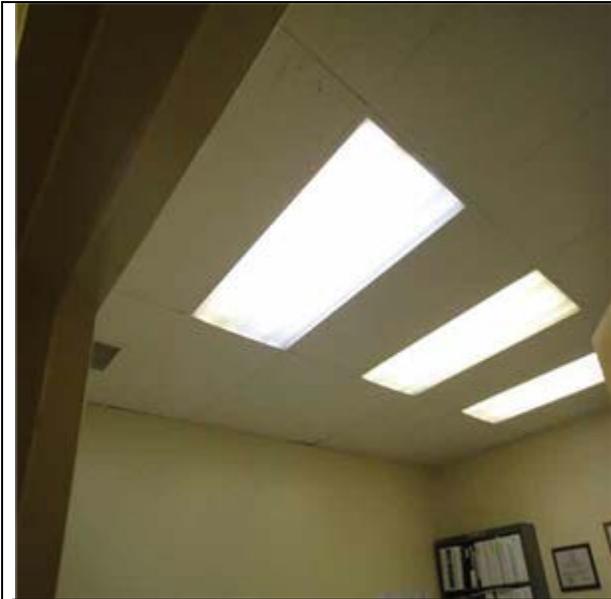
Based on RUL, acoustic ceiling tile replacement is anticipated during the assessment period. Fire sprinkler system installation also necessitates total ceiling replacement.

C3032 Acoustical Ceiling Tile

Type	Component Description	Qty / UOM	Unit Cost (\$)	Plan Type	Priority	Year	Expenditures (\$)
C3032	Replace C3032 Acoustical Ceiling Tile	251.0 - CSF	1201.6	IN - Appearance	Priority 2	2015	301,592

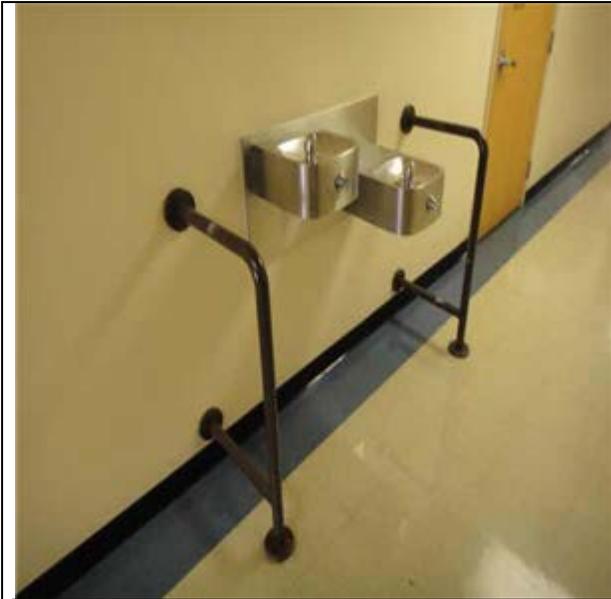
Item	Description
D2018 Drinking Fountains and Coolers	D2018 Drinking Fountain
Condition	Fair
Qty / UOM	2 / EA
RUL (years)	0
Location	Throughout Facility

D2018 Drinking Fountain

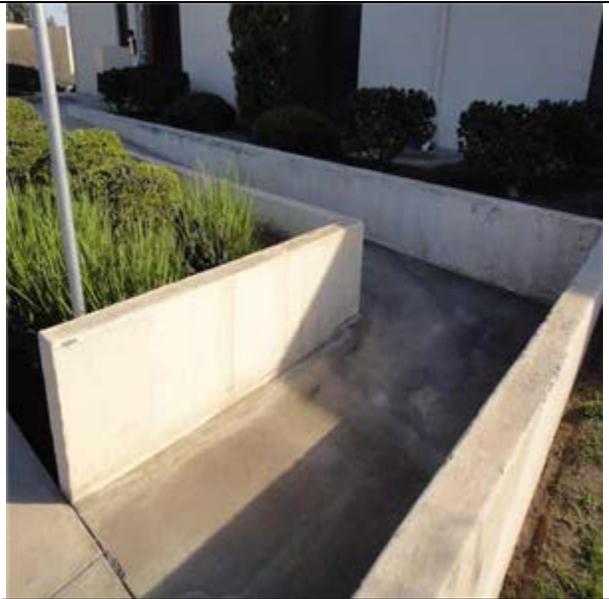
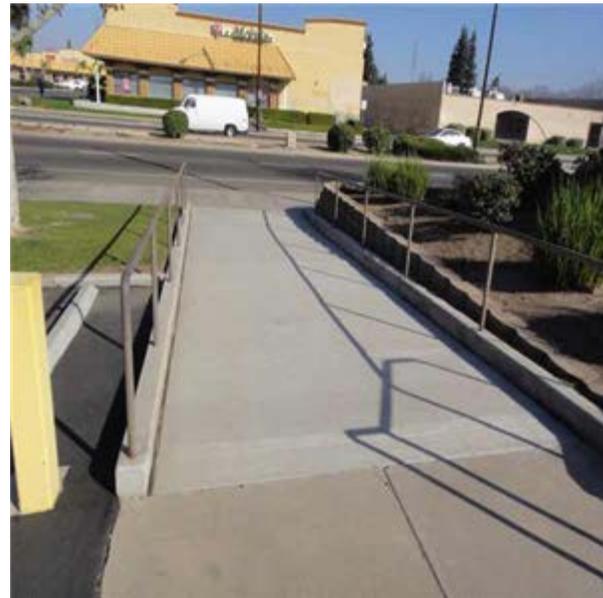
Item	Description
G2035 Exterior Steps & Ramps	G2030 Concrete Ramp with Rails, Including Demo
Condition	Poor
Qty / UOM	74 / LF
RUL (years)	0
Location	Front of Building

G2030 Concrete Ramp with Rails, Including Demo
