## Red Bluff State Building (461)

2440 Main Street, Red Bluff, CA 96080

### Facility Condition Assessment

September 2015

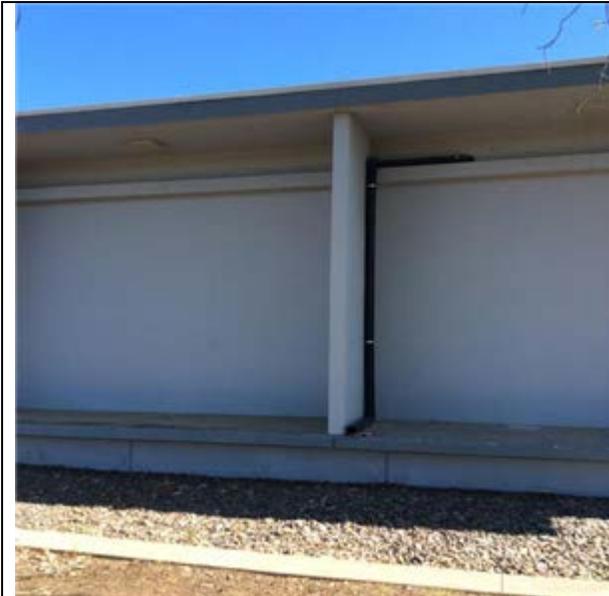
B2011 Exterior Walls, Painted Textured Concrete

Exterior painted walls show fading and minor peeling. Based on condition and remaining useful life (RUL), exterior painting is required.

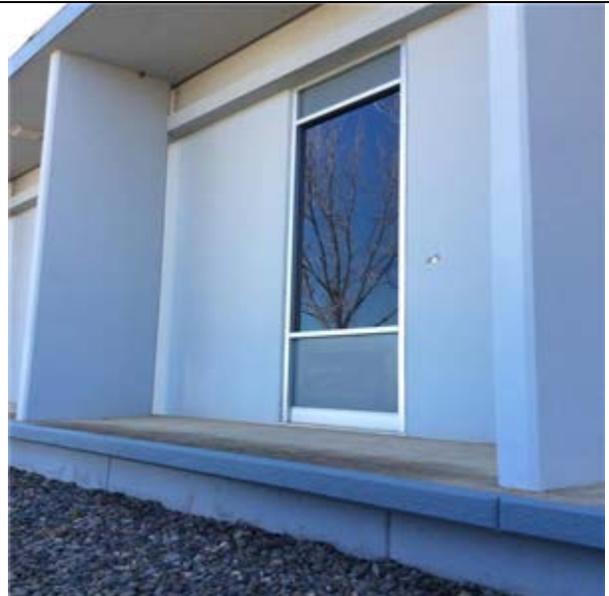
Windows are single pane, appear to be original, and have exceeded their expected life. According to management staff, some leakage is noted. Based on condition and RUL, window replacement is recommended.

Type	Component Description	Qty / UOM	Unit Cost (\$)	Plan Type	Priority	Year	Expenditures (\$)
B2021	Replace B2021 Aluminum Windows, Fixed	212.0 - EA	2652.8	IN - Beyond Rated Life	Priority 1	2016	562,393

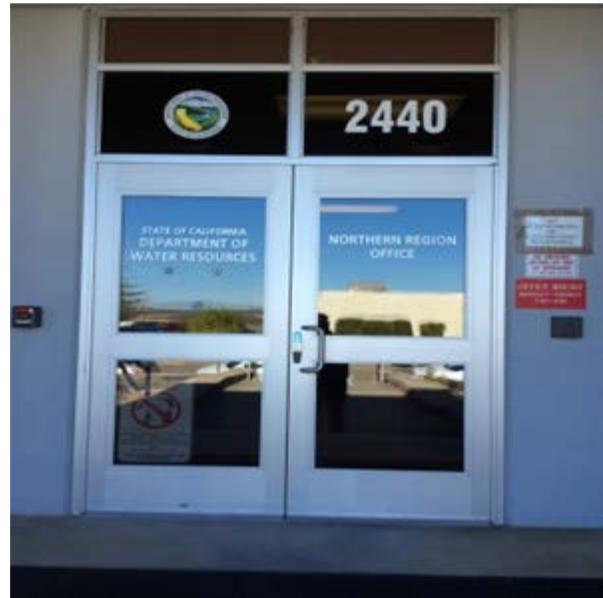
B2031 Glazed Entrance Doors

Aluminum framed glass doors were reportedly replaced in 2012. No further action is required.

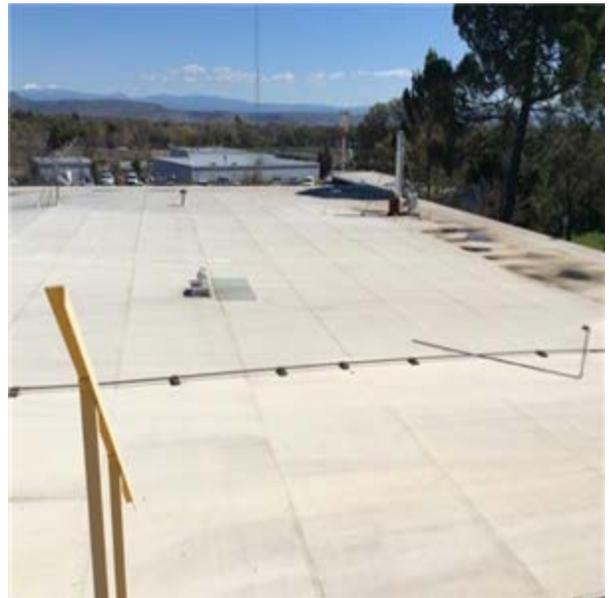
Based on RUL, roof replacement is anticipated during the assessment period.

Type	Component Description	Qty / UOM	Unit Cost (\$)	Plan Type	Priority	Year	Expenditures (\$)
B3011	Replace B3011 Single-Ply Membrane Roofing	280.0 - SQ	1806.4	IN - Beyond Rated Life	Priority 2	2017	505,780

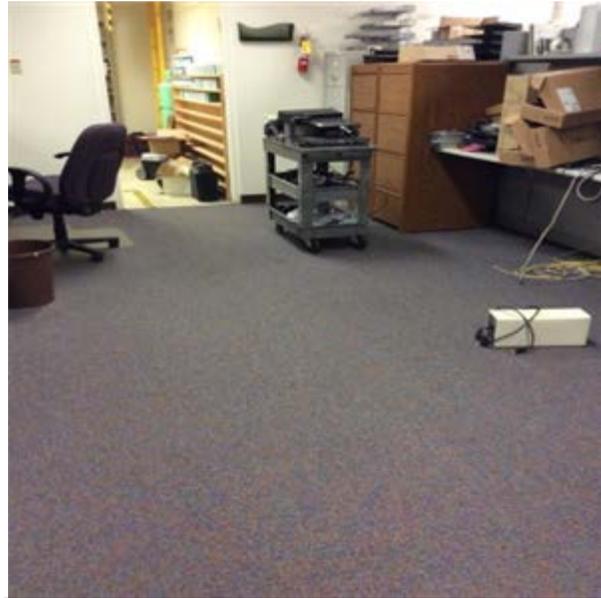
Based on RUL, carpet replacement is anticipated during the assessment period.

Type	Component Description	Qty / UOM	Unit Cost (\$)	Plan Type	Priority	Year	Expenditures (\$)
C3025	Replace C3025 Carpet Tiles - Standard	650.0 - SY	96.6	IN - Appearance	Priority 3	2017	62,794

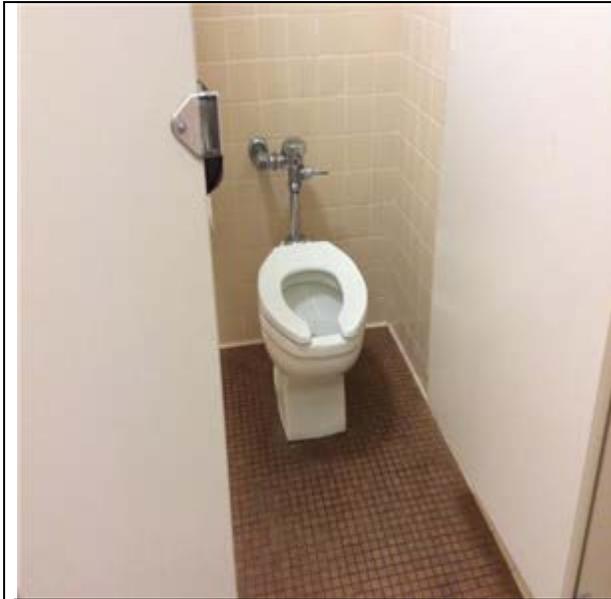
Water closets with manual flush valves are noted. Replacement of the water closets as part of complete restroom renovations are recommended.

Type	Component Description	Qty / UOM	Unit Cost (\$)	Plan Type	Priority	Year	Expenditures (\$)
D2011	Replace D2011 Commercial Water Closet, 1.6 GPF Unit	4.0 - EA	1233.1	OP - Energy	Priority 1	2015	4,933

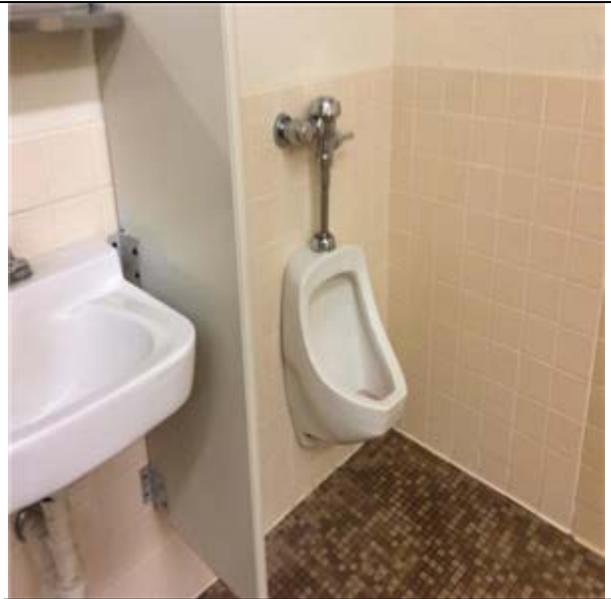
Manual flush valves were observed. Replacement of the urinals as part of complete restroom renovations are recommended.

Type	Component Description	Qty / UOM	Unit Cost (\$)	Plan Type	Priority	Year	Expenditures (\$)
D2012	Replace D2012 Urinal - Standard	3.0 - EA	2440.7	FN - Modernization	Priority 2	2017	7,322

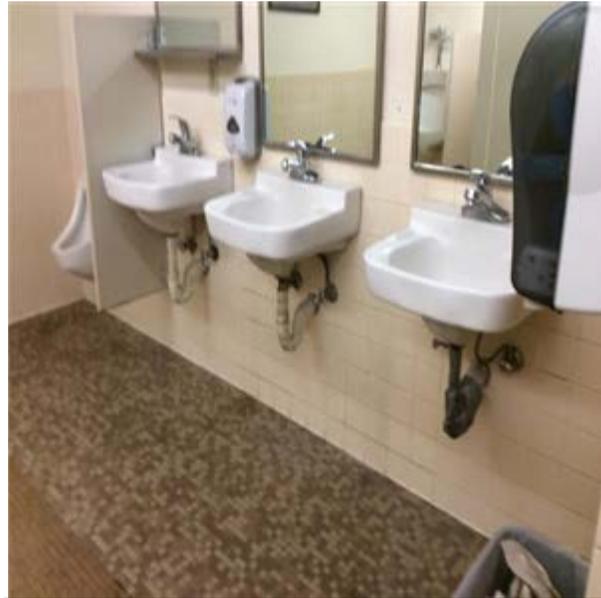
Lavatories with manual faucets appear to be original. Replacement of the faucets and lavatories as part of complete restroom renovations are recommended.

Type	Component Description	Qty / UOM	Unit Cost (\$)	Plan Type	Priority	Year	Expenditures (\$)
D2013	Replace D2013 Wall Hung Lavatory and Faucet - Standard	5.0 - EA	1542.0	FN - Modernization	Priority 2	2017	7,710

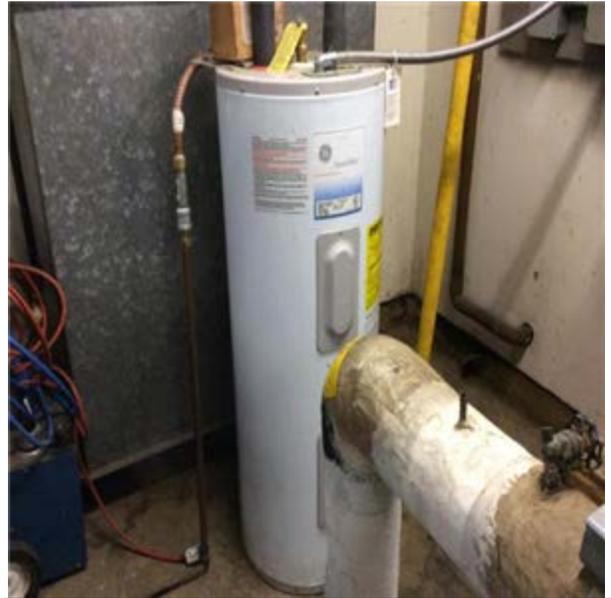
Based on RUL, the water heater will require replacement during the assessment term.

Type	Component Description	Qty / UOM	Unit Cost (\$)	Plan Type	Priority	Year	Expenditures (\$)
D2022	Replace D2020 Domestic Hot Water Heater - Electric - 40 Gal	1.0 - EA	2917.0	IN - Beyond Rated Life	Priority 4	2022	2,917

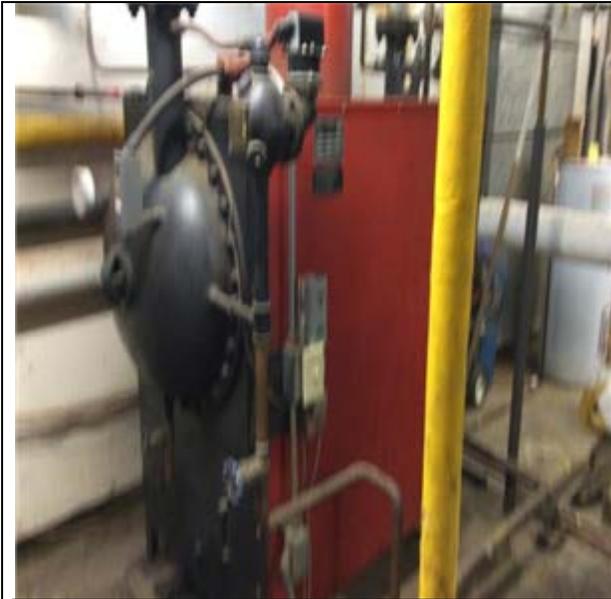
D3020 Water Boiler, Gas 400 MBH

The HVAC boiler is original, outdated, and is recommended for replacement with a high efficiency hot water unit.
