Mission Valley State Building (850)

7575 Metropolitan Drive, San Diego, CA 92108

Facility Condition Assessment

September 2015

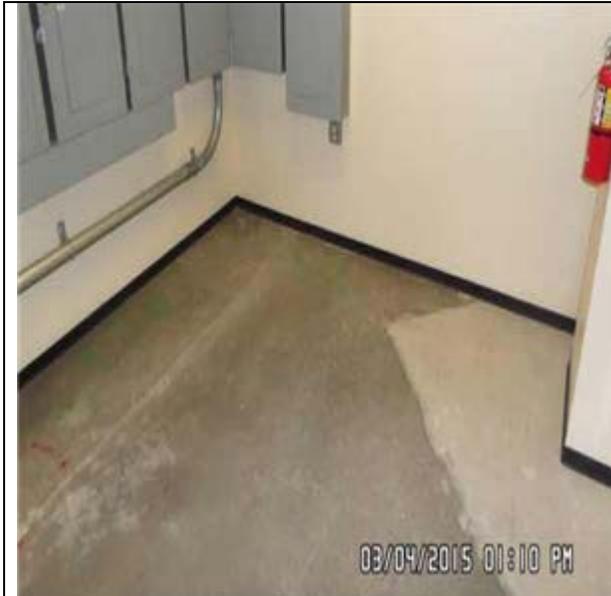
Item	Description
A1011 Wall Foundations	A1011 Reinforced Concrete Foundations
Condition	Fair
Qty / UOM	80,400 / SF
RUL (years)	35
Location	Concrete Slab

A1011 Reinforced Concrete Foundations

Based on current condition and RUL, no further action is recommended.

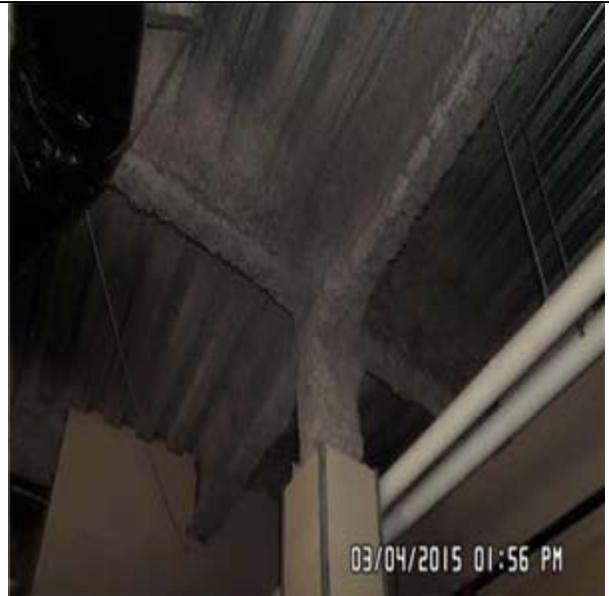
Item	Description
B1031 Steel Frame Structure	B1031 Structural Steel Columns and Beams Frame
Condition	Fair
Qty / UOM	185,000 / SF
RUL (years)	35
Location	Structural

B1031 Structural Steel Columns and Beams Frame

Based on current condition and remaining useful life (RUL), no further action is recommended.

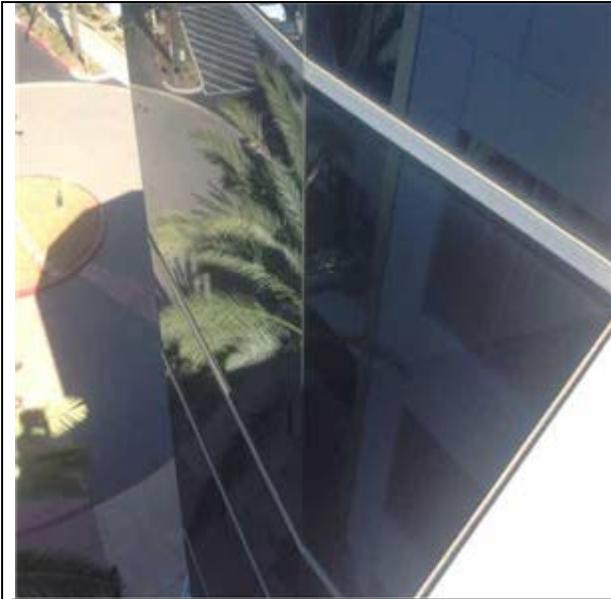
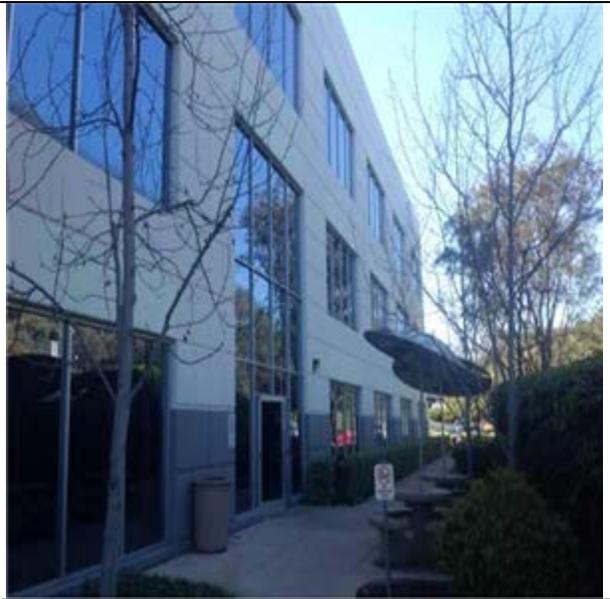
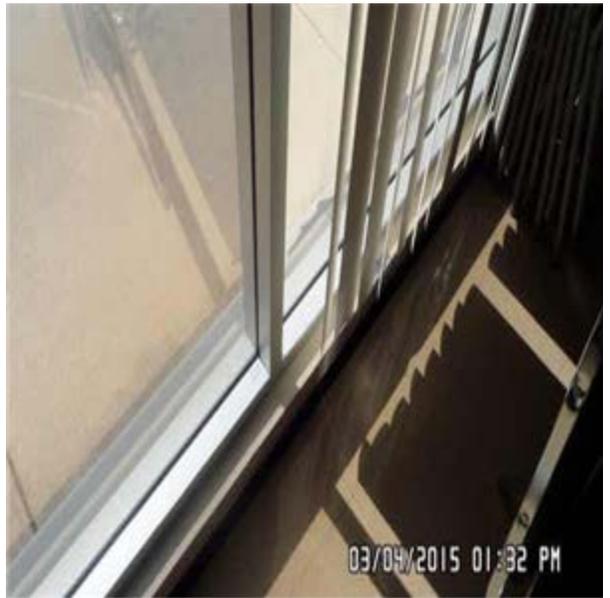
Item	Description
B2021 Windows	B2021 Aluminum Windows
Condition	Fair
Qty / UOM	720 / EA
RUL (years)	10
Location	Windows

B2021 Aluminum Windows

Based on current condition and RUL, no further action is recommended.

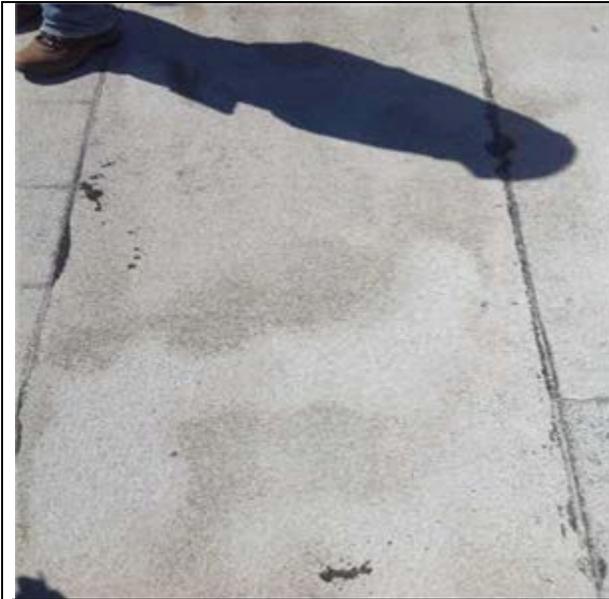
Item	Description
B3011 Roof Finishes	B3011 Modified Bitumen
Condition	Fair
Qty / UOM	800 / SQ
RUL (years)	5
Location	Roof
Insulation	Rigid
Flashings and Trim	Metal
Roof Eaves and Soffits	No
Roof Drainage	Internal Building Piping
Roof Warranty	Unknown

No active roof leaks were noted, however, there was some minor ridging at the parapet walls. The beginning stages of hairline cracking in some of the mastic was noted throughout. Based on current condition and RUL, replacement is recommended during the assessment term.

B3011 Modified Bitumen

Type	Component Description	Qty / UOM	Unit Cost (\$)	Plan Type	Priority	Year	Expenditures (\$)
B3011	Replace B3011 Modified Bitumen	800.0 - SQ	1172.4	IN - Beyond Rated Life	Priority 3	2020	937,912

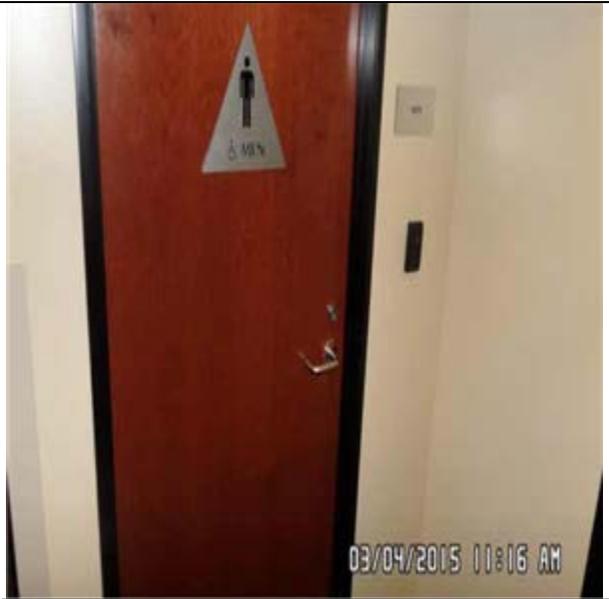
Item	Description
C1021 Interior Doors	C1021 Interior Doors - newer
Condition	Fair
Qty / UOM	180 / EA
RUL (years)	15
Location	Interior Doors

C1021 Interior Doors - newer

Based on current condition and RUL, no further action is recommended.

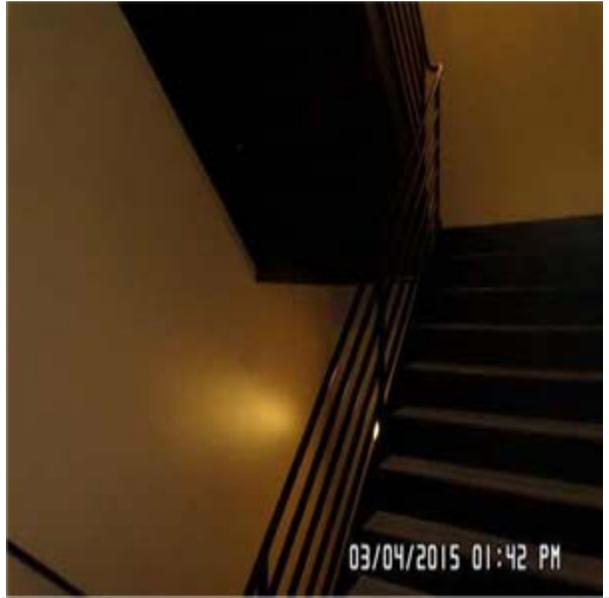
Item	Description
C2011 Regular Stairs	C2011 Concrete Filled Metal Pan Stairs
Condition	Fair
Qty / UOM	2,000 / SF
RUL (years)	35
Location	Exterior Stairs

C2011 Concrete Filled Metal Pan Stairs

Based on current condition and RUL, no further action is recommended.

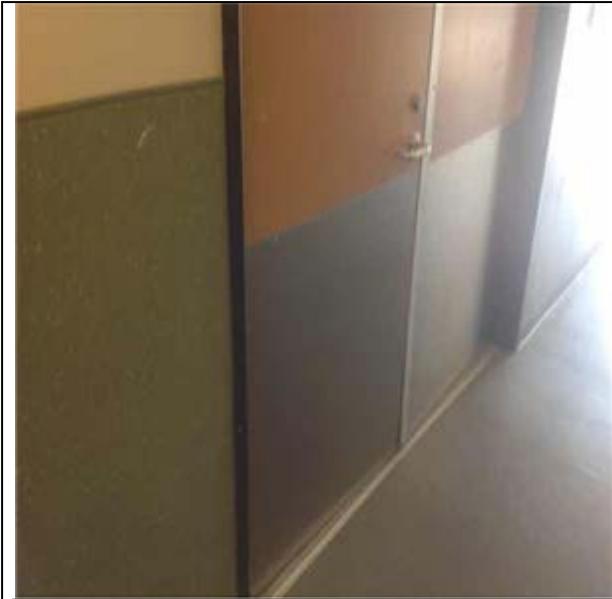
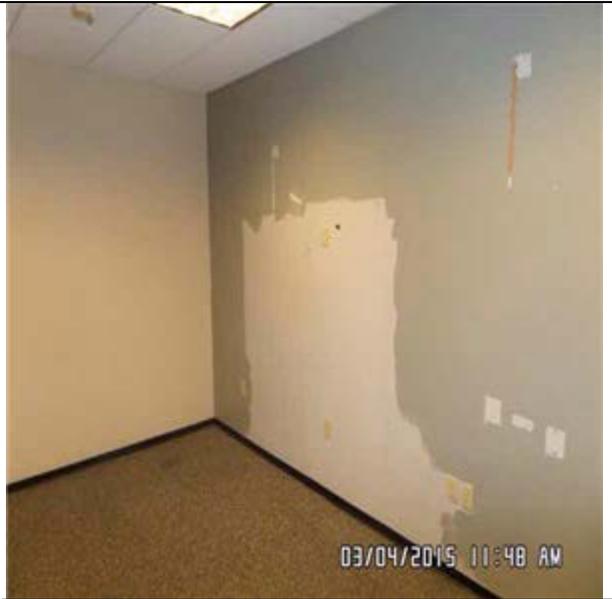
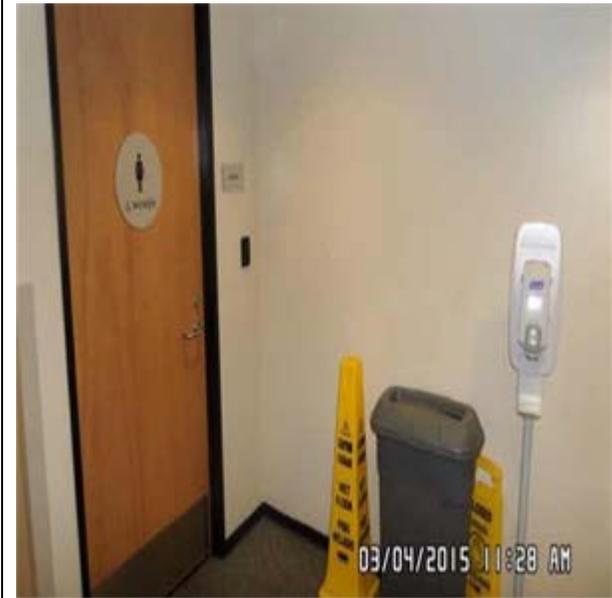
Item	Description
C3012 Wall Finishes to Interior Walls	C3012 Paint Interior Walls, Drywall
Condition	Fair
Qty / UOM	148,500 / SF
RUL (years)	6
Location	Interior Walls

C3012 Paint Interior Walls, Drywall

Based on current condition and RUL, repainting the interior walls is recommended during the assessment term.

Type	Component Description	Qty / UOM	Unit Cost (\$)	Plan Type	Priority	Year	Expenditures (\$)
C3012	Replace C3012 Paint Interior Walls, Drywall	148,500.0 - SF	2.1	IN - Appearance	Priority 4	2021	316,721

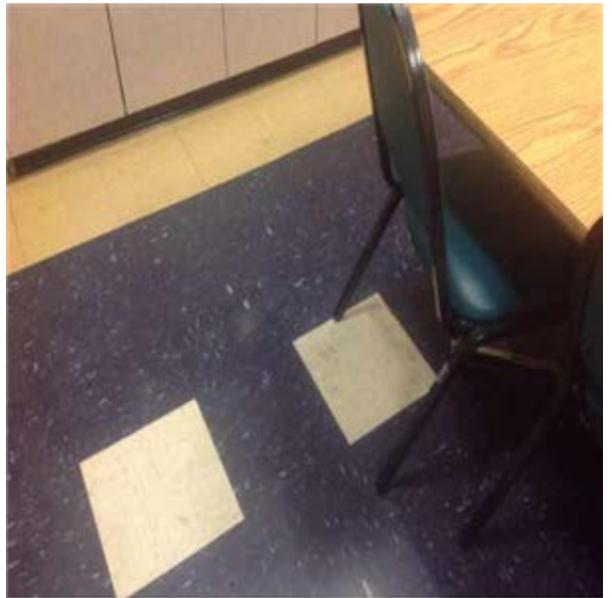
Item	Description
C3024 Flooring	C3024 Vinyl Tile
Condition	Fair
Qty / UOM	72 / SY
RUL (years)	11
Location	Interior Flooring

C3024 Vinyl Tile

Based on current condition and RUL, no further action is recommended.

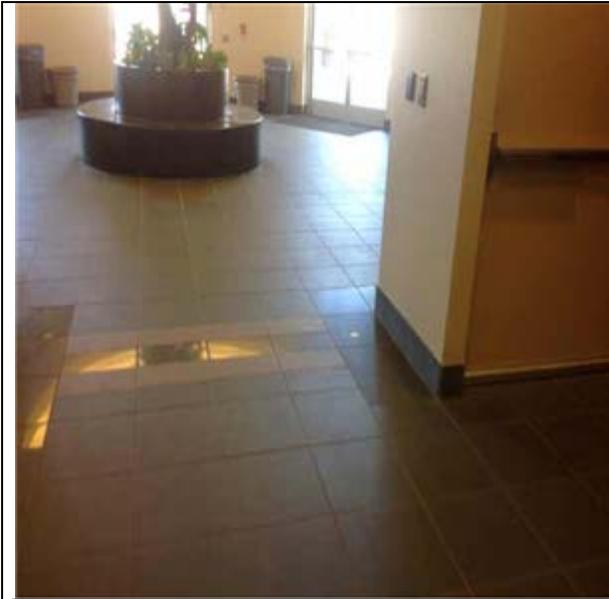
Item	Description
C3024 Flooring	C3024 1x1 Ceramic Tile
Condition	Fair
Qty / UOM	20 / CSF
RUL (years)	15
Location	Interior Flooring

C3024 1x1 Ceramic Tile

Based on current condition and RUL, no further action is recommended.

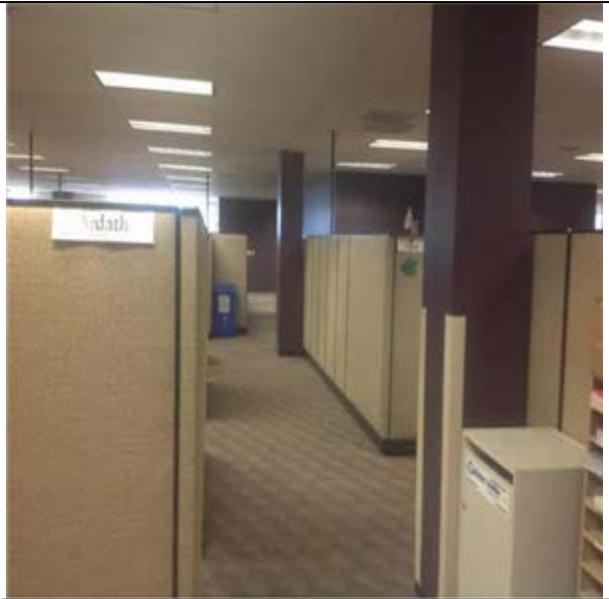
Item	Description
C3025 Carpeting	C3025 Carpet Tiles - Standard
Condition	Fair
Qty / UOM	700 / SY
RUL (years)	3
Location	Interior Flooring

Maintenance staff reports that only the interior hallways are the responsibility of DGS. Based on current condition and RUL, replacement is recommended during the assessment term.

C3025 Carpet Tiles - Standard

Type	Component Description	Qty / UOM	Unit Cost (\$)	Plan Type	Priority	Year	Expenditures (\$)
C3025	Replace C3025 Carpet Tiles - Standard	700.0 - SY	96.6	IN - Appearance	Priority 3	2018	67,624

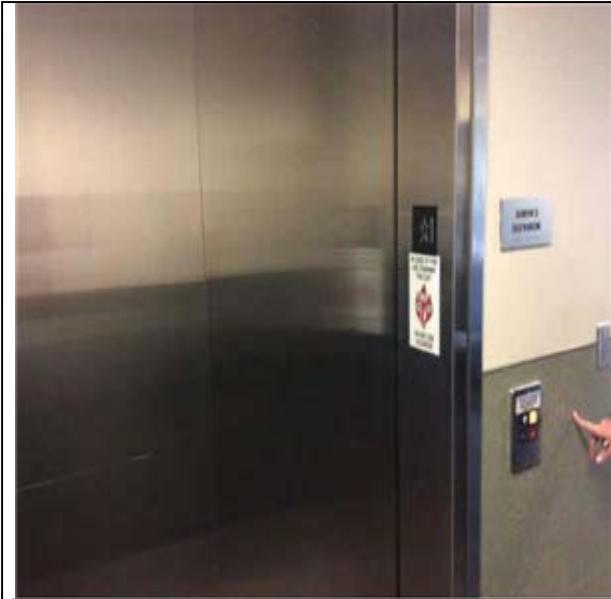
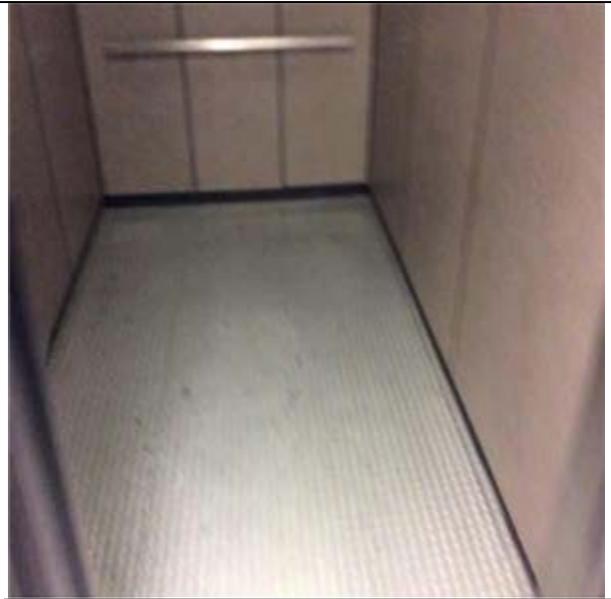
Item	Description
D1011 Passenger Elevators	D1011 Hydraulic Service Elevator 4500 lbs
Condition	Fair
Qty / UOM	1 / EA
RUL (years)	12
Location	Elevator Rooms

D1011 Hydraulic Service Elevator 4500 lbs

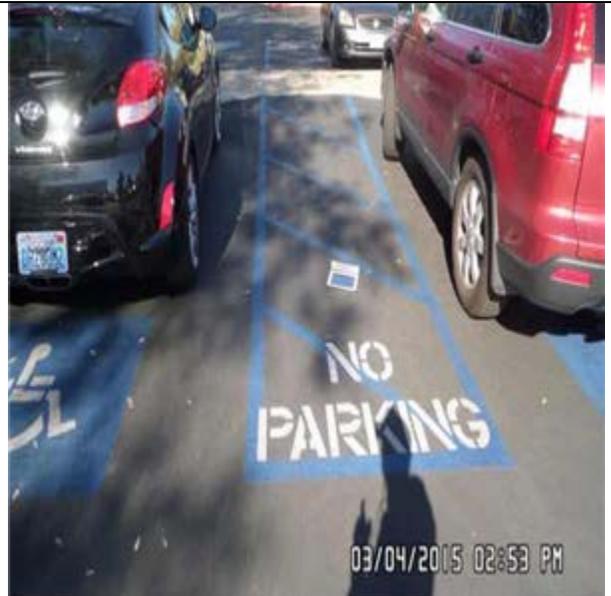
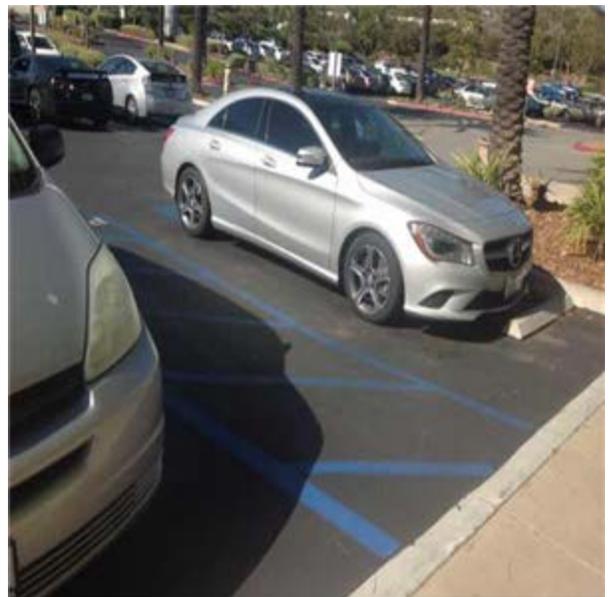
Item	Description
G2022 Paving & Surfacing	G2022 ADA Aisle Too Steep-Install New Base Course and Asphalt
Condition	Poor
Qty / UOM	350 / SF
RUL (years)	0
Location	ADA Parking Space

G2022 ADA Aisle Too Steep-Install New Base Course and Asphalt

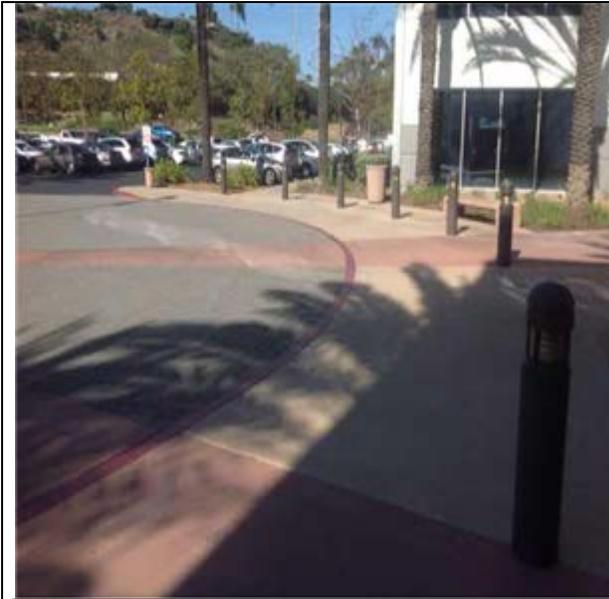
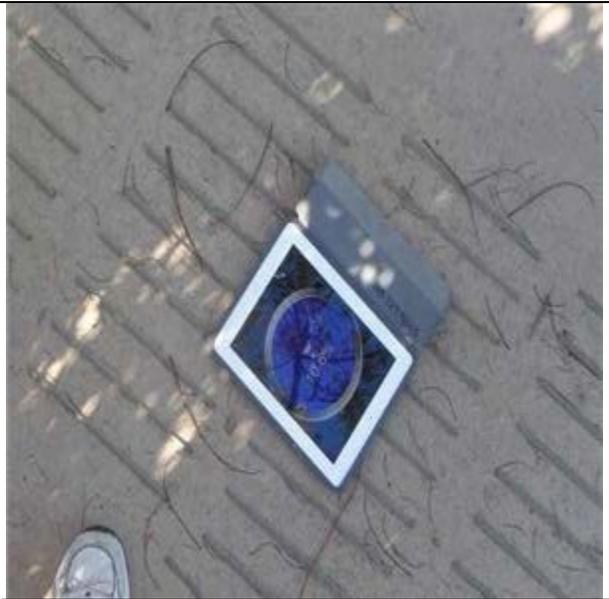
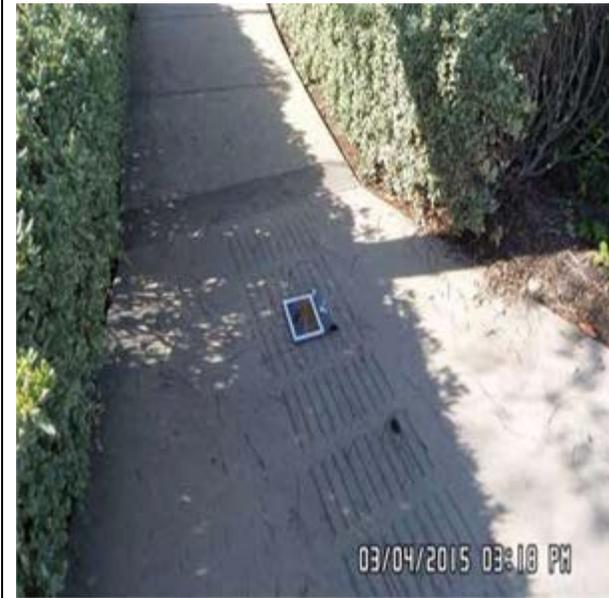
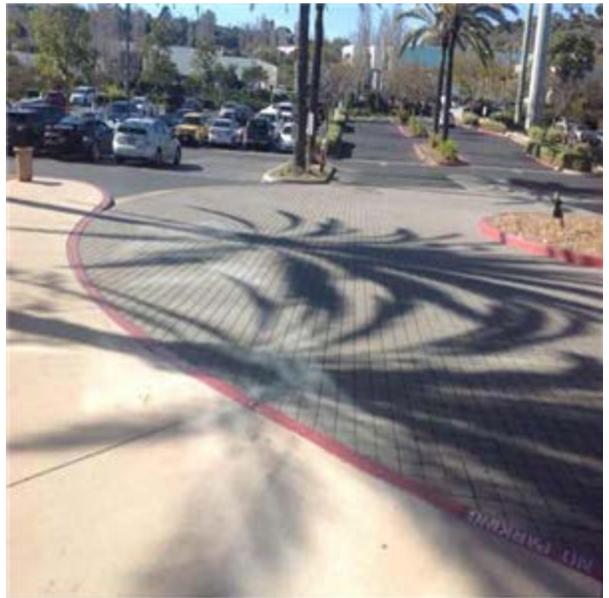
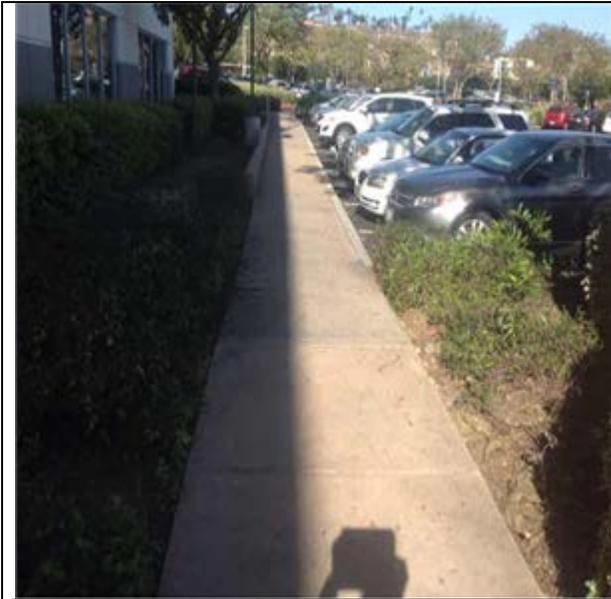
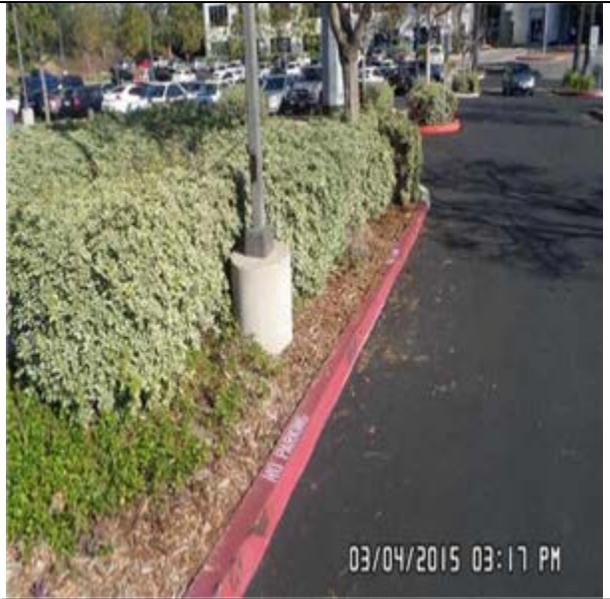
Item	Description
G2031 Paving & Surfacing	G2035 - Install Accessible ramp at path of travel
Condition	Poor
Qty / UOM	25 / LF
RUL (years)	0
Location	ADA Site Walkway

G2035 - Install Accessible ramp at path of travel
