## Justice Joseph A. Rattigan Building (480)

50 D Street, Santa Rosa, CA 95404

### Facility Condition Assessment

September 2015

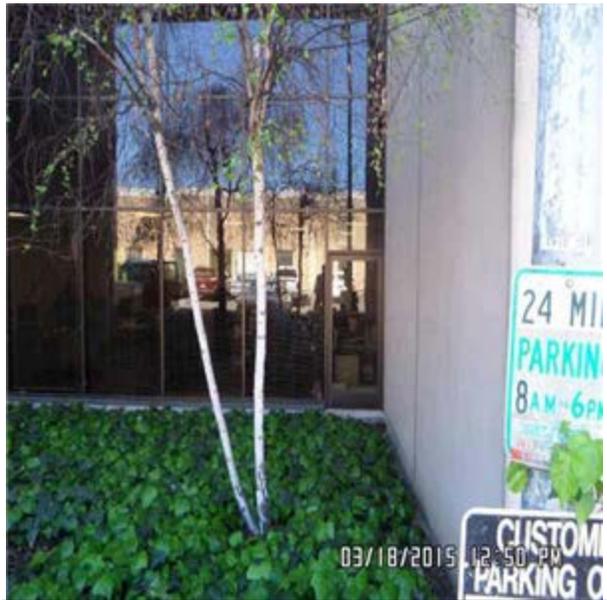
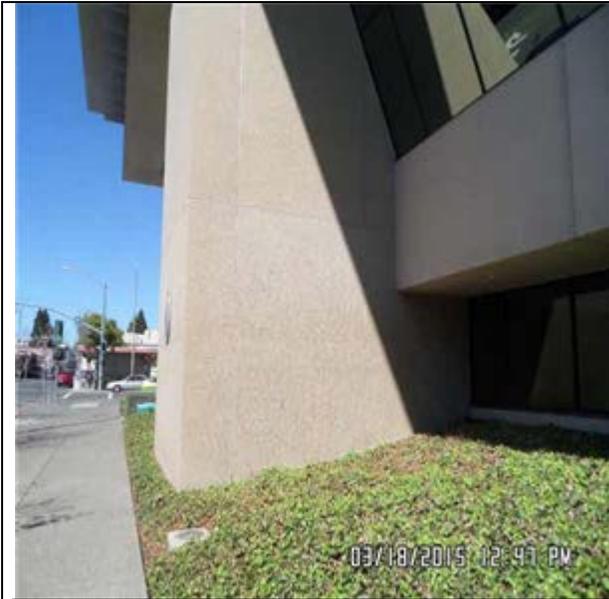
Exterior panels were re-caulked in 2005 and are in good condition.

B2011 Recaulk Exterior Walls

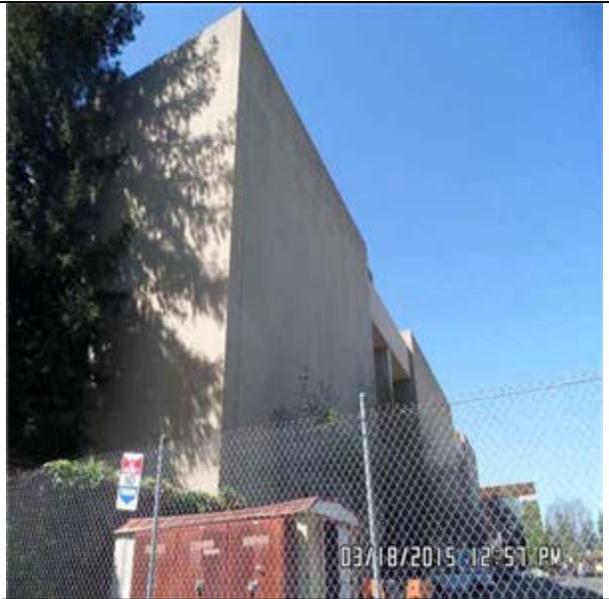
Item	Description
B2011 Exterior Wall Construction	B2011 Paint Stucco and Lath
Condition	Good
Qty / UOM	16,000 / SF
RUL (years)	4
Location	Exterior
Exterior Wall Construction	Stucco
Parapets	Yes

B2011 Paint Stucco and Lath

Type	Component Description	Qty / UOM	Unit Cost (\$)	Plan Type	Priority	Year	Expenditures (\$)
B2011	Replace B2011 Paint Stucco and Lath	16,000.0 - SF	4.6	IN - Beyond Rated Life	Priority 3	2019	73,011

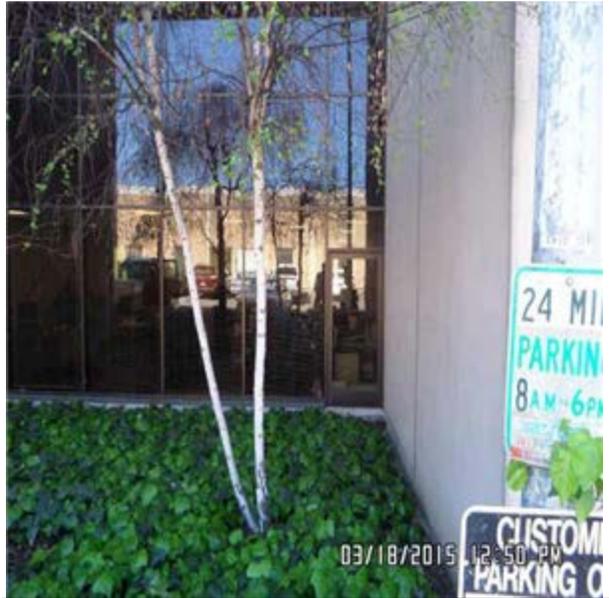
Based on observed conditions, replacement of the windows is not anticipated. Continued maintenance including caulking and weather-stripping replacement will be required,

B2031 Glazed Entrance Doors

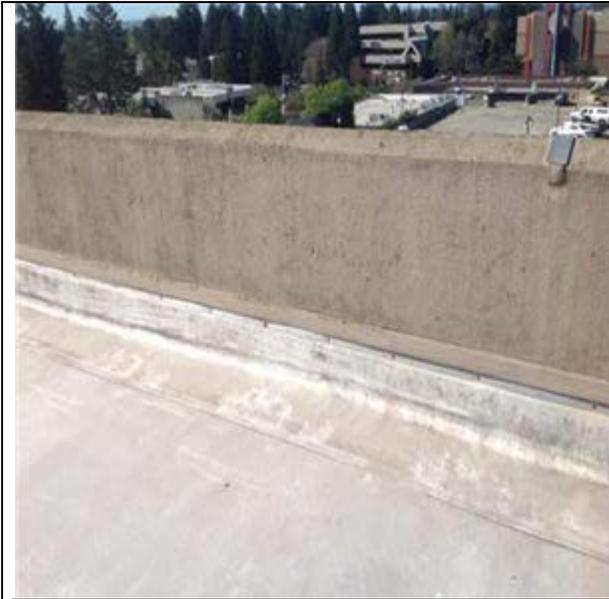
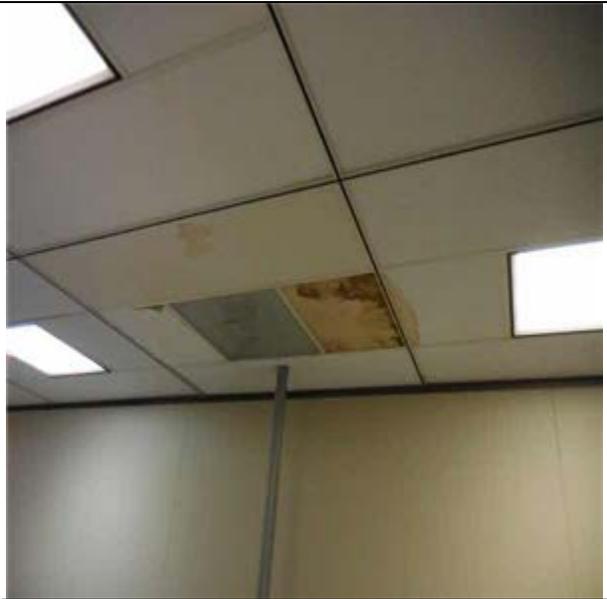
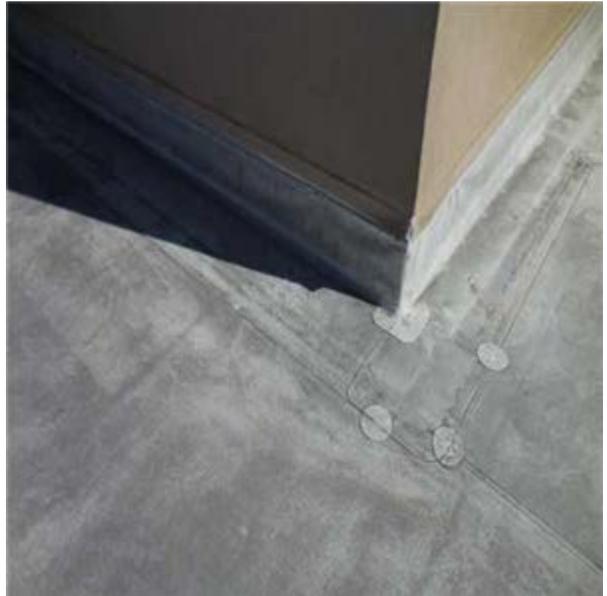
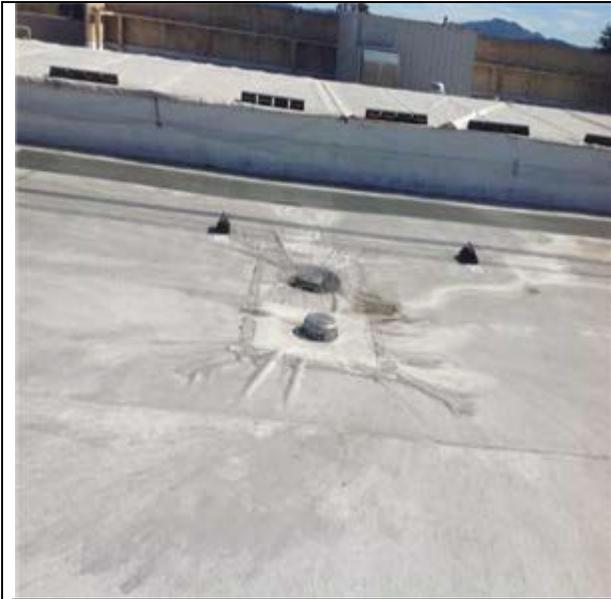
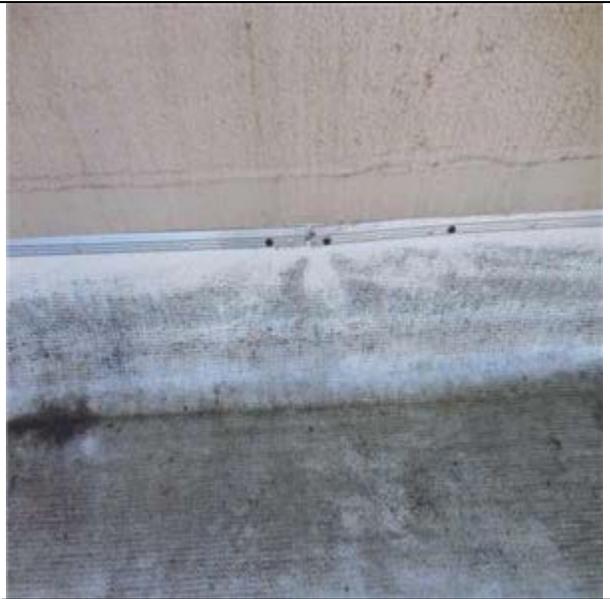
Many leaks were observed and reported, primarily through damaged caulking at roof level ducting. A few gaps in the flashing were observed. The roofing contractor who provided the warranty is out of business. Replacement during the next year is recommended due to continuous leaks.

B3011 PVC Roofing

Type	Component Description	Qty / UOM	Unit Cost (\$)	Plan Type	Priority	Year	Expenditures (\$)
B3011	Replace B3011 PVC Roofing	310.0 - SQ	1499.9	IN - Reliability	Priority 1	2015	464,970

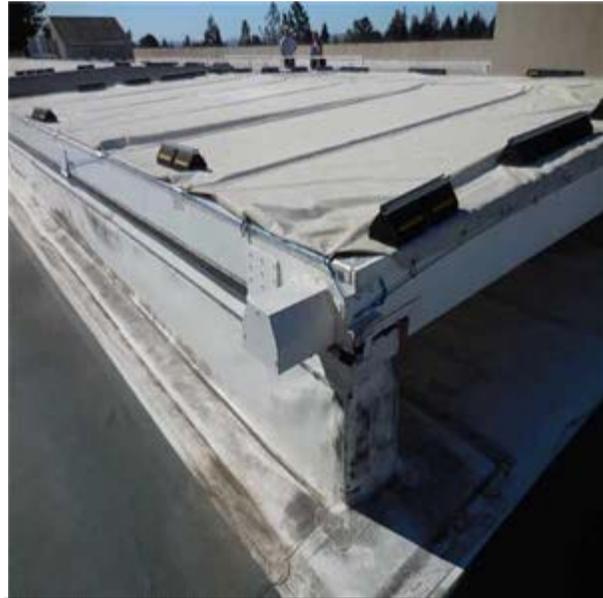
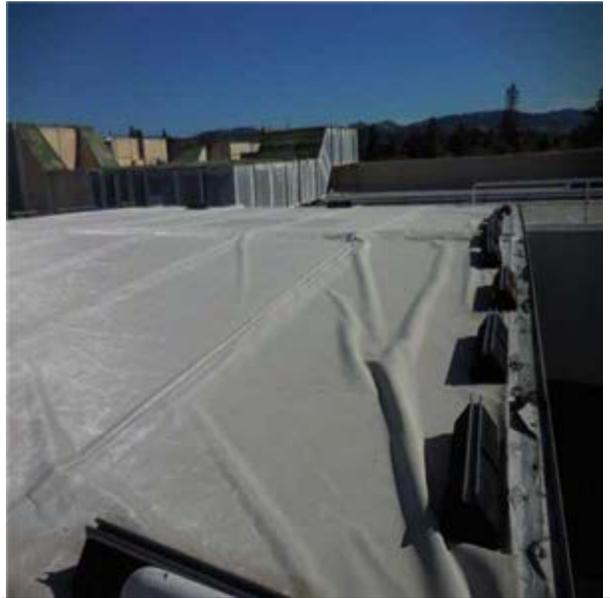
Significant leaking occurs at skylights, namely at the gap between the panels. These are automatic sliding-type skylights.

B3021 Glass Skylight

Type	Component Description	Qty / UOM	Unit Cost (\$)	Plan Type	Priority	Year	Expenditures (\$)
B3021	Replace B3021 Glass Skylight	4,650.0 - SF	114.4	IN - Beyond Rated Life	Priority 1	2015	532,086

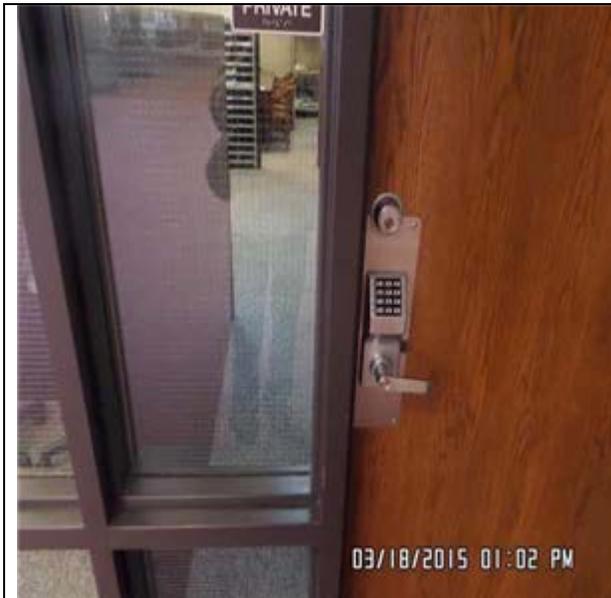
Some interior doors appear to have been replaced. Based on RUL, interior door replacement is anticipated during the assessment period.

C1021 Interior Doors

Type	Component Description	Qty / UOM	Unit Cost (\$)	Plan Type	Priority	Year	Expenditures (\$)
C1021	Replace C1021 Interior Doors	110.0 - EA	2403.1	IN - Beyond Rated Life	Priority 4	2024	264,343

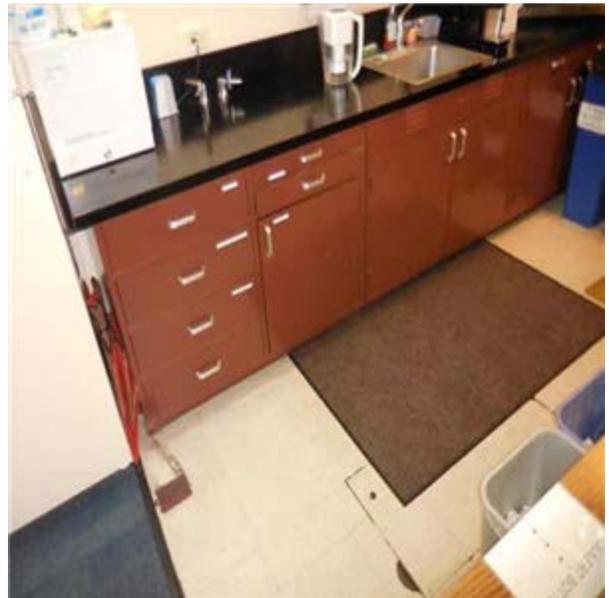
Based on RUL, vinyl tile replacement is anticipated during the assessment period.

C3024 Vinyl Tile

Type	Component Description	Qty / UOM	Unit Cost (\$)	Plan Type	Priority	Year	Expenditures (\$)
C3024	Replace C3024 Vinyl Tile	2,400.0 - SY	125.8	IN - Appearance	Priority 4	2023	301,872

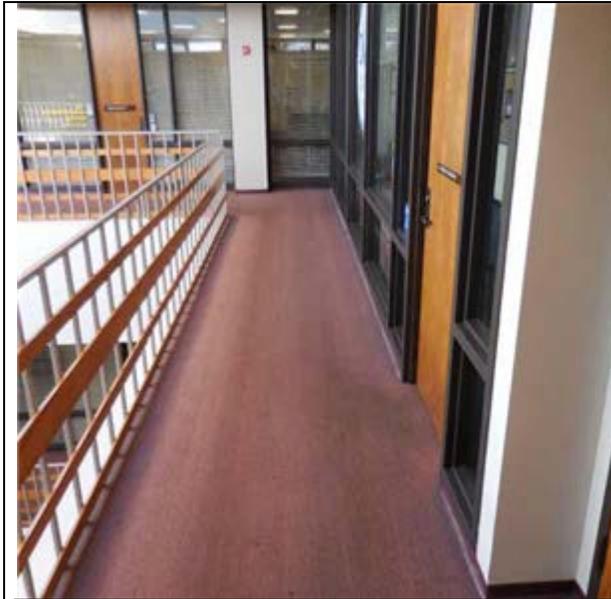
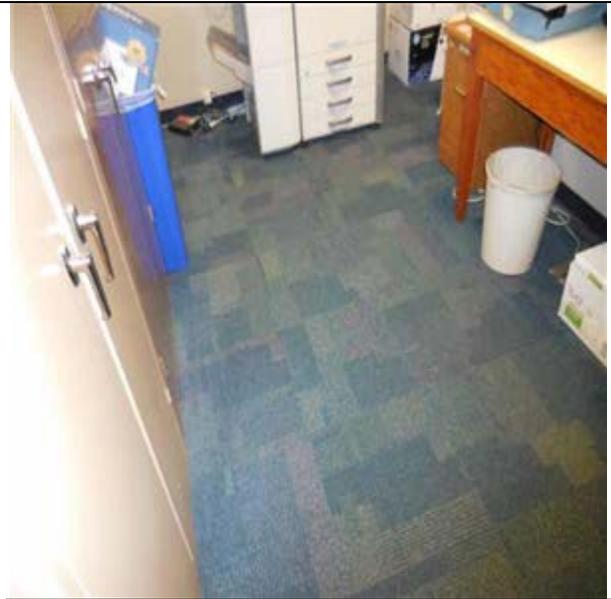
Based on RUL, carpet tile replacement is anticipated during the assessment period.

C3025 Carpet Tiles - Standard

Type	Component Description	Qty / UOM	Unit Cost (\$)	Plan Type	Priority	Year	Expenditures (\$)
C3025	Replace C3025 Carpet Tiles - Standard	7,570.0 - SY	96.6	IN - Appearance	Priority 3	2017	731,304

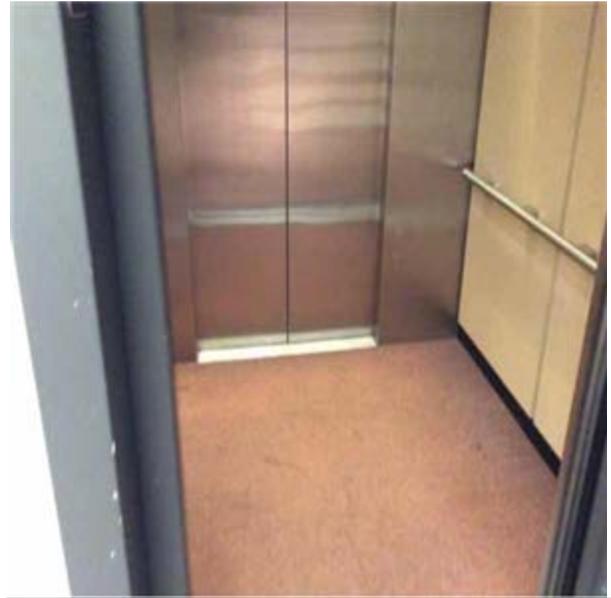
Based on RUL, replacement is anticipated during the reserve term.

D1011 Hydraulic Passenger Elevator 3500 lbs
