Board of Equalization Headquarters Building (028)

450 N Street, Sacramento, CA 95814

Facility Condition Assessment

June 2015

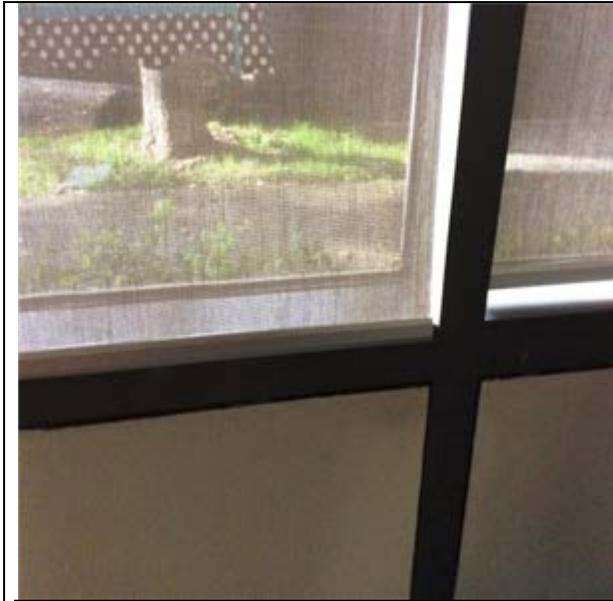
B2021 Spandrel Panels

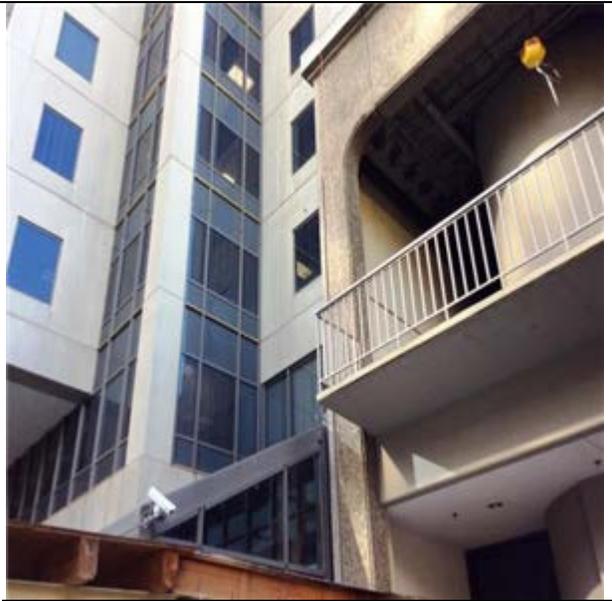
B2021 Spandrel Panels

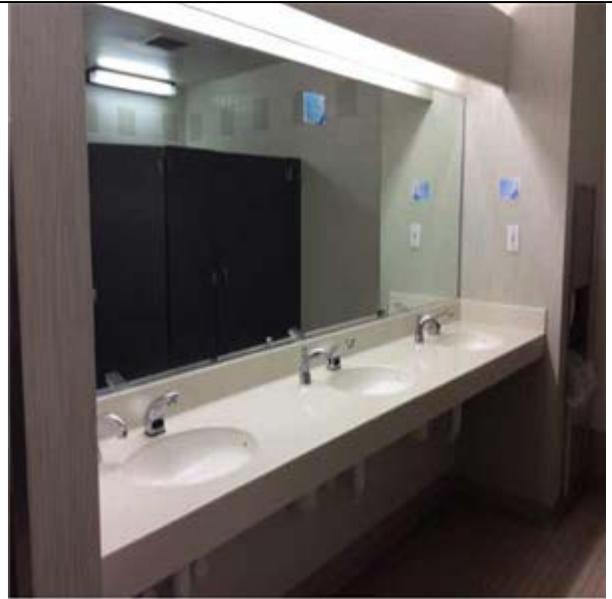
Item	Description
C3005 ADA Renovations	C3005 Restrooms /ADA Renovations
Condition	Poor - Fair
Qty / UOM	52 / EA
RUL (years)	0
Location	All Floors

C3005 Restrooms /ADA Renovations

Type	Component Description	Qty / UOM	Unit Cost (\$)	Plan Type	Priority	Year	Expenditures (\$)
C3005	Replace C3005 Restrooms /ADA Renovations	52.0 - EA	13602.8	CC - Accessibility	Priority 1	2015	707,346

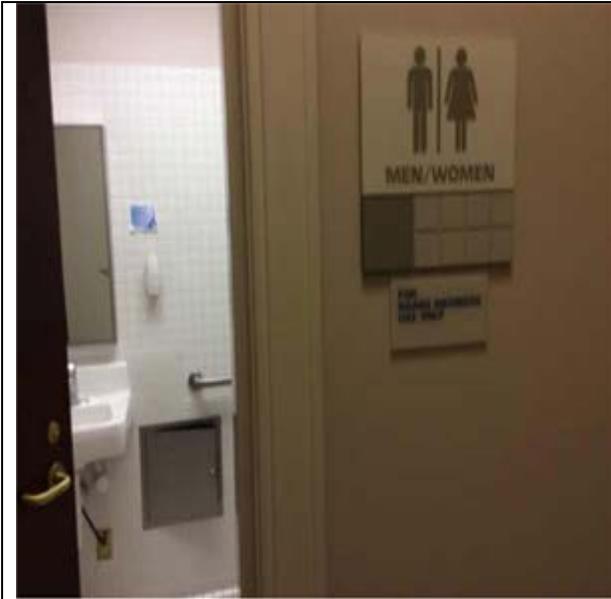
C3005 Restrooms /ADA Renovations

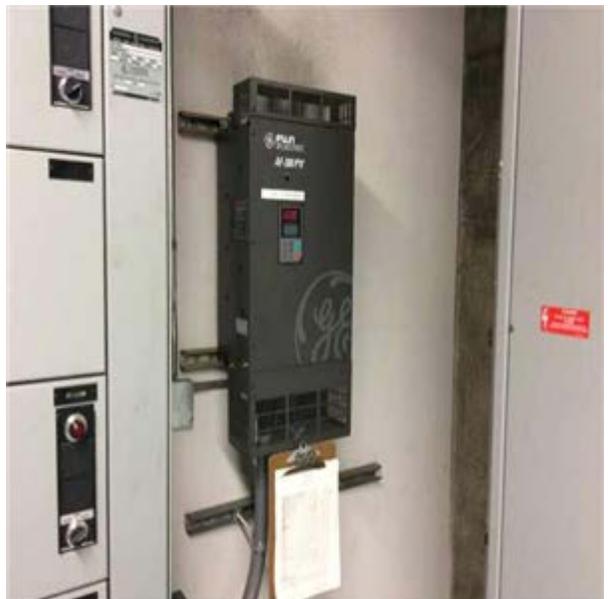
D3063 Variable Frequency Drive, 20 HP Motor:- Older VFD's

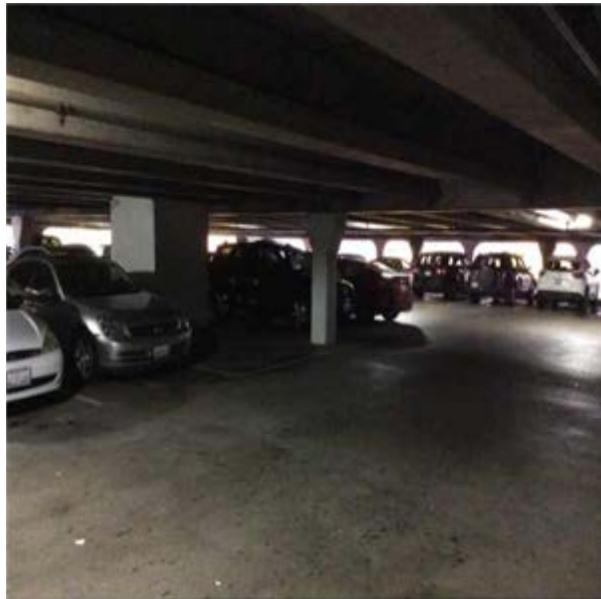
D5022 Inadequate Parking Garage Lighting :- Dark area of parking garage

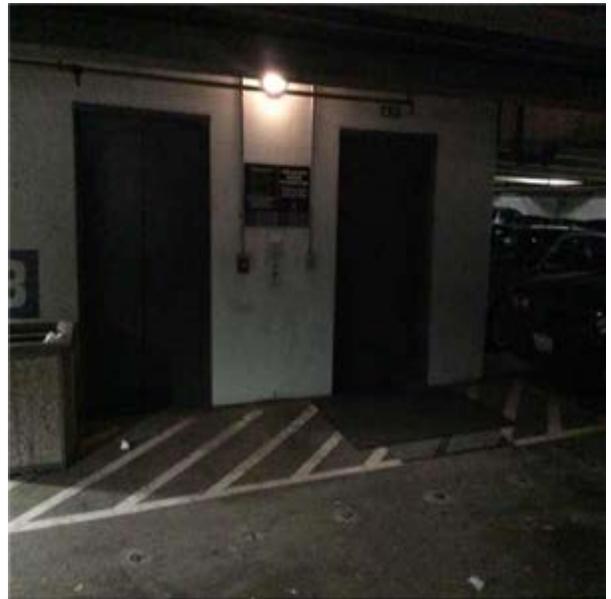
D5022 Inadequate Parking Garage Lighting:- Dark area at parking garage elevator

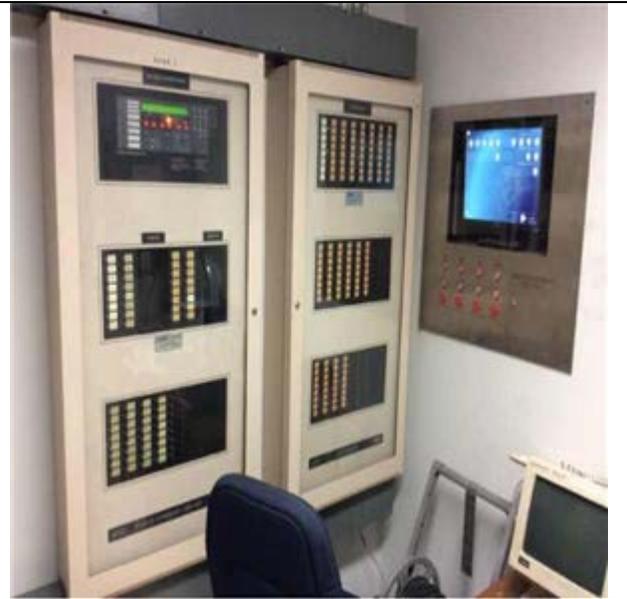
D5037 Fire Alarm System, Modernize:- Original fire alarm panels

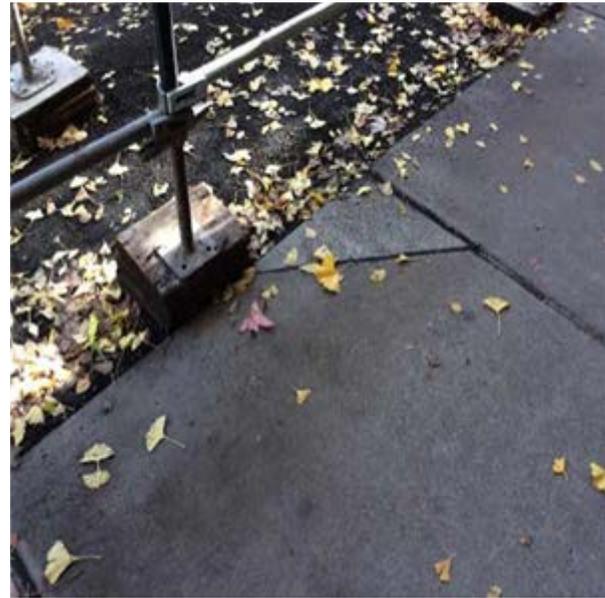
G2031 Concrete Pavement :- Crack at side walk

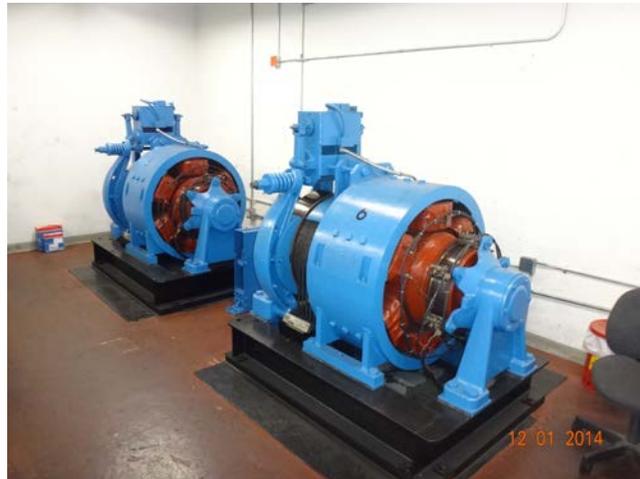
All the high-rise elevators have Dover gearless machines. The machines have D.C. hoist motors and appear to have been refurbished when modernized in the last 4 years. All the machines were found to be in good condition.

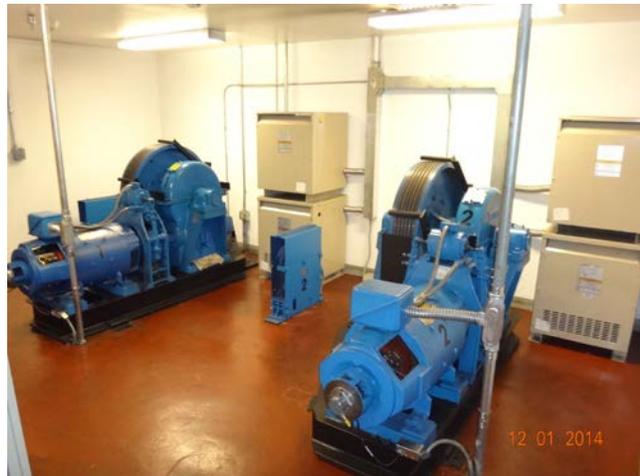
All the low-rise elevators and the service car have Dover geared machines. The machines have the original D.C. hoist motors. All the machines were found to be in good condition.

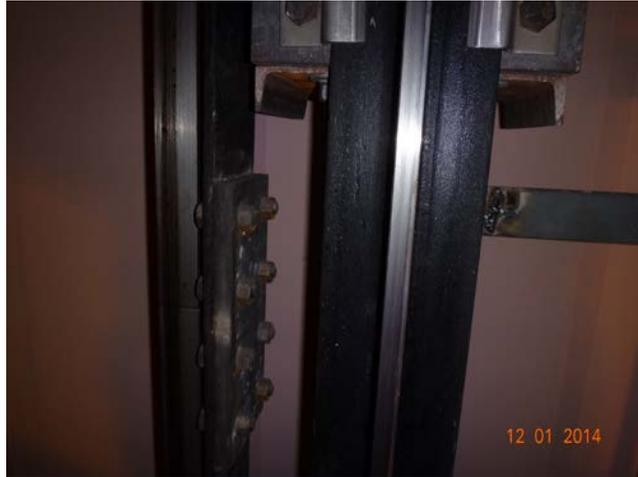
The car rails are in good condition but do not have seismic fish plates. Upgrading the guide rails to current seismic standards is voluntary.

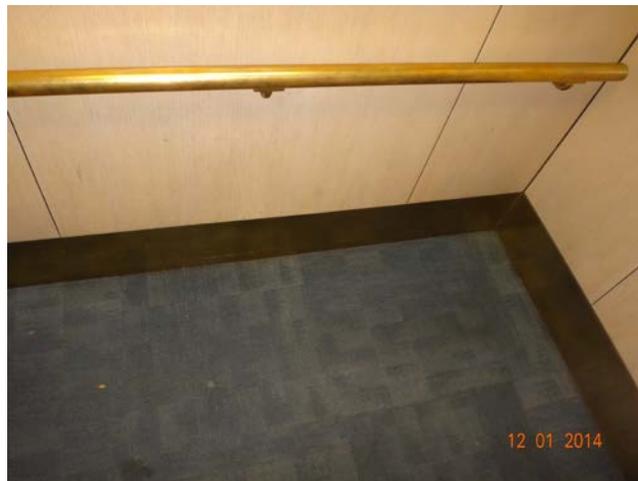
The existing cab interiors are likely original and are in fair condition. The back wall has the code required handrail. The railing heights are in compliance with Title 24 California code.
