Senator William P. Campbell Building California Office of Emergency Services (087)

3650 Schriever Avenue, Mather, CA 95655

Facility Condition Assessment

June 2015

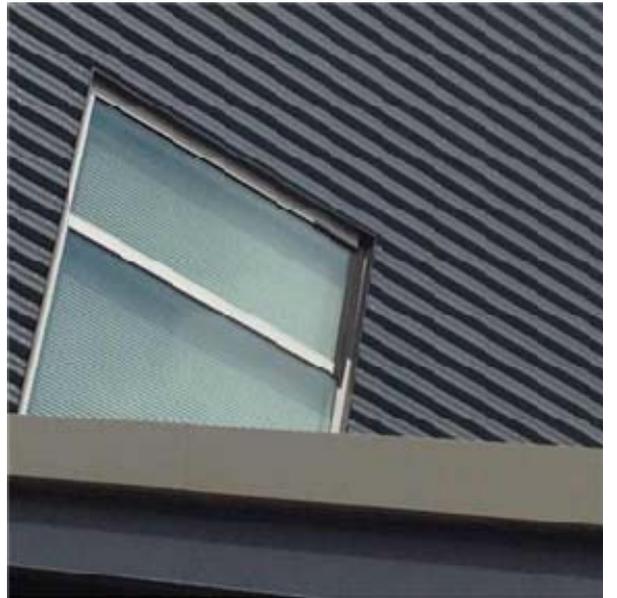
There are three reported active window leaks where gaskets require replacement. There are minimal other areas of gasket shrinkage. Based on these conditions, partial gasket replacement is required.

B2021 Window Gaskets

Type	Component Description	Qty / UOM	Unit Cost (\$)	Plan Type	Priority	Year	Expenditures (\$)
B2021	Repair/ replace gaskets	300.0 - LF	86.8	IN - Beyond Rated Life	Priority 1	2016	26,040

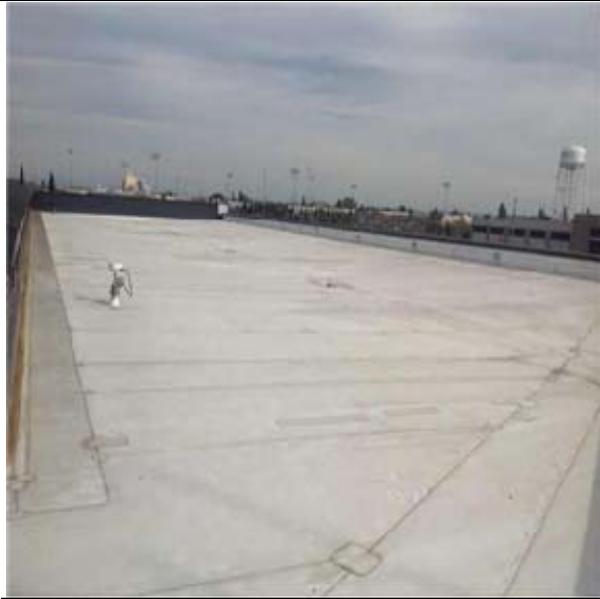
Some small ceiling stains were observed. Roof leaks have reportedly been problematic, notably above server equipment. Repairs should be accomplished on an as-needed basis. Based on the estimated RUL, roof replacement is recommended.

B3011 TPO Roof Replacement

Type	Component Description	Qty / UOM	Unit Cost (\$)	Plan Type	Priority	Year	Expenditures (\$)
B3011	D3011 Repair roof leaks	1.0 - LS	2850.0	OP - Maintenance	Priority 2	2015	2,850
B3011	Replace B3011 TPO Roof Replacement	563.0 - SQ	1697.9	IN - Beyond Rated Life	Priority 3	2020	955,932

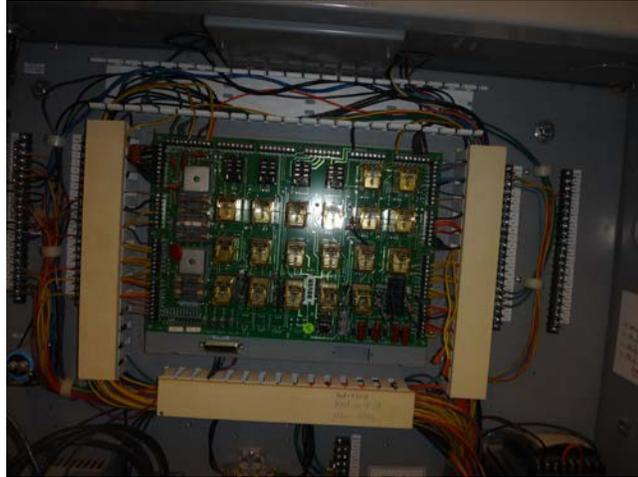
Controllers:

The controllers were manufactured by ThyssenKrupp Elevator when the elevators were installed in 2000. The controllers utilize digital board technology that is known to be reliable. These Dover DMC-1 models are known to be dependable. If properly maintained the controllers should last another 10 years with no major updates.

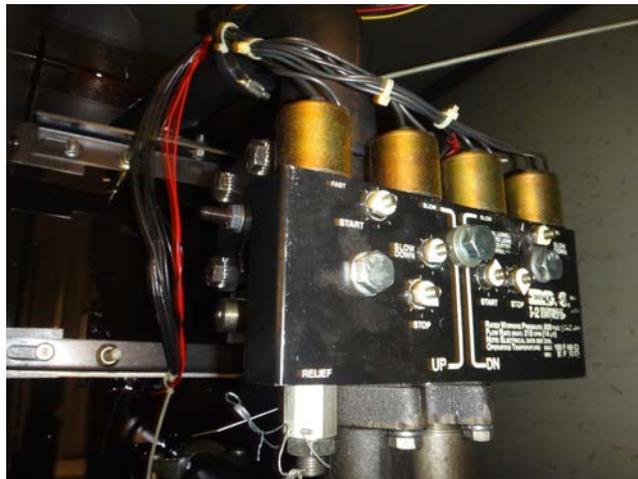
Hydraulic Power Units:

The elevators have TKE power units equipped with a TKE I2 valves and IMO pumps. The power units are in relatively good condition.

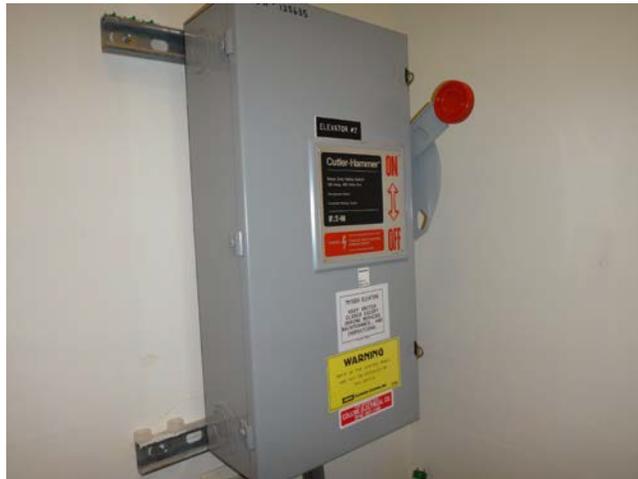
Disconnect:

The elevator disconnects are in good condition and do not need any work. The shunt trip feature is upstream and was being tested while onsite.

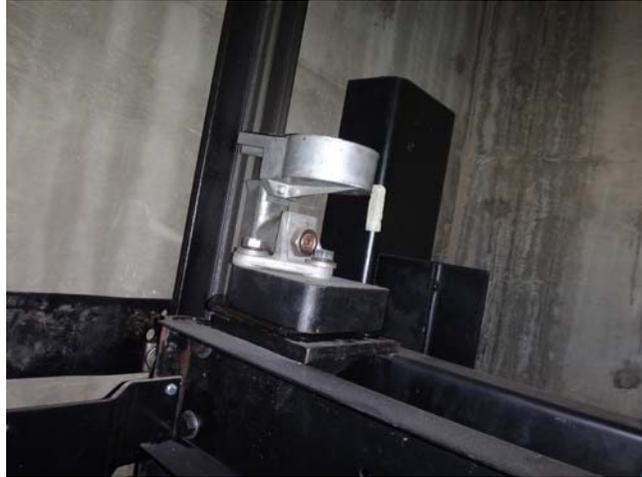
Car Guide Rails:

The car rails are in good condition and have seismic fishplates. No work is anticipated.

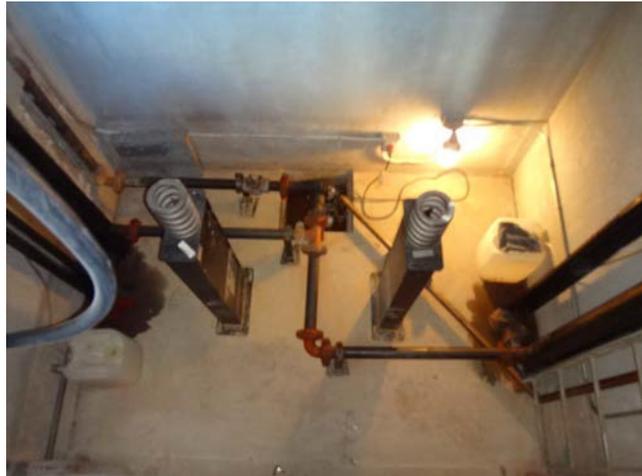
Pits:

The pits are in good condition. The pits are equipped with a seismic rupture valve.

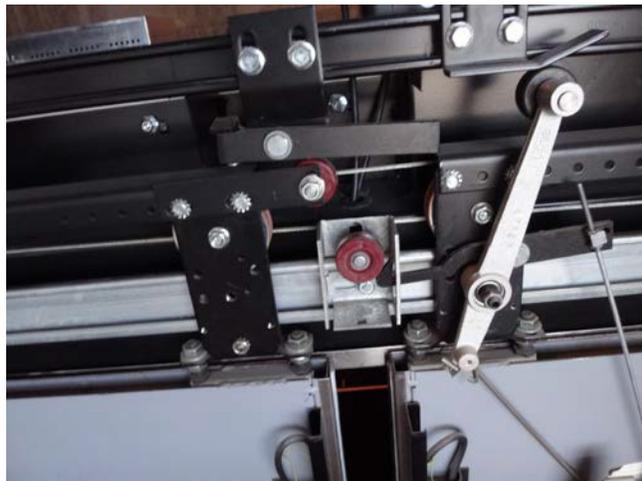
Door Operator:

The door operators are Dover/Thyssen HD-85 models which are known to be reliable and dependable. The door operation was noted to be fair with room for improvement. The elevators have the code required door restrictor, but the north door of Car 2 door restrictor does not catch and should be adjusted.

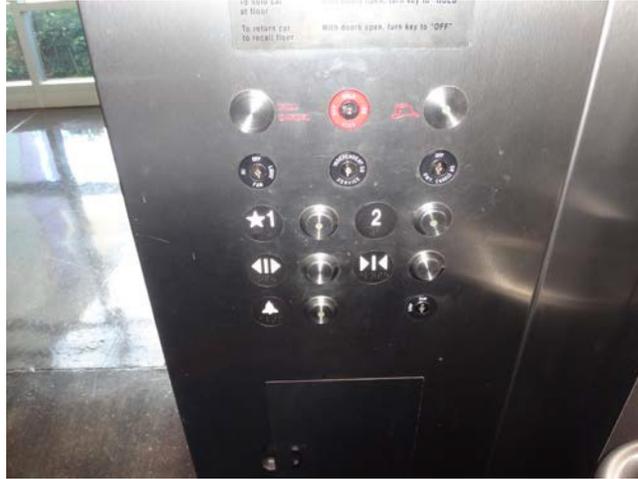
Car Operating Panels:

The elevators have Car Operating Panels (COP) with stainless steel vandal buttons. The panels are in good condition and the buttons comply with ADA and Title 24. No work is needed on the COP.

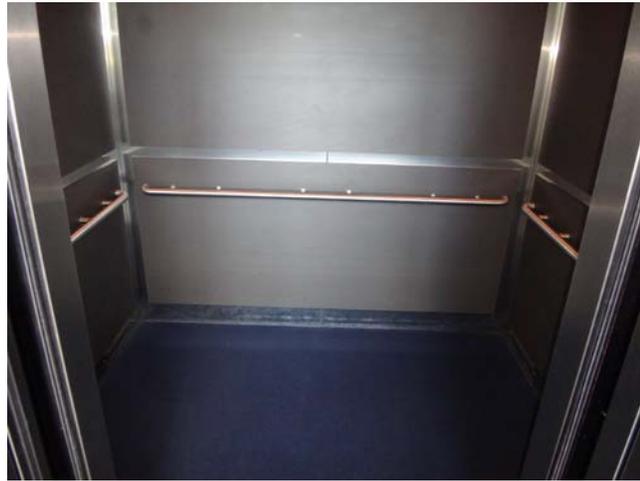
Passenger Wall Finish:

The existing cab interiors are in good condition. The passenger elevator has decorative walls and the sides have the code required handrails. The railing heights are in compliance with Title 24 California code.

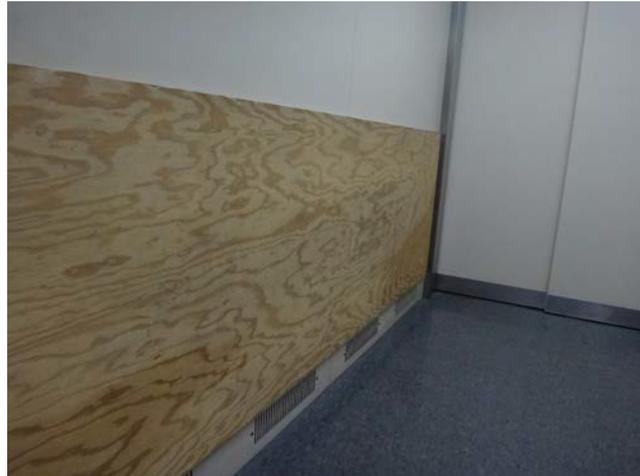
Service Wall Finish:

The service elevator has had the handrails removed and wood paneling added. The wood does not appear to be fire rated. We recommend further review to confirm if the wood is fire rated or not.

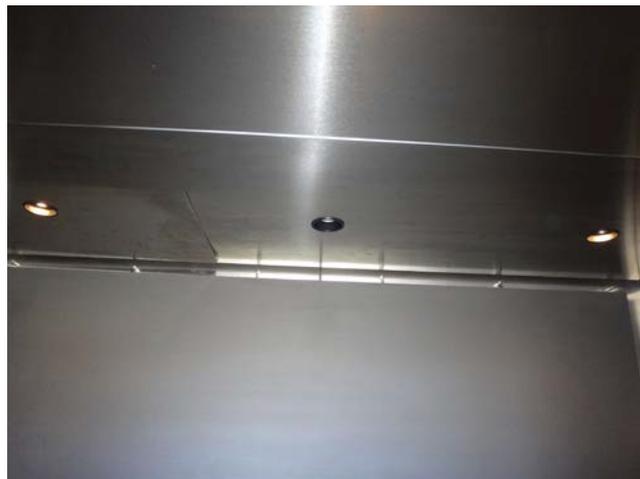
Ceilings:

The ceiling of the service car consists of translucent panels with a T frame design. The appearance is adequate. The passenger car has a down light ceiling that is in good condition.
