East End Complex Block 171 (051)

1501 Capitol Avenue, Sacramento, CA 95814

Facility Condition Assessment

June 2015

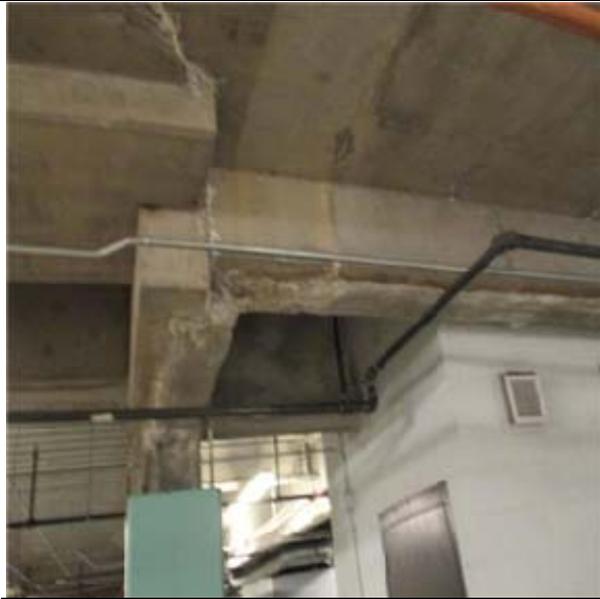
B1032 Concrete Frame Structure, walls

Some water seepage and leakage into the garage is noted. According to the maintenance staff, it is coming from the planters above. Repair is recommended. Refer to the planter cost.

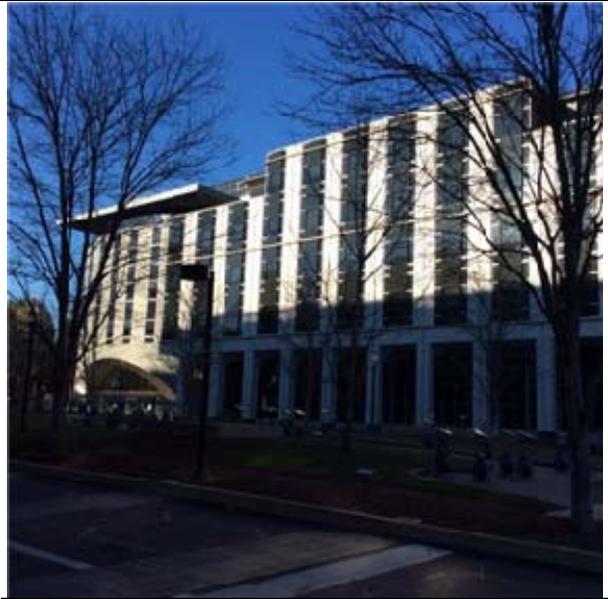
Item	Description
B2011 Exterior Wall Construction	B2011 Precast veneer panels
Condition	Fair
Qty / UOM	22515 / SF
RUL (years)	25
Location	First through sixth floors

Mortar joints between stones are beginning to deteriorate and water penetration is reported. Replacement with a flexible material is recommended.

Type	Component Description	Qty / UOM	Unit Cost (\$)	Plan Type	Priority	Year	Expenditures (\$)
B2011	B2011 Replace exterior sealant	6,000.0 - LF	15.7	OP - Maintenance	Priority 2	2015	93,900

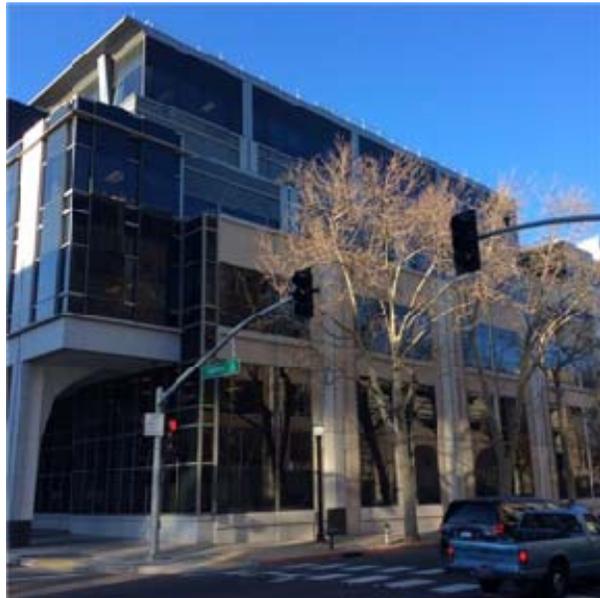
Item	Description
B2022 Curtain Walls	B2022 Curtain Walls
Condition	Fair - Good
Qty / UOM	1000 / SF
RUL (years)	18
Location	Exteriors

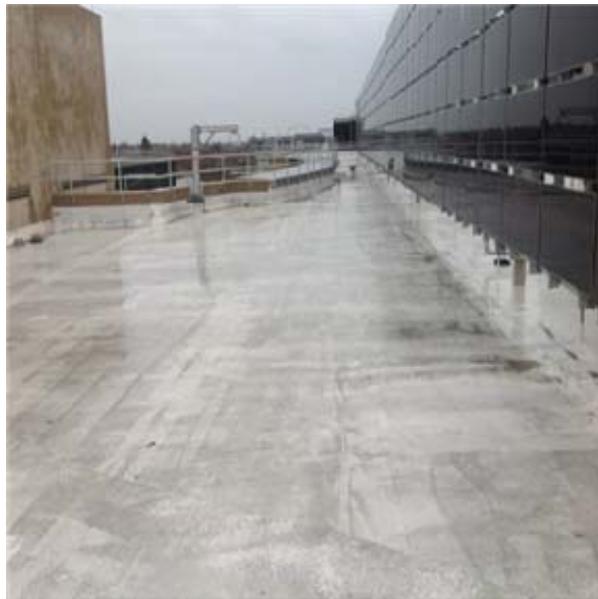
Item	Description
B3011 Roof Finishes	B3011 Liquid Applied Waterproofing
Condition	Fair
Qty / UOM	824 / SQ
RUL (years)	8
Location	Roofs and decks

Based on the estimated RUL, roof finish replacement is recommended.

Type	Component Description	Qty / UOM	Unit Cost (\$)	Plan Type	Priority	Year	Expenditures (\$)
B3011	Replace B3011 Liquid Applied Waterproofing	824.0 - SQ	1806.4	IN - Beyond Rated Life	Priority 4	2023	1,488,439
B3011	B3011 Pressure wash roof	82,380.0 - SF	1.5	IN - Reliability	Priority 4	2023	123,570

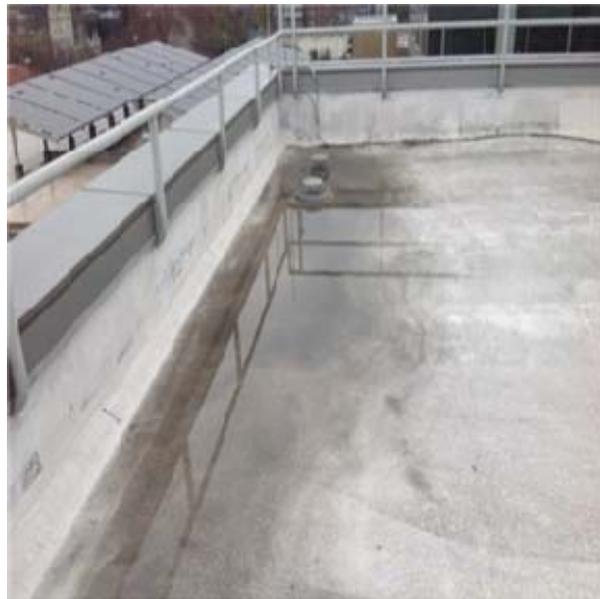
B3014 Coping

The sealant is failing due to birds pecking at it. Patching the sealant will remain a constant maintenance item until the sealant is replaced by a material that is not attractive to birds. Based on the estimated RUL and condition, sealant replacement is anticipated.

Type	Component Description	Qty / UOM	Unit Cost (\$)	Plan Type	Priority	Year	Expenditures (\$)
B3014	B3014 Replace sealant at coping	2,100.0 - LF	15.7	OP - Maintenance	Priority 3	2018	32,865

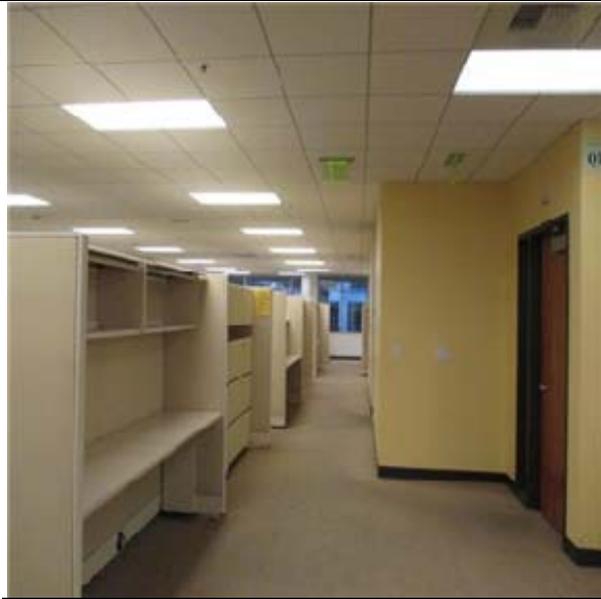
Item	Description
C1021 Interior Doors	C1021 Fire Door, Wood, Flush, 60 Minute, Incl. Demo, with Hardware
Condition	Fair
Qty / UOM	190 / EA
RUL (years)	12
Location	Doors to corridors, offices

C1021 Fire Door, Wood, Flush, 60 Minute, Incl. Demo, with Hardware :- Door to corridor

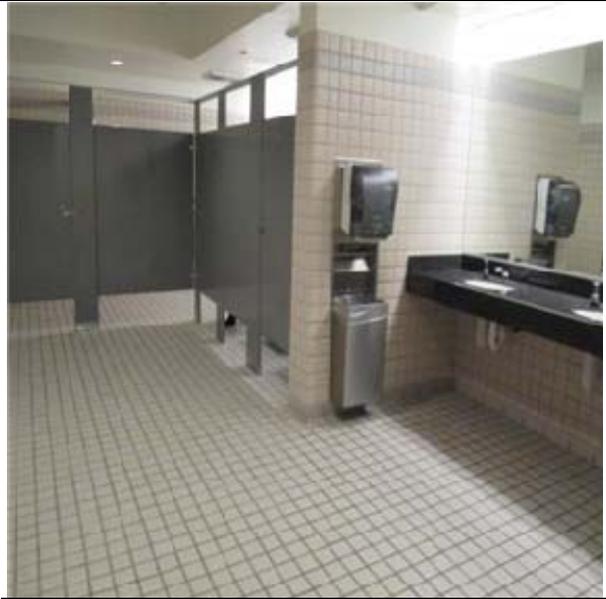
Item	Description
C1031 Fabricated Toilet Partitions	C1031 Fabricated Toilet Partitions
Condition	Fair - Good
Qty / UOM	84 / EA
RUL (years)	7
Location	Restrooms

C1031 Fabricated Toilet Partitions:- Interior of restroom

Based on the estimated RUL, replacement of toilet partitions is anticipated.

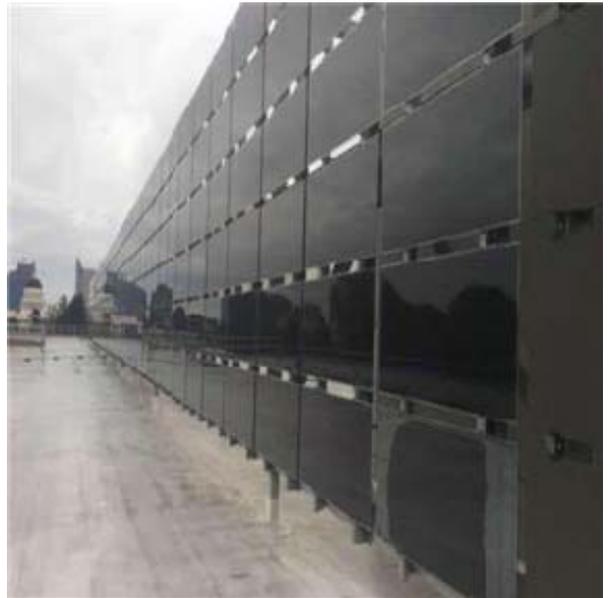
D3016 Solar Panels 2' x 4':- Lower right panel has failed

- The mortar joints between the precast veneer panels are beginning to deteriorate, and water penetration is reported. Replacement with a flexible sealant is recommended.
- Repair and replace non-working panels in the rooftop photovoltaic system.
- There are trip hazards at the main entry and sidewalk corners, related to the decorative stone installed adjacent to the walkways.
- Water is seeping into the underground parking garage from planters located at the Department of Health Care Services Headquarters.

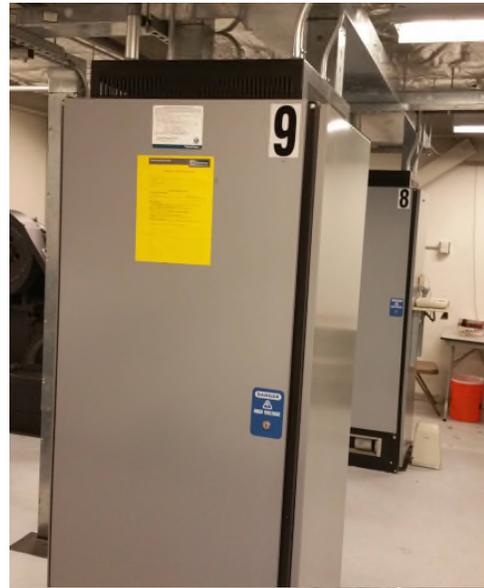
Controllers:

The controllers were manufactured and installed by TKE in 2003/2003. The controllers are TKE's TAC 50 which are known to be a reliable elevator system.

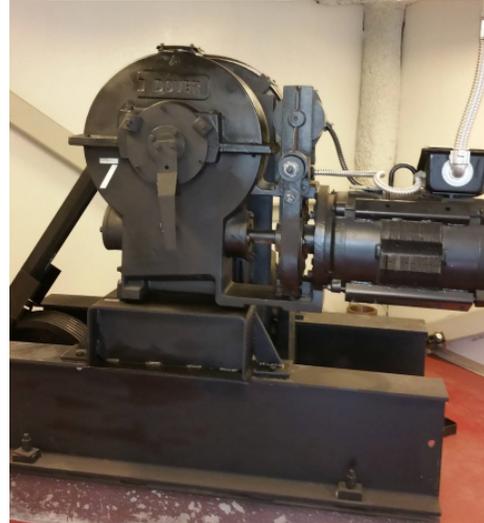
Machines:

All the traction elevators have TKE geared hoist machines that were found to be in good to excellent condition. The machines have AC hoist motors and the sheaves have seismic rope guards.

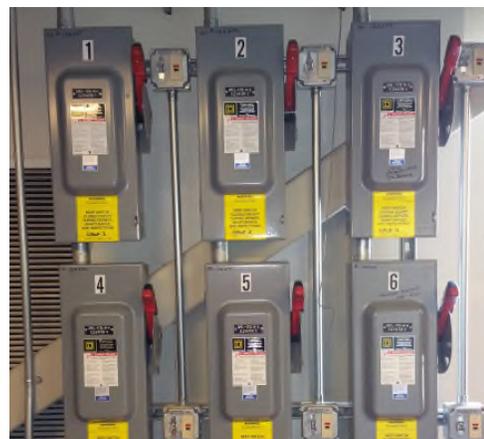
Mainline Disconnect:

The elevators have code complying disconnects that are in good condition. No work is anticipated.

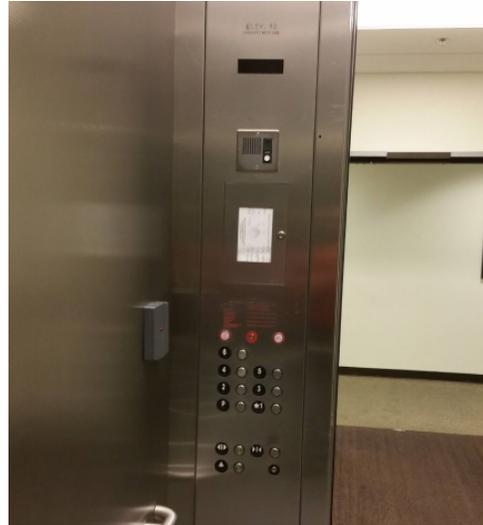
Car Operating Panels:

All the Car Operating Panels (COP's) are original. The panels are in good condition and meet all ADA and T24 however. The buttons are stainless steel and high quality.

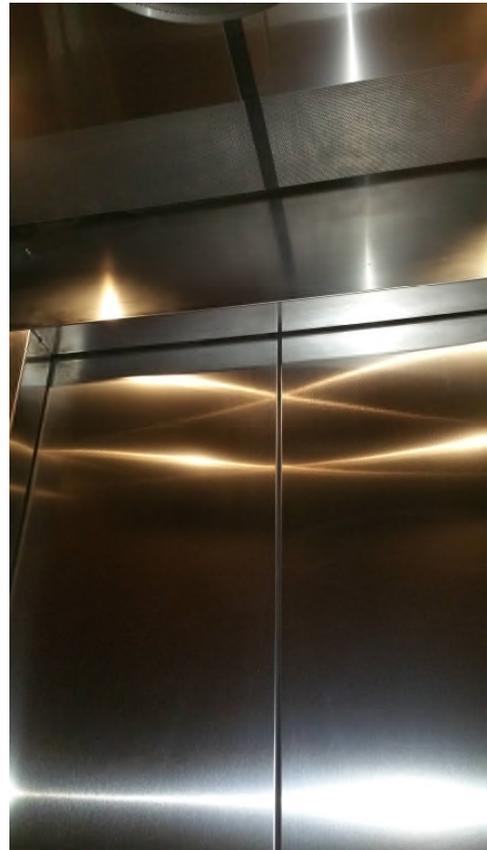
Ceilings:

The passenger elevators have decorative stainless steel ceilings with incandescent light fixtures. The light fixtures could be updated with energy efficient LED's and/or the entire ceiling could be replaced.
