Franchise Tax Board San Diego Building (084)

9645 Butterfield Way, Rancho Cordova, CA 95827

Facility Condition Assessment

June 2015

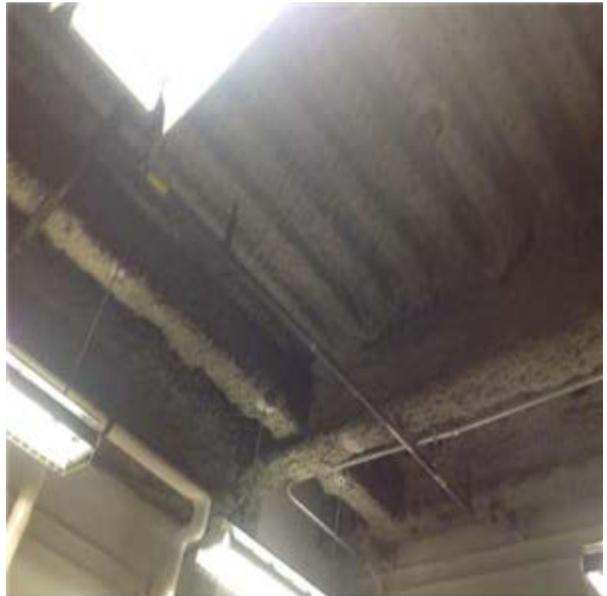
The roof framing is in good condition.

B1021 Roof Structure:- first level

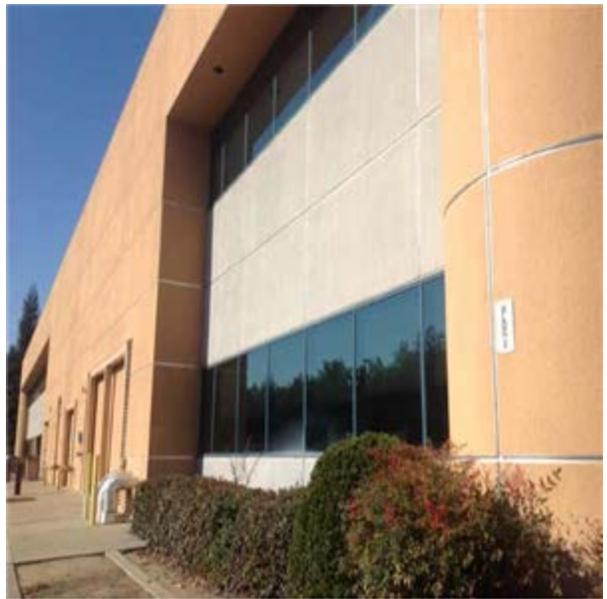
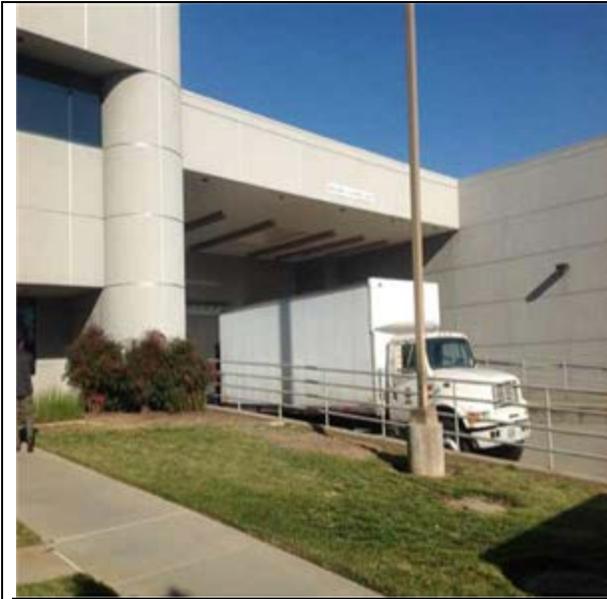
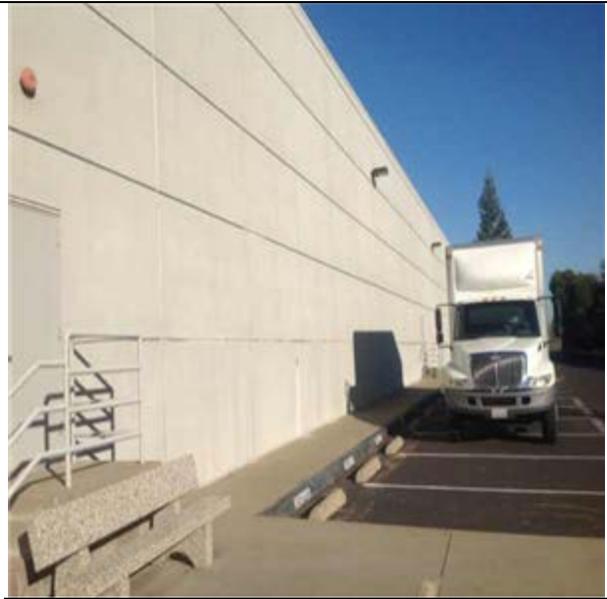
Item	Description
B2011 Exterior Wall Construction	B2011 Stucco Exterior Walls
Condition	Fair - Good
Qty / UOM	56500 / SF
RUL (years)	3
Location	Building exterior
Exterior Wall Construction	Stucco
Exterior Soffits	Concealed

B2011 Stucco Exterior Walls

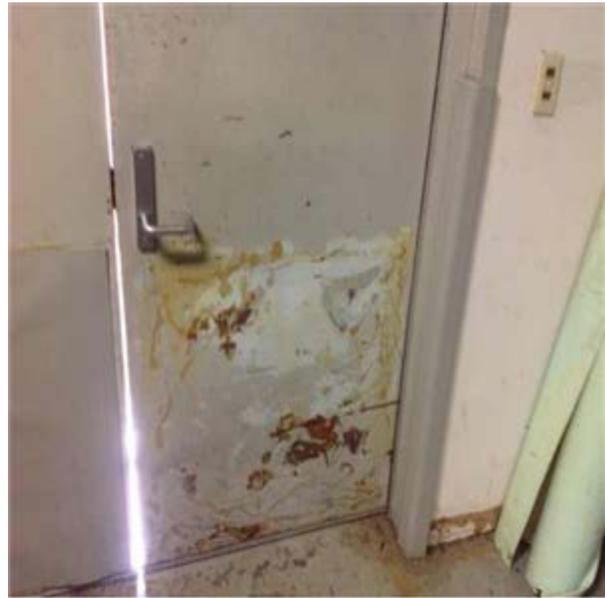
Item	Description
B2032 Solid Exterior Doors	B2032 Solid Exterior Doors, Metal
Condition	Poor - Fair
Qty / UOM	3 / EA
RUL (years)	0
Location	Building exterior
Door Hardware	Lever
Door Operation	Manual
Core Type	Hollow Core
Door Frame	Metal Framed

Some of the exterior doors are showing visible signs of wear and corrosion, with loss of metal. Replacement is recommended.

B2032 Solid Exterior Doors, Metal:- B2032 Rust at Utility Room Door

Type	Component Description	Qty / UOM	Unit Cost (\$)	Plan Type	Priority	Year	Expenditures (\$)
B2032	Replace B2032 Solid Exterior Doors, Metal	3.0 - EA	6149.4	IN - Beyond Rated Life	Priority 1	2015	18,448

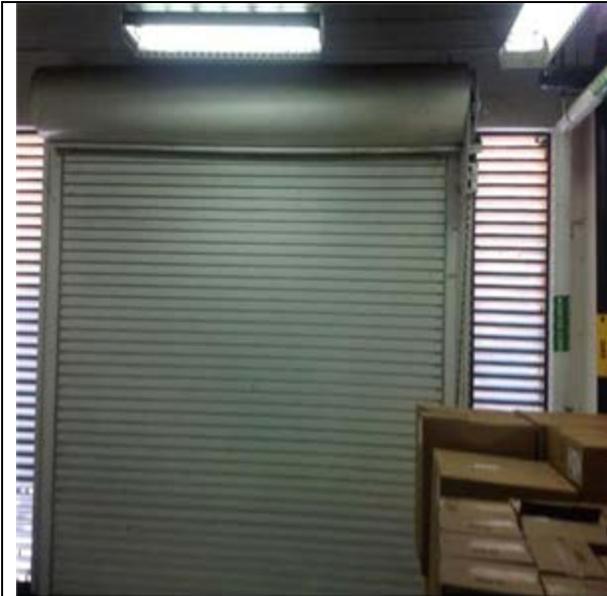
The steel coiling door is in good condition.

B2034 Steel Coiling Overhead Doors

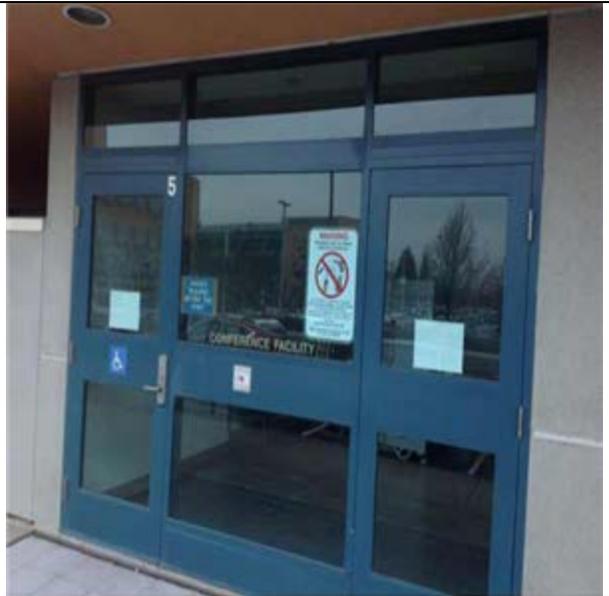
The aluminum storefront entrance doors are in good condition.

B2039 Aluminum Storefront Entrance Doors

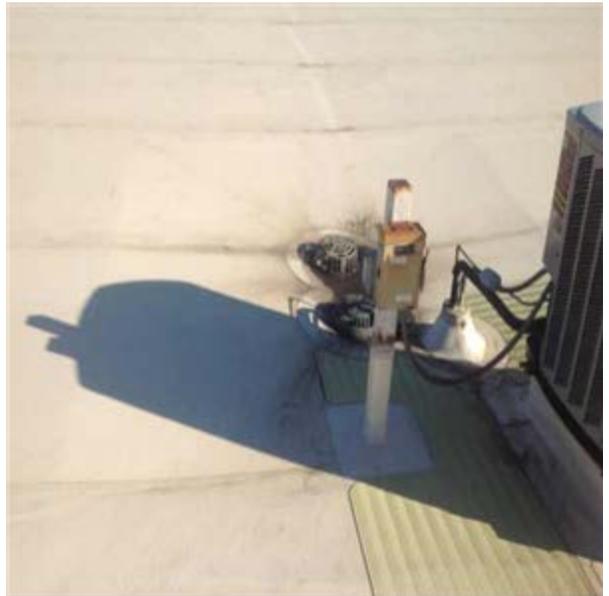
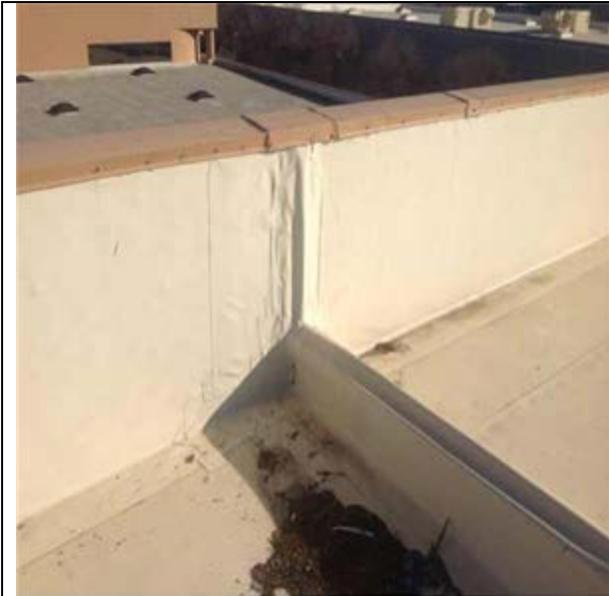
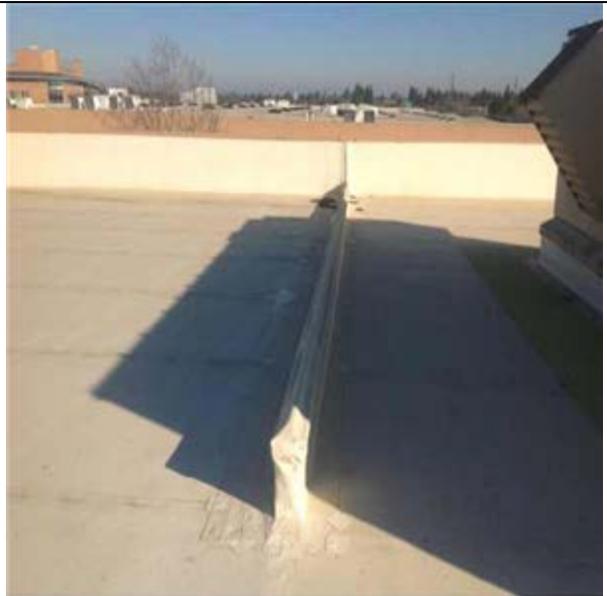
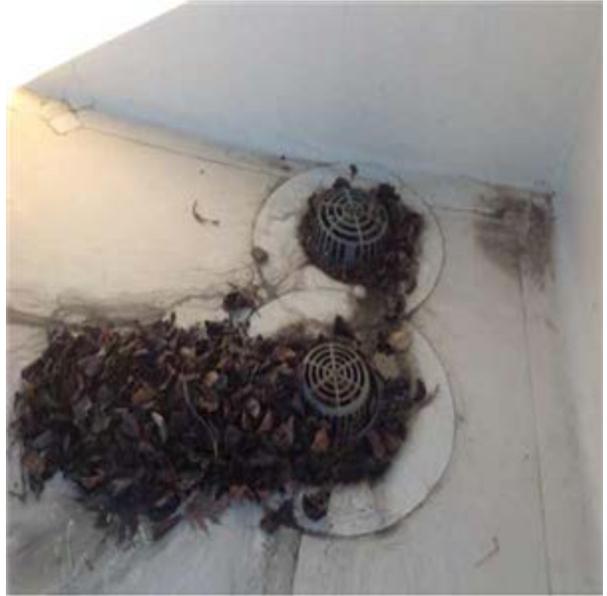
The roof is reportedly only one year old. Cleaning of debris and roof drains is recommended as normal operation and maintenance . The roof is in good condition. Lifecycle will be required in the long term. No further costs have been included.

B3011 TPO Single Ply Membrane

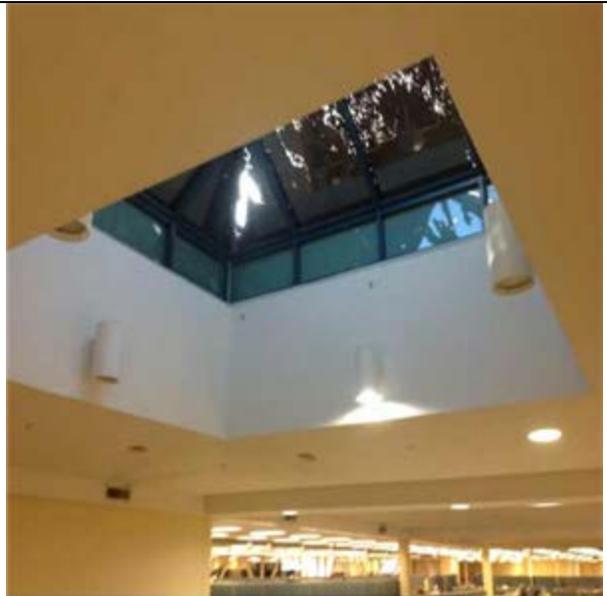
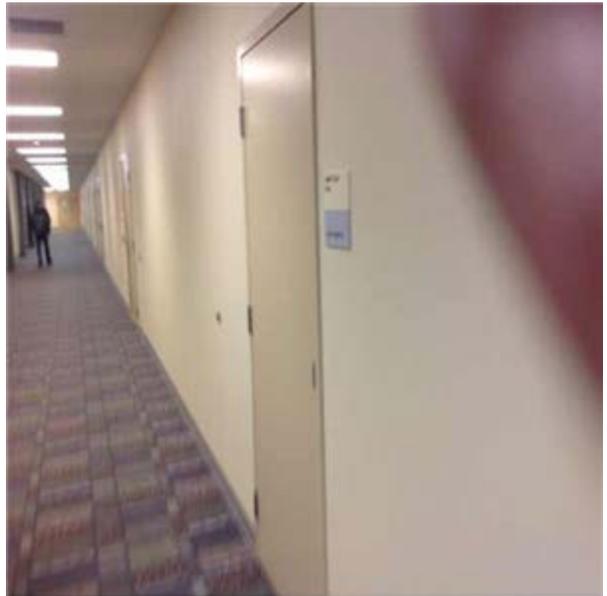
Item	Description
B3021 Glazed Roof Openings	B3021 Glass Skylight
Condition	Poor
Qty / UOM	900 / SF
RUL (years)	3
Location	Roof
Roof Opening Operation	Fixed

B3021 Glass Skylight

Type	Component Description	Qty / UOM	Unit Cost (\$)	Plan Type	Priority	Year	Expenditures (\$)
B3021	Replace	900.0 - SF	112.2	IN - Appearance	Priority 3	2018	100,976

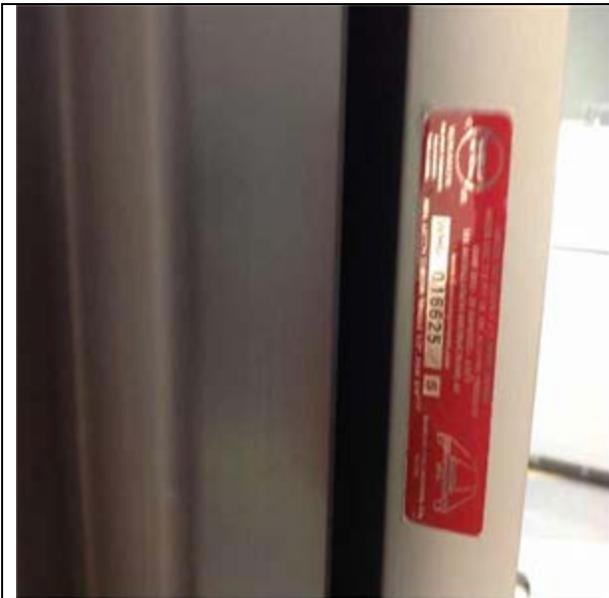
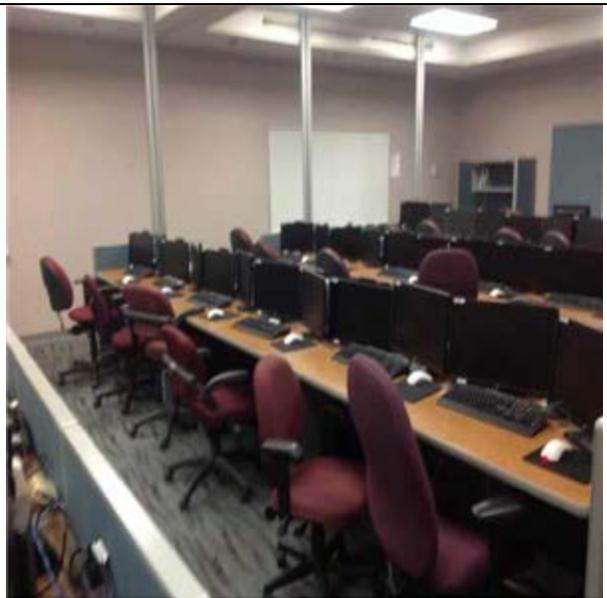
Interior fire rated doors are in fair condition.

C1021 Interior Doors

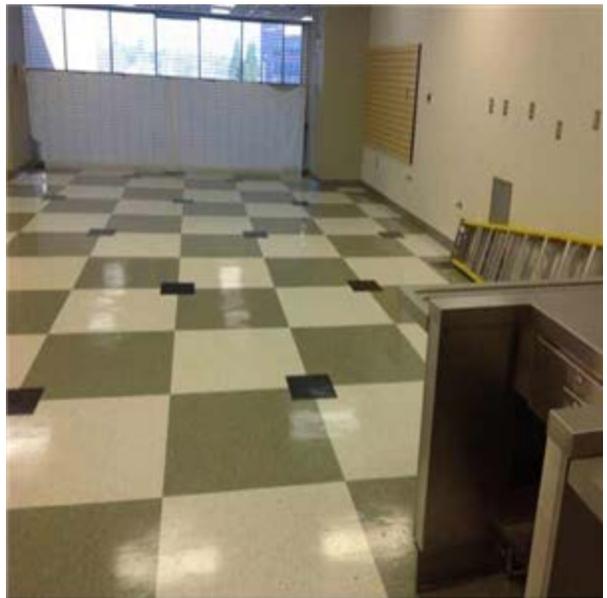
Item	Description
C3012 Wall Finishes to Interior Walls	C3012 Paint Interior Walls
Condition	Good
Qty / UOM	57000 / SF
RUL (years)	4
Location	Throughout interior

C3012 Paint Interior Walls

Type	Component Description	Qty / UOM	Unit Cost (\$)	Plan Type	Priority	Year	Expenditures (\$)
C3012	Replace C3012 Paint Interior Walls	57,000.0 - SF	2.1	IN - Appearance	Priority 3	2019	121,570

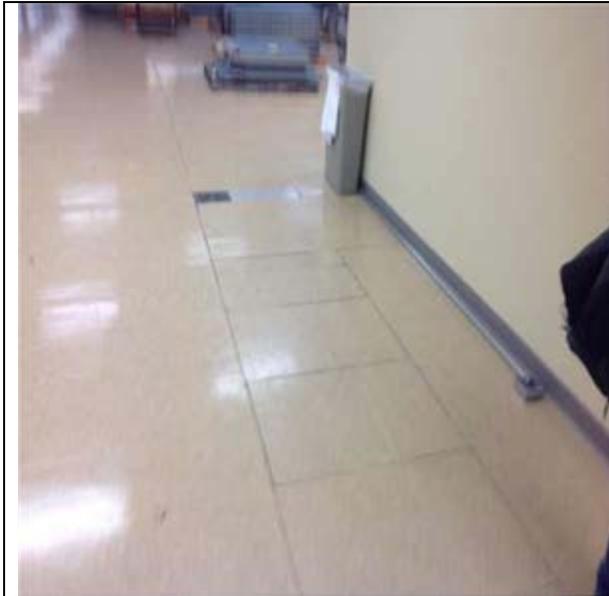
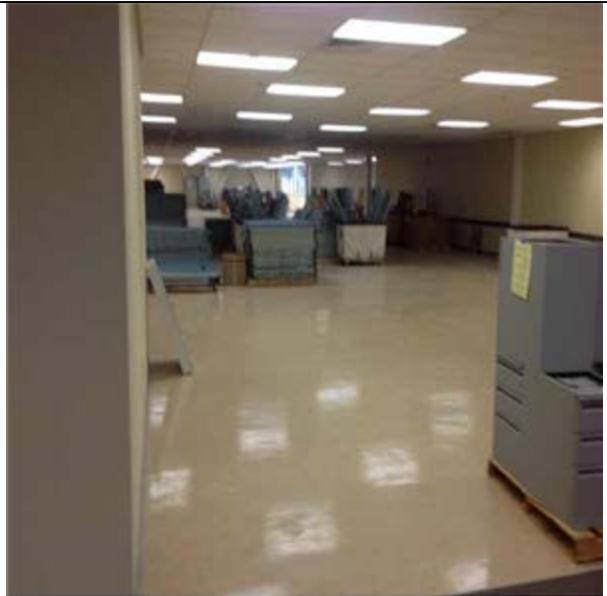
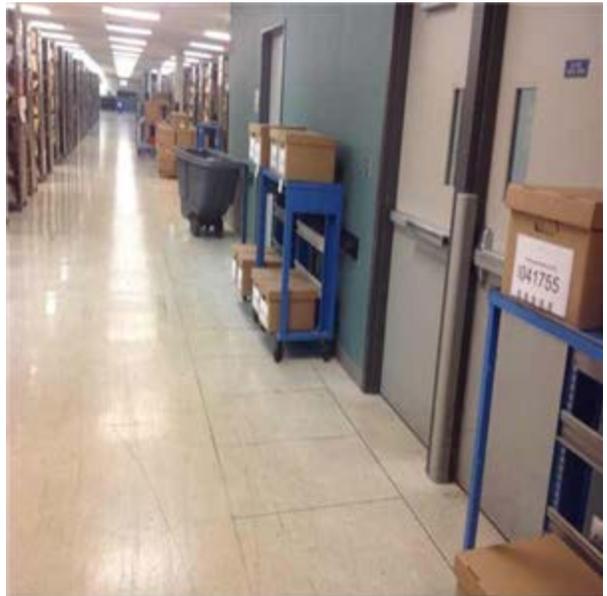
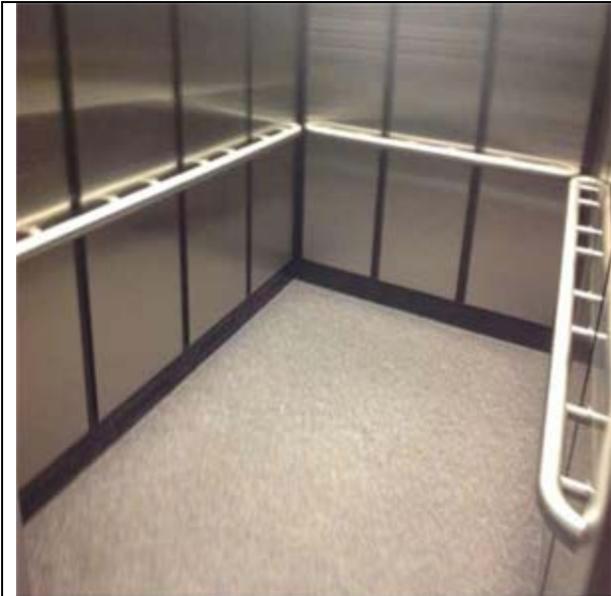
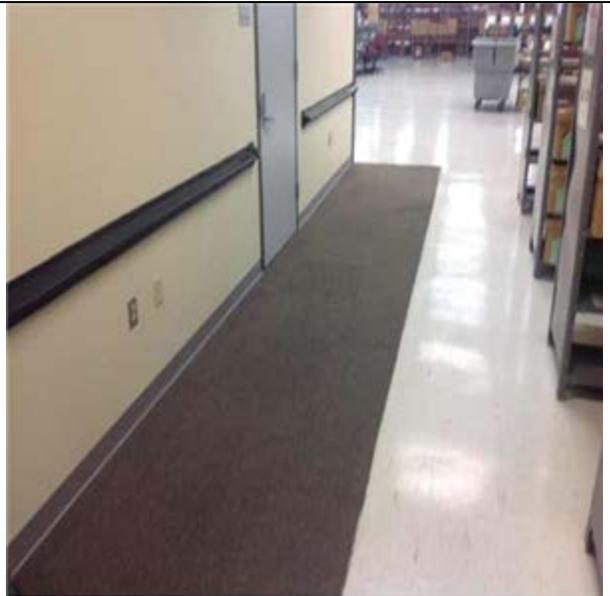
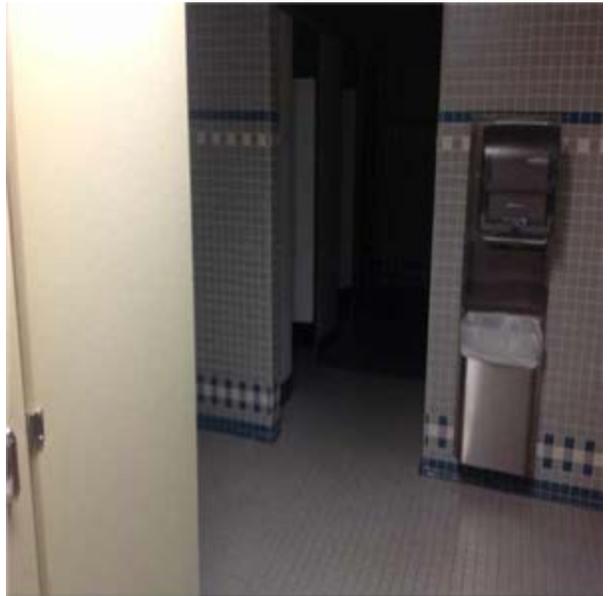
Based on its estimated RUL, vinyl floor tile replacement is anticipated.

C3024 Vinyl Floor Tile

Type	Component Description	Qty / UOM	Unit Cost (\$)	Plan Type	Priority	Year	Expenditures (\$)
C3024	Replace C3024 Vinyl Floor Tile	23,400.0 - SY	125.8	IN - Appearance	Priority 3	2019	2,943,257

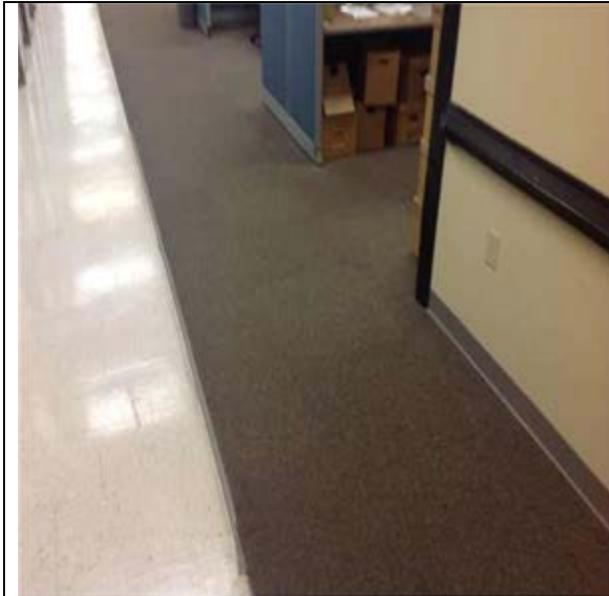
The older carpet is worn and faded. Replacement is recommended.

C3025 Carpet Tiles - older

Type	Component Description	Qty / UOM	Unit Cost (\$)	Plan Type	Priority	Year	Expenditures (\$)
C3025	Replace C3025 Carpet Tiles - older	6,000.0 - SY	96.6	IN - Appearance	Priority 2	2015	579,634

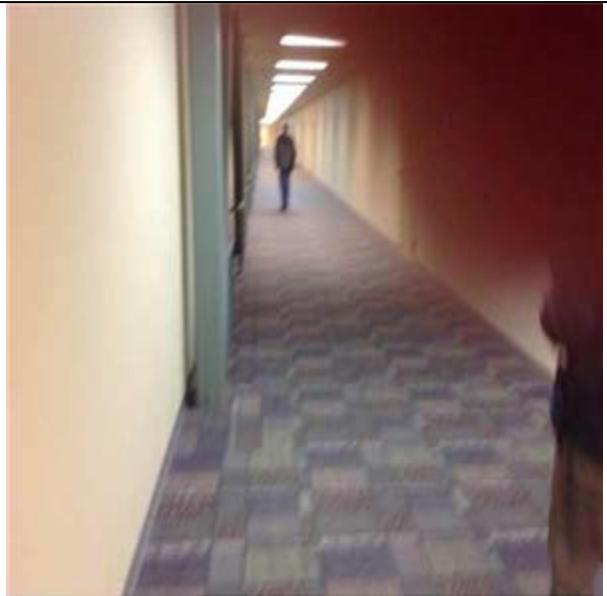
Based on its RUL, carpet tile replacement is anticipated during the assessment period.

C3026 Carpet Tiles, Standard

Type	Component Description	Qty / UOM	Unit Cost (\$)	Plan Type	Priority	Year	Expenditures (\$)
C3025	Replace C3026 Carpet Tiles, Standard	6,500.0 - SY	96.6	IN - Appearance	Priority 4	2020	627,936
