Franchise Tax Board Sacramento and San Francisco Buildings (084)

9645 Butterfield Way, Rancho Cordova, CA 95827

Facility Condition Assessment

June 2015

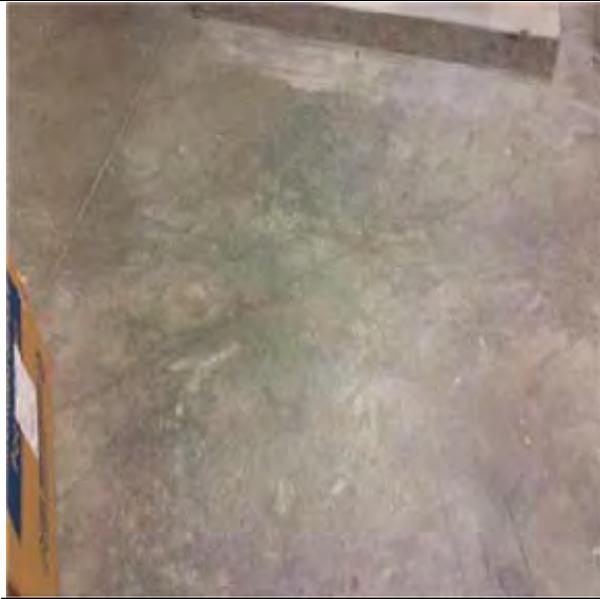
Item	Description
A1013 Perimeter Drainage & Insulation	A1010 Concrete Foundations
Condition	Good
Qty / UOM	834533 /
RUL (years)	65
Location	All Buildings

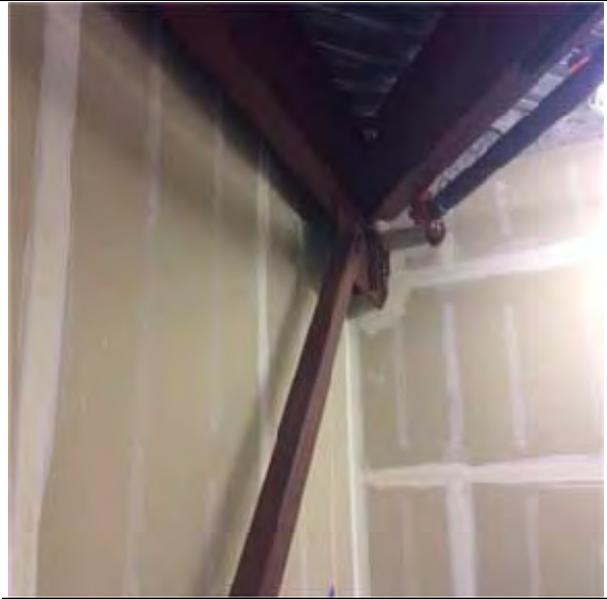
Item	Description
B1031 Steel Frame Structure	B1031 Structural Steel Columns and Beams Frame
Condition	Good
Qty / UOM	834533 / SF
RUL (years)	60
Location	All Buildings

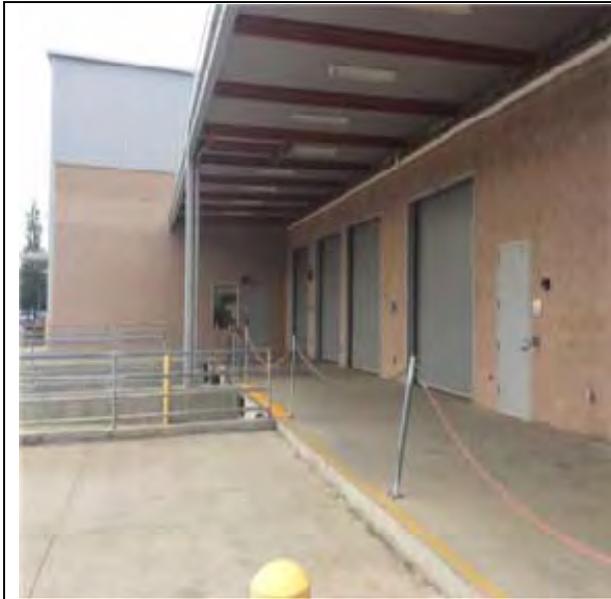
Item	Description
B2011 Exterior Wall Construction	B2011 Concrete Block Masonry-warehouse
Condition	Good
Qty / UOM	9680 / SF
RUL (years)	30
Location	Warehouse

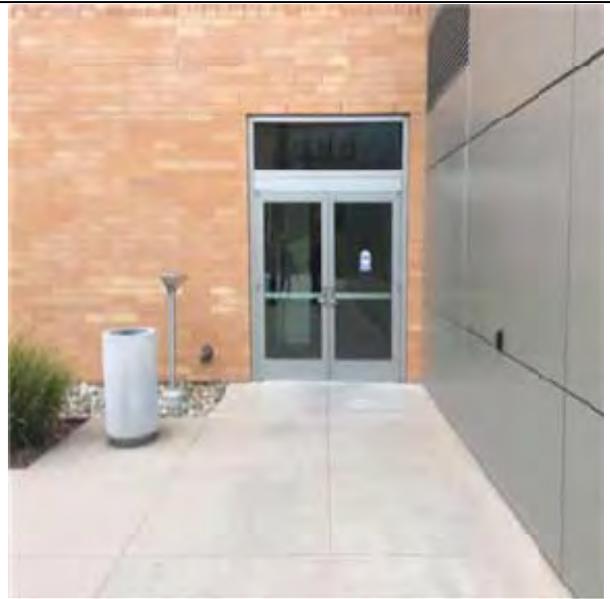
Item	Description
B2011 Exterior Wall Construction	B2011 Metal panel Exterior Walls
Condition	Good
Qty / UOM	3250 / SF
RUL (years)	20
Location	San Francisco Sacramento and Towne Center buildings
Exterior Wall Construction	Prefinished Metal Siding
Parapets	Yes
Balcony Walls and Handrails	Metal

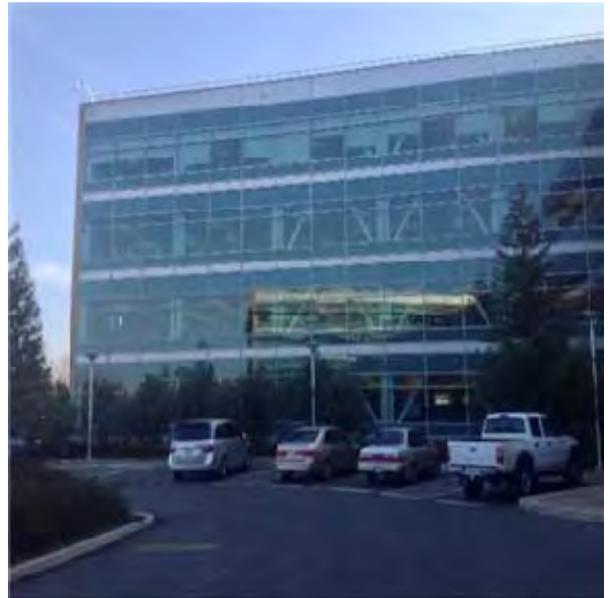
Item	Description
B2021 Windows	B2021 Exterior Windows
Condition	Fair - Good
Qty / UOM	19700 / sf
RUL (years)	15
Location	SC exteriors
Window Type	Fixed
Windows Material	Aluminum

Sporadic window leaks were reported, but not observed. A small number of gaskets had a gap at the edge, and some gaskets were slightly loose. Caulking at frame perimeters and loose gaskets should be repaired, including curtain walls and stand-alone windows.

Type	Component Description	Qty / UOM	Unit Cost (\$)	Plan Type	Priority	Year	Expenditures (\$)
B2021	B2021 Caulking at frame perimeters and loose gaskets should be repaired.	19,700.0 - LF	1.0	IN - Beyond Rated Life	Priority 1	2015	18,715

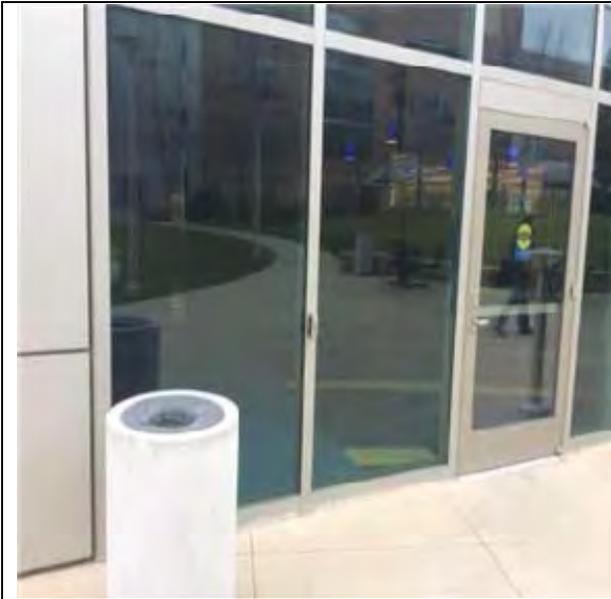
Item	Description
B2021 Windows	B2020 Exterior Windows SF
Condition	Fair
Qty / UOM	15000 / Sf
RUL (years)	15
Location	SF Exteriors
Window Type	Fixed
Windows Material	Aluminum
Windows Glazing	Double Glazed

Sporadic window leaks were reported but not observed. A small number of gaskets had a gap at the edge, and some gaskets were slightly loose. Caulking at frame perimeters and loose gaskets should be repaired, including curtain walls and stand-alone windows.

Type	Component Description	Qty / UOM	Unit Cost (\$)	Plan Type	Priority	Year	Expenditures (\$)
B2021	B2021 Caulking and loose gaskets repair,	15,000.0 - LF	3.7	OP - Maintenance	Priority 2	2015	55,800
