## Department of Justice Office Building (030)

1300 "I" Street, Sacramento, CA 95814

### Facility Condition Assessment

June 2015

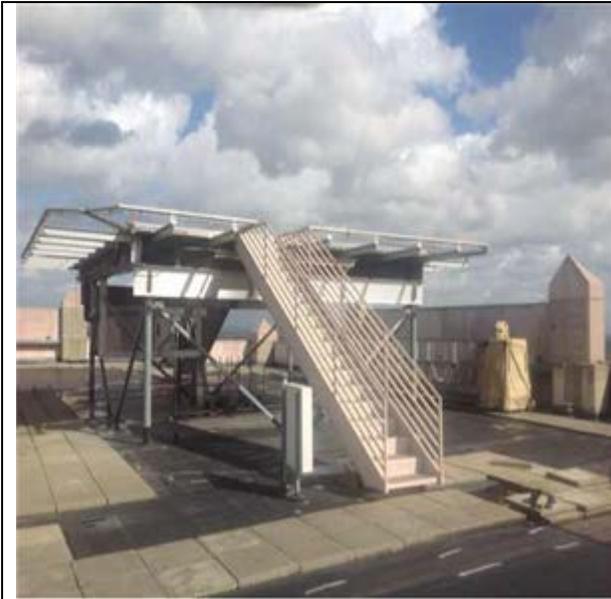
**B1021 Helipad framing**

Diagonal bracing is open at the top with no water outlet at the bottom of the structural members. Repair is recommended at this time to prevent corrosion to the structural steel members.

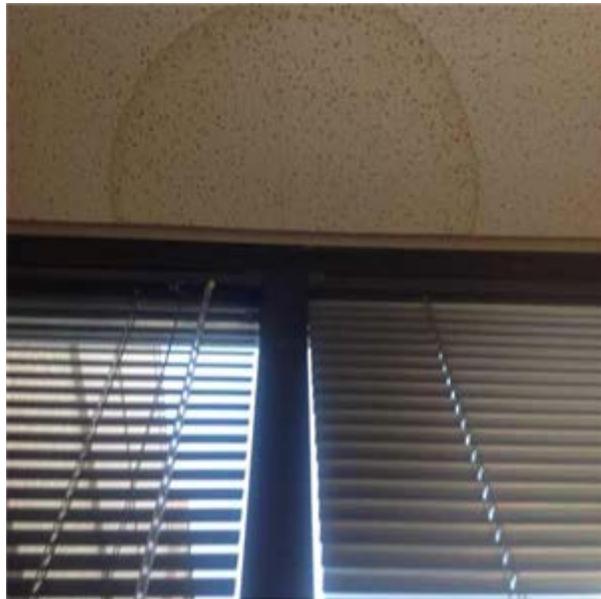
- Roof leaks have been reported and observed on the 17th floor, beneath the main roof area. Moisture infiltration has been observed within the lower terrace roofing. It is recommended that the roofing be replaced.
- The building heating and cooling system runs on the original pneumatic control system. There are some direct digital controls (DDC) in limited areas. Most of the system is original to the building. Installation of DDC is recommended.
- The swing staging for window cleaning and exterior façade work does not function properly. The rollers and retraction equipment are dysfunctional.
- The first three levels of the parking garage have water infiltration issues from both vehicular runoff and exterior water infiltration. The original parking surface sealant is at the end of its useful life and should be recoated.

**B3011 Single-Ply EPDM with Insulation, Fully Adhered 60 Mills :- Visible moisture staining at the suspended ceiling tiles.**

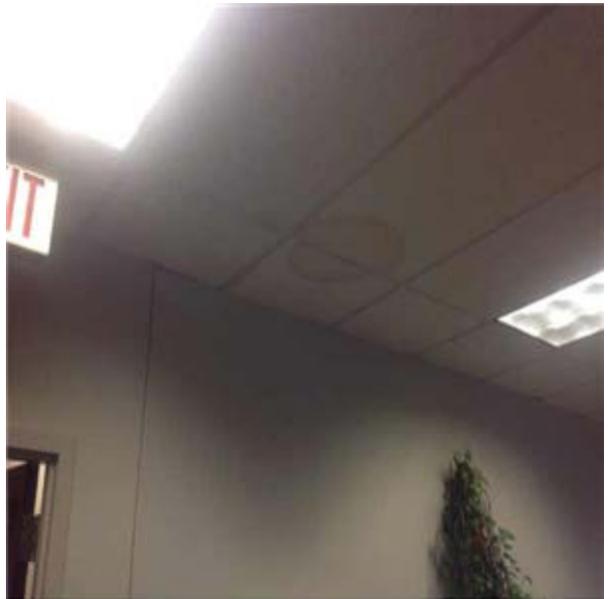
**B3011 Single-Ply EPDM with Insulation, Fully Adhered 60 Mills:- Visible moisture damage at the suspended ceiling.**

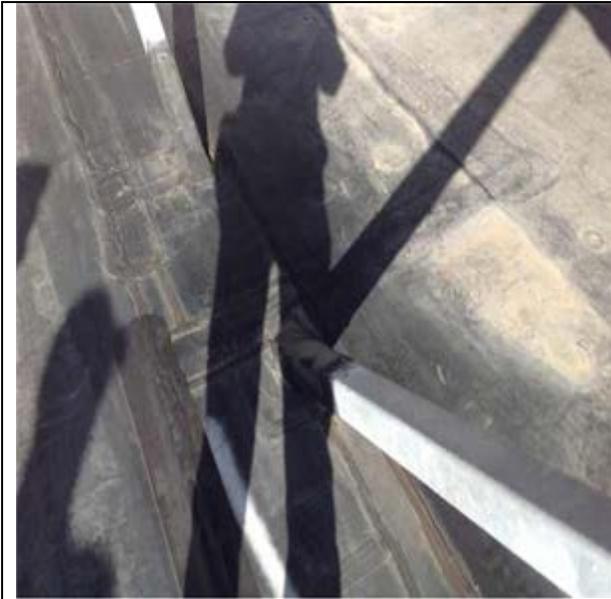
**B3011 Single-Ply EPDM with Insulation, Fully Adhered 60 Mills :- Helipad steel framing members.**

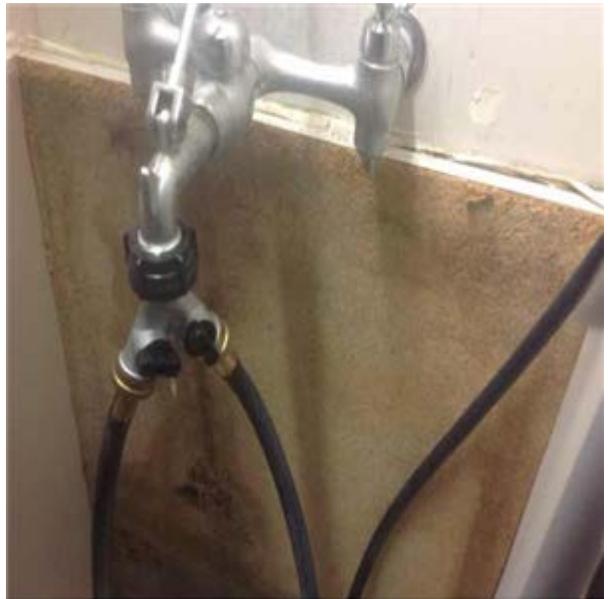
**C3012 Fiberglass Reinforced Plastic Backsplash:- Damaged original FRP**

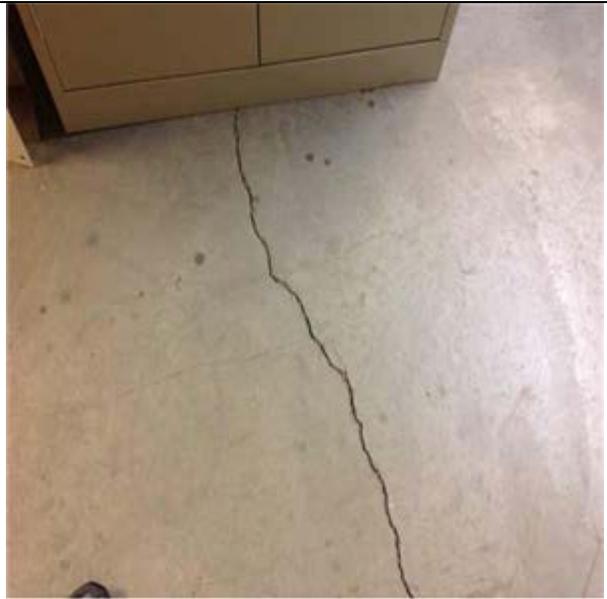
Z1011 Structural Study:- Cracking in the floor slab at the 17th level.

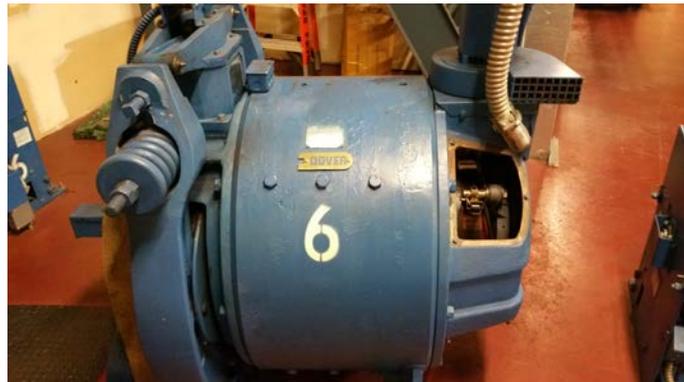
The elevators for Cars 1-6 have gearless machines manufactured and installed by Dover Elevator. The elevators for Cars 7-8 have geared Dover machines. They were all noted to be in good condition, except the commutators on a few of the gearless cars have severe burn marks.

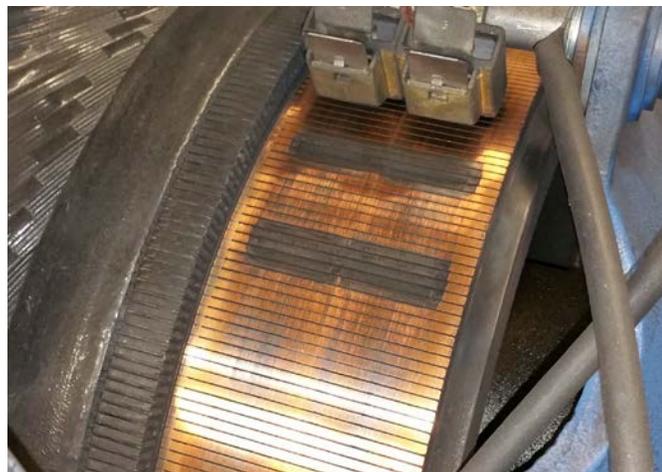
The commutators on several of the gearless machines had severe burn marks.

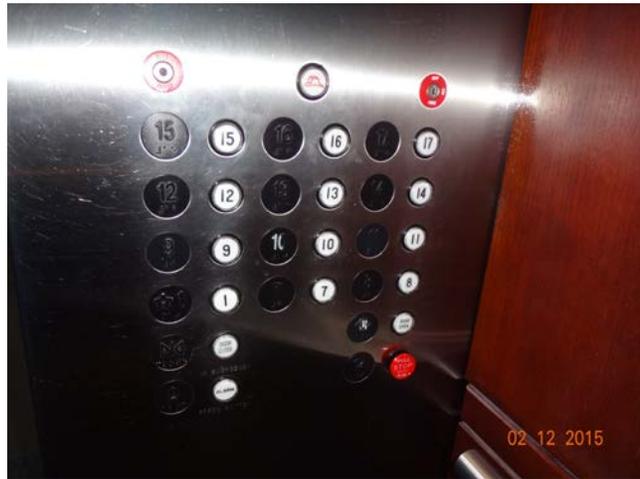
All the Car Operating Panels (COP's) are original. The panels are in good condition and meet all ADA and T24. The stop switches are not keyed and many did not ring the alarm bell as required by code.

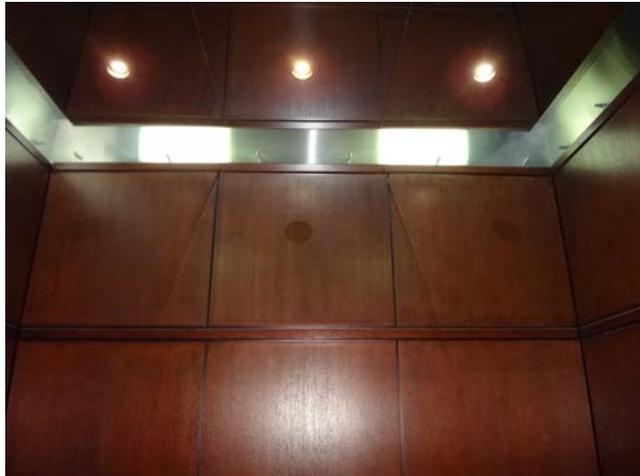
The passenger elevators have down light ceilings with incandescent light fixtures. The light fixtures could be updated with energy efficient LED's and/or the entire ceiling could be replaced.
