Rehabilitation Building (OB10) (010)

721 Capitol Mall, Sacramento, CA 95814

Facility Condition Assessment

June 2015

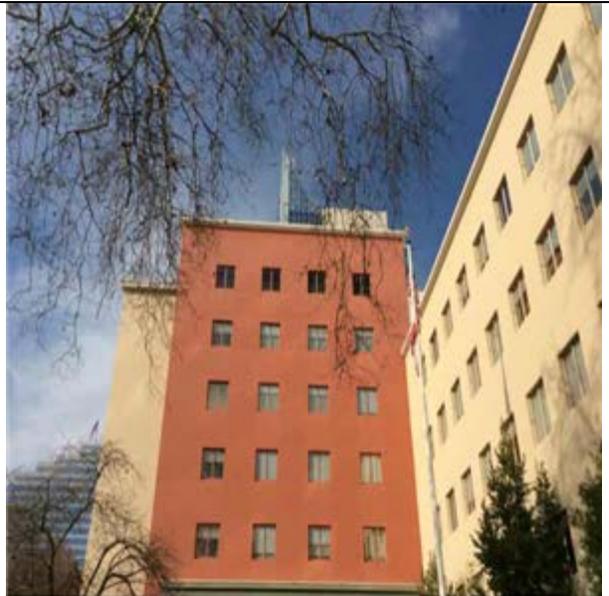
B2011 Masonry Exterior Walls:- Exterior Walls

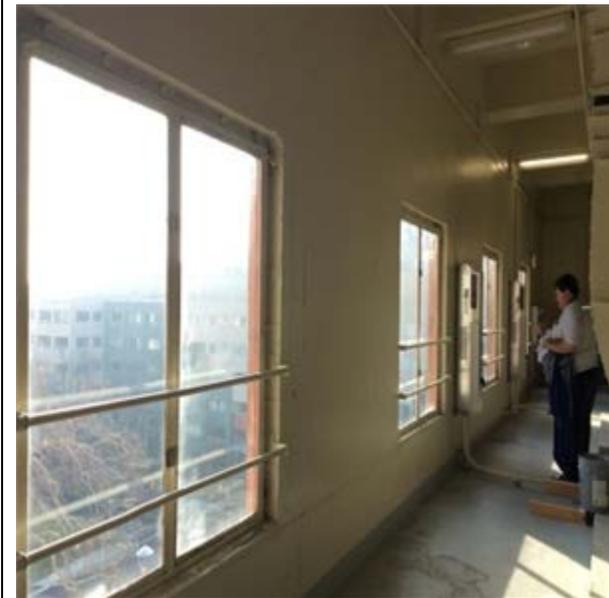
The storefront doors at the main lobby were installed in 2008 and some of the windows were replaced as part of the seismic renovation.

B2021 Windows re-sealing

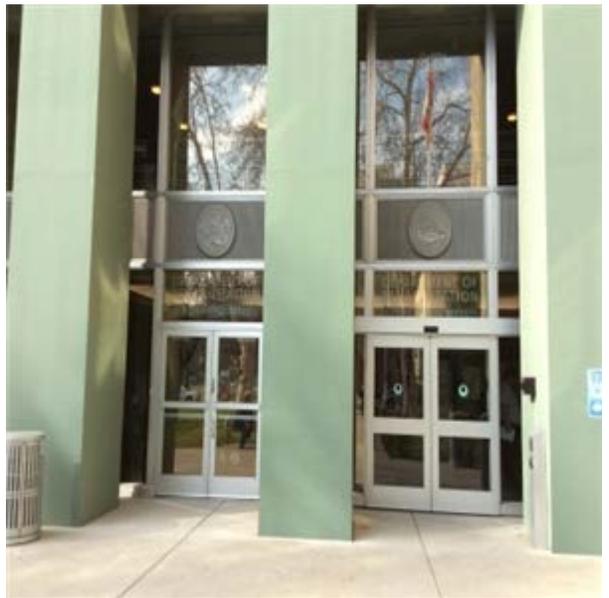
All double entrance doors are in good condition. No further action required.

B2031 Entrance double doors to office area

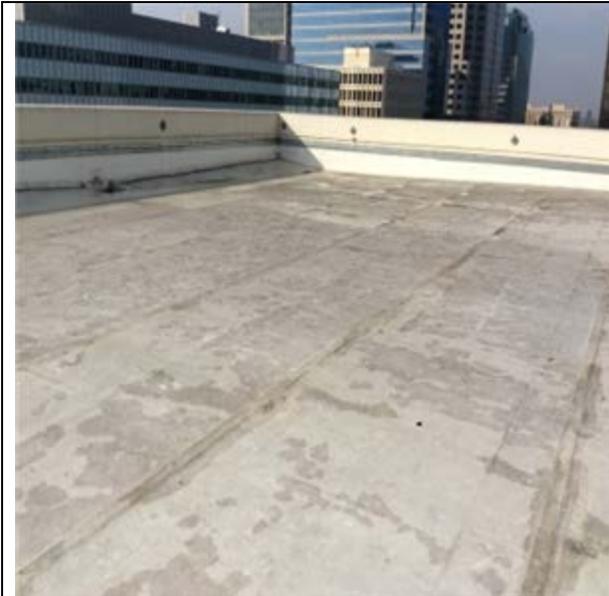
Item	Description
B3011 Roof Finishes	B3011 Roof Protection Mats
Condition	Poor
Qty / UOM	8 / EA
RUL (years)	5
Location	Roof

B3011 Roof Protection Mats

Type	Component Description	Qty / UOM	Unit Cost (\$)	Plan Type	Priority	Year	Expenditures (\$)
B3011	Replace B3011 Roof Protection Mats	8.0 - EA	487.5	IN - Beyond Rated Life	Priority 3	2020	3,900

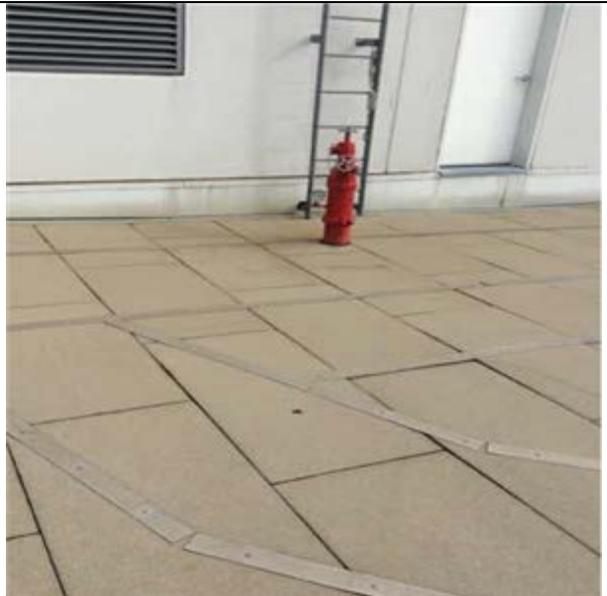
The building roof was replaced in 2008. Water ponding was observed during the review. Re-sloping these areas to prevent premature degradation of the roof membrane is recommended.

B3011 Building Roof:- Roofing

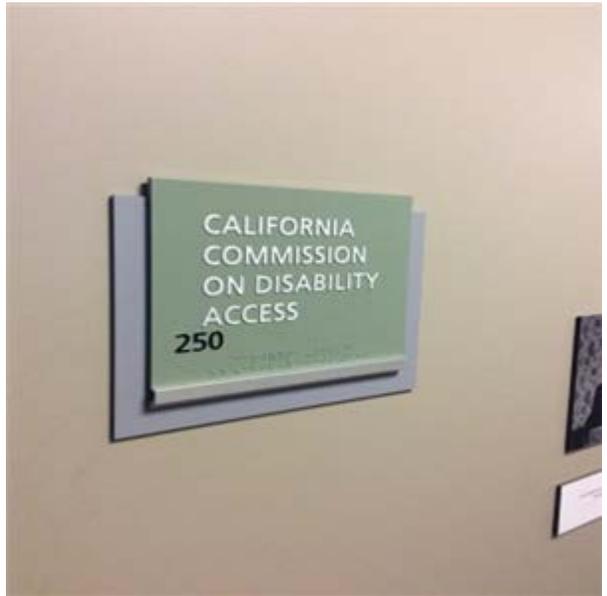
Item	Description
C1035 Identifying Devices	C1035 Directional Signage
Condition	Poor
Qty / UOM	12 / EACH
RUL (years)	0
Location	All Floor

C1035 Directional Signage

Adding directional signage at lobby area and hallways as part of ADA is recommended.

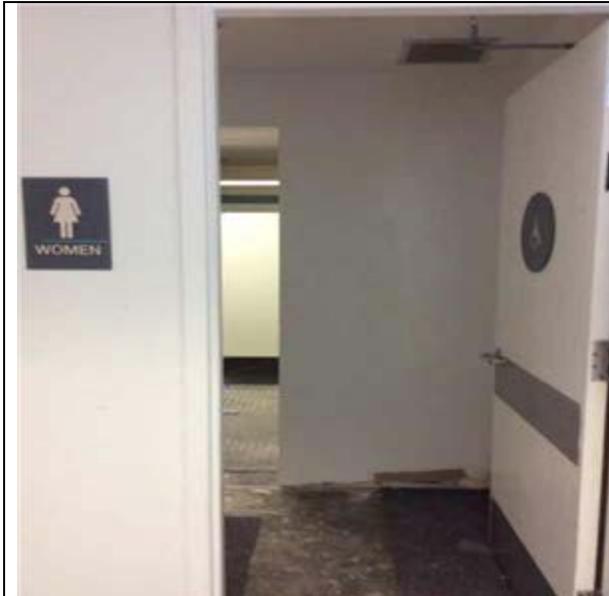
Item	Description
C3005 ADA Renovations	C3005 ADA door signage
Condition	Fair
Qty / UOM	20 / EA
RUL (years)	0
Location	Upper floors

C3005 ADA door signage :- ADA signage

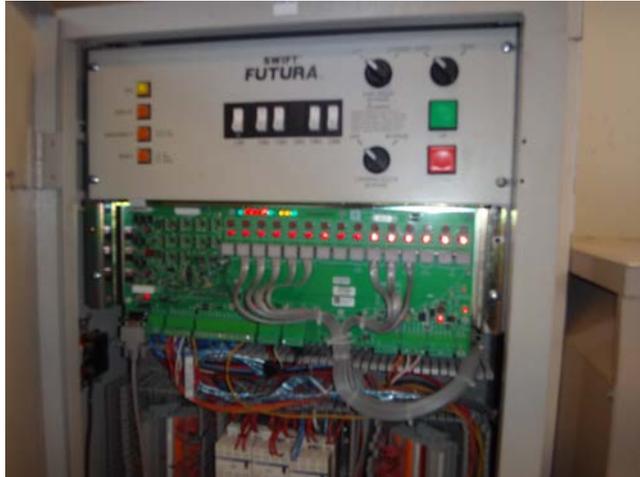
Controllers:

The controllers were manufactured by Swift (CEC) and installed locally by TKE when the elevators were modernized in 2007. The controllers utilize energy efficient SCR drives.

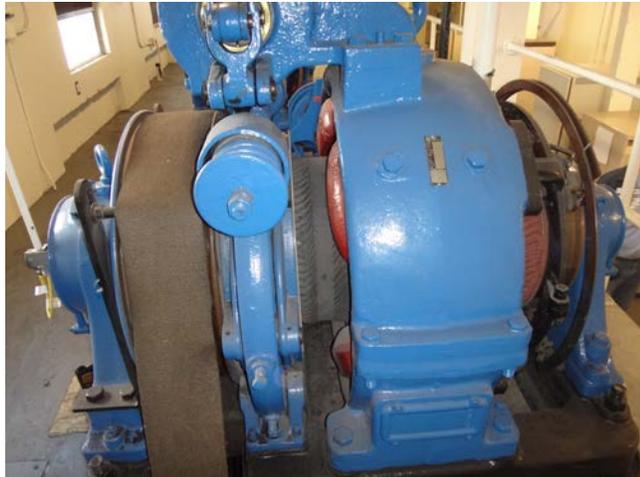
Gearless Machines:

All three elevators have Otis gearless machines that were installed in 1955 when the elevators were new. These appeared to be in good condition and do not need any major work.

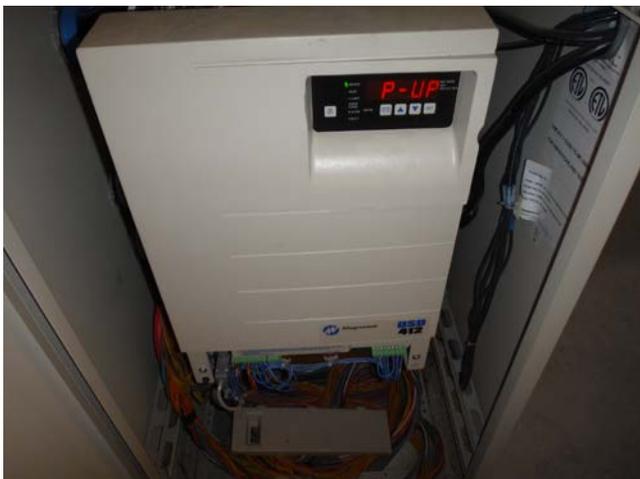
SCR Drives:

All the elevators have high quality Magnetek DSD 412 SCR drives. These are known in the industry to be very reliable and dependable.

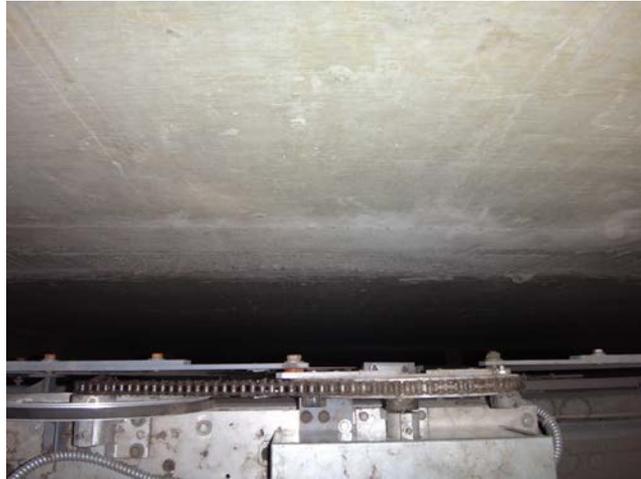
Hoistway Construction:

The hoistway (elevator shaft) is the main area where the elevators go up and down. The hoistways are mostly built of concrete. Behind the rear entrance for Car 1 there is a 12" space. Fascia should be installed to reduce the space.

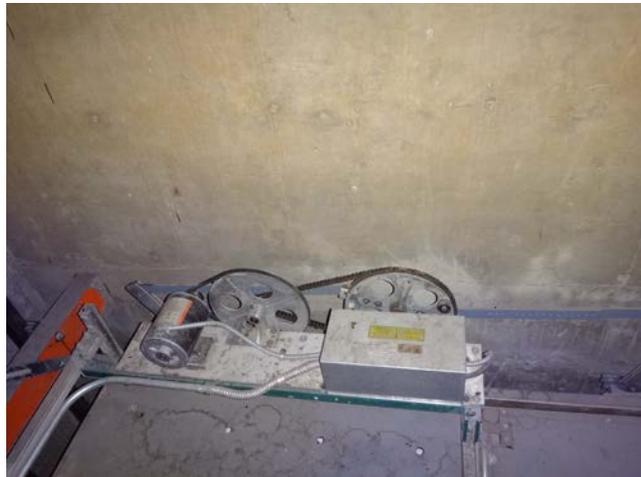
Door Operator:

The operators were upgraded with GAL closed loop units that are known to be of high quality. The door operators have door restrictors, but on Car 1 front side it did not work.

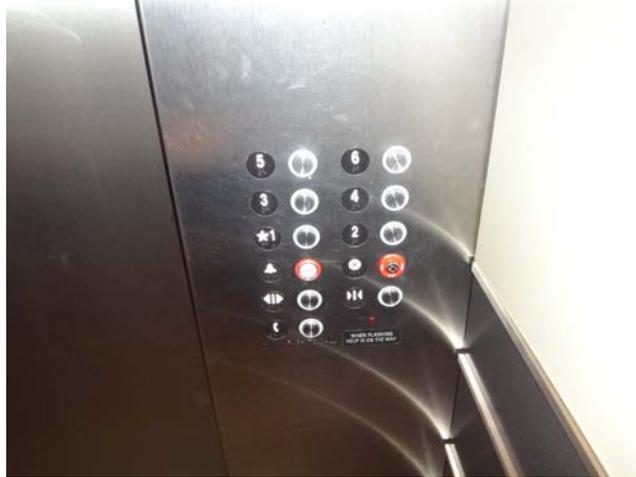
Car Operating Panels:

All the elevators have newer Car Operating Panels (COP's) that were installed during the elevator modernizations. The panels are in good condition and meet all ADA and T24 however, the buttons are hard to push. Several passengers were observed pushing the buttons a 2nd or 3rd time in order to get the button to register a call.

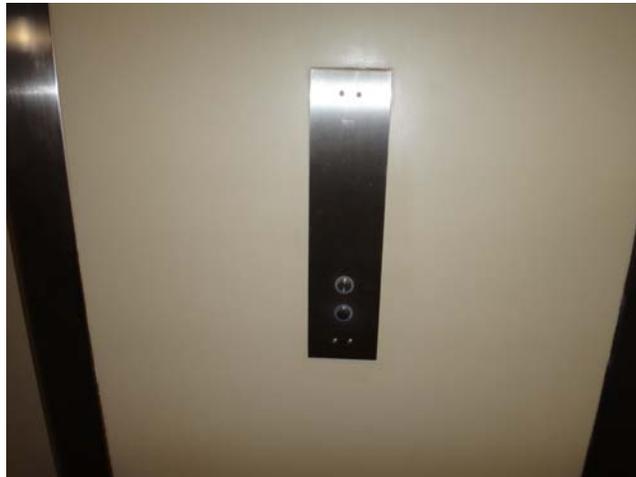
Hall Call Pushbuttons:

At each floor hall call push buttons are located so that users can call the elevator. The hall call stations have raised operation buttons which meet ADA and California Title 24. However, the buttons were hard to push and the face plates do not have code required fire exit signs.

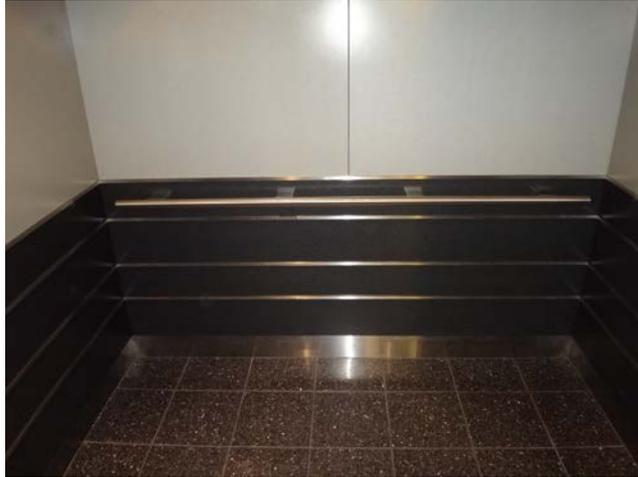
Wall Finish:

The existing cab interiors were most likely updated when the elevators were modernized and are in good condition. The back wall has the code required handrail. The railing heights are in compliance with Title 24 California code.

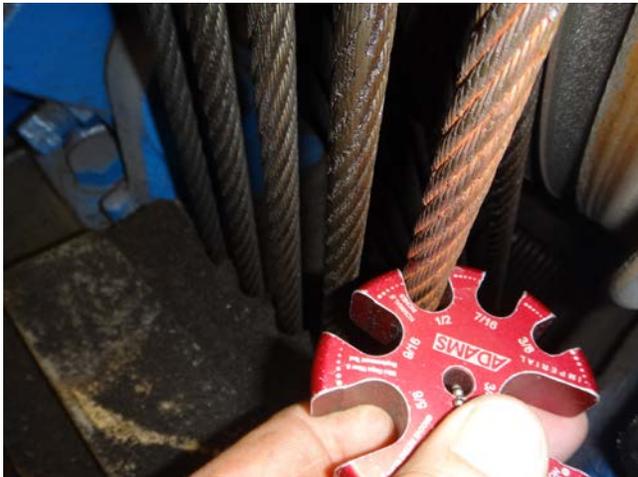
Miscellaneous:

The hoist ropes for Car 1 failed to meet minimum size requirements and should be replaced immediately.
