Stanley Mosk Library and Courts Building (003)

914 Capitol Mall, Sacramento, CA 95814

Facility Condition Assessment

June 2015

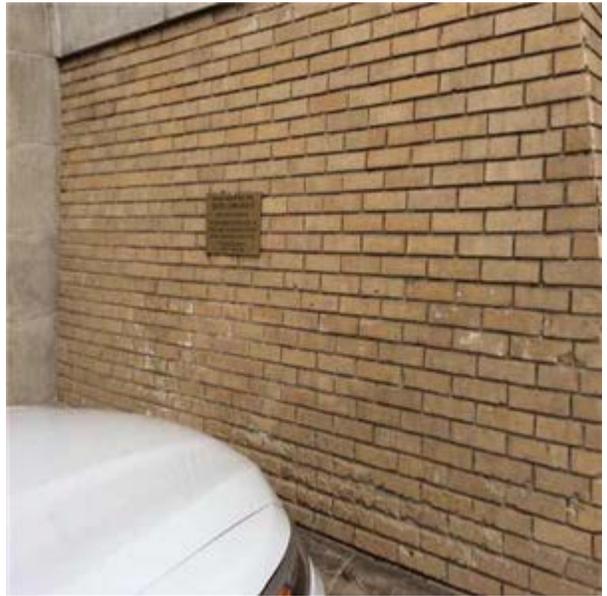
B2011 Light Well Walls

All light well brick veneer walls were repaired in 2013.

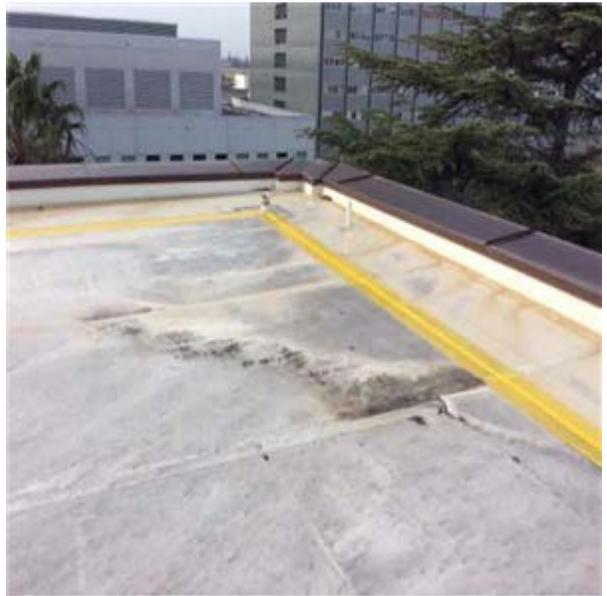
B301 | Building Roof

The roof is polyvinyl chloride (PVC) single ply membrane, replaced in 2013. No further action is required.

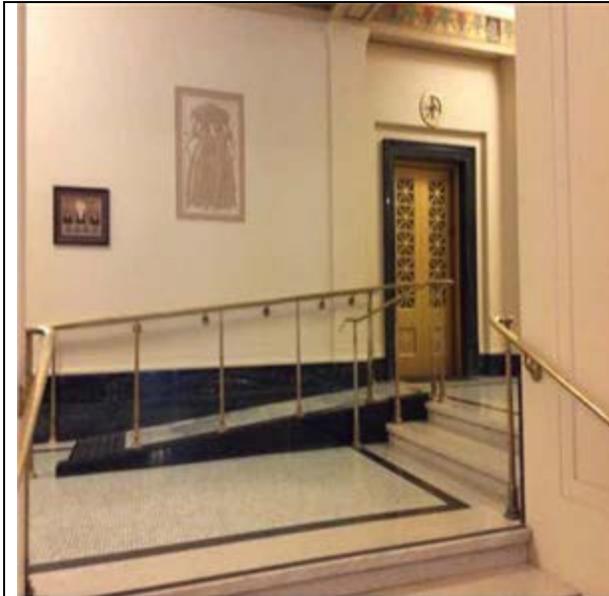
Based on estimated RUL, interior painting is recommended.

Type	Component Description	Qty / UOM	Unit Cost (\$)	Plan Type	Priority	Year	Expenditures (\$)
C3012	Replace C3012 Wall Finishes - Elevator Lobby	6,850.0 - SF	2.1	IN - Appearance	Priority 4	2023	14,610

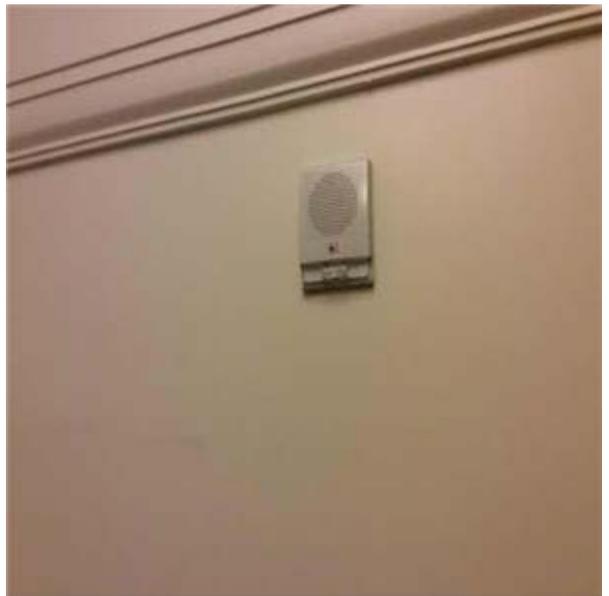
Based on estimated RUL, interior painting is recommended.

Type	Component Description	Qty / UOM	Unit Cost (\$)	Plan Type	Priority	Year	Expenditures (\$)
C3012	Replace C3012 Paint Interior Walls, Drywall	52,050.0 - SF	2.1	IN - Appearance	Priority 4	2023	111,012

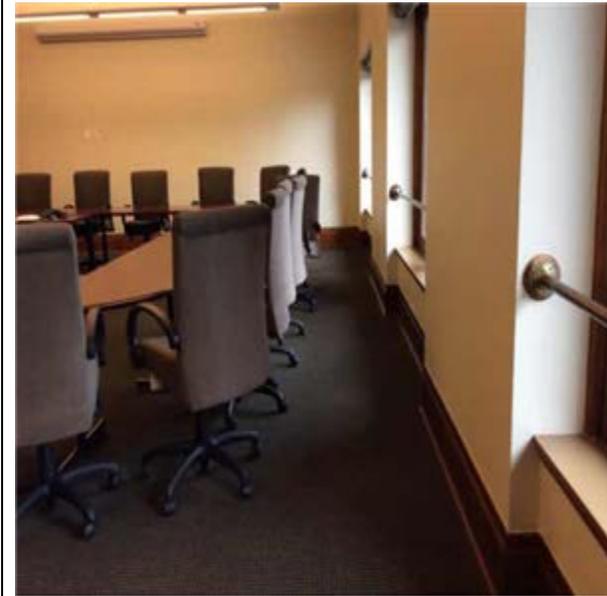
Based on estimated RUL, carpet replacement is anticipated.

Type	Component Description	Qty / UOM	Unit Cost (\$)	Plan Type	Priority	Year	Expenditures (\$)
C3025	Replace C3025 Carpet flooring	6,575.0 - SY	96.6	IN - Appearance	Priority 4	2023	635,182

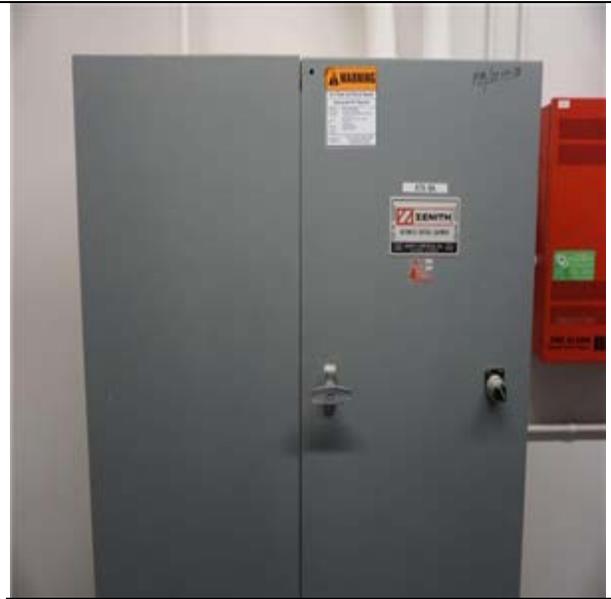
D5092 Emergency Generator 350 kW

- The elevators require five-year load tests. The test tags on the cars are dated 2006.
- The emergency generator does not have a secondary containment barrier around the diesel tank to prevent contamination in the event of a fuel leak.

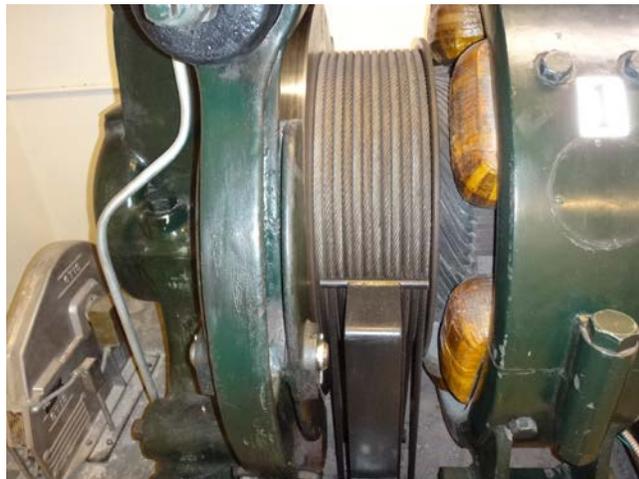
Gearless Machines:

The main passenger Cars have the original G.E. gearless machines that were installed in 1928 when the elevators were new. The machines appear to be in good condition and do not need any major upgrades at this time.

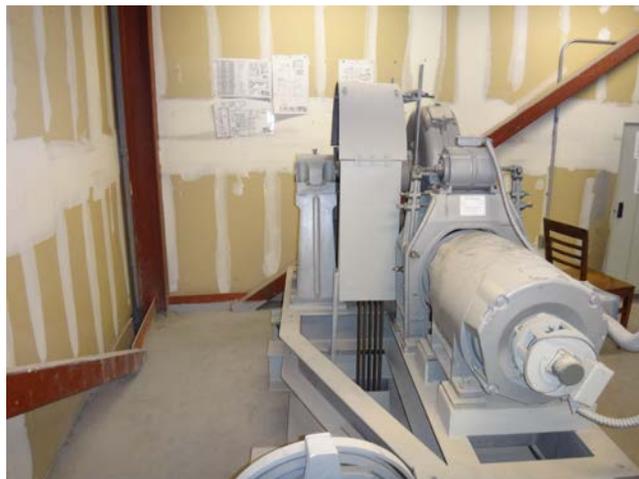
Geared Machines:

The stack elevators have new Hollister Whitney machines that were installed in 1999 when the elevators were fully replaced.

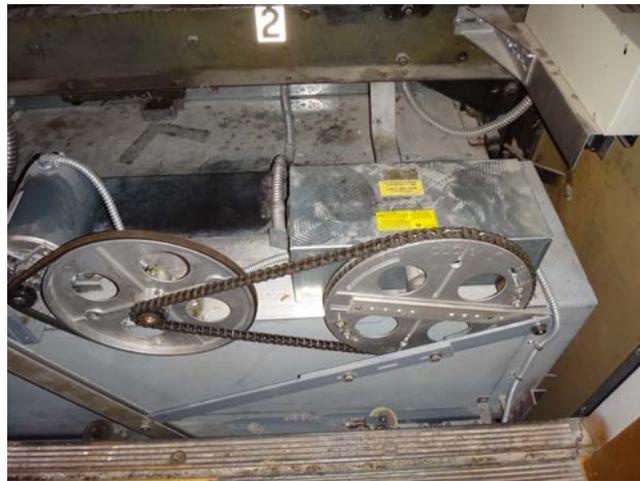
Door Operator:

The door operators for Cars 1-2 have closed loop GAL door operators that are in good condition. Cars 3 and 4 have MAC door operators that are also in good condition. No work is anticipated on these door operators in the near future.

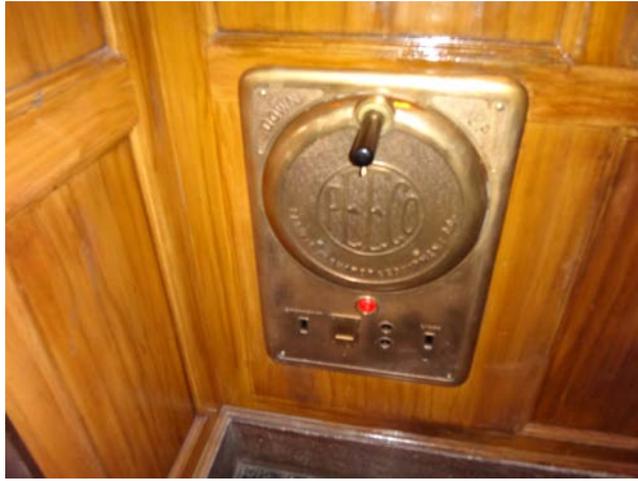
Car Operating Panels:

All the elevators have newer Car Operating Panels (COP's) that were installed during the elevator modernizations/additions. The panels are in good condition and meet ADA and T24. The passenger elevators have the original manual car switches that add a unique historical perspective.

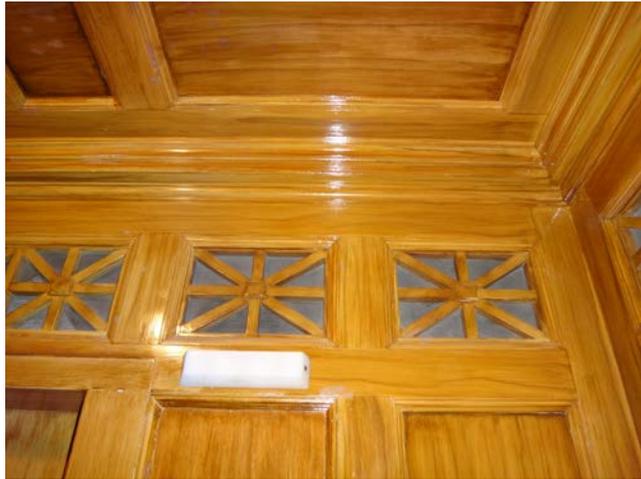
Passenger Wall Finish:

The existing cab interiors for the two passenger elevators are in excellent condition and appear to have the original wood paneling.

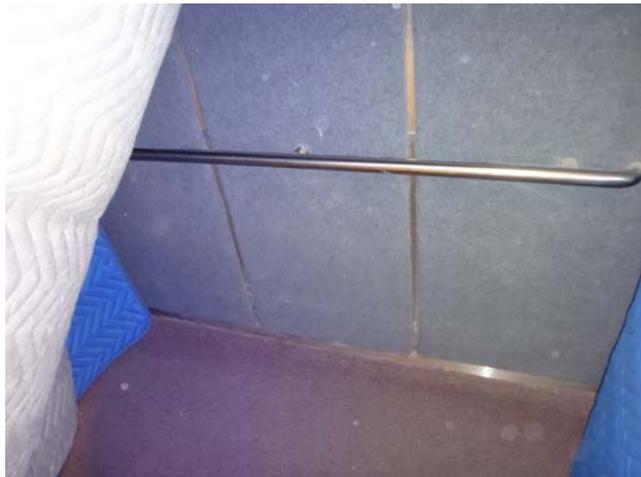
Stack Wall Finish:

The cab interiors for the stack elevators have carpet walls and are also in good condition.
