Blue Anchor Building (091)

1400 10th Street, Sacramento, CA 95814

Facility Condition Assessment

June 2015

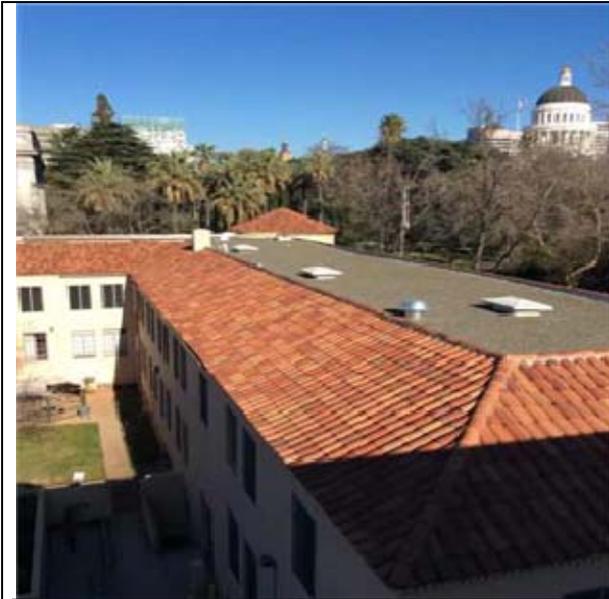
Item	Description
B1022 Pitched Roof Construction	B1022 Pitched Roof Construction
Condition	Good
Qty / UOM	120 / SQ
RUL (years)	16
Location	Mansard roof
Roofing Type	Pitched
Parapet Wall Edge Flashing	Concrete
Attic	No
Roof Access	Roof Hatch

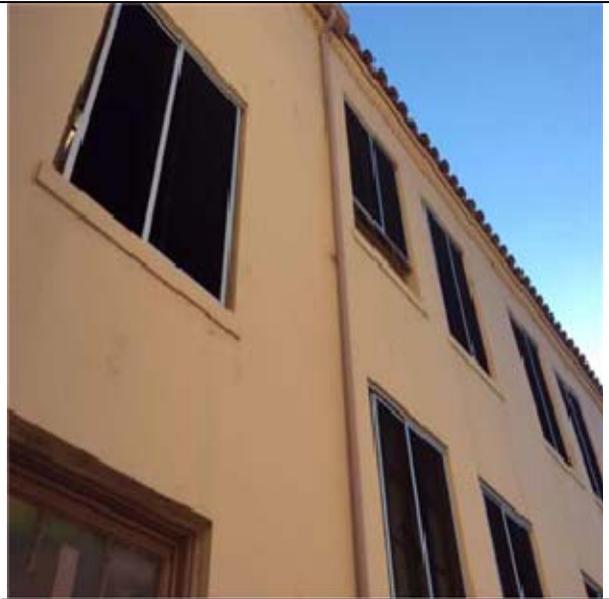
Item	Description
B2011 Exterior Wall Construction	B2011 Concrete Block Masonry
Condition	Fair - Good
Qty / UOM	16000 / SF
RUL (years)	20
Location	Throughout Facility
Exterior Wall Construction	Solid Masonry
Parapets	Yes
Balcony Walls and Handrails	Concrete
Exterior Soffits	Concealed
Lintels and Sills	Concrete

B2011 Concrete Block Masonry:- paint finish

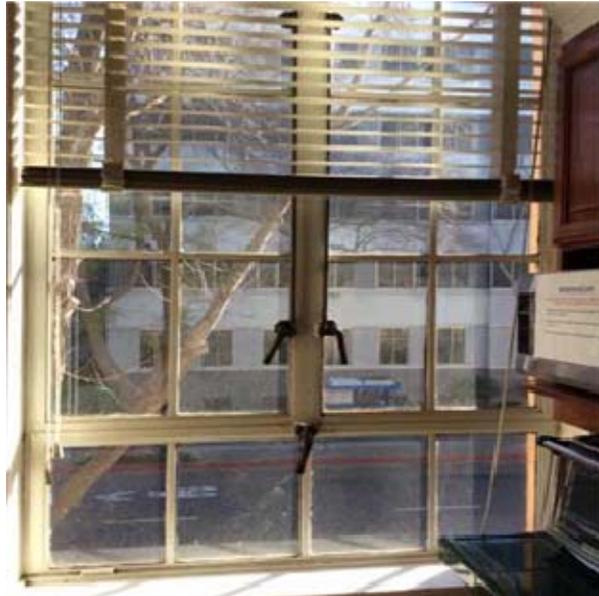
B2021 Wood Windows :- With aluminum fixed storm windows

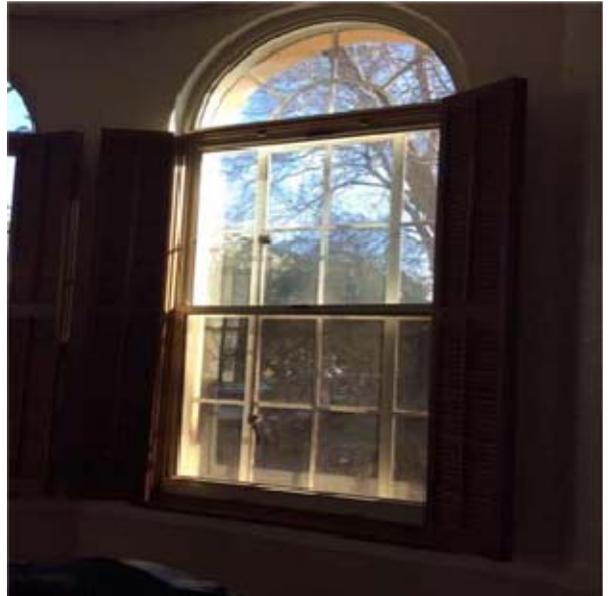
Item	Description
B2021 Windows	B2021 Wood Windows
Condition	Fair
Qty / UOM	125 / EA
RUL (years)	5
Location	Exterior walls
Window Type	Double Hung
Windows Material	Wood
Windows Glazing	Single Glazed
Window Operation	Manual

The wood windows are historic and must be managed in place. Requires regular maintenance including replacement of weights, painting, and repair of glazing will be required.

Type	Component Description	Qty / UOM	Unit Cost (\$)	Plan Type	Priority	Year	Expenditures (\$)
B2021	B2021 Repair and Paint Wood Windows	125.0 - EA	669.1	OP - Maintenance	Priority 3	2020	83,635

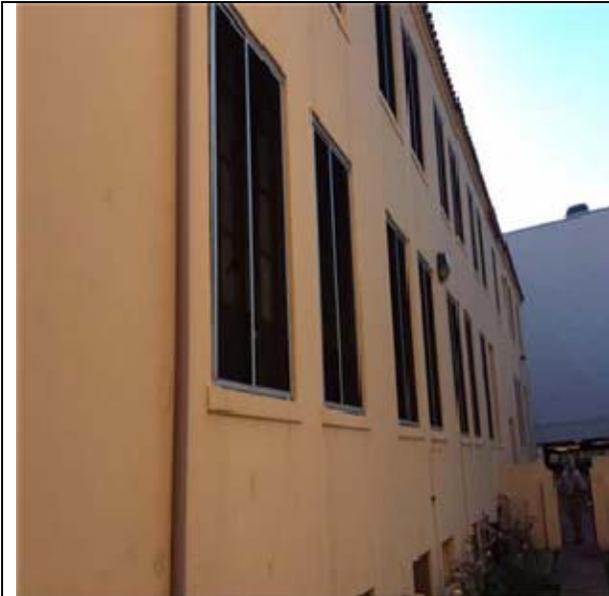
Item	Description
B2021 Windows	B2021 Aluminum Windows
Condition	Fair
Qty / UOM	80 / EA
RUL (years)	0
Location	Exterior walls at rear
Window Type	Fixed
Windows Material	Aluminum
Windows Glazing	Single Glazed
Window Operation	Fixed

Previously installed aluminum windows that are not in keeping with the character of the building are recommended for replacement.

Type	Component Description	Qty / UOM	Unit Cost (\$)	Plan Type	Priority	Year	Expenditures (\$)
B2021	Replace B2021 Aluminum Windows	80.0 - EA	3509.2	FN - Modernization	Priority 1	2015	280,736

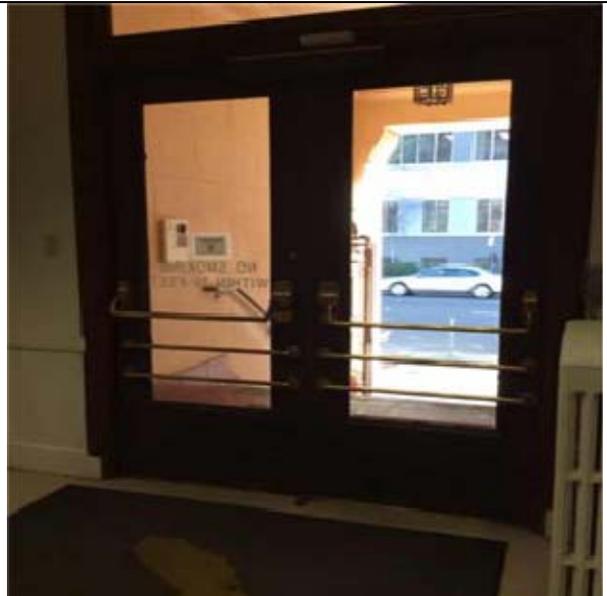
Item	Description
B2031 Glazed Doors & Entrances	B2031 Glazed Entrance Doors
Condition	Fair
Qty / UOM	2 / EA
RUL (years)	0
Location	Front Entry
Door Hardware	Lever
Door Operation	Manual
Glass Type	Standard Glass
Door Frame	Wood Framed
Door Use	Entrance

Entrance doors are non-compliant with ADA and should be replaced

B2031 Glazed Entrance Doors:- Glazed entry doors

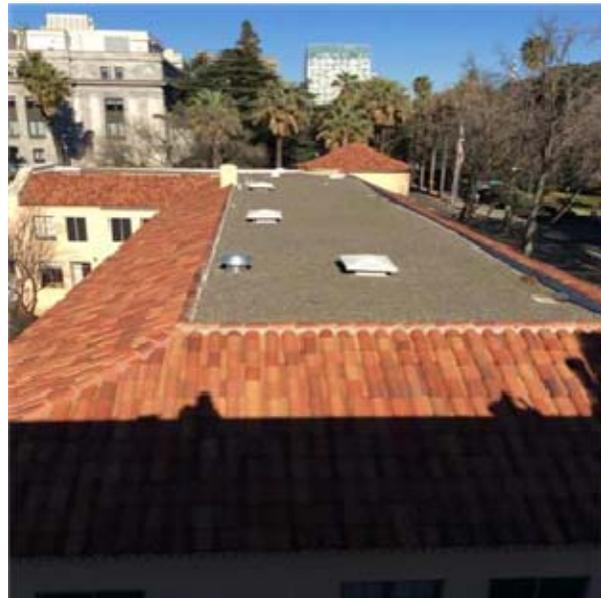
The roof has exceeded its EUL and requires replacement.

B3011 Built-Up Roofing :- Built up and clay tile

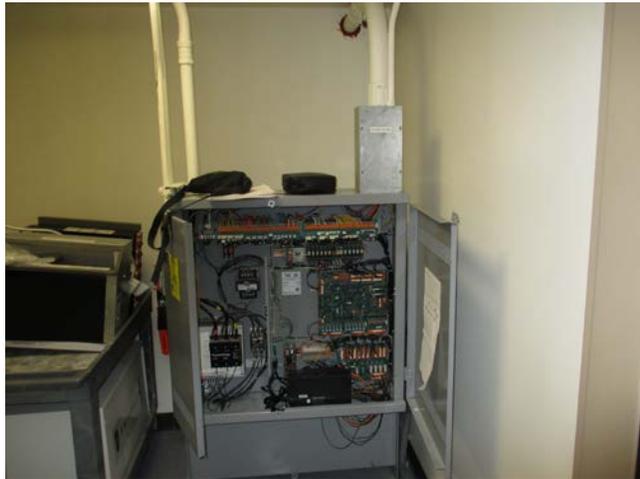
Controllers:

The controller was manufactured and installed by ThyssenKrupp Elevator when the elevator was added in 2002. The controller utilizes digital board technology that is known to be reliable. This TAC 20 model is known to be dependable. If properly maintained the controllers should last another 10 to 15 years with no major updates.

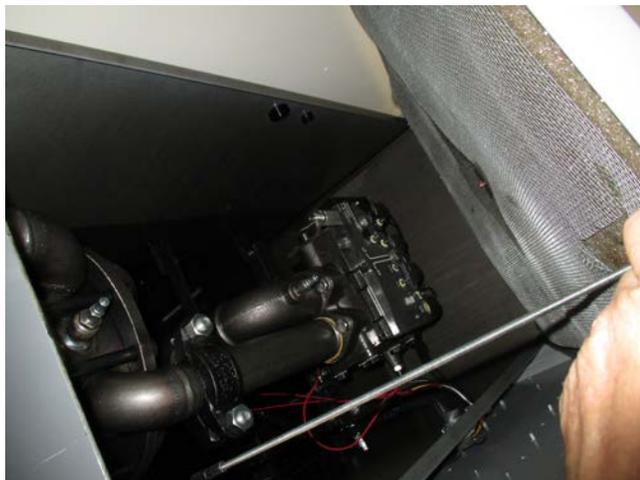
Hydraulic Power Units:

The elevator has a TKE power unit equipped with a TKE I2 valve and IMO pump. The power unit was installed in 2002 when the elevator was erected. The power unit is in relatively good condition.

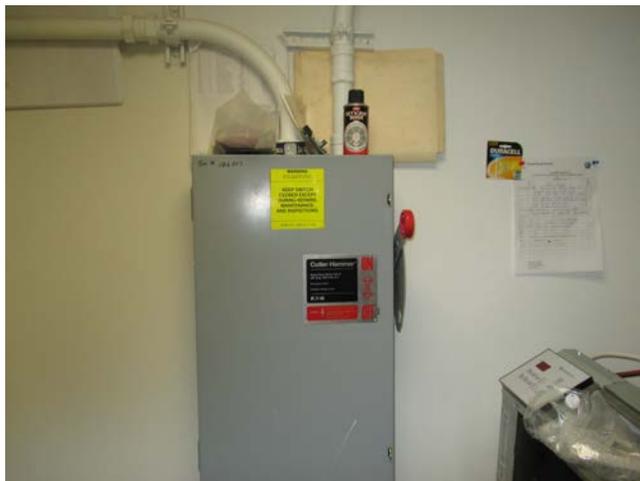
Disconnect:

The elevator disconnect is in good condition and does not need any work.

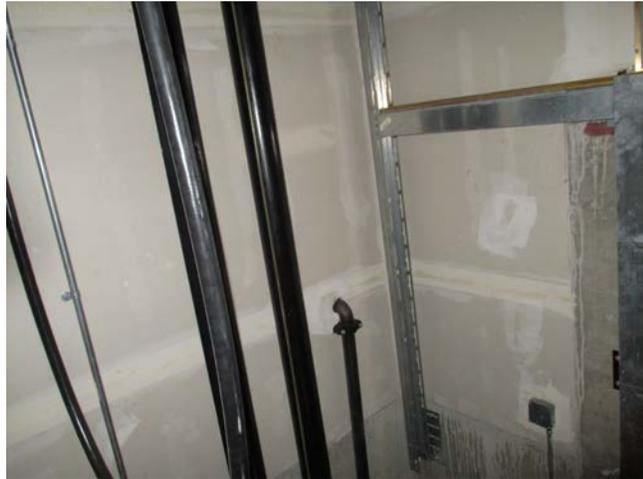
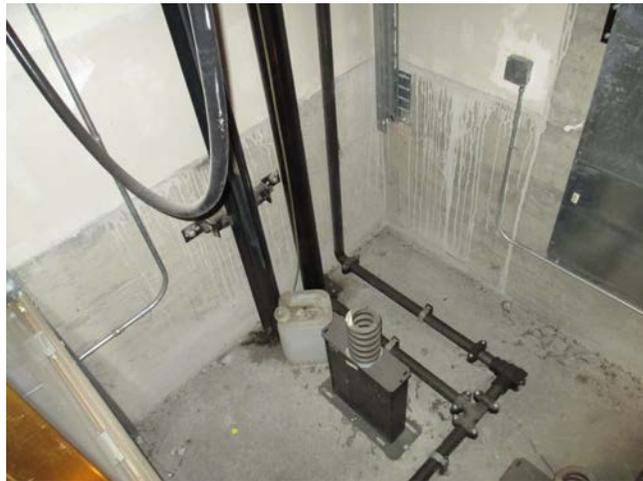
Car Guide Rails:

The car rails are in good condition but do not have seismic fish plates. During the proposed modernization, these could be installed. This is recommended as an option but is rarely cost effective.

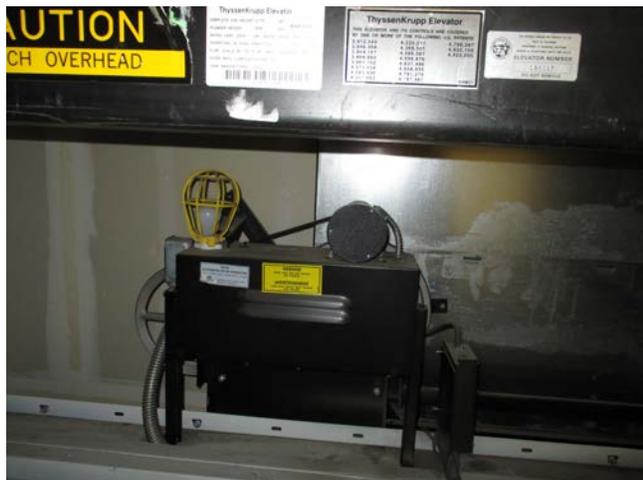
Door Operator:

The door operator is Thyssen's HD -98 model which is known to be reliable and dependable. The door operation was noted to be fair with room for improvement. The elevator has the code required door restrictor.

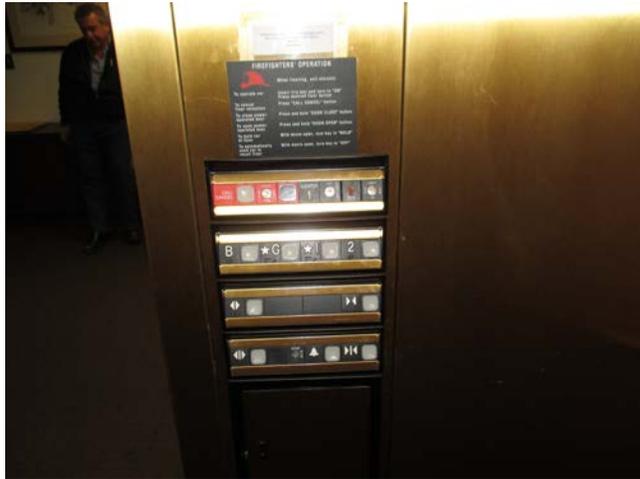
Car Operating Panels:

The elevator has the original Car Operating Panel (COP). The panel is in good condition and the buttons comply with ADA and Title 24. No work is needed on the COP.

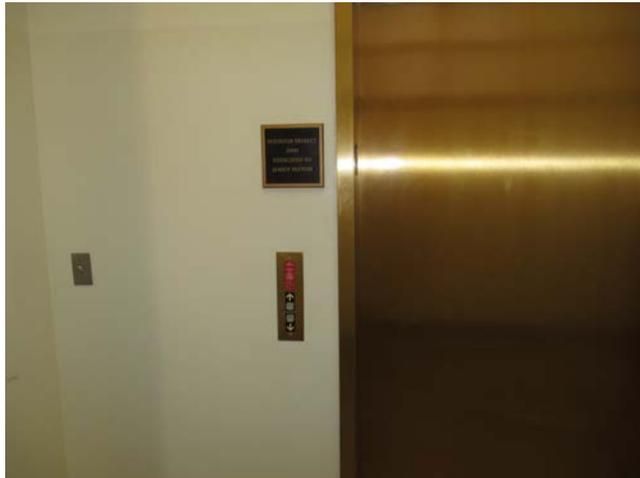
Hall Call Pushbuttons:

At each floor hall call push buttons are located so that users can call the elevator. The hall call stations have raised operation buttons which are ADA and T24 compliant. During a modernization the fixture and fire exit sign will be replaced.

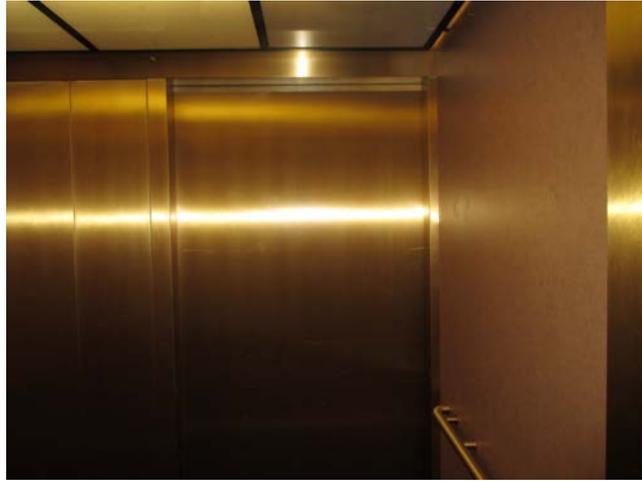
Ceilings:

The ceiling consists of translucent panels with a T frame design. The appearance is adequate.
