Justice Building (075)

4949 Broadway, Sacramento, CA 95820

Facility Condition Assessment

June 2015

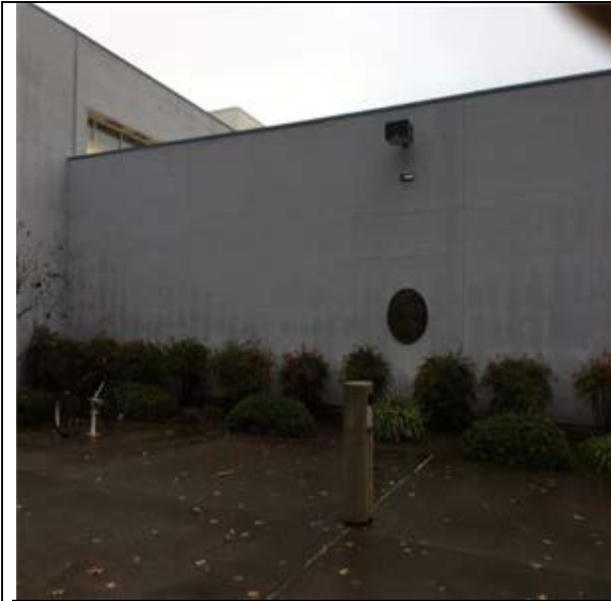
The exterior of the building appears to be telegraphing previous work and patch jobs, and the paint is faded. A complete paint job, with thorough prep work is recommended.

B2011 Stucco and Lath :- Exterior walls

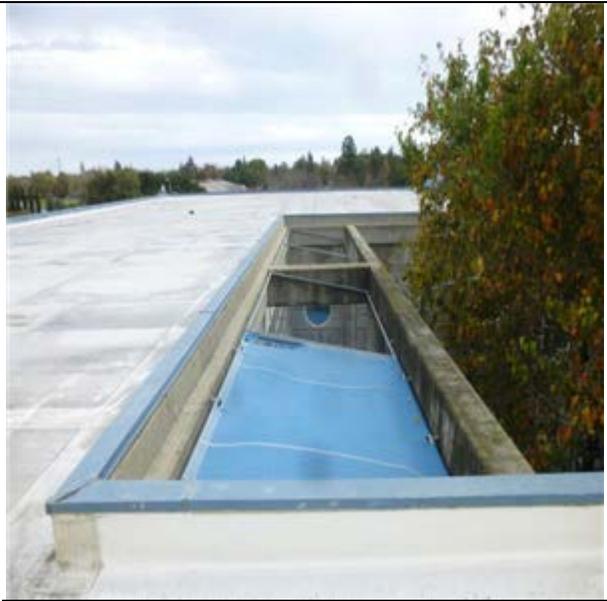
Most of the fabric canopies show significant deterioration. Replacement is recommended.

Type	Component Description	Qty / UOM	Unit Cost (\$)	Plan Type	Priority	Year	Expenditures (\$)
B2014	Replace B2014 Awning, Cloth Overhang	2,400.0 - SF	37.9	IN - Reliability	Priority 1	2015	91,066

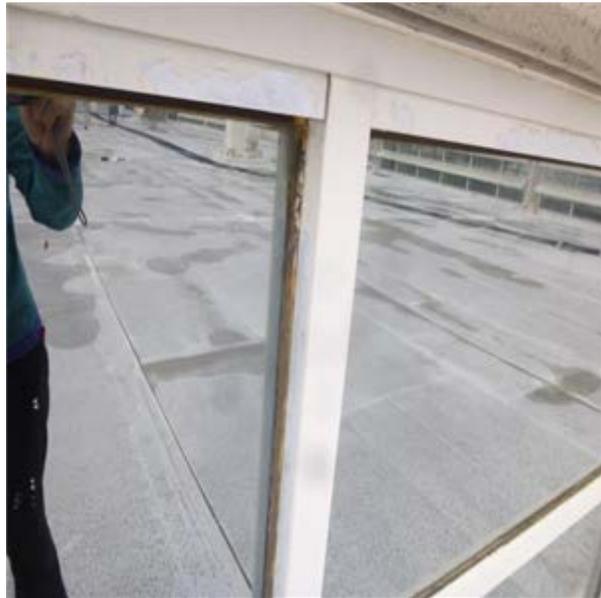
The window seals and gaskets are failing. There are some reports of leakage, and the factory applied paint is coming off. Replacement is recommended.

B2021 2' X 3' Aluminum Window Fixed :- Peeling paint and gasket failure

Type	Component Description	Qty / UOM	Unit Cost (\$)	Plan Type	Priority	Year	Expenditures (\$)
B2021	Replace B2021 2' X 3' Aluminum Window Fixed	600.0 - EA	1482.3	IN - Beyond Rated Life	Priority 1	2015	889,407

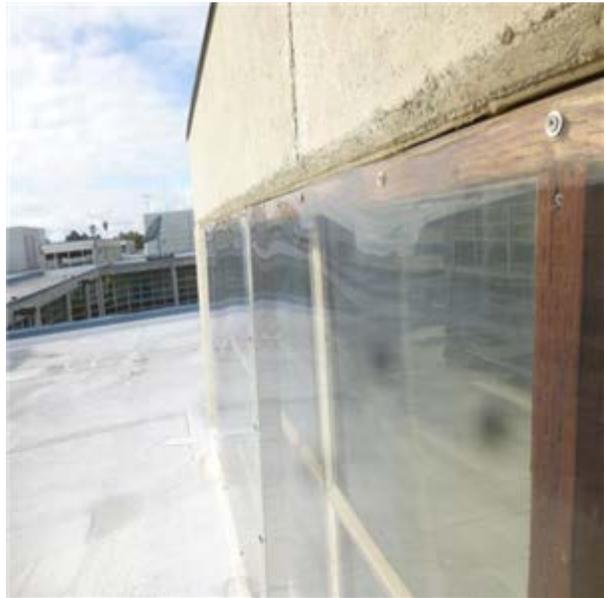
B2021 2' X 3' Aluminum Window Fixed:- Acrylic sheets were installed over the dining room clerestory windows

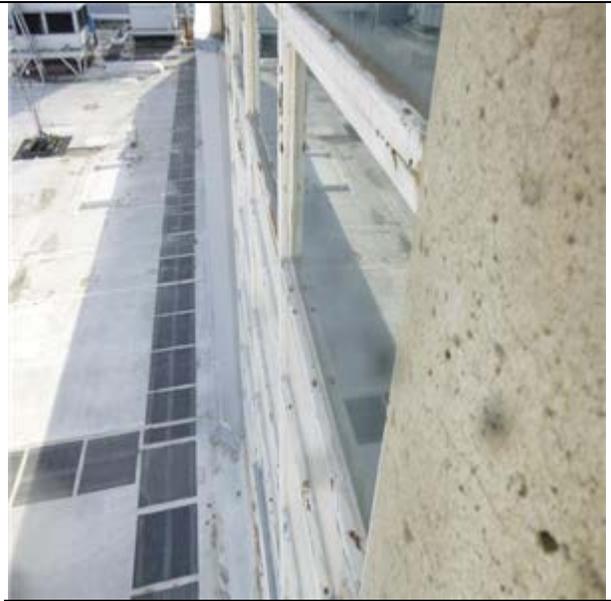
B2021 2' X 3' Steel Frame Window:- Evident corrosion

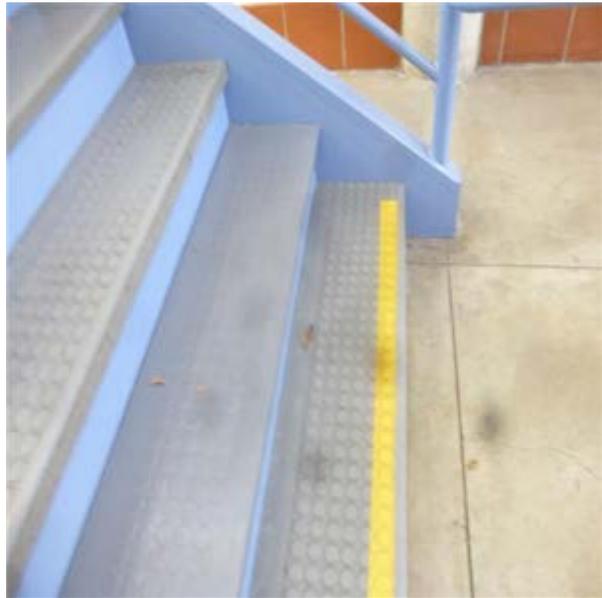
C2011 Steel stairs :- Worn raised rubber treads

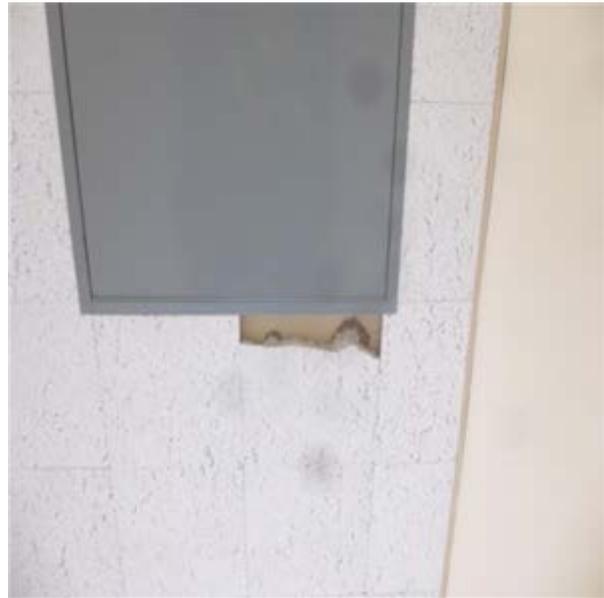
C3033 Glued Acoustic tile :- Broken tile

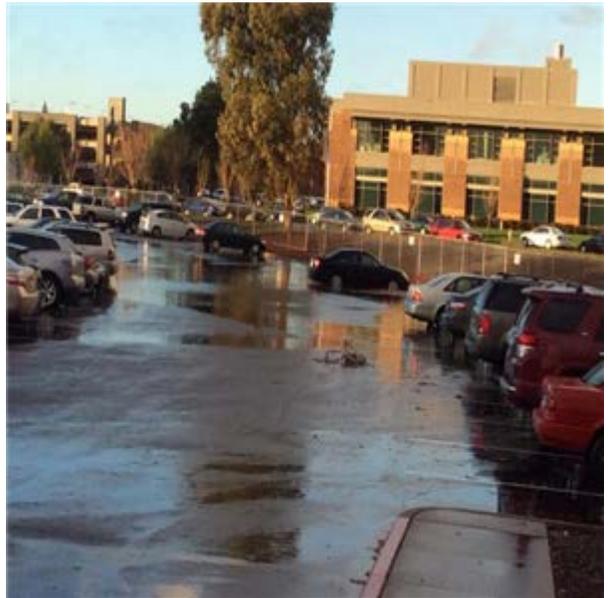
G2021 Asphalt pavement:- Flooded area after a minor rain storm

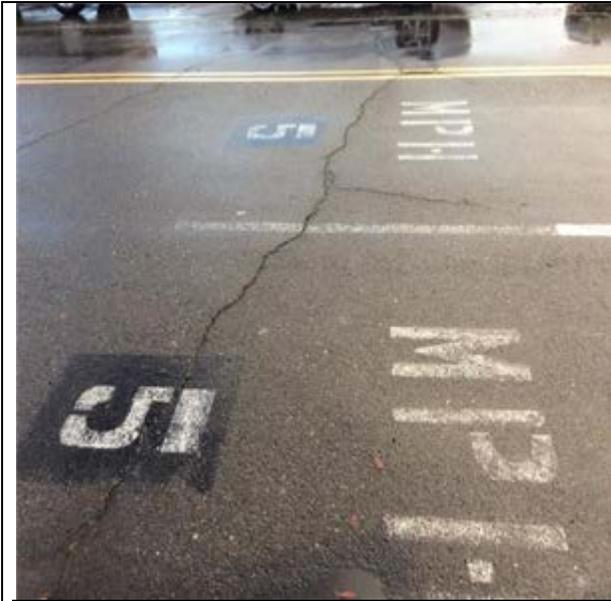
G2021 Asphalt pavement :- Wearing of the markings and pavement cracking

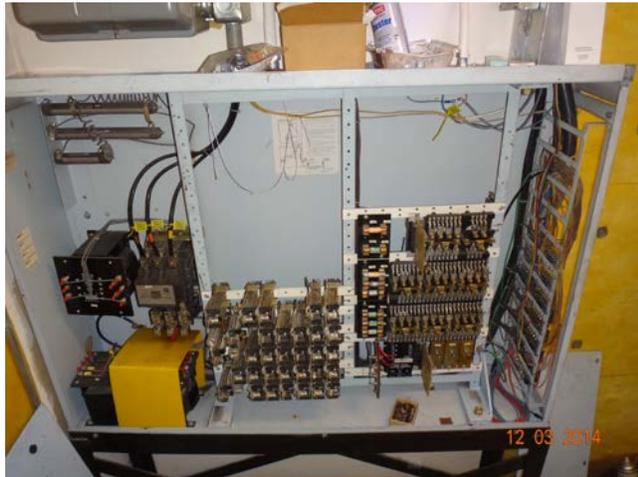
Controllers:

The controllers for were manufactured and installed by Westinghouse Elevator company during the original building construction in 1981. The controllers have old relay logic technology that is known to be reliable but have reached the end of their useful lives. If properly maintained the controllers should last another 3 to 5 years with no major updates.

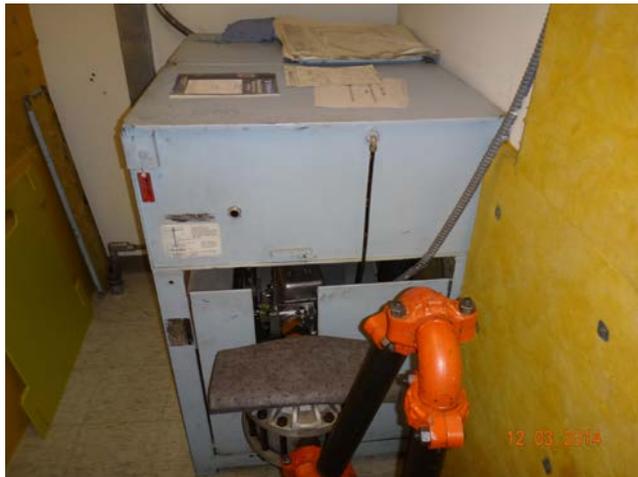
Hydraulic Power Units:

All the elevators have Westinghouse power units equipped with Maxton valves and IMO pumps. The machines were installed in 1981 when the building was erected. The machines are in relatively good condition considering their age. Full modernization is recommended in 3 to 5 years

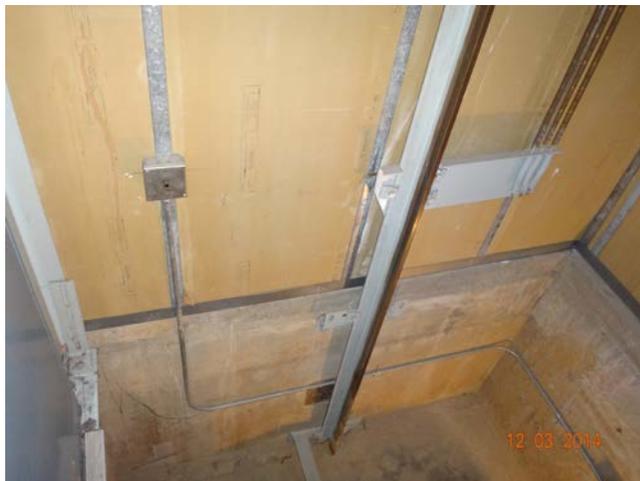
Car Guide Rails:

The car rails are in good condition but do not have seismic fish plates. During the proposed modernization, these could be installed. Upgrading the guide rails to current seismic standards is voluntary.

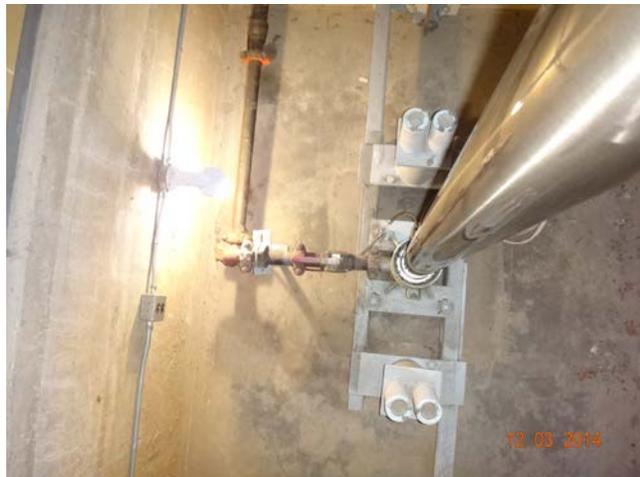
Pits:

The pits for are poured concrete with sump areas and metal grating. The pits were found to be clean and dry. Some of the jack seals need to be fixed. The pits are equipped with manual shut off valve but no seismic rupture valves were present. Seismic rupture valves will be required as part of the recommended full modernization.

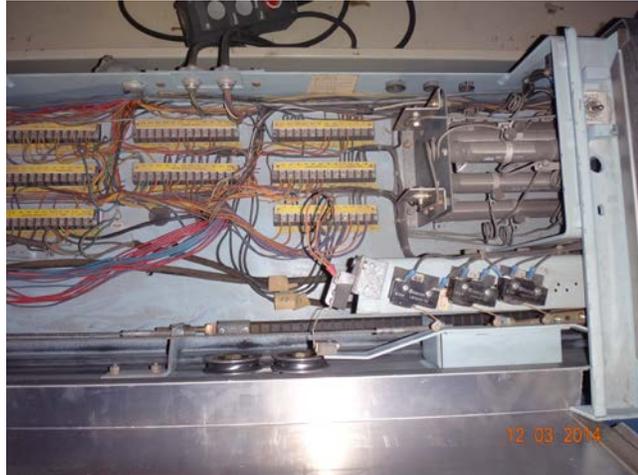
Door Operator:

The door operators are made by Westinghouse Elevator Company. The door operation was noted to be fair with room for improvement. None of the cars are equipped with door restrictors. Immediate installation is highly recommended, at a minimum during the proposed modernization.

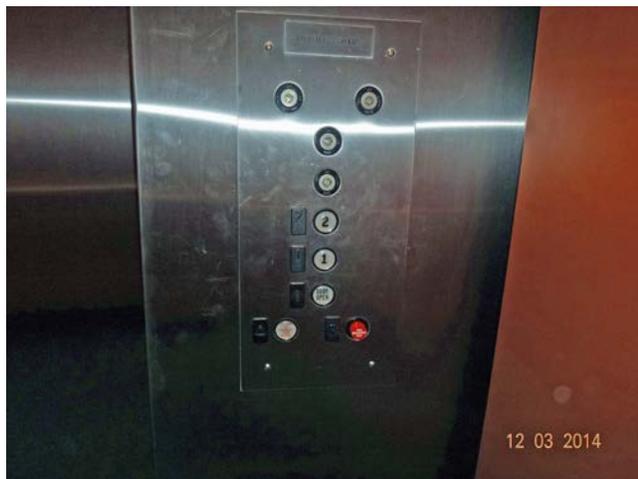
Car Operating Panels:

All the elevators have the original equipment Car Operating Panels (COP's). These should be replaced during the proposed modernization. The panels are in good condition; even though, the buttons had proper braille and are at the proper height they do not meet Title 24. The aesthetics is poor and the stop switch is not keyed as required by code.

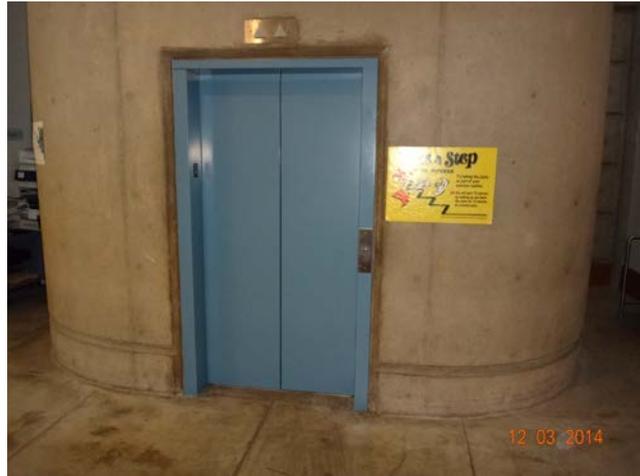
Hall Lanterns:

Hall lanterns inform persons waiting in the hall of which direction the elevator is about to travel in next. ADA requires that the hall lanterns illuminate and sound for the waiting passengers. The existing elevators have hall lanterns for each car. The lanterns have the proper gong for up and down. Some lanterns were inoperative during our survey. None of the cars were equipped with in-car position indicators.

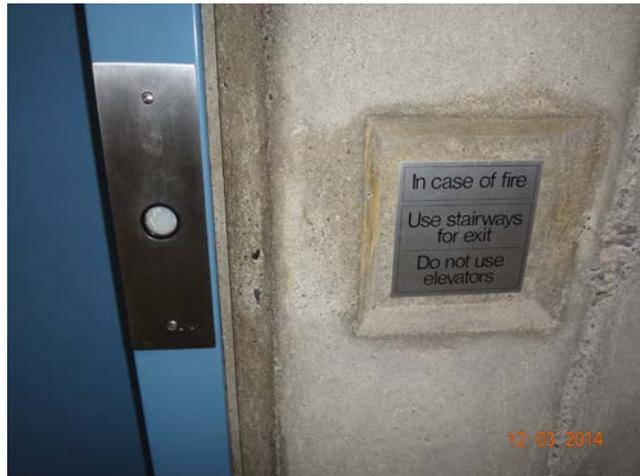
Hall Call Pushbuttons:

At each floor hall call push buttons are located so that users can call the elevator. The hall call stations do not have raised operation buttons which are required by California Title 24. During a modernization the fixtures and fire exit sign will be replaced.
