Warren-Alquist State Energy Building (008)

1516 9th Street, Sacramento, CA 95814

Facility Condition Assessment

June 2015

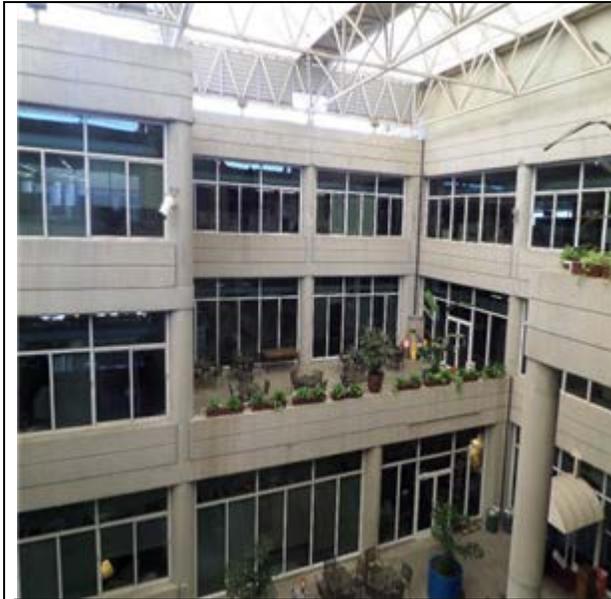
Item	Description
B2011 Exterior Wall Construction	B2011 - Stucco paint
Condition	Fair - Good
Qty / UOM	14000 / SF
RUL (years)	2
Location	Exteriors

B2011 - Stucco paint :- Painted Stucco

Based on RUL, repainting of the stucco exterior is recommended during the assessment period.

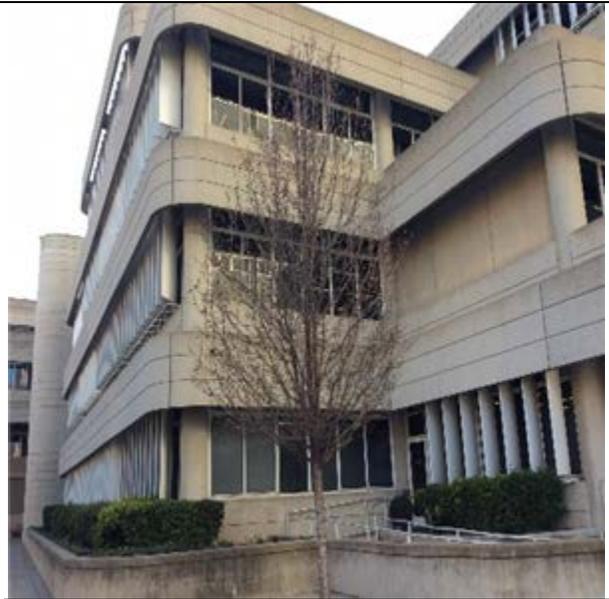
Building exterior concrete is stained by storm water. Small amounts of moss are present. Based on the condition, exterior power washing is recommended during the assessment period.

B2011 Unfinished Concrete:- Staining

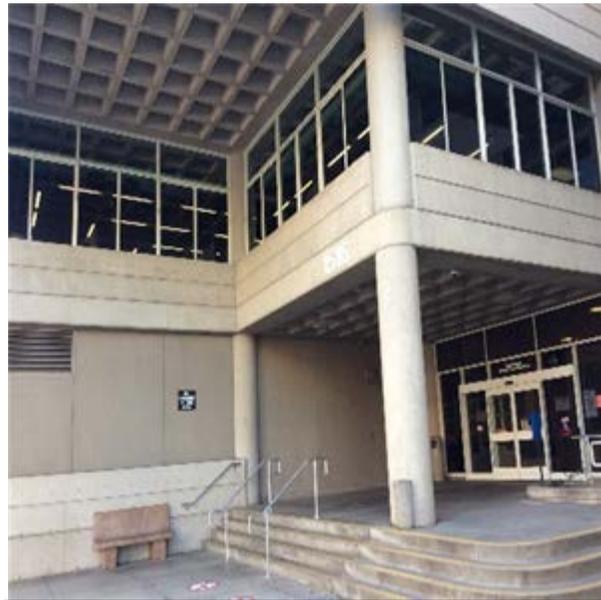
Isolated window leaks have been reported. Based on RUL, gasket replacement is recommended during the assessment period.

B2020- Storefronts :- Storefront door system

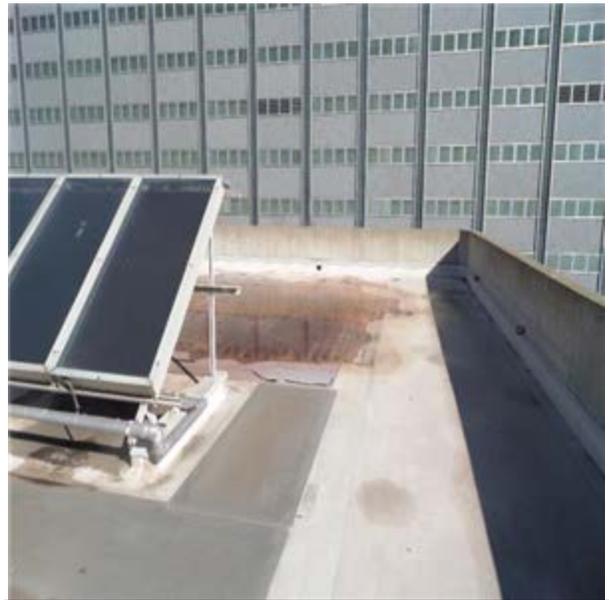
Item	Description
B3011 Roof Finishes	B3011 Single Ply Epdm with Insulation, Fully Adhered 45 Mills, Including Demo
Condition	Fair
Qty / UOM	400 / SQ
RUL (years)	3
Location	Roof
Roof Drainage	Internal Building Piping

B3011 Single Ply Epdm with Insulation, Fully Adhered 45 Mills, Including Demo:- Single Ply EPDM roof

Based on RUL, roofing replacement is recommended during the assessment period.

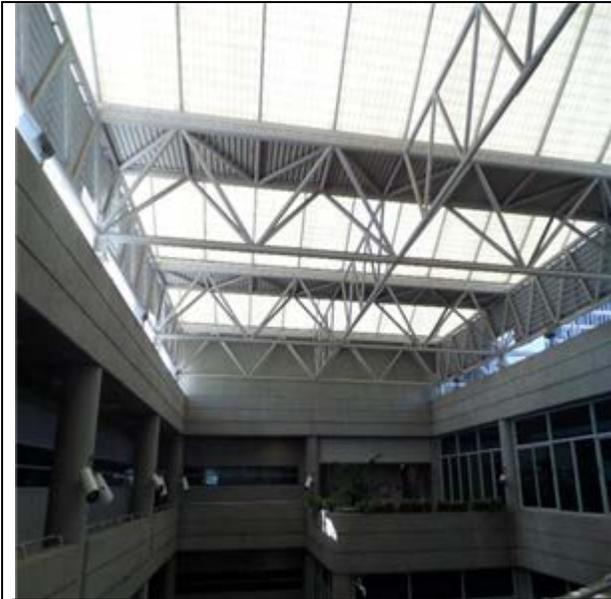
Skylights are comprised of polycarbonate panels, which are leaking, fading, and discoloring. Based on RUL, polycarbonate panel replacement is recommended during the assessment period.

B3011 Polycarbonate panels :- Polycarbonate panels

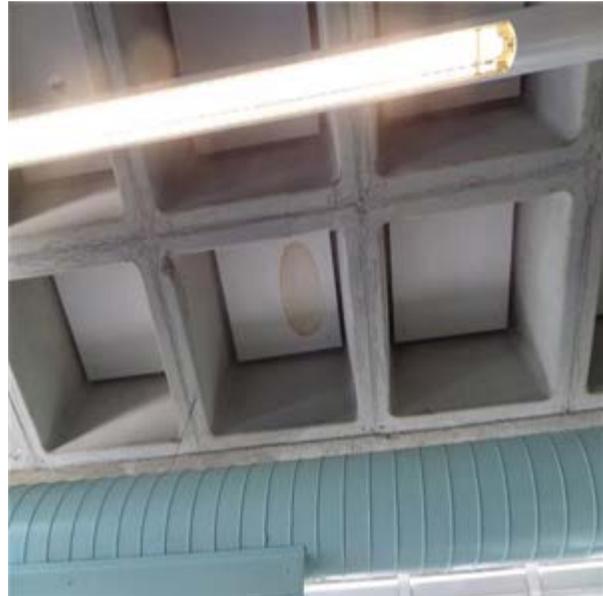
C3032 Acoustical Ceiling Tiles - Partial :- Damaged acoustic ceiling tile

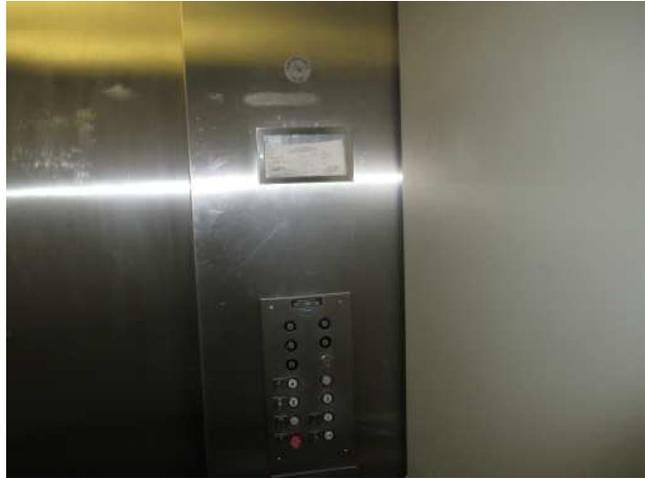
Car Operating Panels:

All the Car Operating Panels (COP's) are original. The panels are in good condition and meet all ADA but the buttons are not raised so they do not meet T24. Upgrading the buttons to raised caps is relatively easy to do.

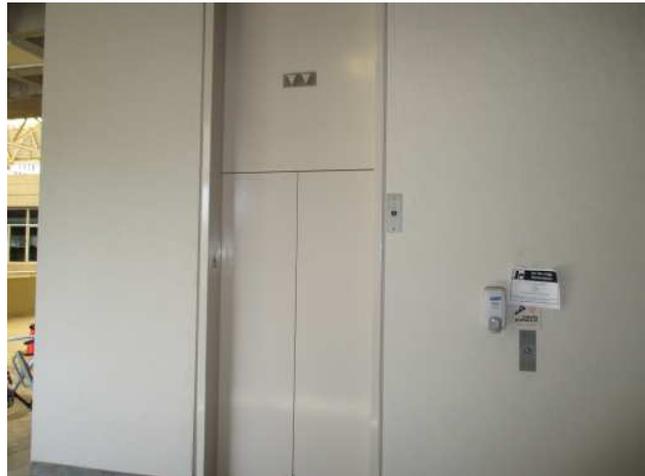
Hall Lanterns:

Hall lanterns inform persons waiting in the hall of which direction the elevator is about to travel in next. ADA requires that the hall lanterns illuminate and sound for the waiting passengers. The existing passenger elevators have hall lanterns for each car. The lanterns have the proper gong for up and down.

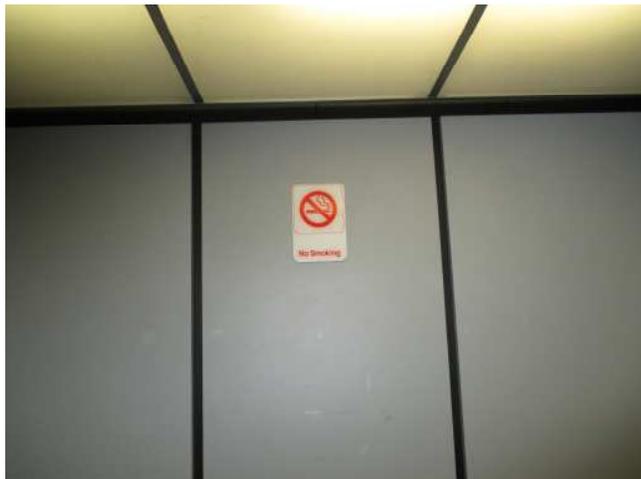
Wall Finish:

The existing cab interiors are in good condition and have the code required handrails, but are dated.
