Elihu M. Harris State Building (602)

1515 Clay Street, Oakland, CA 94612

Facility Condition Assessment

September 2015

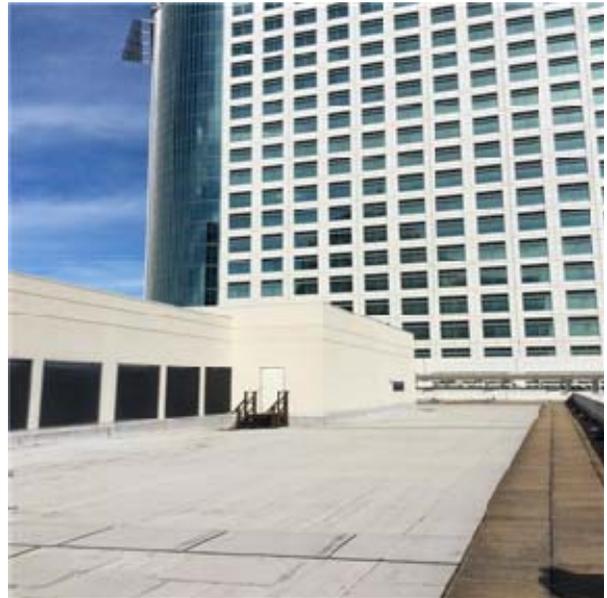
Item	Description
B3011 Roof Finishes	B3011 Modified Bitumen Roofing Membrane
Condition	Fair
Qty / UOM	880 / SQ
RUL (years)	3
Location	Flat Roofs

The flat roofs are granular surface modified bitumen with concrete pavers in several locations. The roofs are original to the building construction. Based on the remaining useful life (RUL) and condition, roof replacement is anticipated.

Type	Component Description	Qty / UOM	Unit Cost (\$)	Plan Type	Priority	Year	Expenditures (\$)
B3011	Replace B3011 Modified Bitumen Roofing Membrane	880.0 - SQ	1806.4	IN - Beyond Rated Life	Priority 2	2018	1,589,595

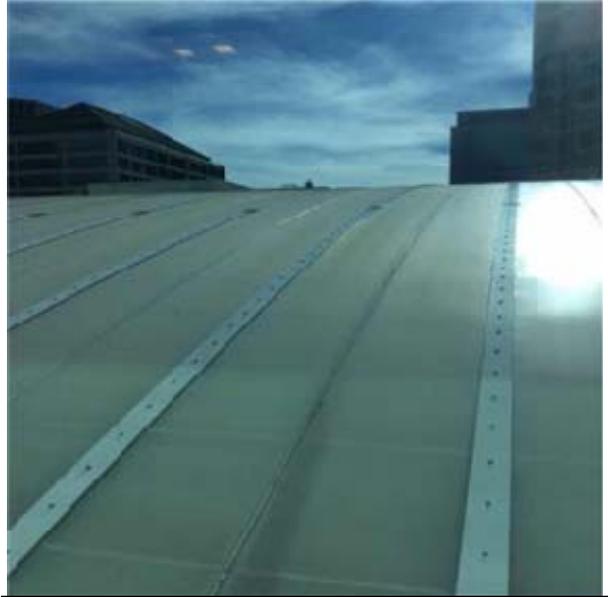
Item	Description
B3021 Glazed Roof Openings	B3021 Curved Plexi-Glas Panels
Condition	Fair
Qty / UOM	3,600 / SF
RUL (years)	13
Location	Atrium

Replacement of Curved Plexi-Glas Panels is not required, however, the panels should be resealed within the next 12 months.

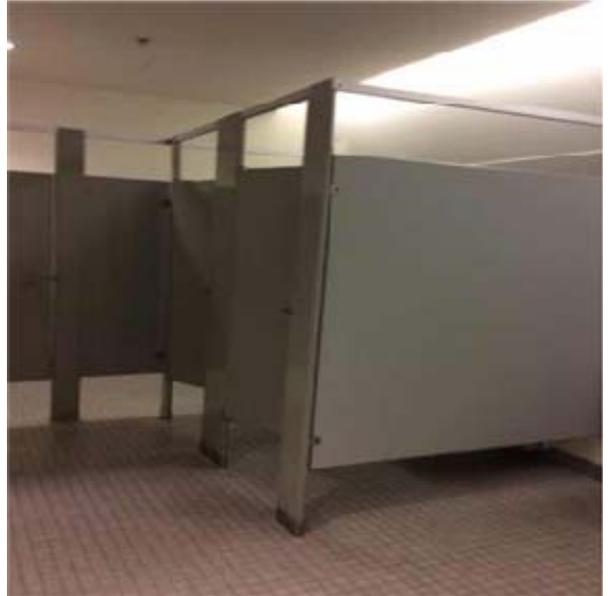
CI014 Toilet Partitions

Item	Description
C1014 Site Built Toilet Partitions	C1014 Toilet Partitions
Condition	Fair
Qty / UOM	60 / EA
RUL (years)	3
Location	Restrooms

Based on RUL and condition, toilet partition replacement is anticipated during the term.

Type	Component Description	Qty / UOM	Unit Cost (\$)	Plan Type	Priority	Year	Expenditures (\$)
C1014	Replace C1014 Toilet Partitions	60.0 - EA	2182.4	IN - Beyond Rated Life	Priority 3	2018	130,944

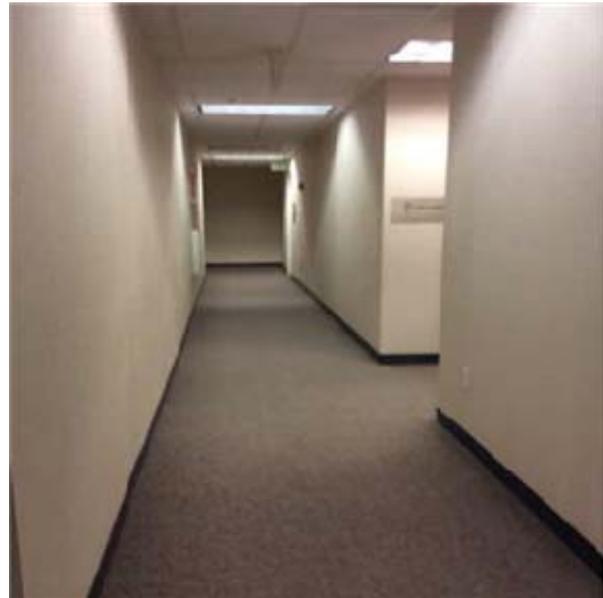
Item	Description
C3012 Wall Finishes to Interior Walls	C3012 Paint Interior Walls, Drywall
Condition	Fair
Qty / UOM	528,000 / SF
RUL (years)	3
Location	Throughout interior

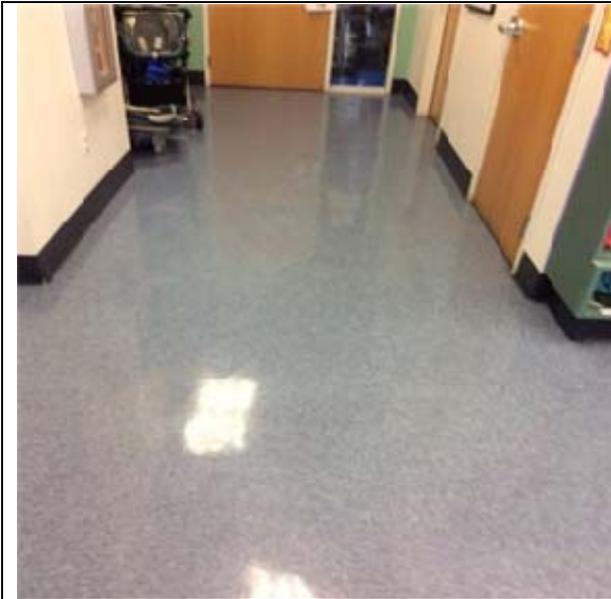
Item	Description
C3024 Flooring	C3024 Vinyl Tile
Condition	Good
Qty / UOM	2,200 / SY
RUL (years)	5
Location	Entire Facility

Based on RUL, vinyl tile replacement is anticipated during the assessment period.

Type	Component Description	Qty / UOM	Unit Cost (\$)	Plan Type	Priority	Year	Expenditures (\$)
C3024	Replace C3024 Vinyl Tile	2,200.0 - SY	125.8	IN - Appearance	Priority 4	2020	276,716

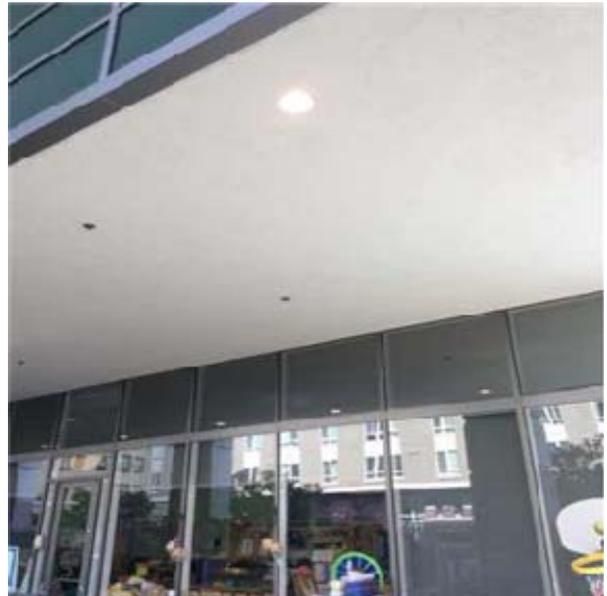
Item	Description
C3031 Ceiling Finishes	C3031 Painted Drywall Ceilings
Condition	Fair
Qty / UOM	48,000 / SF
RUL (years)	3
Location	Restrooms and select locations

Based on RUL and condition, repainting of drywall ceiling is anticipated.

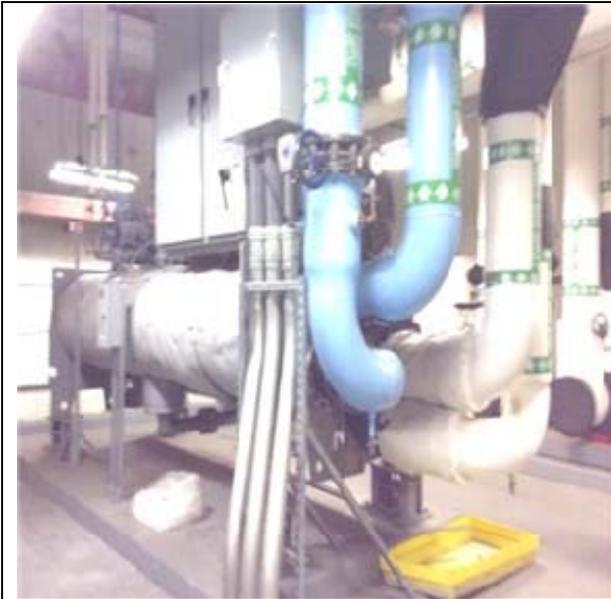
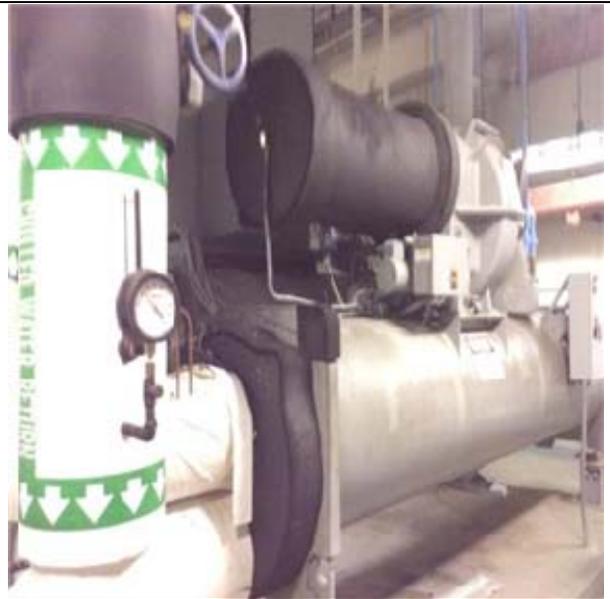
- One of the chillers is currently inoperative. Immediate replacement is recommended.
- The direct digital control (DDC) system is original and in need of a software and hardware upgrade.
- According to management staff, some surveillance cameras are inoperative and perimeter security lighting is lacking. The system should be repaired and additional lights installed.
