Governor Edmund G. "Pat" Brown Building (418)

505 Van Ness Avenue, San Francisco, CA 94102

Facility Condition Assessment

September 2015

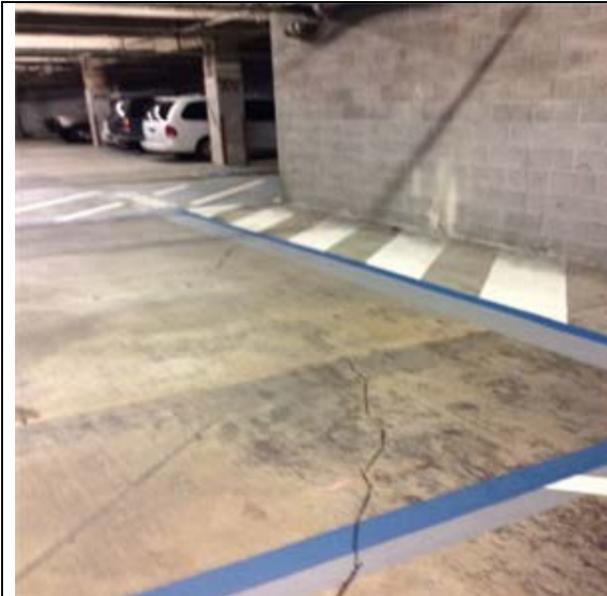
Item	Description
A1031 Standard Slab on Grade	A1031 Standard Slab on Grade
Condition	Fair
Qty / UOM	383,500 / SF
RUL (years)	19
Location	Entire Facility

Based on current condition and RUL, no further action is recommended.

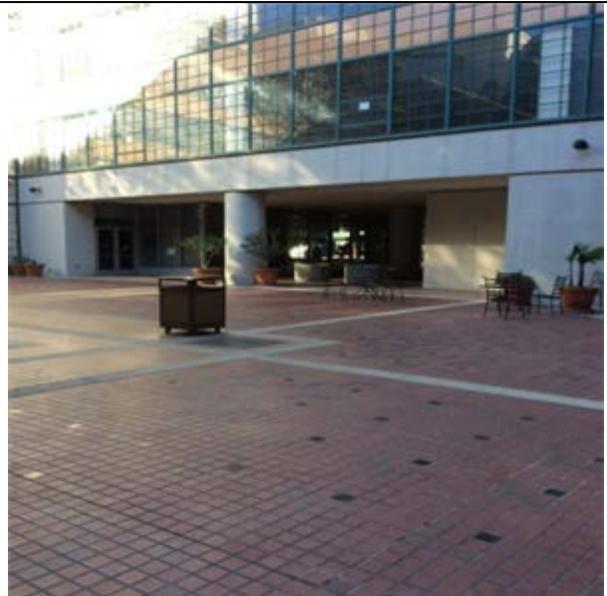
Item	Description
B1012 Upper Floors Construction	B1010 Cast-in-place Concrete Beams and Floor Slabs
Condition	Fair
Qty / UOM	383,505 / SF
RUL (years)	19
Location	Entire Facility

Based on current condition and RUL, no further action is recommended.

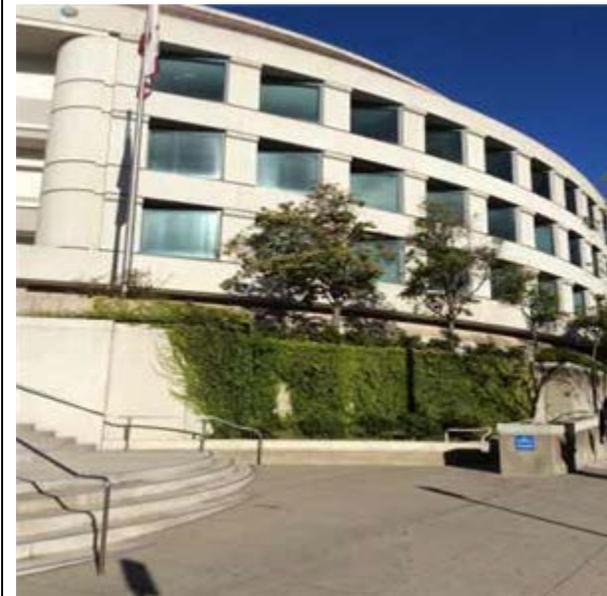
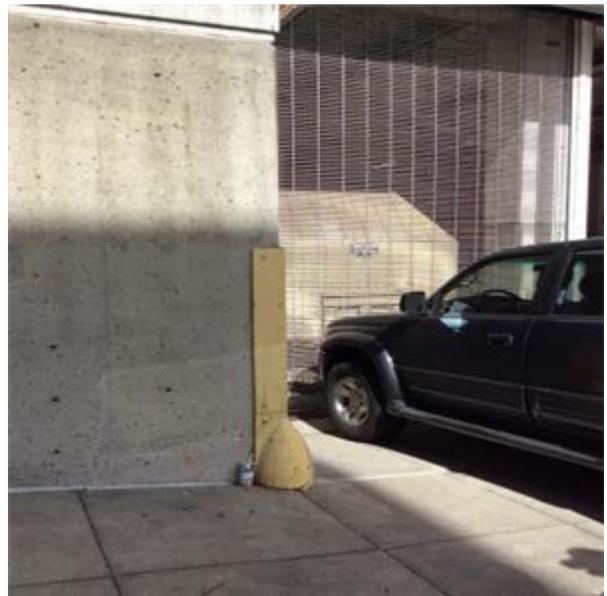
Item	Description
B2011 Exterior Wall Construction	B2011 Exterior Concrete Walls
Condition	Fair
Qty / UOM	92,000 / SF
RUL (years)	10
Location	Exterior Walls

Based on current condition and RUL, no further action is recommended.

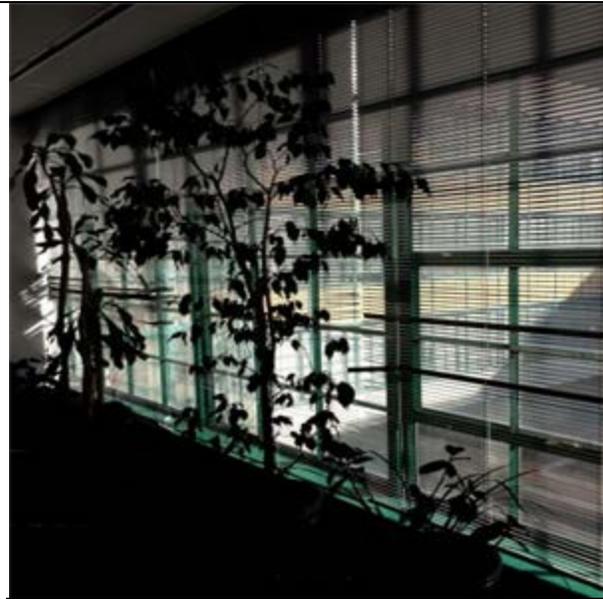
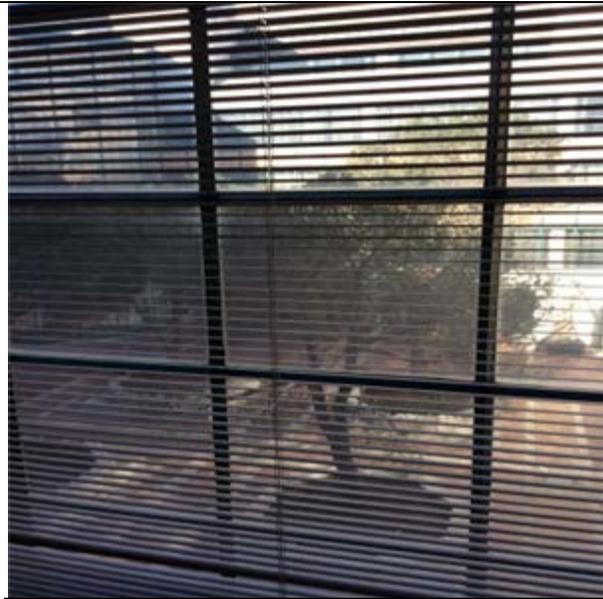
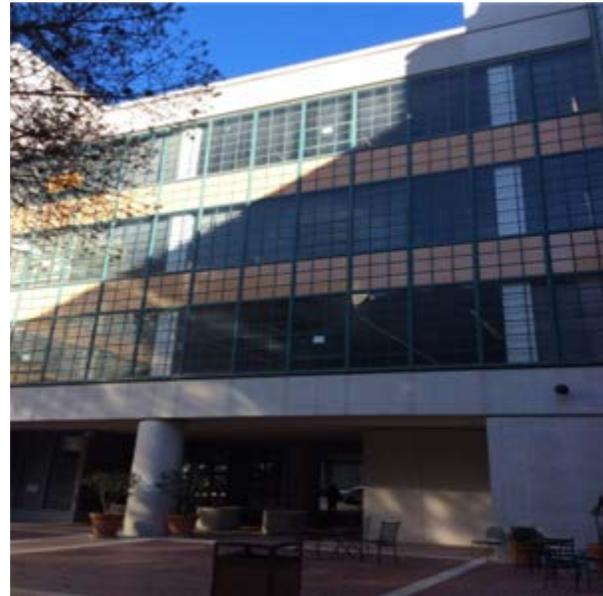
Item	Description
B2021 Windows	B2021 Aluminum Windows
Condition	Fair
Qty / UOM	1,500 / EA
RUL (years)	2
Location	Windows

Based on current condition and RUL, replacement is recommended during the assessment term.

Type	Component Description	Qty / UOM	Unit Cost (\$)	Plan Type	Priority	Year	Expenditures (\$)
B2021	Replace B2021 Aluminum Windows	1,500.0 - EA	3614.8	IN - Beyond Rated Life	Priority 2	2017	5,422,198

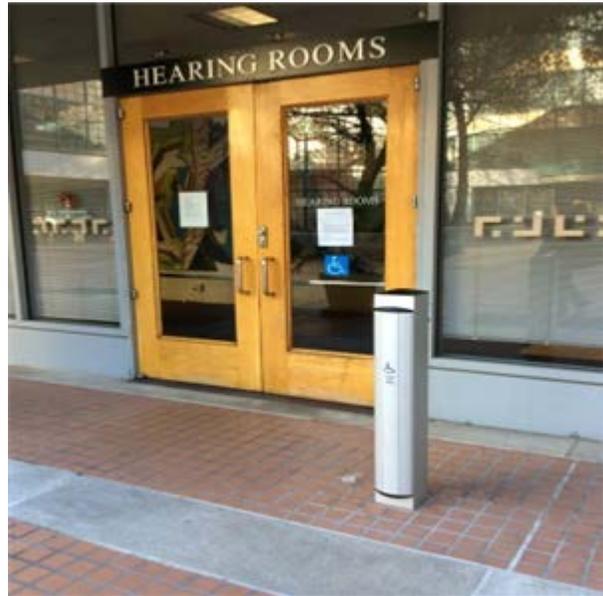
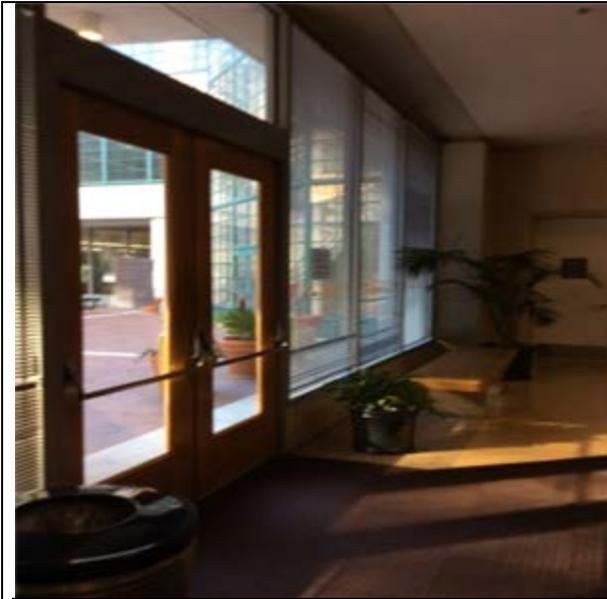
Item	Description
B2031 Glazed Doors & Entrances	B2031 Glazed Entrance Doors
Condition	Fair
Qty / UOM	28 / EA
RUL (years)	2
Location	Entrance Doors

Based on current condition and RUL, replacement is recommended during the assessment term.

Type	Component Description	Qty / UOM	Unit Cost (\$)	Plan Type	Priority	Year	Expenditures (\$)
B2031	Replace B2031 Glazed Entrance Doors	28.0 - EA	4335.5	IN - Beyond Rated Life	Priority 2	2017	121,394

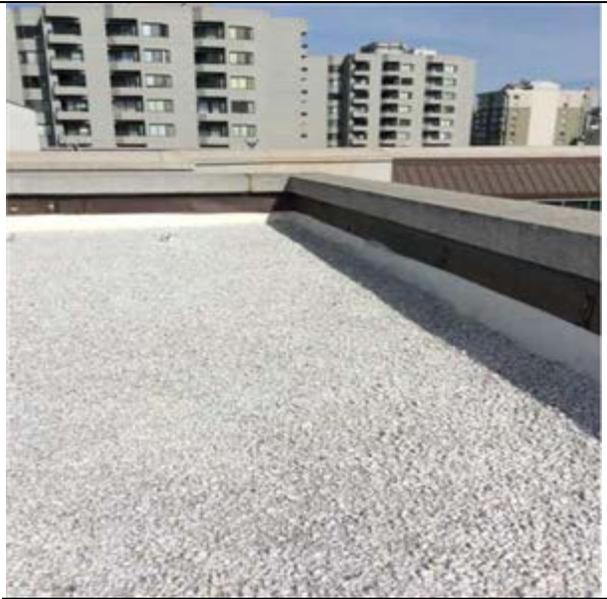
Item	Description
B3011 Roof Finishes	B3011 Built-Up Roofing
Condition	Fair
Qty / UOM	410 / SQ
RUL (years)	1
Location	Roof Covering

Based on current condition and RUL, replacement is recommended during the assessment term.

Type	Component Description	Qty / UOM	Unit Cost (\$)	Plan Type	Priority	Year	Expenditures (\$)
B3011	Replace B3011 Built-Up Roofing	410.0 - SQ	1861.5	IN - Beyond Rated Life	Priority 1	2016	763,200

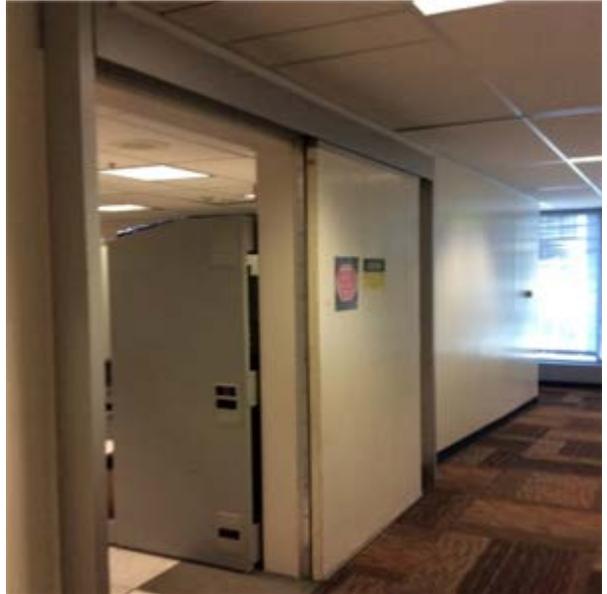
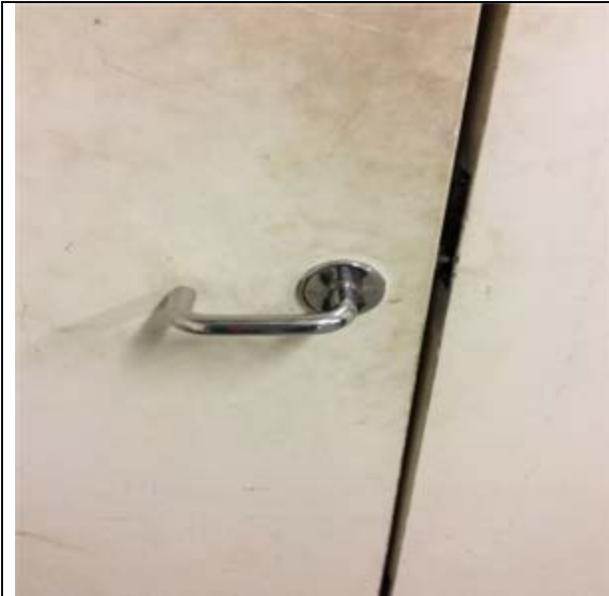
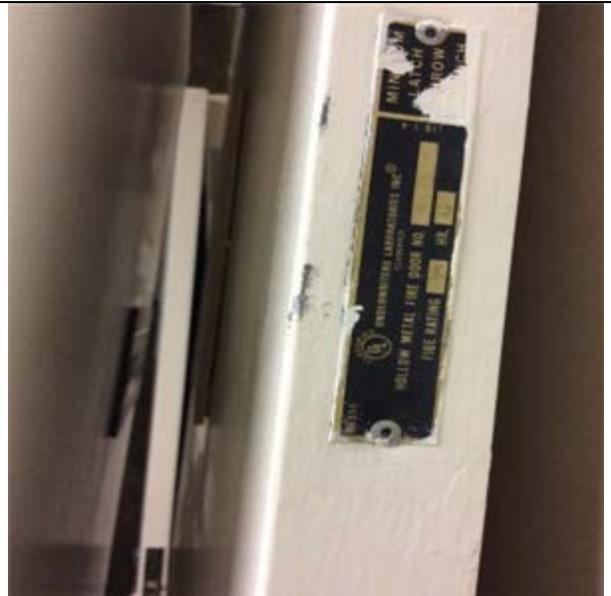
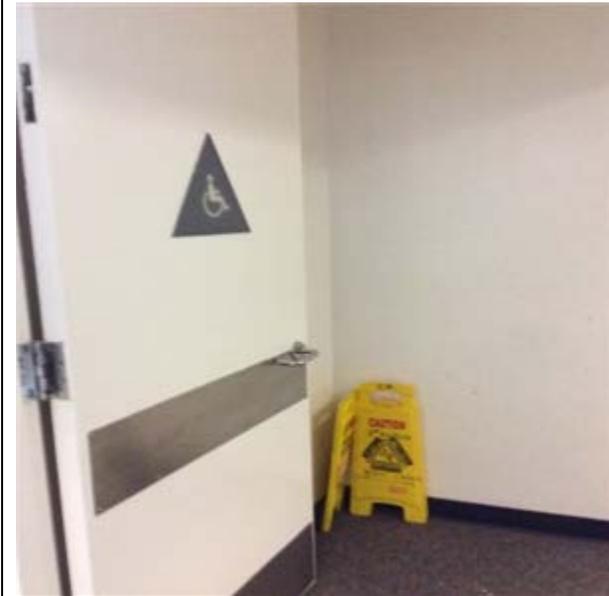
Item	Description
C1021 Interior Doors	C1021 Interior Doors
Condition	Fair
Qty / UOM	655 / EA
RUL (years)	3
Location	Interior Doors

Based on current condition and RUL, replacement is recommended during the assessment term.

Type	Component Description	Qty / UOM	Unit Cost (\$)	Plan Type	Priority	Year	Expenditures (\$)
C1021	Replace C1021 Interior Doors	655.0 - EA	2403.1	IN - Beyond Rated Life	Priority 3	2018	1,574,044

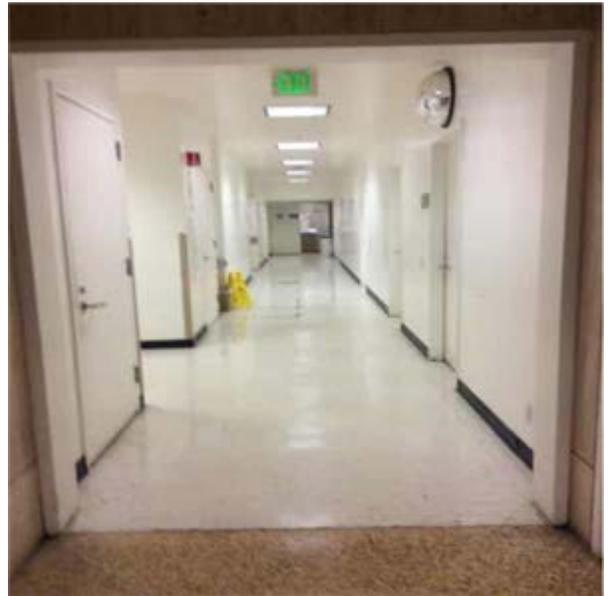
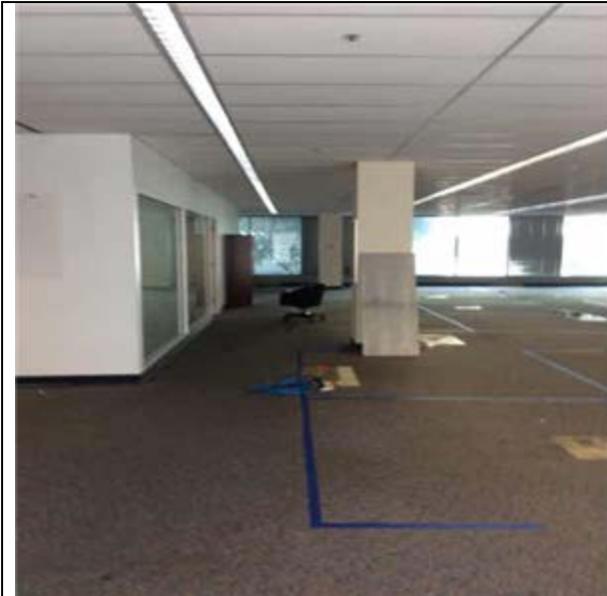
Item	Description
C3012 Wall Finishes to Interior Walls	C3012 Paint Interior Walls, Drywall
Condition	Fair
Qty / UOM	219,892 / SF
RUL (years)	3
Location	Interiors

Based on current condition and RUL, repainting the interior walls is recommended during the assessment term.

Type	Component Description	Qty / UOM	Unit Cost (\$)	Plan Type	Priority	Year	Expenditures (\$)
C3012	Replace C3012 Paint Interior Walls, Drywall	219,892.0 - SF	2.1	IN - Appearance	Priority 3	2018	468,986

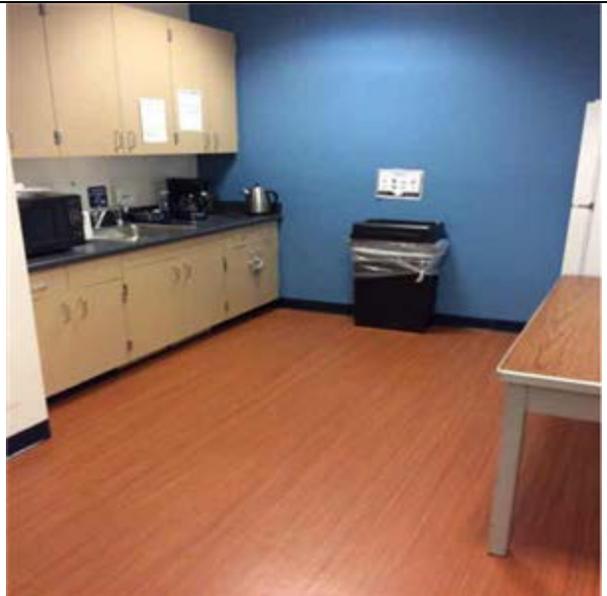
Item	Description
C3024 Flooring	C3020 Vinyl Tile
Condition	Fair
Qty / UOM	19,610 / SY
RUL (years)	2
Location	Interior Flooring

Based on current condition and RUL, replacement is recommended during the assessment term.

Type	Component Description	Qty / UOM	Unit Cost (\$)	Plan Type	Priority	Year	Expenditures (\$)
C3024	Replace C3020 Vinyl Tile	19,610.0 - SY	125.8	IN - Appearance	Priority 3	2017	2,466,550

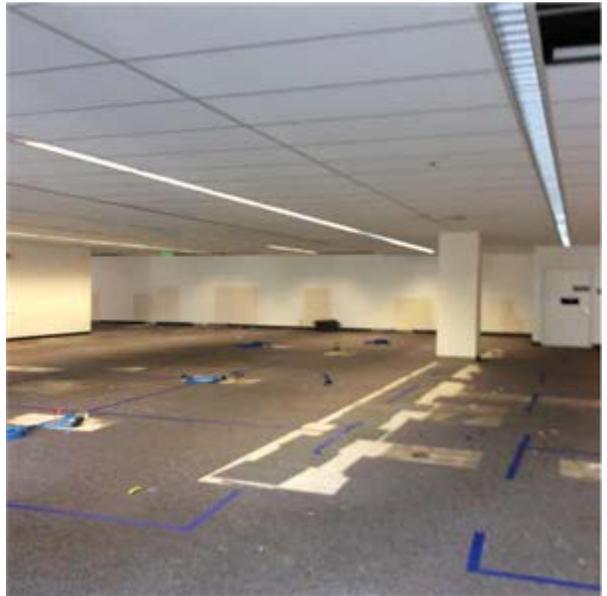
C3025 Carpeting:- Interior construction

Item	Description
C3025 Carpeting	C3025 Carpeting
Condition	Fair
Qty / UOM	17,445 / SY
RUL (years)	2
Location	Interior Flooring

Based on current condition and RUL, replacement is recommended during the assessment term.

Type	Component Description	Qty / UOM	Unit Cost (\$)	Plan Type	Priority	Year	Expenditures (\$)
C3025	Replace C3025 Carpeting	17,445.0 - SY	96.6	IN - Appearance	Priority 3	2017	1,685,285

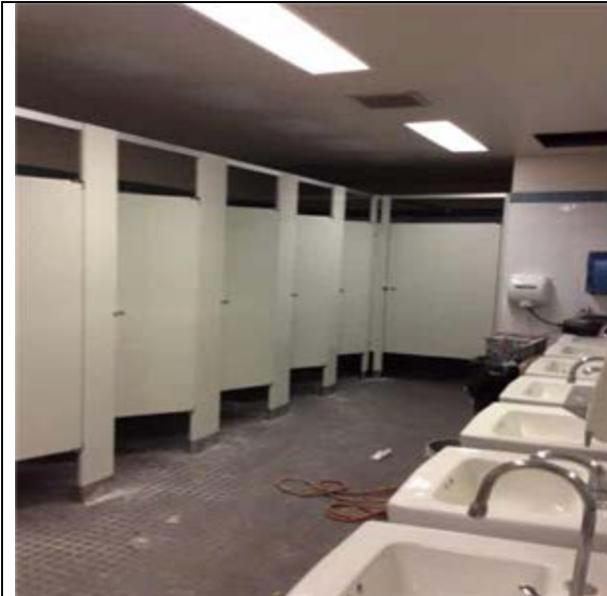
Item	Description
C3031 Ceiling Finishes	C3031 Drywall – Painted Finished Ceilings
Condition	Fair
Qty / UOM	68,000 / SF
RUL (years)	2
Location	Interior Ceiling

Based on current condition and RUL, repainting the interior painted ceilings is recommended during the assessment term.

Type	Component Description	Qty / UOM	Unit Cost (\$)	Plan Type	Priority	Year	Expenditures (\$)
C3031	Replace C3031 Drywall – Painted Finished Ceilings	68,000.0 - SF	4.5	IN - Appearance	Priority 3	2017	308,611

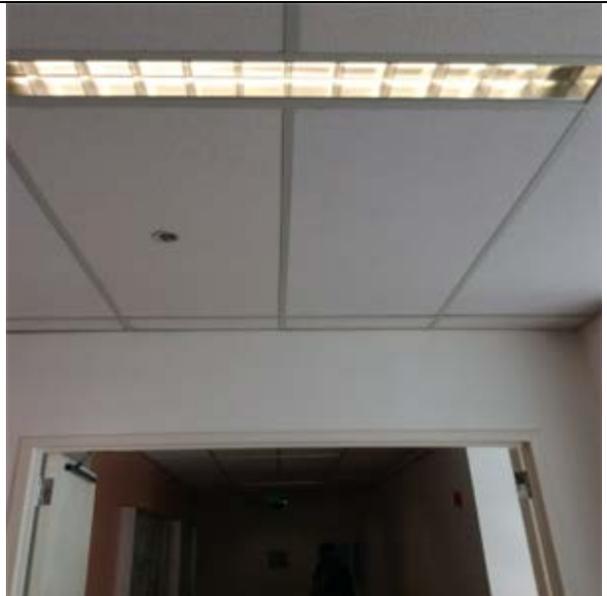
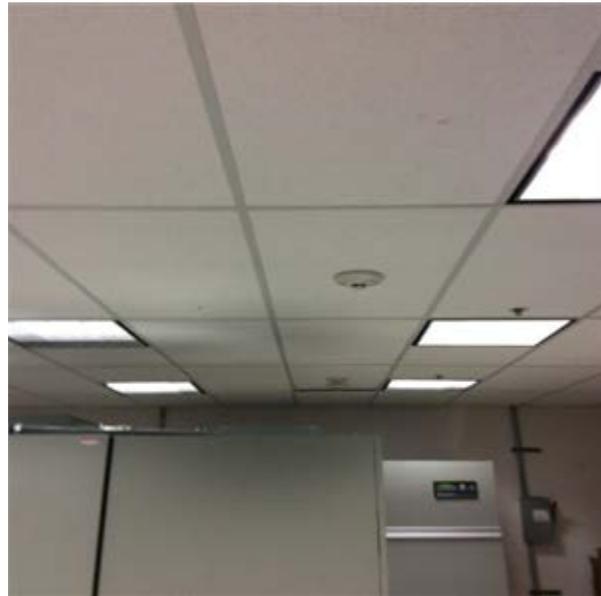
Item	Description
C3032 Suspended Ceilings	C3032 Acoustical Ceiling Tile
Condition	Fair
Qty / UOM	2,835 / CSF
RUL (years)	5
Location	Interior Ceiling

Based on current condition and RUL, replacement is recommended during the assessment term, at the same time as the fire sprinkler replacement.

Type	Component Description	Qty / UOM	Unit Cost (\$)	Plan Type	Priority	Year	Expenditures (\$)
C3032	Replace C3032 Acoustical Ceiling Tile	2,835.0 - CSF	1201.6	IN - Appearance	Priority 4	2020	3,406,423
