Ronald M. George State Office Complex/ Hiram W. Johnson Building (402)

455 Golden Gate Ave., San Francisco, CA 94104

Facility Condition Assessment

September 2015

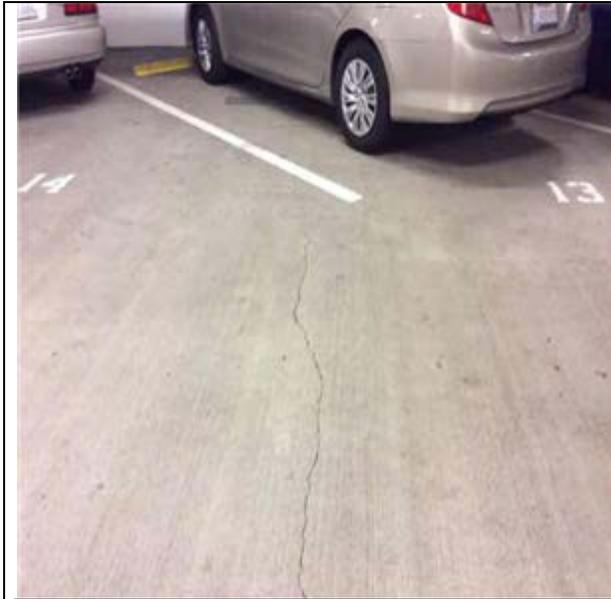
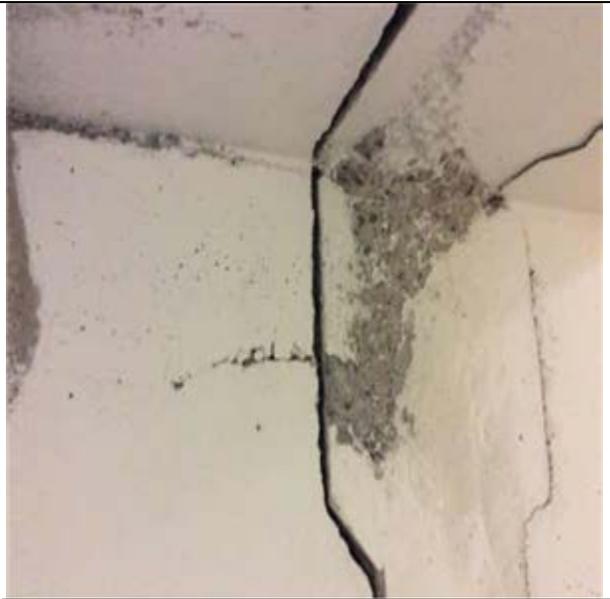
| Item | Description |
|---|---|
| A1027 Pressure Injected Grouting | A1027 Concrete Slab - Crack Repair |
| Condition | Fair |

A1027 Concrete Slab - Crack Repair

Repair concrete slab cracks with epoxy injection during the assessment period.

| Type | Component Description | Qty / UOM | Unit Cost (\$) | Plan Type | Priority | Year | Expenditures (\$) |
|---|--|---|---|---|---|---|---|
| A1027 | Replace A1027 Concrete Slab - Crack Repair | 150.0 - LF | 101.5 | OP - Maintenance | Priority 1 | 2015 | 15,228 |

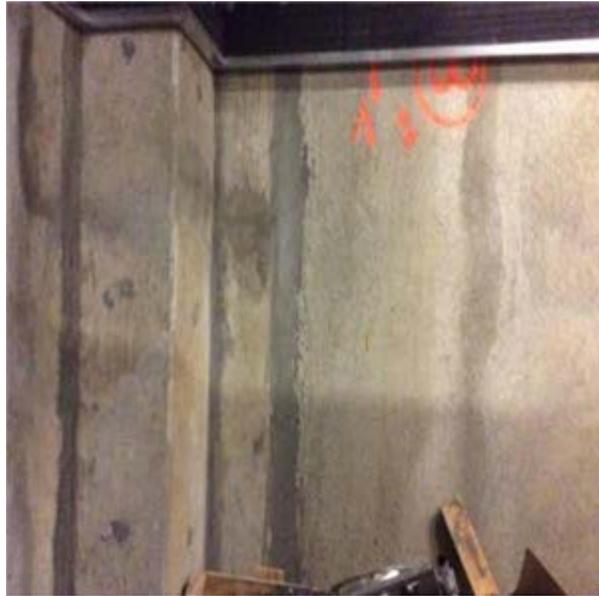
| Item | Description |
|---|---|
| A2022 Moisture Protection | A2020 Basement Walls - Waterproofing |
| Condition | Poor |

There are signs of water intrusion at basement north walls. Waterproof coating is recommended.

A2020 Basement Walls - Waterproofing

| Type | Component Description | Qty / UOM | Unit Cost (\$) | Plan Type | Priority | Year | Expenditures (\$) |
|---|--|---|---|---|---|---|---|
| A2022 | Replace A2020 Basement Walls - Waterproofing | 1,250.0 - SF | 4.6 | OP - Maintenance | Priority 1 | 2015 | 5,756 |

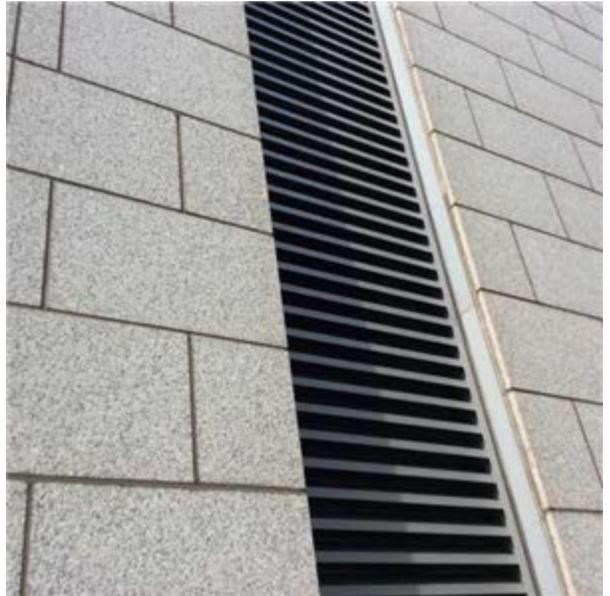
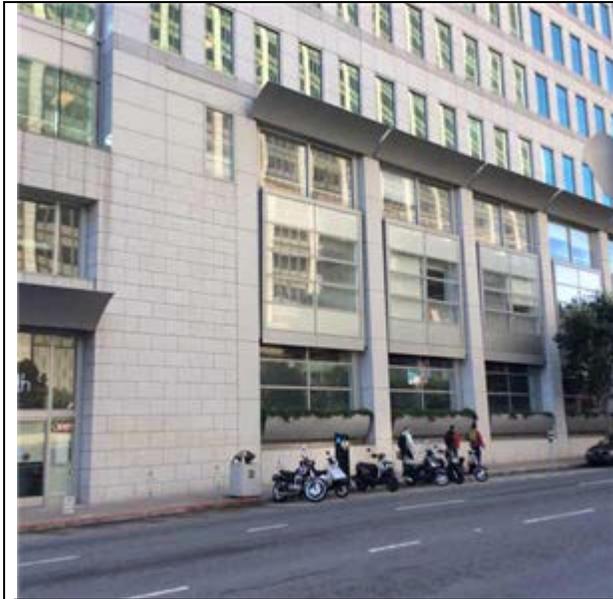
B2011 Exterior Walls

| Type | Component Description | Qty / UOM | Unit Cost (\$) | Plan Type | Priority | Year | Expenditures (\$) |
|---|---|---|---|---|---|---|---|
| B2011 | B2011 Replace damaged joint sealant as needed | 12,391.0 - LF | 7.4 | OP - Maintenance | Priority 2 | 2017 | 91,569 |

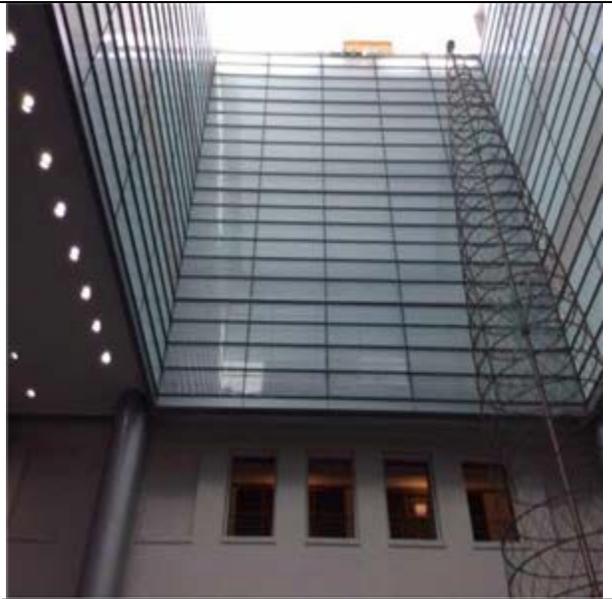
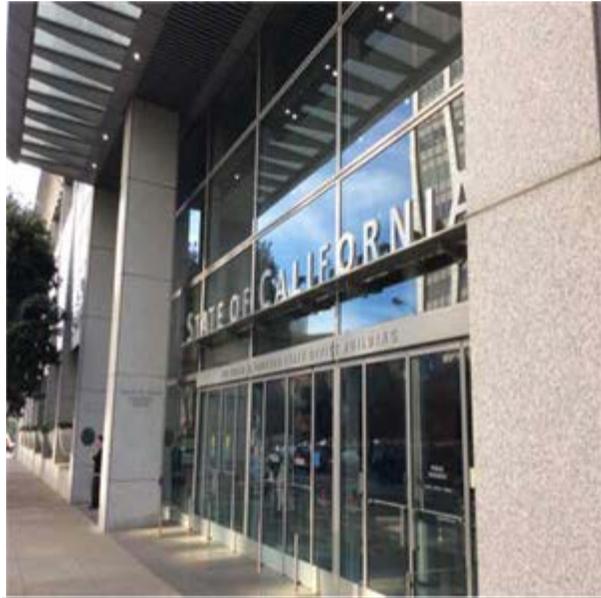
The curtain walls at the main lobby and light wells were installed in 1998. Re-sealing windows and replacing gaskets during the term is recommended.

B2021 Windows /Curtain Walls

| Type | Component Description | Qty / UOM | Unit Cost (\$) | Plan Type | Priority | Year | Expenditures (\$) |
|---|---|---|---|---|---|---|---|
| B2021 | B2021 Re-seal windows and replace gaskets | 3,950.0 - LF | 15.4 | OP - Maintenance | Priority 3 | 2018 | 60,633 |

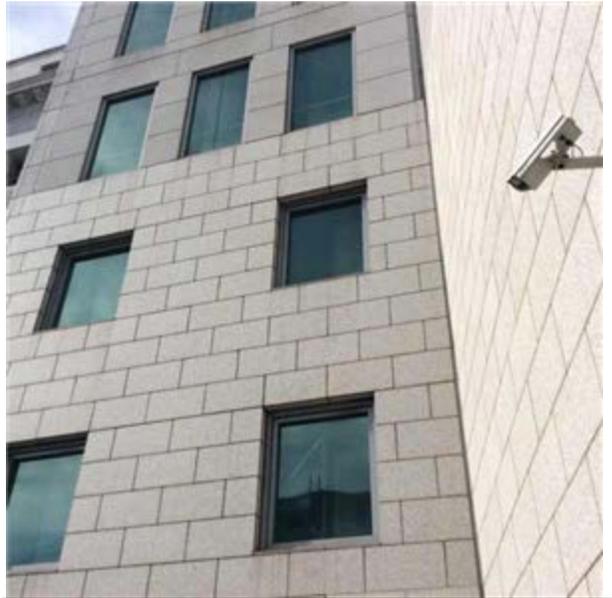
There are 234 single-pane metal windows installed in 1998. Re-sealing windows and replacing gaskets during the term is recommended.

B2021 Windows, Single Pane Metal

| Type | Component Description | Qty / UOM | Unit Cost (\$) | Plan Type | Priority | Year | Expenditures (\$) |
|---|---|---|---|---|---|---|---|
| B2021 | B2021 Replace caulking | 3,950.0 - LF | 15.4 | OP - Maintenance | Priority 2 | 2016 | 60,633 |

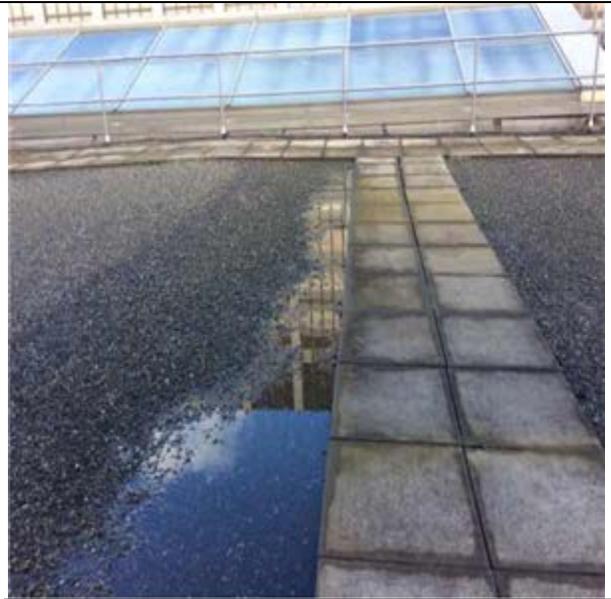
Based on remaining useful life (RUL), roof replacement is anticipated during the assessment period.

B3011 Built-up Roof

| Type | Component Description | Qty / UOM | Unit Cost (\$) | Plan Type | Priority | Year | Expenditures (\$) |
|---|---|---|---|---|---|---|---|
| B3011 | Replace B3011 Built-up Roof | 206.0 - SQ | 1861.5 | IN - Beyond Rated Life | Priority 2 | 2018 | 383,461 |

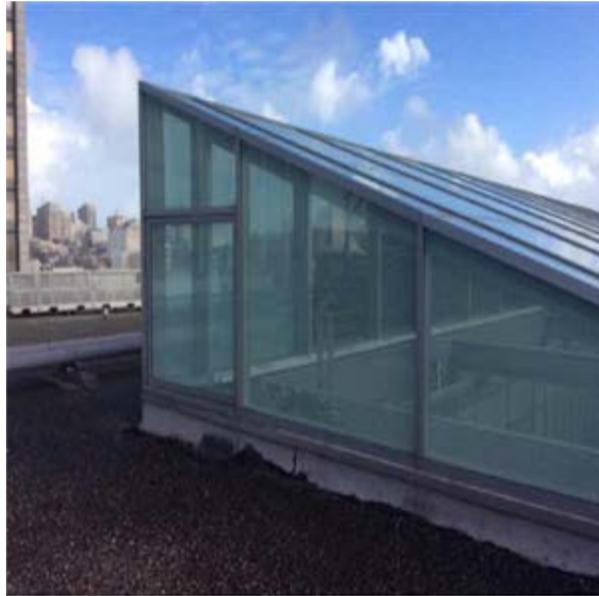
Based on conversation with maintenance staff, the two skylights over the light wells have water leakage problems. A project is in place to repair these during the term.

B3021 Glass Skylight

| Type | Component Description | Qty / UOM | Unit Cost (\$) | Plan Type | Priority | Year | Expenditures (\$) |
|---|---|---|---|---|---|---|---|
| B3021 | Replace B3021 Glass Skylight | 7,500.0 - SF | 114.4 | OP - Maintenance | Priority 1 | 2015 | 858,204 |

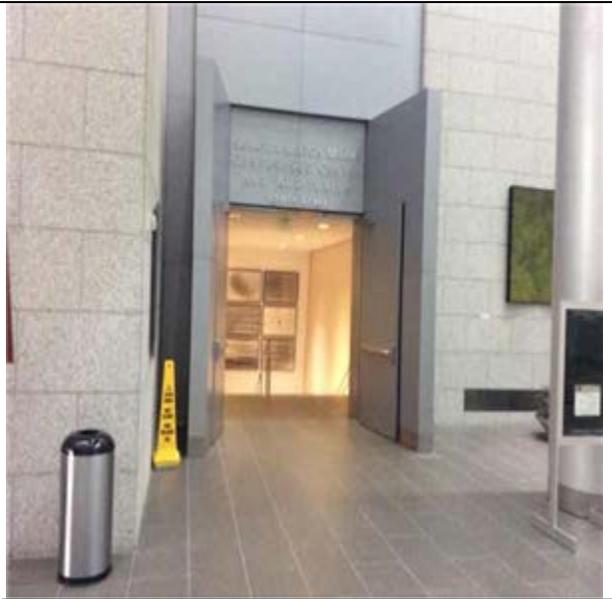
According to the DGS access barrier plans dated October 2014, adding directional signage at lobby area and hallways as part of ADA accessibility requirement is recommended.

C1035 Directional Signage

| Type | Component Description | Qty / UOM | Unit Cost (\$) | Plan Type | Priority | Year | Expenditures (\$) |
|---|---|---|---|---|---|---|---|
| C1035 | Replace C1035 Directional Signage | 14.0 - EACH | 316.2 | CC - Accessibility | Priority 1 | 2015 | 4,427 |

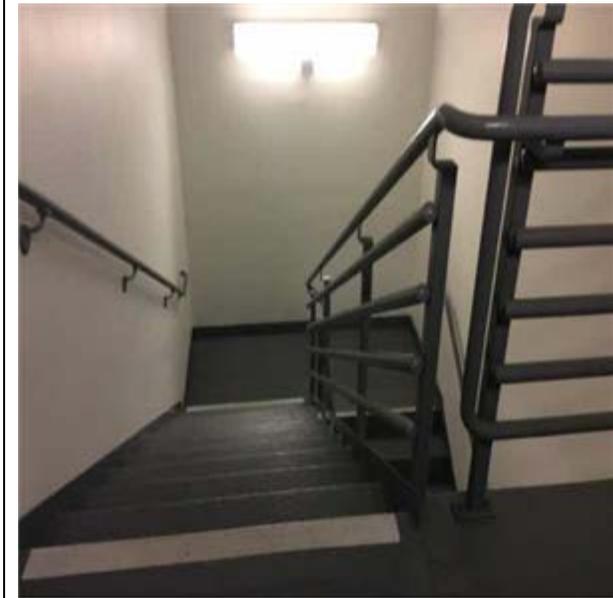
There are six fire exit stairs with concrete flooring, and additional stairs near elevators with terrazzo flooring. Recommend periodic refinishing of terrazzo flooring, no further action required.

C2011 Fire Exit Stairs

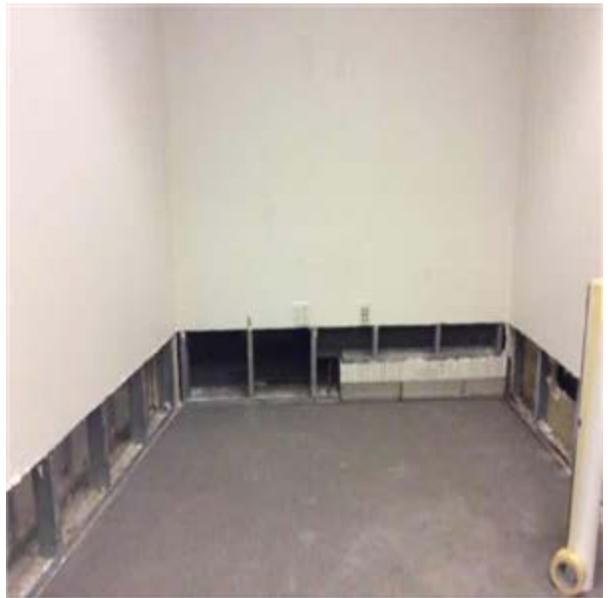
Based on conversation with maintenance staff, a mold issue exists due to water leakage in the fifth floor northwest meeting room. Mold and air quality evaluations are recommended.

C3015 Mold Evaluation

| Type | Component Description | Qty / UOM | Unit Cost (\$) | Plan Type | Priority | Year | Expenditures (\$) |
|---|---|---|---|---|---|---|---|
| C30 | Replace C3015 Mold Evaluation | 1.0 - EA | 13640.0 | EN - Air/ Water Quality | Priority 1 | 2015 | 13,640 |

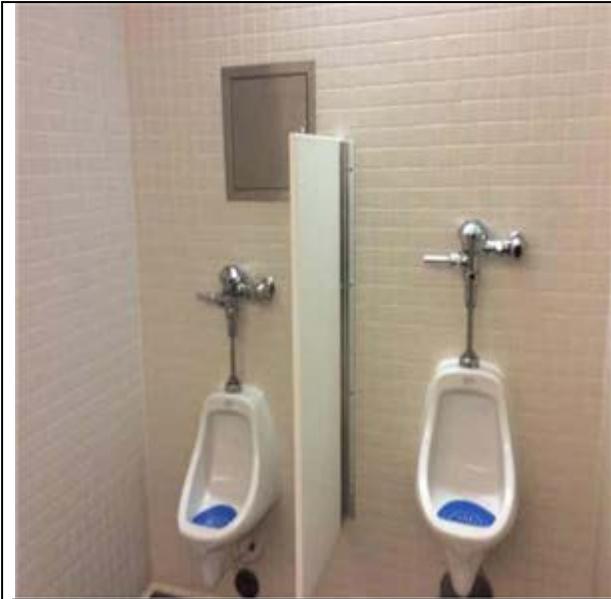
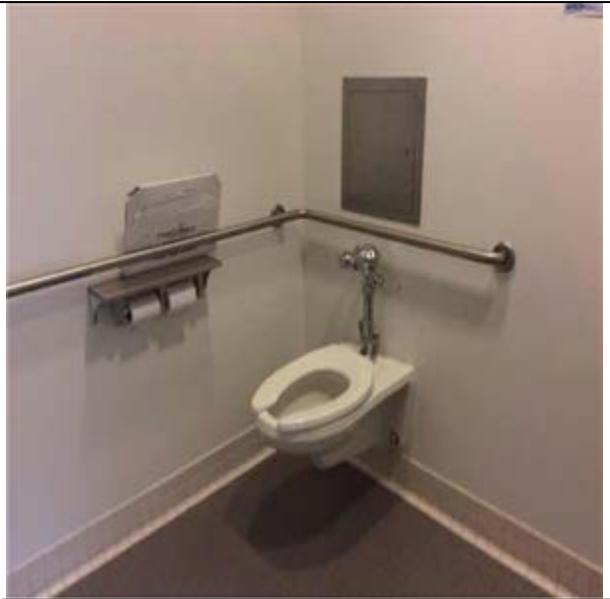
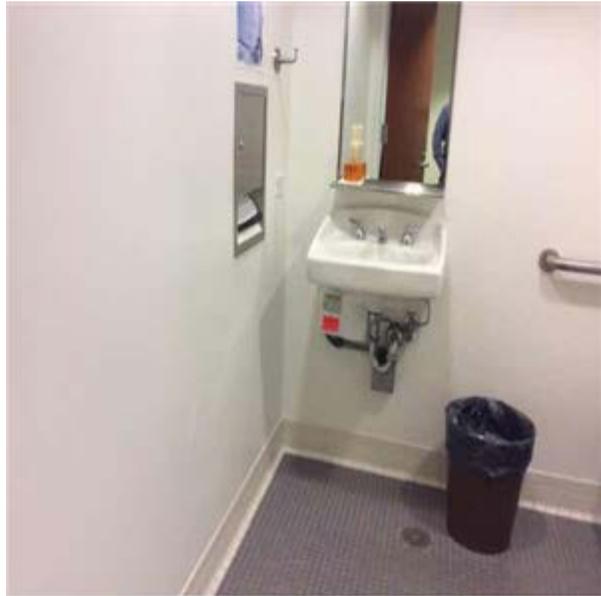
C3005 ADA Restrooms

| Type | Component Description | Qty / UOM | Unit Cost (\$) | Plan Type | Priority | Year | Expenditures (\$) |
|---|---|---|---|---|---|---|---|
| C3005 | Replace C3005 ADA Restrooms | 30.0 - EA | 12400.0 | CC - Accessibility | Priority 1 | 2015 | 372,000 |

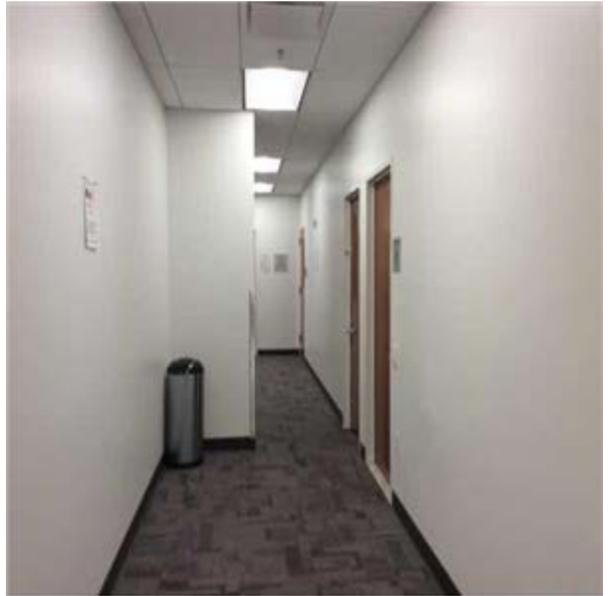
Due to normal wear, interior wall finishes for offices and common areas will require paint maintenance during the assessment period.

C3012 Interior Painted Walls

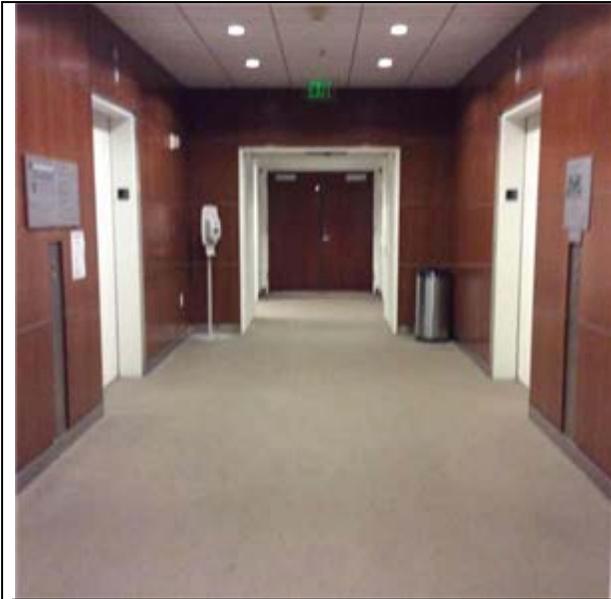
| Item | Description |
|--|---|
| C3012 Wall Finishes to Interior Walls | C3012 Stained Wood Paneled Walls |

Stained wood-paneled wall finishes are in elevator lobbies, court room, and various other locations. No further action is required.

C3012 Stained Wood Paneled Walls

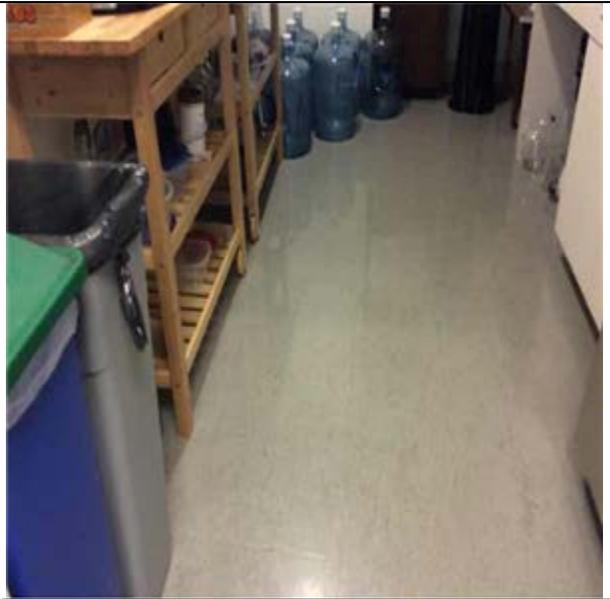
Based on RUL, vinyl tile replacement is anticipated during the assessment period.

C3024 Vinyl Tile

| Type | Component Description | Qty / UOM | Unit Cost (\$) | Plan Type | Priority | Year | Expenditures (\$) |
|---|---|---|---|---|---|---|---|
| C3024 | Replace C3024 Vinyl Tile | 11,000.0 - SY | 125.8 | IN - Appearance | Priority 4 | 2020 | 1,383,582 |

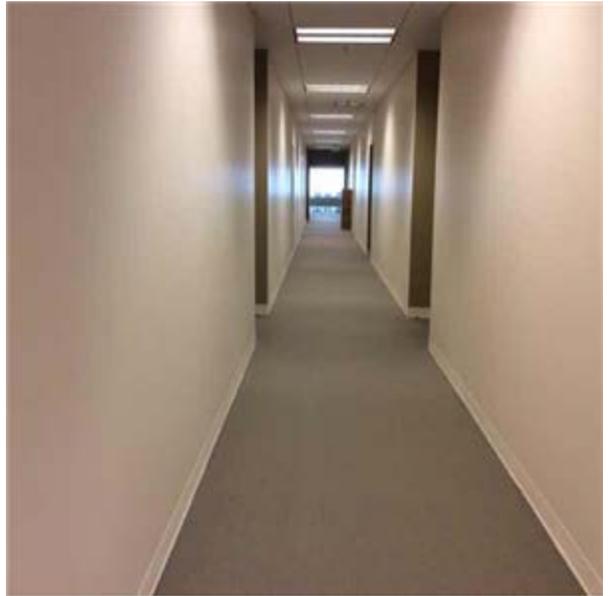
All office areas are covered with carpet. The 6th, 8th and 14th floor carpets were replaced in 2006. Based on normal wear and deterioration, replacement will be required in the near term.

C3025 Carpet Flooring

| Type | Component Description | Qty / UOM | Unit Cost (\$) | Plan Type | Priority | Year | Expenditures (\$) |
|---|---|---|---|---|---|---|---|
| C3025 | Replace C3025 Carpet Flooring | 52,645.0 - SY | 96.6 | IN - Appearance | Priority 3 | 2016 | 5,085,802 |

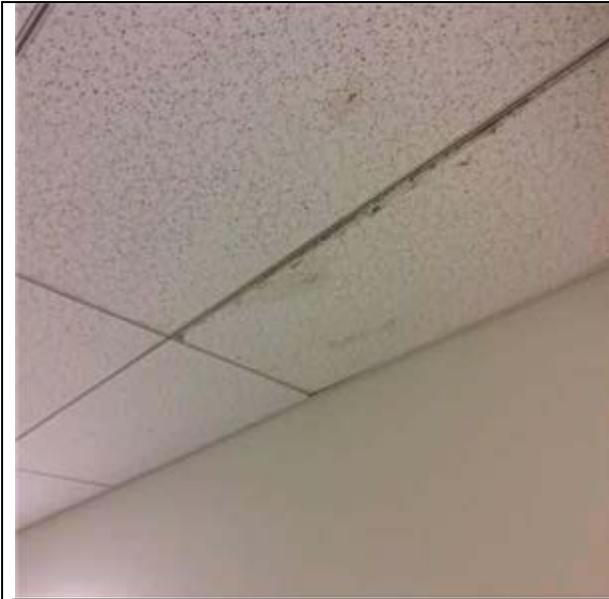
All office and hallway ceilings are acoustic tile suspended ceilings. There is water intrusion at the fifth floor. Replacement of 25 percent of the damaged tiles is recommended in the near term.

C3032 Suspended Acoustical Tiles

| Type | Component Description | Qty / UOM | Unit Cost (\$) | Plan Type | Priority | Year | Expenditures (\$) |
|---|--|---|---|---|---|---|---|
| C3032 | Replace C3032 Suspended Acoustical Tiles | 5,200.0 - CSF | 1201.6 | IN - Appearance | Priority 3 | 2018 | 6,248,112 |

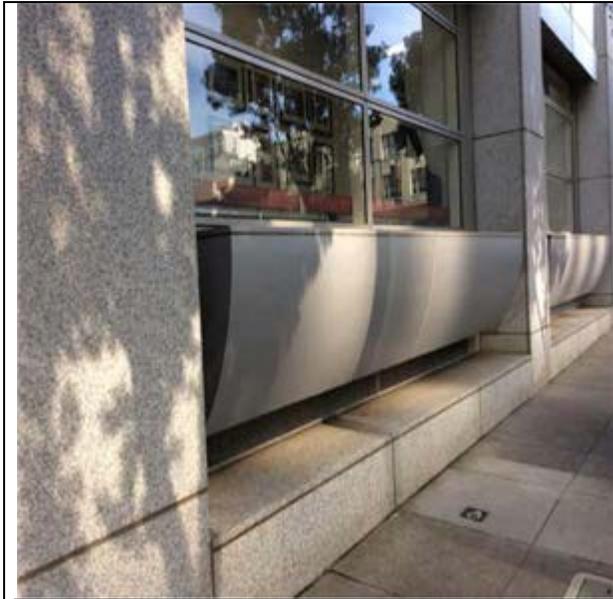
G2053 Landscaping :- Water Intrusion
