Stockton State Building (901)

31 East Channel Street, Stockton, CA 95202

Facility Condition Assessment

September 2015

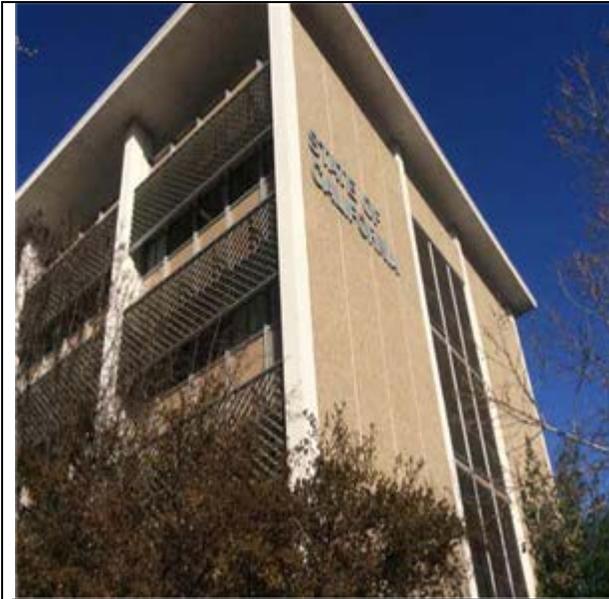
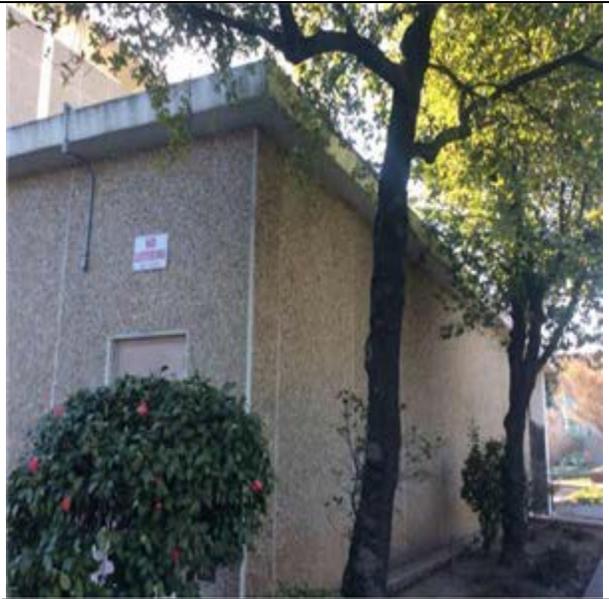
B2011 Exterior Walls, Pressure Wash

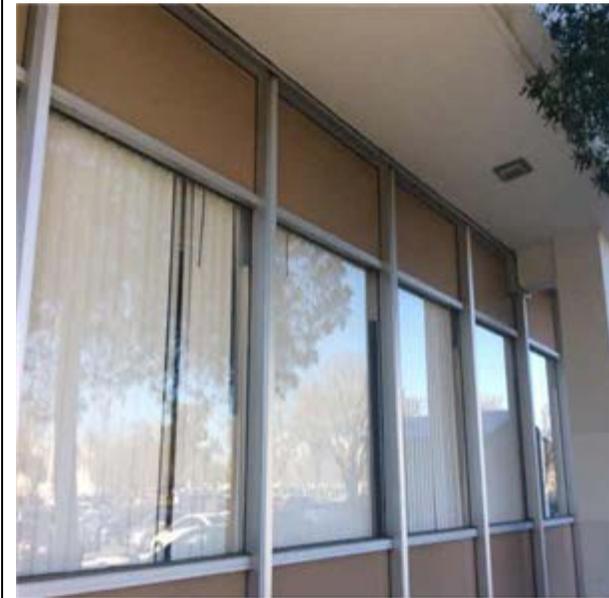
The curtain wall system includes aluminum framed panels and fixed glazing. The system appears to be original and has exceeded EUL. Gasket failure is noted. Replacement is recommended.

B2021 Curtain Wall Windows

Type	Component Description	Qty / UOM	Unit Cost (\$)	Plan Type	Priority	Year	Expenditures (\$)
B2021	Replace B2021 Curtain Wall Windows	9,752.0 - SF	304.8	IN - Beyond Rated Life	Priority 2	2017	2,972,332

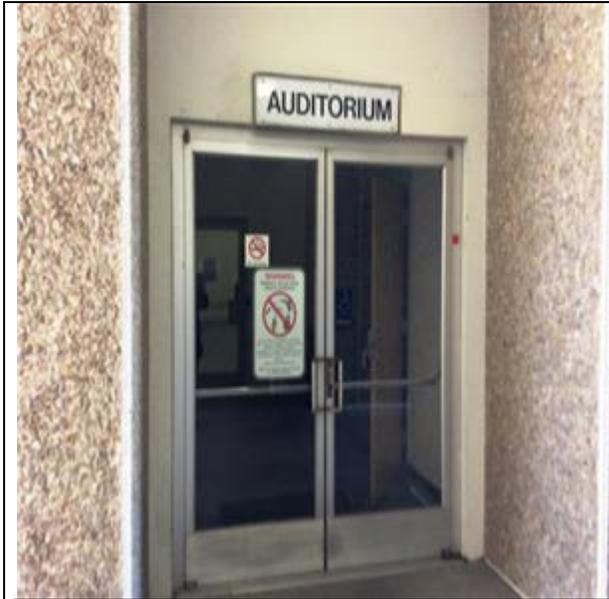
The aluminum framed glazed double doors appear to be original and have exceeded their expected serviceable life. Replacement is recommended.

B2031 Glazed Doors & Entrances, 6' X 7'

Type	Component Description	Qty / UOM	Unit Cost (\$)	Plan Type	Priority	Year	Expenditures (\$)
B2031	Replace B2031 Glazed Doors & Entrances, 6' X 7'	2.0 - EA	12400.0	IN - Beyond Rated Life	Priority 1	2016	24,800

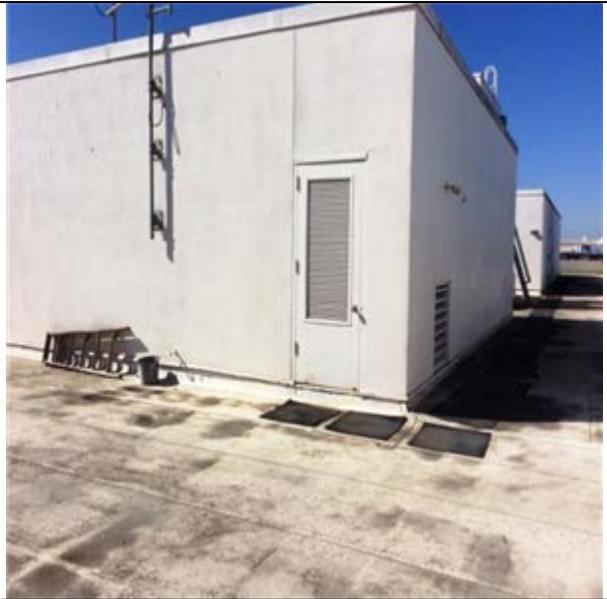
Exterior steel louvered and solid core doors are located along the first floor perimeter at mechanical and electrical rooms, auditorium, and loading dock. Similar doors are located in the upper roof level mechanical rooms. Some corrosion is noted, especially along the base of doors. Based on estimated RUL and condition, replacements will be required.

B2032 Exterior Steel Doors, Painted

Type	Component Description	Qty / UOM	Unit Cost (\$)	Plan Type	Priority	Year	Expenditures (\$)
B2032	Replace B2032 Exterior Steel Doors, Painted	8.0 - EA	2723.0	IN - Beyond Rated Life	Priority 2	2017	21,784

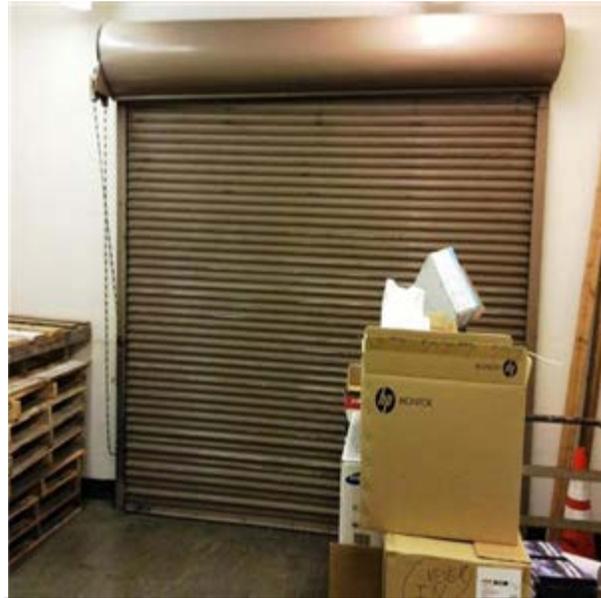
The coiling steel cargo door on the north side appears to be original and shows mild corrosion and physical damage. Based on estimated RUL, replacement is recommended.

B2039 Steel Rolling Overhead Door

Type	Component Description	Qty / UOM	Unit Cost (\$)	Plan Type	Priority	Year	Expenditures (\$)
B2034	Replace B2039 Steel Rolling Overhead Door	1.0 - EA	4966.5	IN - Beyond Rated Life	Priority 2	2017	4,966

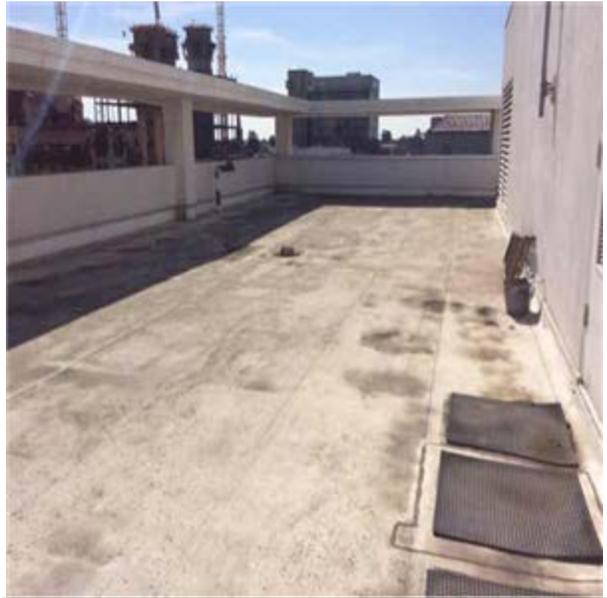
According to management staff, there are several water leaks on the southwest roof. The roofs are nearing the end of their expected useful life (EUL) and will require replacement.

B3011 Single Ply Membrane Roof

Type	Component Description	Qty / UOM	Unit Cost (\$)	Plan Type	Priority	Year	Expenditures (\$)
B3011	Replace B3011 Single Ply Membrane Roof	180.0 - SQ	2845.8	OP - Maintenance	Priority 2	2016	512,244

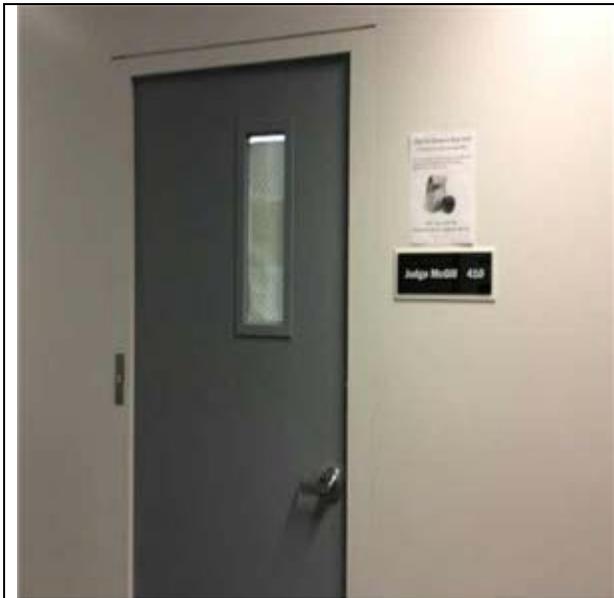
Many of the doors appear to be original. Based on the estimated RUL and condition, painting and repair are recommended.

C1021 Interior Doors

Type	Component Description	Qty / UOM	Unit Cost (\$)	Plan Type	Priority	Year	Expenditures (\$)
C1021	C1021 Repair and Paint Interior Doors	68.0 - EA	2403.1	OP - Maintenance	Priority 3	2016	163,412

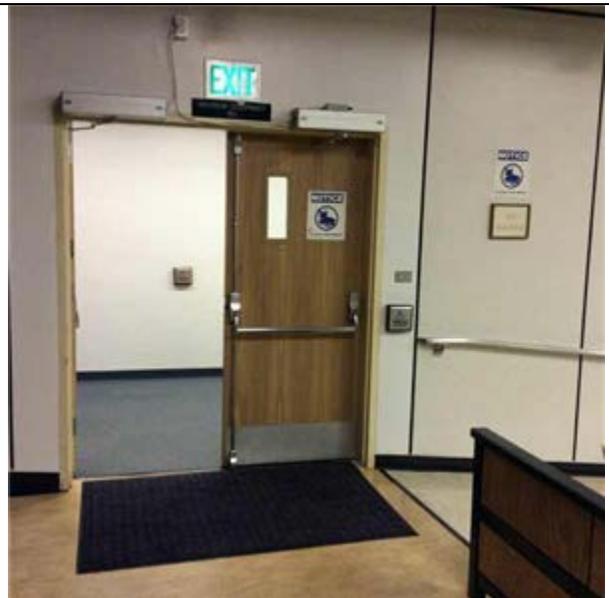
The emergency exit wood double doors appear to be original. Based on estimated RUL and condition, replacement is recommended.

C1021 Wood Double Doors

Type	Component Description	Qty / UOM	Unit Cost (\$)	Plan Type	Priority	Year	Expenditures (\$)
C1021	Replace C1021 Wood Double Doors	1.0 - EA	11383.2	IN - Beyond Rated Life	Priority 4	2020	11,383

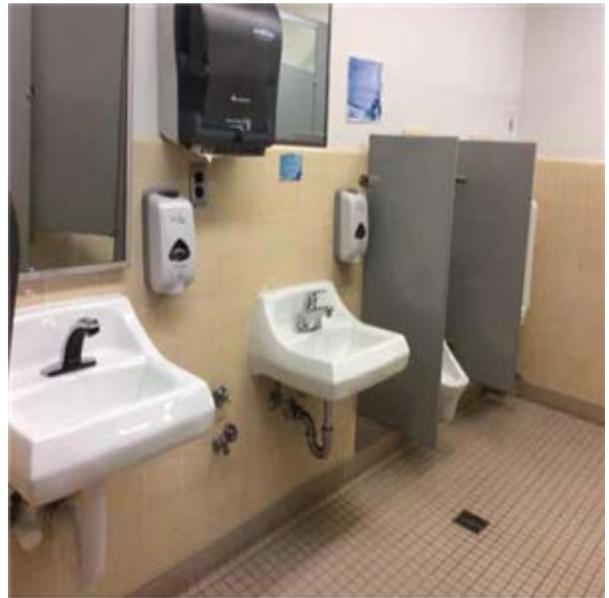
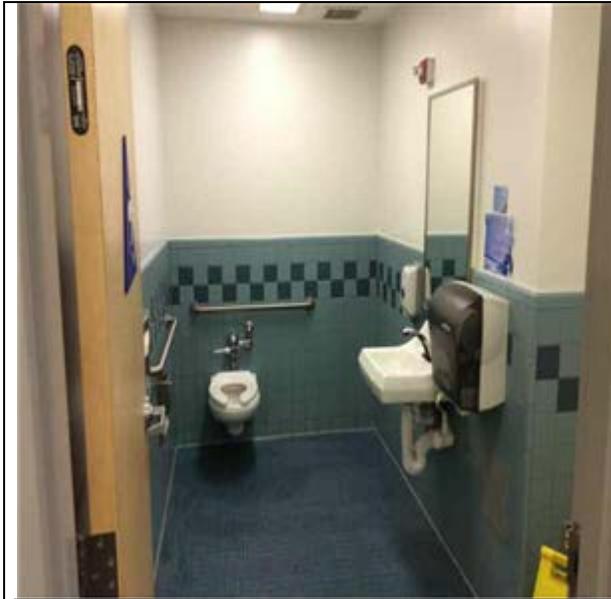
All restrooms and drinking fountains were renovated in 1998. Based on the estimated RUL, painting and repair are anticipated during the assessment period.

C3005 ADA Restrooms

Type	Component Description	Qty / UOM	Unit Cost (\$)	Plan Type	Priority	Year	Expenditures (\$)
C3005	Replace C3005 ADA Restrooms	10.0 - EA	12400.0	CC - Accessibility	Priority 3	2018	124,000

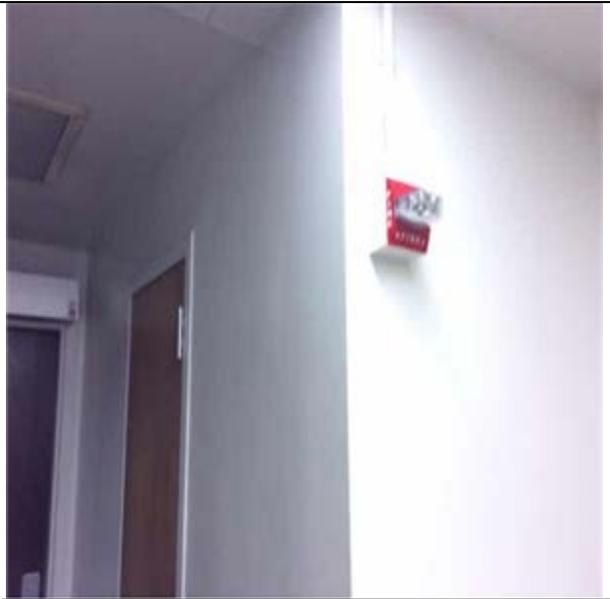
Based on condition and normal deterioration, interior painting of walls and some ceilings will be required.

C3012 Paint Interior Walls

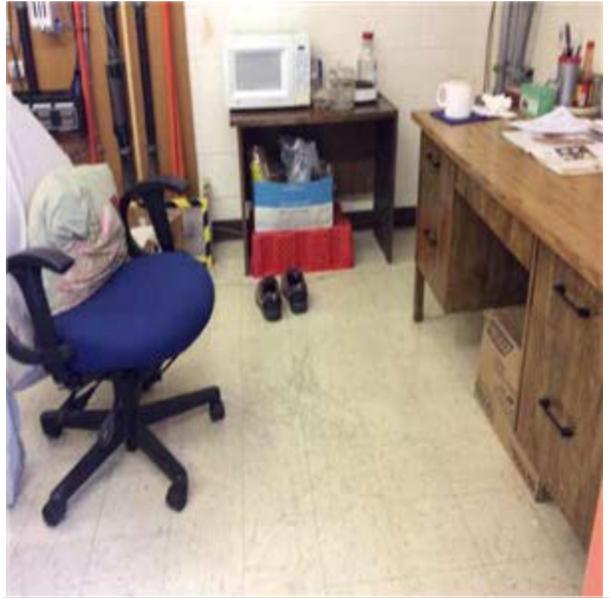
Based on RUL and condition, vinyl floor tile replacement is required.

C3024 Vinyl Tile

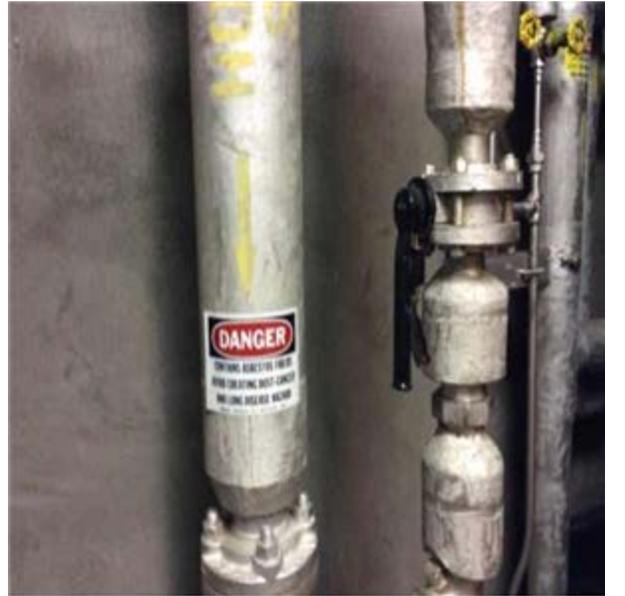
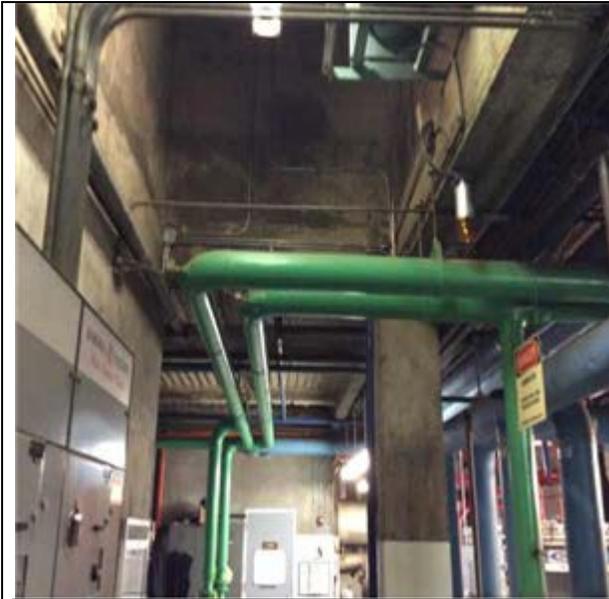
F2021 ACM Removal

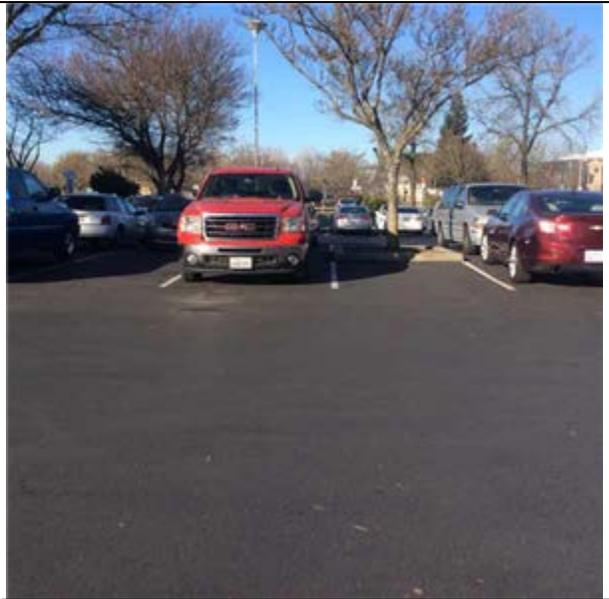
G2012 Sealcoat and Restripe Parking Lot

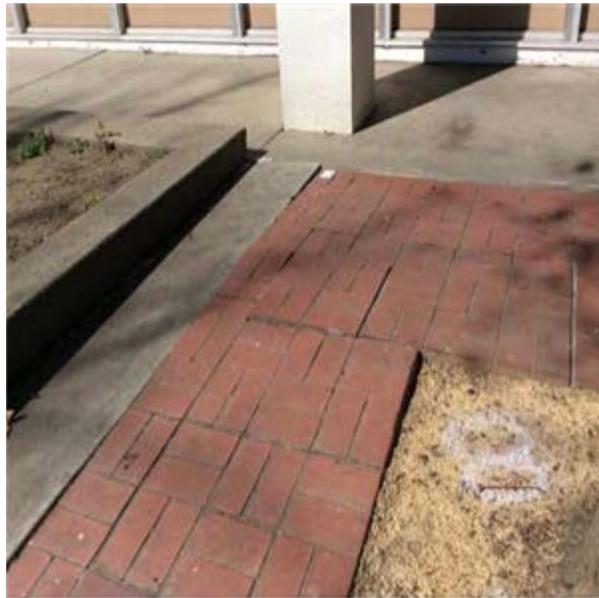
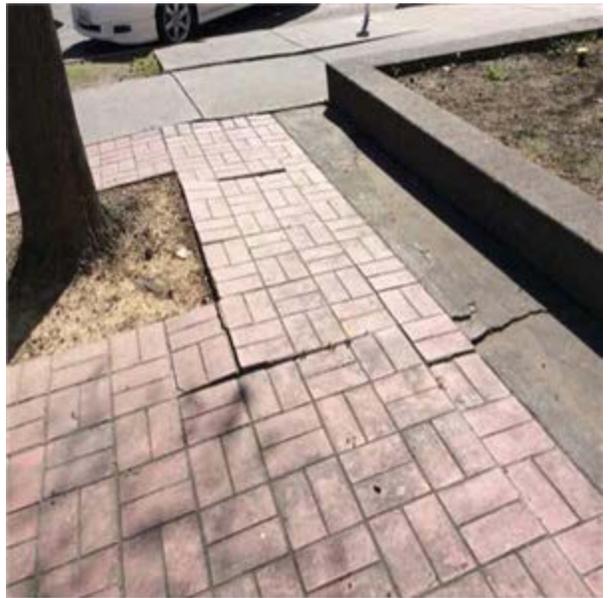
G2031 Brick Pavers Repair
