Alfred E. Alquist Building (470)

100 Paseo de San Antonio, San Jose, CA 95113

Facility Condition Assessment

September 2015

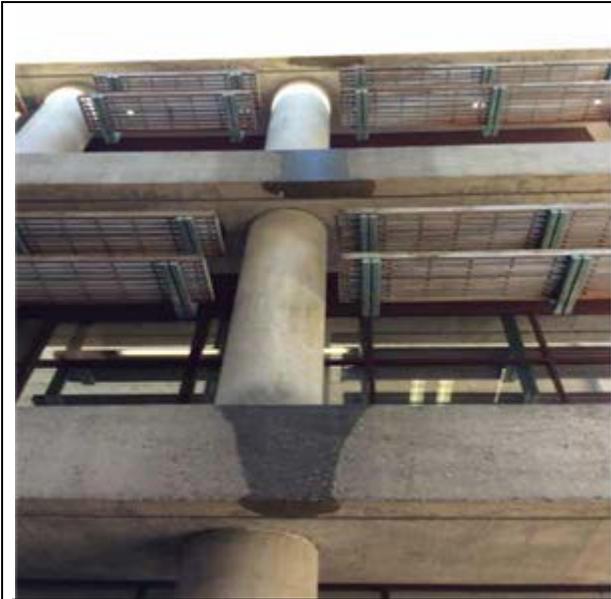
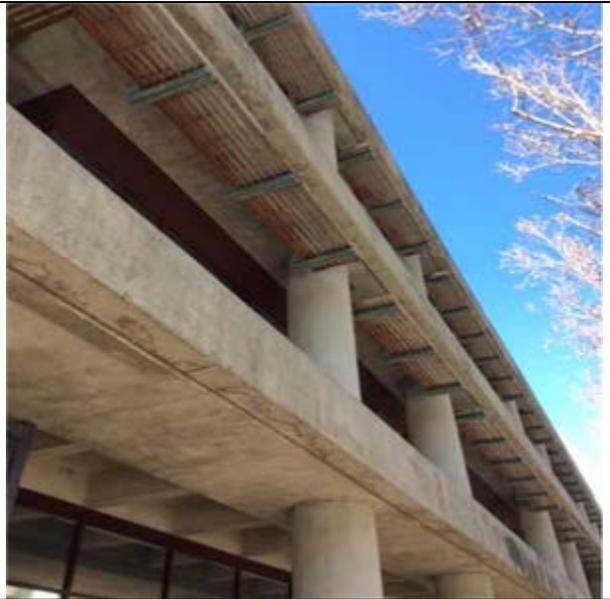
Item	Description
B2013 Exterior Louvers, Screens, and Fencing	B2013 Wood Louver
Condition	Fair
Qty / UOM	700 / SF
RUL (years)	4
Location	Exterior Walls

Type	Component Description	Qty / UOM	Unit Cost (\$)	Plan Type	Priority	Year	Expenditures (\$)
B2013	Replace B2013 Wood Louver	700.0 - SF	621.0	IN - Appearance	Priority 3	2019	434,712

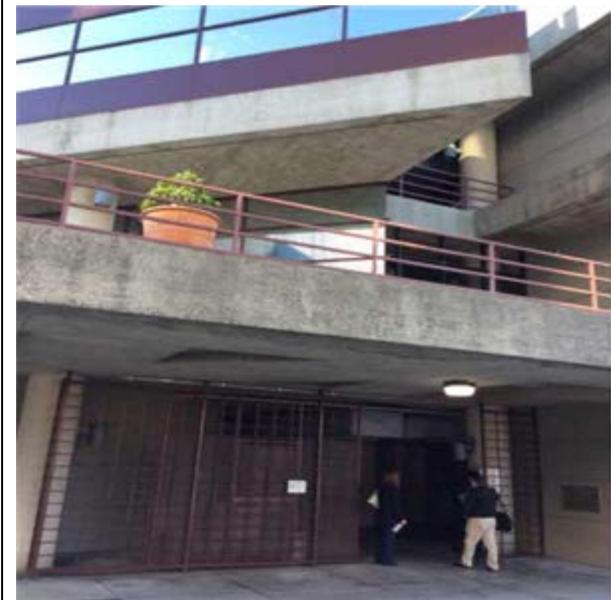
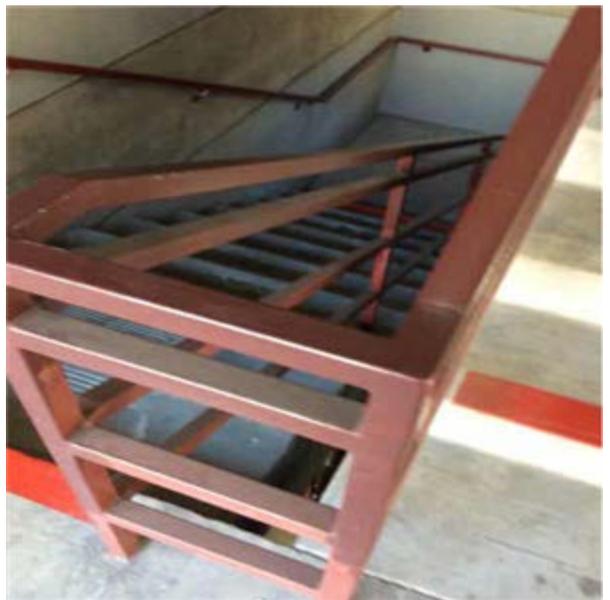
Item	Description
B2015 Balcony Walls & Handrails	B2015 Steel Guardrails and Handrails
Condition	Fair
Qty / UOM	880 / LF
RUL (years)	15
Location	Entire Facility

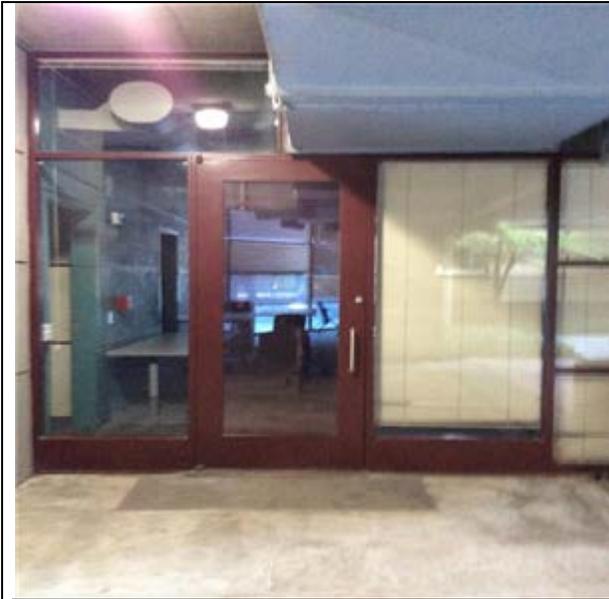
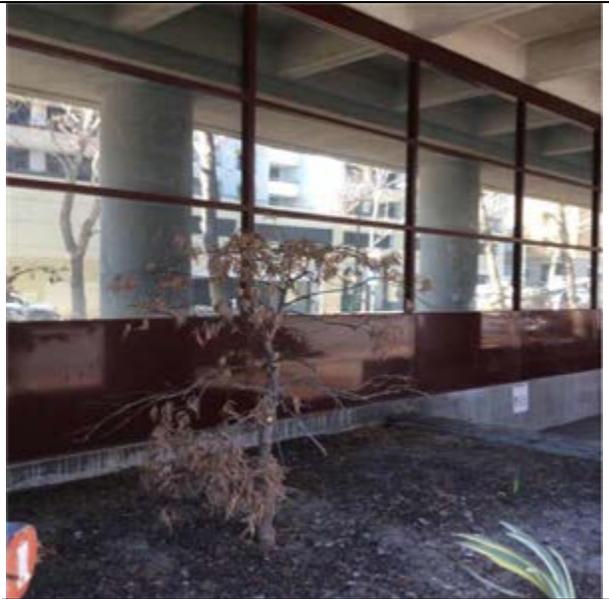
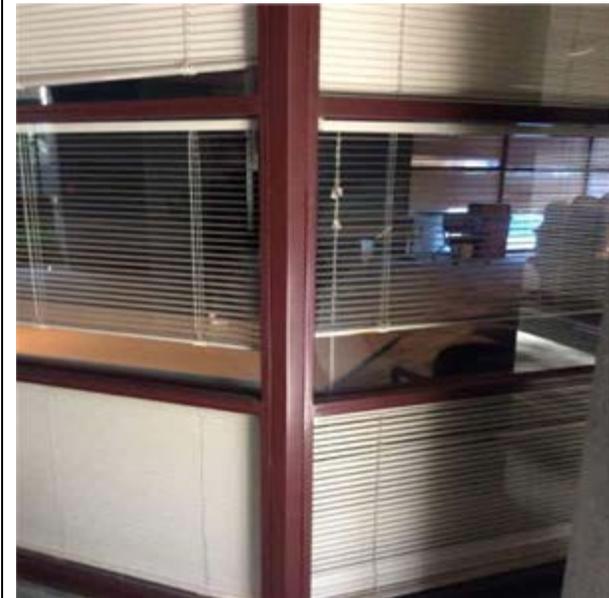
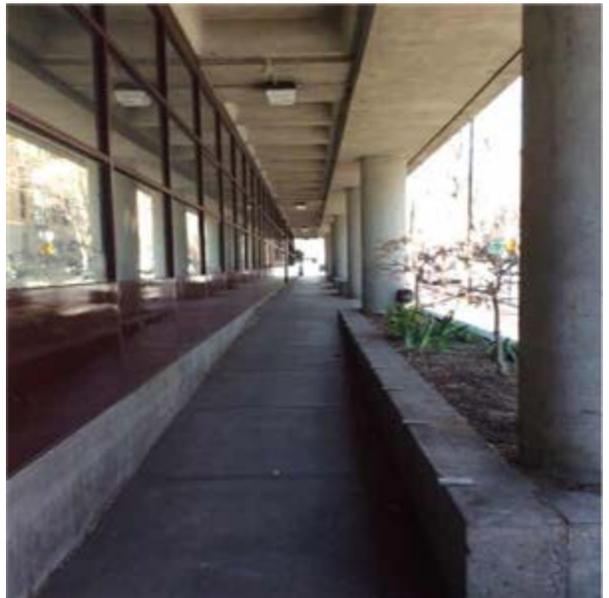
Item	Description
B2021 Windows	B2021 Aluminum Window Walls
Condition	Fair
Qty / UOM	22,000 / SF
RUL (years)	9
Location	Exterior Walls

Based on estimated RUL and condition, exterior window replacement is anticipated.

Type	Component Description	Qty / UOM	Unit Cost (\$)	Plan Type	Priority	Year	Expenditures (\$)
B2021	Replace B2021 Aluminum Window Walls	22,000.0 - SF	85.0	IN - Beyond Rated Life	Priority 4	2024	1,869,771

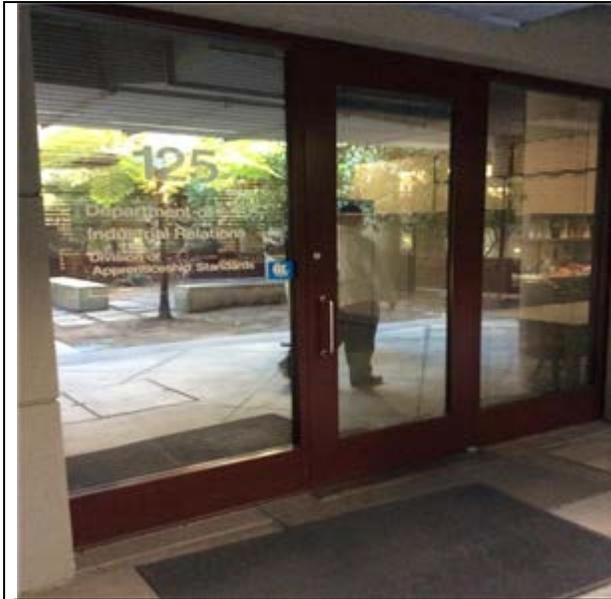
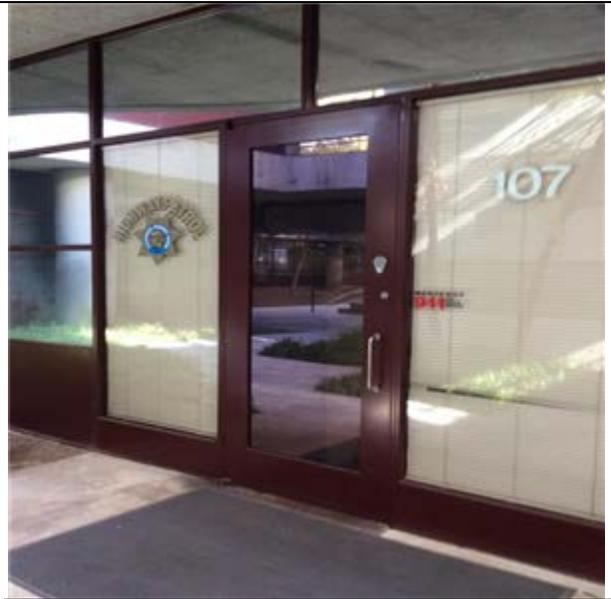
Item	Description
B2031 Glazed Doors & Entrances	B2031 Glazed Entrance Doors
Condition	Fair
Qty / UOM	18 / EA
RUL (years)	9
Location	Exterior Walls

Based on the estimated RUL and condition, glazed door replacements are anticipated.

Type	Component Description	Qty / UOM	Unit Cost (\$)	Plan Type	Priority	Year	Expenditures (\$)
B2031	Replace B2031 Glazed Entrance Doors	18.0 - EA	4335.5	IN - Beyond Rated Life	Priority 4	2024	78,039

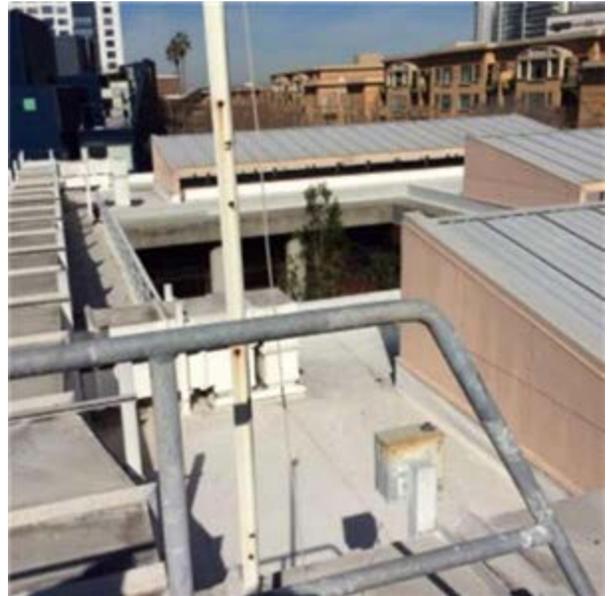
Item	Description
B3011 Roof Finishes	B3011 Preformed Steel Roofing
Condition	Good
Qty / UOM	63 / SQ
RUL (years)	20
Location	Roof

Roof monitors are finished with preformed steel roofing panels. No further action is anticipated for roof surfaces; however, supporting steel framing and other roof mounted steel beams require painting, due to corrosion and peeling.

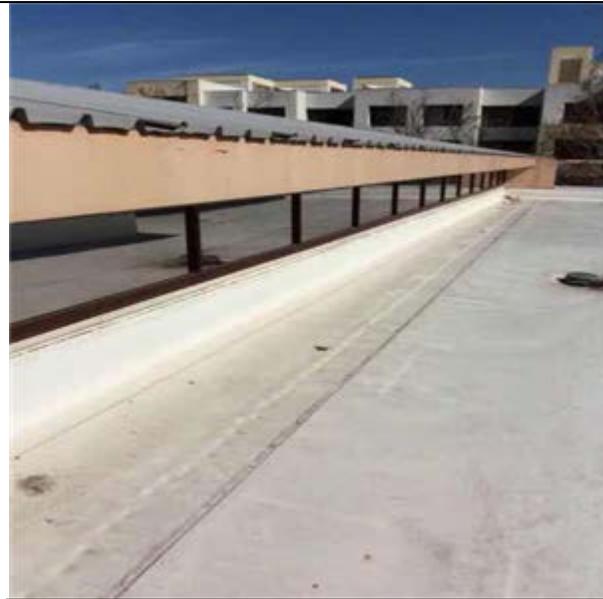
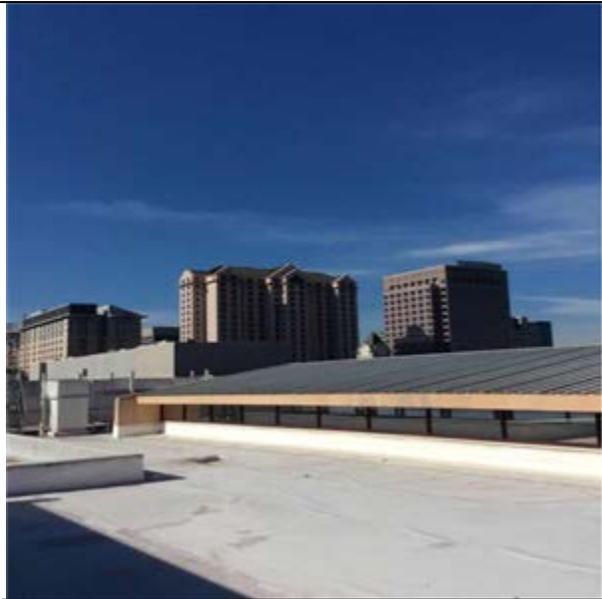
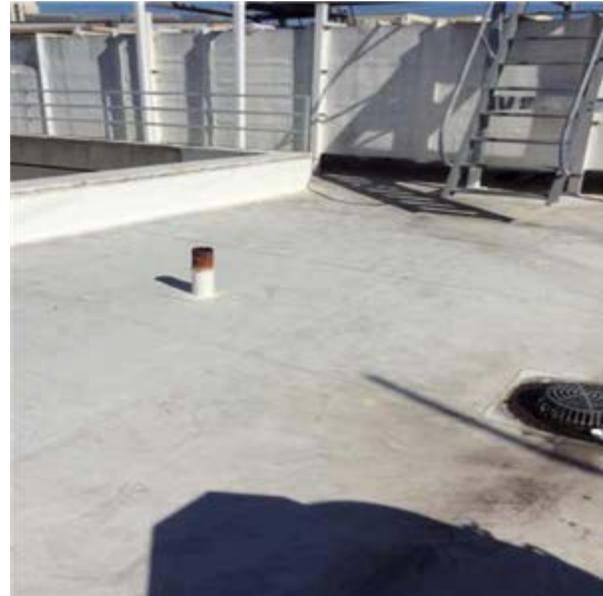
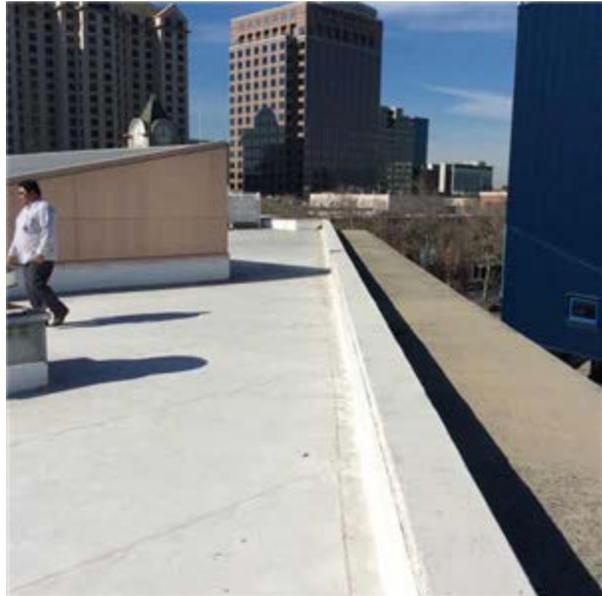
Item	Description
B3011 Roof Finishes	B3011 Single Ply TPO Roofing, 60 Mills
Condition	Fair
Qty / UOM	200 / SQ
RUL (years)	15
Location	Roof

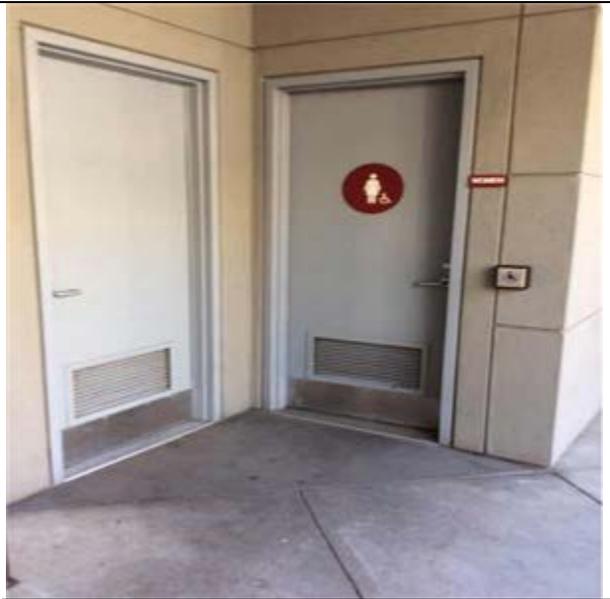
Item	Description
C1021 Interior Doors	C1021 Flush Steel Painted Door
Condition	Fair
Qty / UOM	60 / EA
RUL (years)	15
Location	Entire Facility

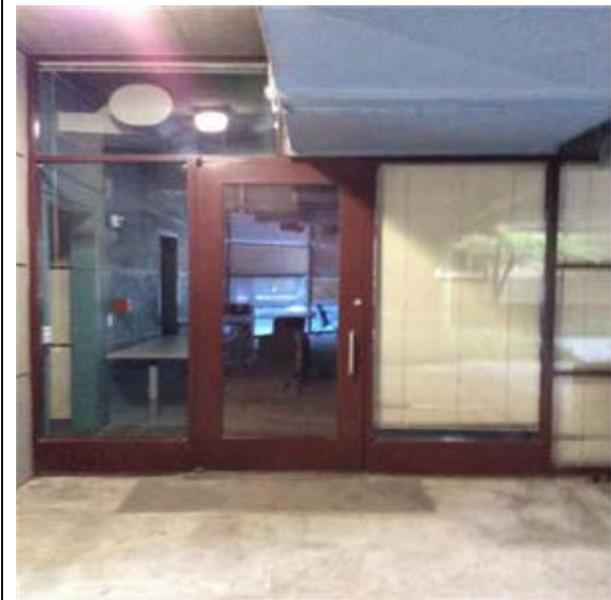
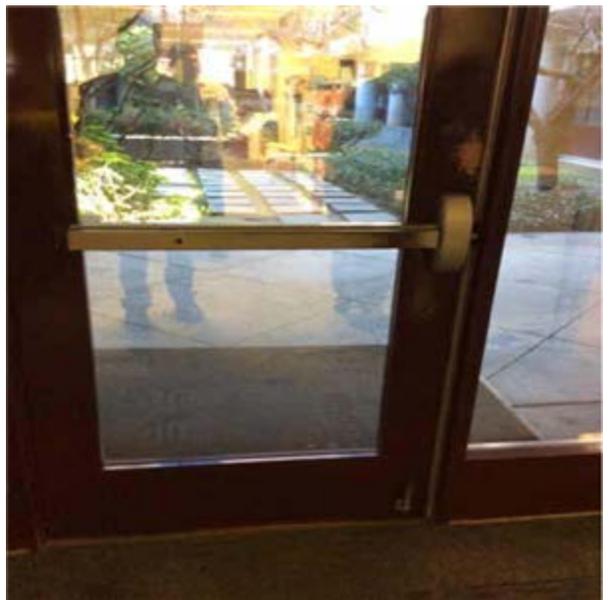
Item	Description
C1021 Interior Doors	C1021 Aluminum Frame Glazed Interior Doors
Condition	Fair
Qty / UOM	22 / EA
RUL (years)	25
Location	Throughout Facility

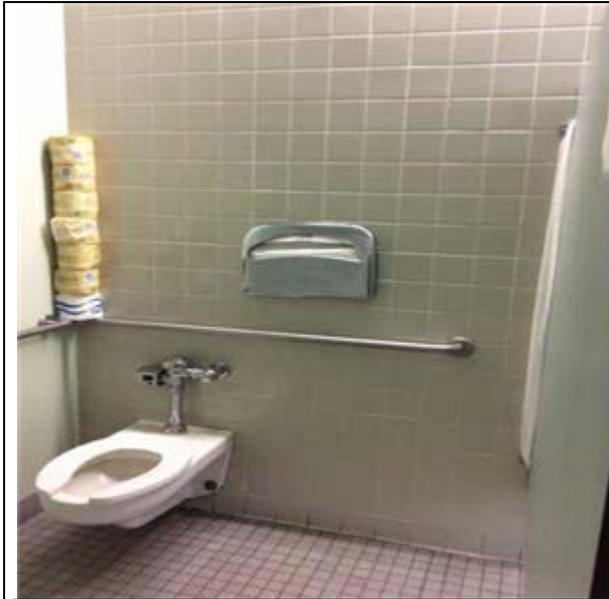
Item	Description
C3012 Wall Finishes to Interior Walls	C3012 Ceramic Tile Walls
Condition	Fair
Qty / UOM	12,200 / SF
RUL (years)	25
Location	Restrooms

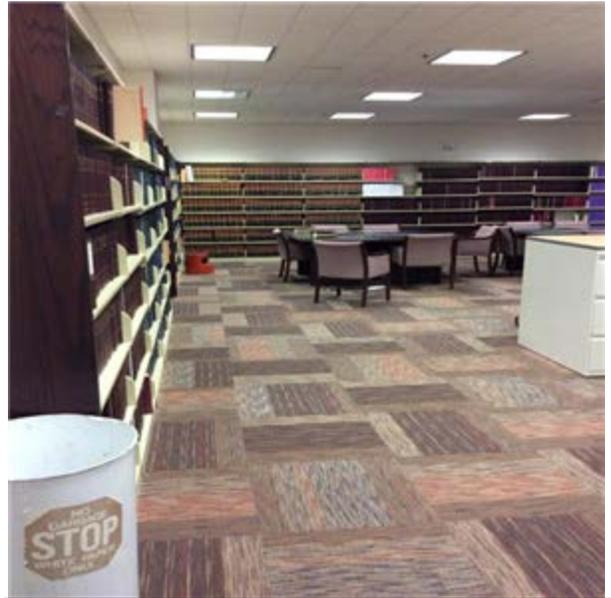
Item	Description
C3025 Carpeting	C3025 Carpet Tiles - Standard
Condition	Fair
Qty / UOM	611 / SY
RUL (years)	1
Location	Throughout Facility

Based on the estimated RUL and condition, carpet tile replacement is required.

Type	Component Description	Qty / UOM	Unit Cost (\$)	Plan Type	Priority	Year	Expenditures (\$)
C3025	Replace C3025 Carpet Tiles - Standard	611.0 - SY	96.6	IN - Appearance	Priority 3	2016	59,026

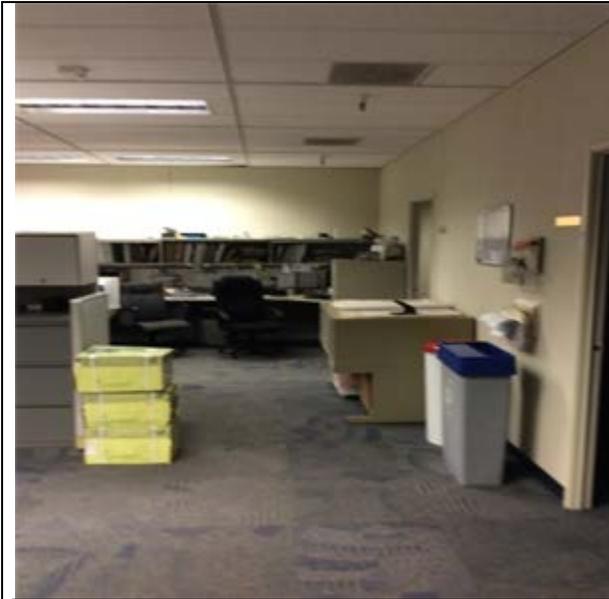
Item	Description
C3032 Suspended Ceilings	C3032 Acoustical Ceiling Tile
Condition	Fair
Qty / UOM	361 / CSF
RUL (years)	1
Location	Throughout interior

Based on estimated RUL and condition, acoustic ceiling tile replacement is recommended.

Type	Component Description	Qty / UOM	Unit Cost (\$)	Plan Type	Priority	Year	Expenditures (\$)
C3032	Replace C3032 Acoustical Ceiling Tile	361.0 - CSF	1201.6	IN - Appearance	Priority 3	2016	433,763

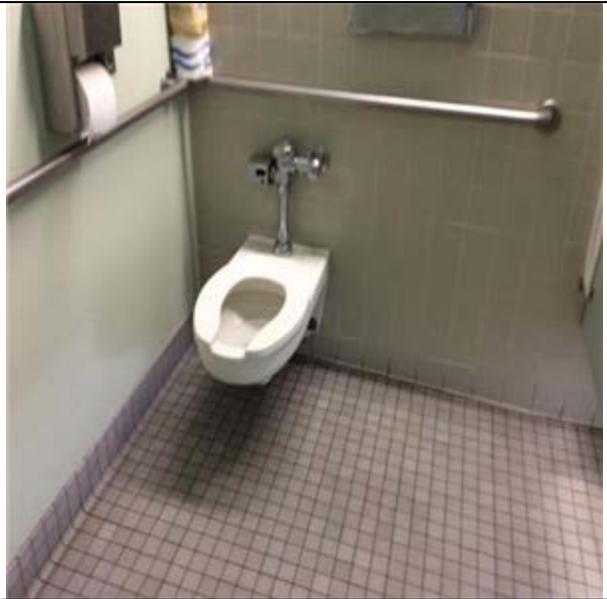
Item	Description
D2011 Water Closets	D2011 Commercial Water Closet - Standard
Condition	Fair
Qty / UOM	39 / EA
RUL (years)	2
Location	Restrooms throughout facility
Low Flow Toilet	Yes
System Grade	Commercial Grade

The water closets appear to be original equipment. The plumbing fixtures have exceeded their expected service life and should be budgeted for replacement.

Type	Component Description	Qty / UOM	Unit Cost (\$)	Plan Type	Priority	Year	Expenditures (\$)
D2011	Replace D2011 Commercial Water Closet - Standard	39.0 - EA	1233.1	OP - Energy	Priority 2	2017	48,093

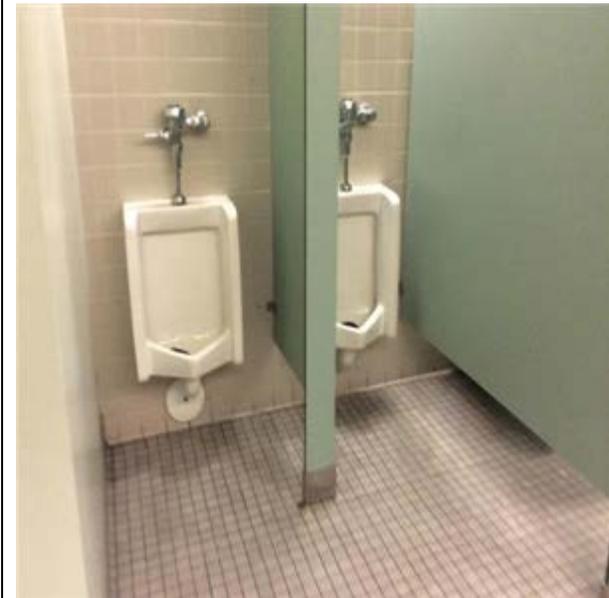
Item	Description
D2012 Urinals	D2012 Urinal - Standard
Condition	Fair
Qty / UOM	12 / EA
RUL (years)	2
Location	Restrooms throughout facility
Low Flow Toilet	Yes
System Grade	Commercial Grade

The urinals appear to be original equipment and have reached the end of EUL. Based on age and condition, replacement is recommended.
