Redding State Building (460)

2135 Civic Center Driver, Redding, CA 96001

Facility Condition Assessment

September 2015

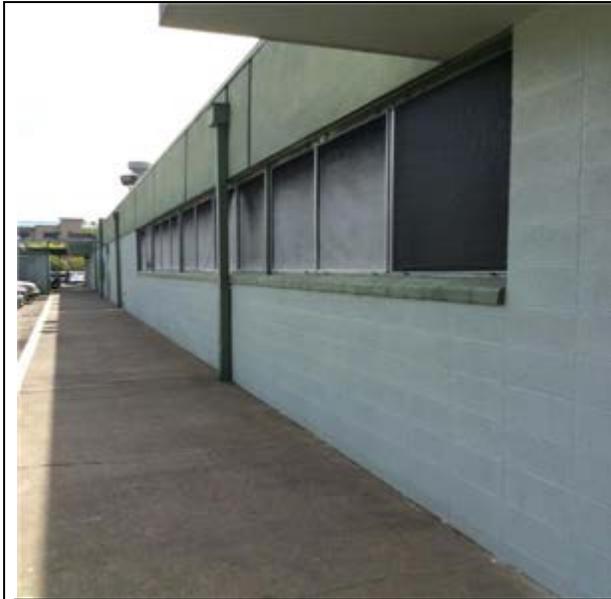
The windows are single pane and have far exceeded their expected useful life (EUL). Replacement is recommended due to extended age and condition.

Type	Component Description	Qty / UOM	Unit Cost (\$)	Plan Type	Priority	Year	Expenditures (\$)
B2021	Replace B2021 Aluminum Windows	80.0 - EA	3227.8	IN - Beyond Rated Life	Priority 1	2016	258,222

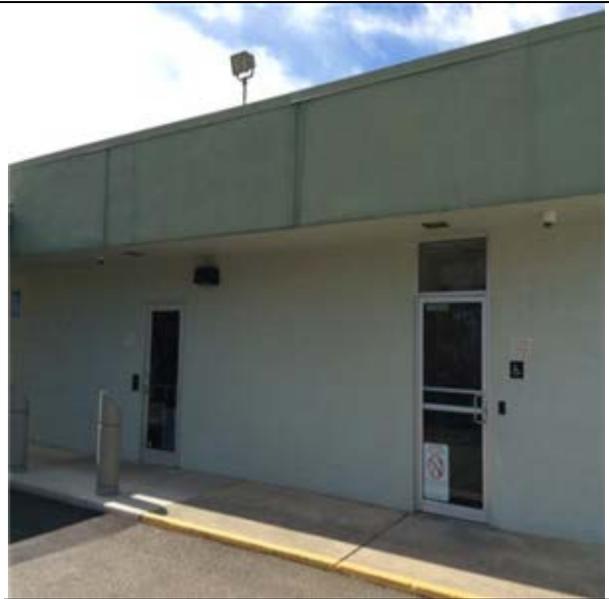
The exterior full vision doors have exceeded their expected serviceable life and are not energy efficient. Based on remaining useful life (RUL), replacement is recommended.

Type	Component Description	Qty / UOM	Unit Cost (\$)	Plan Type	Priority	Year	Expenditures (\$)
B2031	Replace B2031 Glazed Entrance Doors	8.0 - EA	4335.5	IN - Beyond Rated Life	Priority 1	2016	34,684

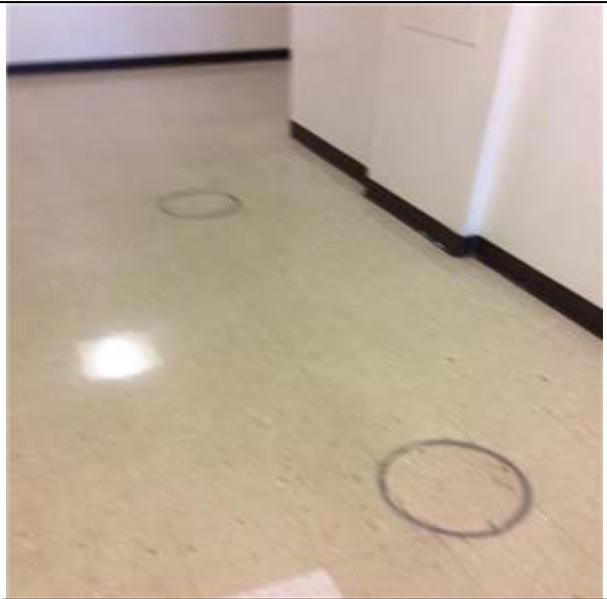
Based on RUL and condition, vinyl tile replacement is anticipated during the assessment period, with the exception of the newly renovated DMV area.

Type	Component Description	Qty / UOM	Unit Cost (\$)	Plan Type	Priority	Year	Expenditures (\$)
C3024	Replace C3024 Vinyl Tile	1,600.0 - SY	125.8	IN - Appearance	Priority 3	2016	201,248

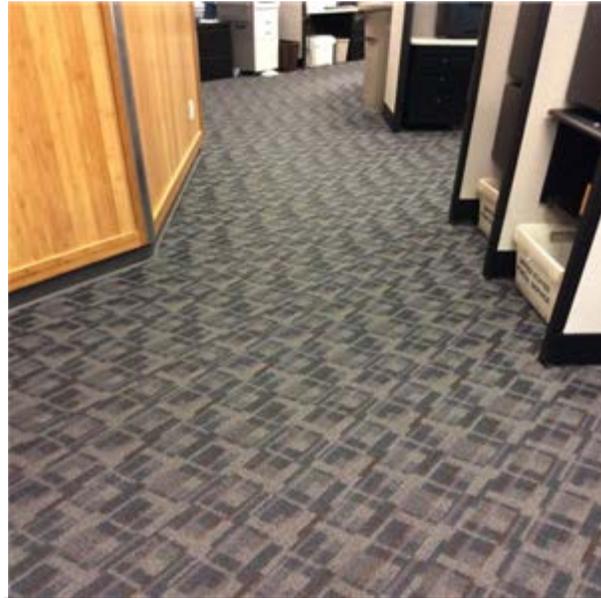
Based on RUL and condition, carpet tile replacement is anticipated during the assessment period, with the exception of the newly renovated DMV area.

Type	Component Description	Qty / UOM	Unit Cost (\$)	Plan Type	Priority	Year	Expenditures (\$)
C3025	Replace C3025 Carpet Tiles - Standard	400.0 - SY	96.6	IN - Appearance	Priority 3	2016	38,642

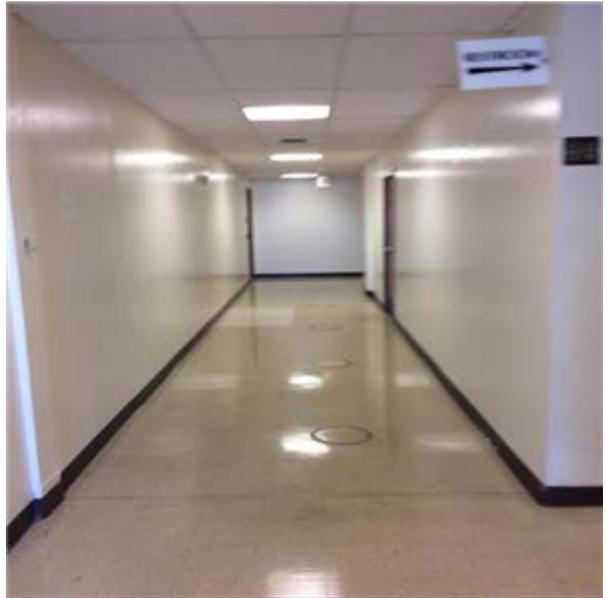
Based on RUL, acoustic tile ceiling replacement is anticipated during the assessment period in all areas of the building, except the newly renovated DMV customer area, offices, and restrooms.

Type	Component Description	Qty / UOM	Unit Cost (\$)	Plan Type	Priority	Year	Expenditures (\$)
C3032	Replace C3032 Acoustical Ceiling Tile	132.0 - CSF	1201.6	IN - Appearance	Priority 4	2020	158,606

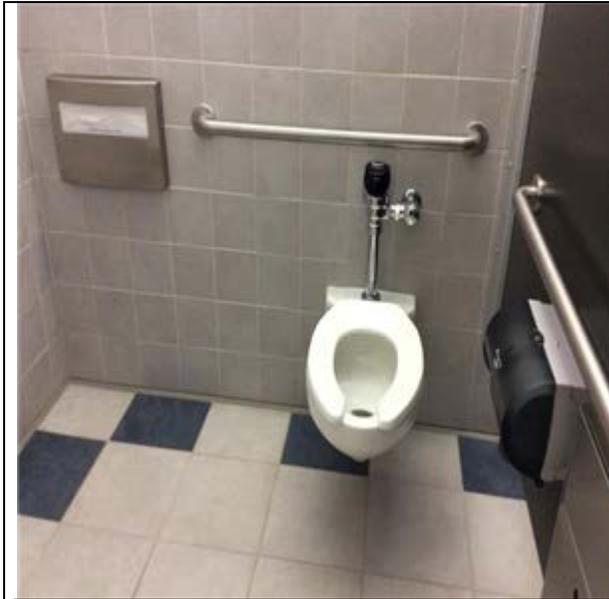
D2011 Commercial Water Closet - Auto

Restrooms were upgraded in 2014. Automatic flush valves were observed. No further action is required.

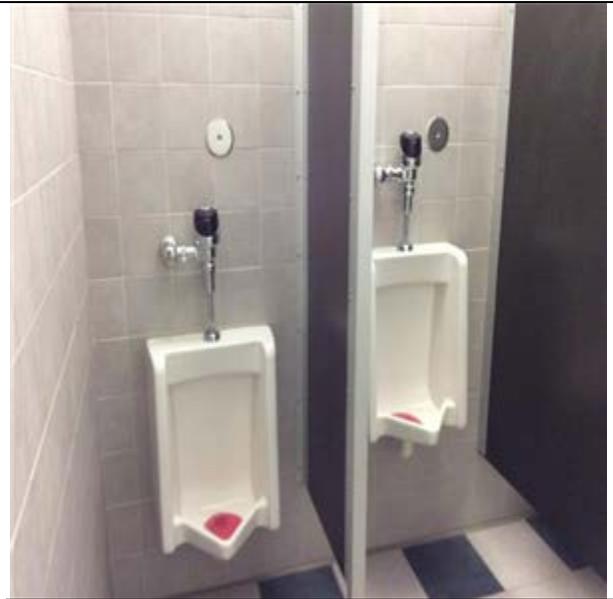
D2012 Urinal - Auto

Restrooms were upgraded in 2014. Automatic flush valves were observed. No further action is required.

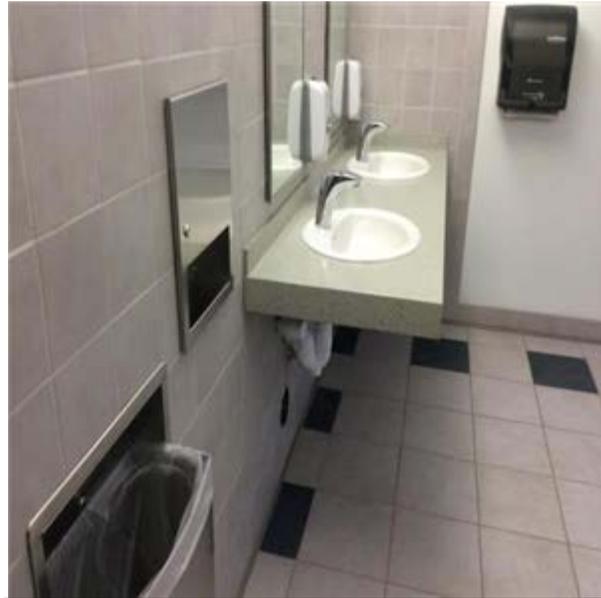
D2013 Wall Hung Lavatory and Faucet - Auto

Restrooms were upgraded in 2014. Automatic faucets were observed. No further action is required.

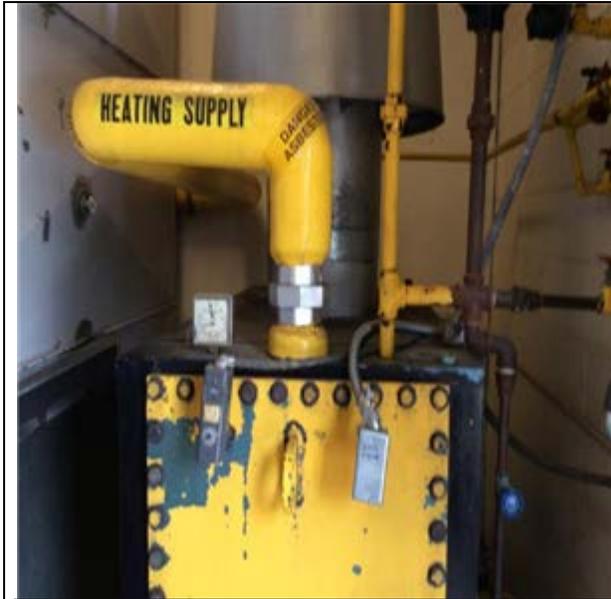
The heating boiler is original and has far exceeded EUL. It is recommended for replacement with a high efficiency hot water unit.

Type	Component Description	Qty / UOM	Unit Cost (\$)	Plan Type	Priority	Year	Expenditures (\$)
D3021	Replace D3020 Water Boiler, Gas 1300 MBH	1.0 - EA	62000.0	IN - Beyond Rated Life	Priority 1	2015	62,000

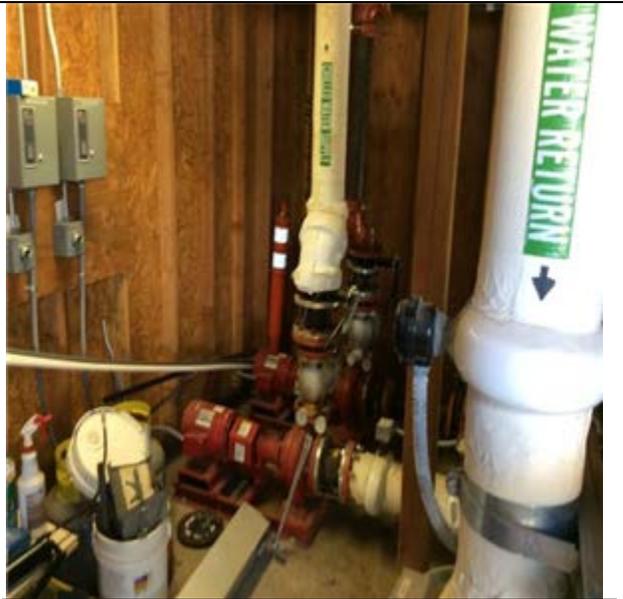
Based on RUL, the chilled water circulation pump will require replacement during the term.

Type	Component Description	Qty / UOM	Unit Cost (\$)	Plan Type	Priority	Year	Expenditures (\$)
D3022	Replace D3022 Chilled Water Circ Pump 2 HP	1.0 - EA	12202.8	IN - Beyond Rated Life	Priority 4	2023	12,203

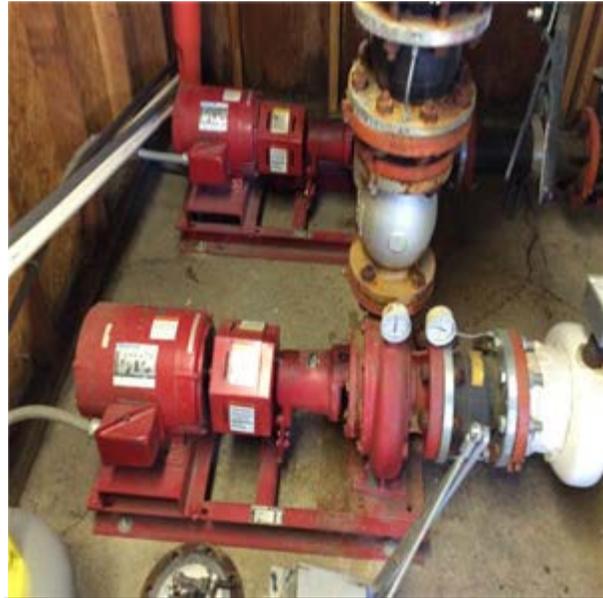
Based on RUL, the hot water circulation pump will require replacement during the term.

Type	Component Description	Qty / UOM	Unit Cost (\$)	Plan Type	Priority	Year	Expenditures (\$)
D3022	Replace D3023 HW Circulating Pump -1 HP	1.0 - EA	3144.2	IN - Beyond Rated Life	Priority 4	2023	3,144
