Leo J. Trombatore Building (153)

703 B Street, Marysville, CA 95901

Facility Condition Assessment

September 2015

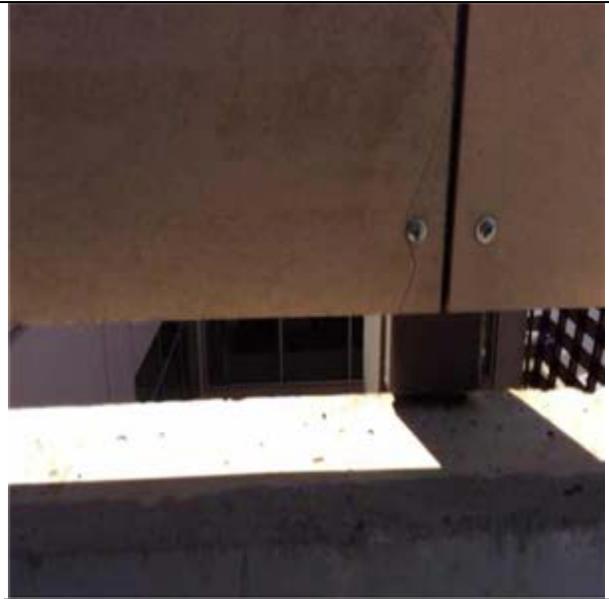
Item	Description
B2011 Exterior Wall Construction	B2011 Custom Siding
Condition	Poor
Qty / UOM	2,150 / SF
RUL (years)	0
Location	West exterior
Parapets	No
Balcony Walls and Handrails	Metal

The architectural siding on the west side near the main entrance shows significant cracking and breakage at several connection points. This poses potential a safety hazard due to falling debris. Total replacement is recommended with a more suitable product.

Type	Component Description	Qty / UOM	Unit Cost (\$)	Plan Type	Priority	Year	Expenditures (\$)
B2011	Replace B2011 Custom Siding	2,150.0 - SF	39.2	CC - Life Safety	Priority 1	2015	84,246

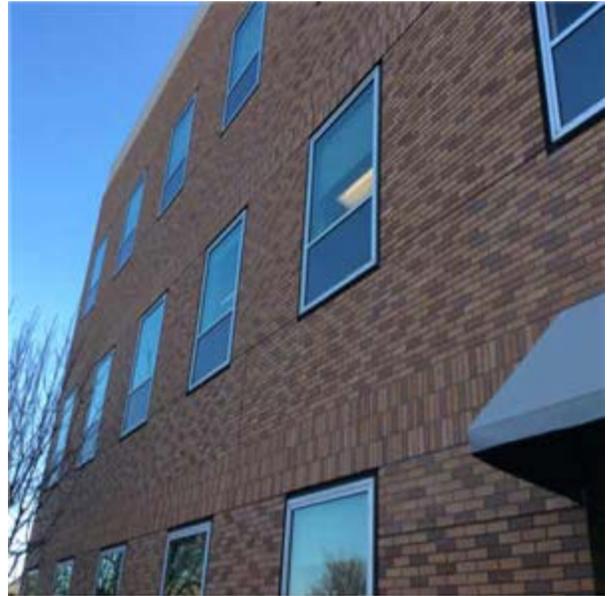
Item	Description
B2021 Windows	B2021 Windows
Condition	Good
Qty / UOM	128 / EA
RUL (years)	20
Location	All Floors
Window Type	Fixed
Windows Material	Aluminum
Windows Glazing	Double Glazed
Window Operation	Manual

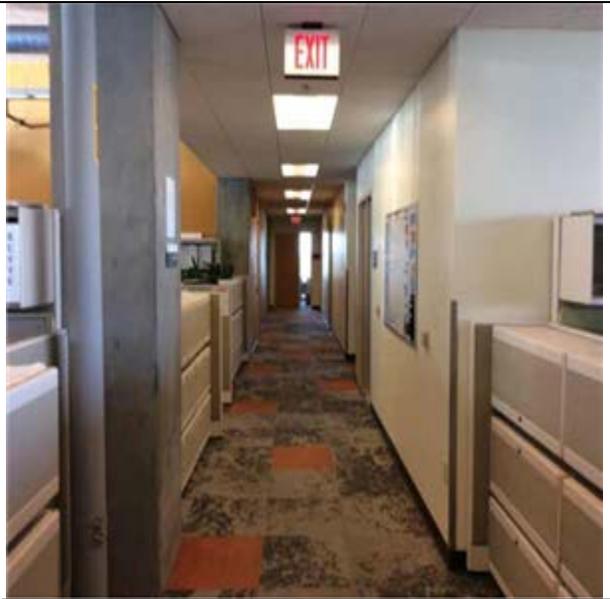
Item	Description
C3012 Wall Finishes to Interior Walls	C3012 Paint Interior Walls, Drywall
Condition	Good
Qty / UOM	68,500 / SF
RUL (years)	5
Location	All Floors

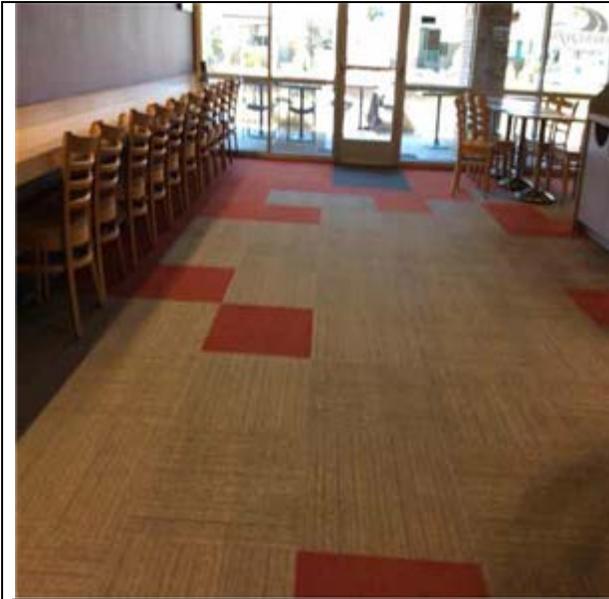
Item	Description
C3025 Carpeting	C3025 Carpet Tiles
Condition	Good
Qty / UOM	14,740 / SY
RUL (years)	5
Location	All Floors
Floor Toppings	Light Weight Concrete

All open space office areas are covered with carpet. Based on RUL, carpet replacement is anticipated.

Type	Component Description	Qty / UOM	Unit Cost (\$)	Plan Type	Priority	Year	Expenditures (\$)
C3025	Replace C3025 Carpet Tiles	14,740.0 - SY	96.6	IN - Appearance	Priority 4	2020	1,423,967

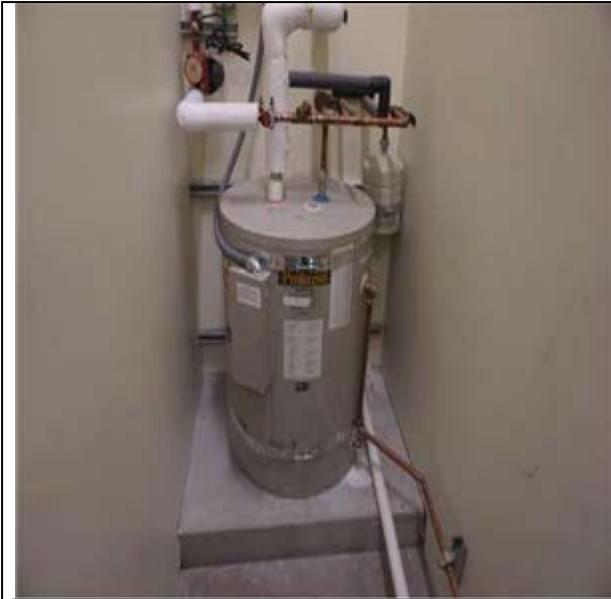
Item	Description
D2022 Hot Water Service	D2022 Domestic Water Heater
Condition	Good
Qty / UOM	8 / EA
RUL (years)	5
Location	Throughout Facility

The small electric water heaters are expected to require replacement during the assessment term.

Type	Component Description	Qty / UOM	Unit Cost (\$)	Plan Type	Priority	Year	Expenditures (\$)
D2022	Replace D2022 Domestic Water Heater	8.0 - EA	1805.4	IN - Beyond Rated Life	Priority 3	2020	14,443

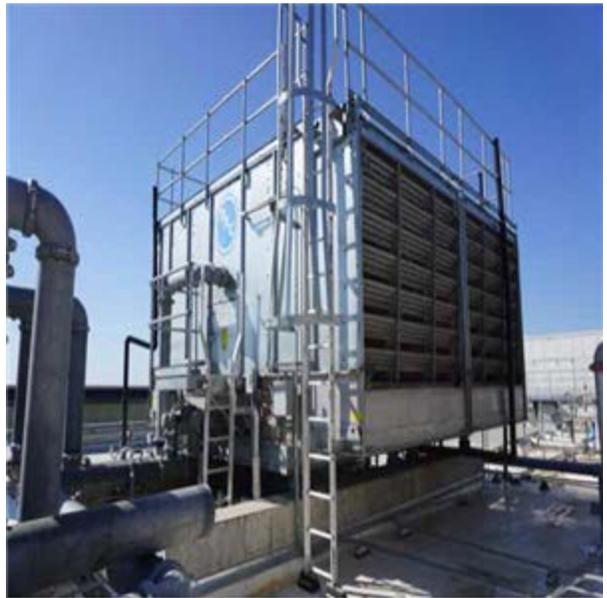
Item	Description
D3031.2 Cooling Towers	D3031 Cooling Tower, Galvanized Steel
Condition	Good
Qty / UOM	2 / EA
RUL (years)	20
Location	Rooftop

Continued regular monitoring of tower water chemistry is encouraged to prevent corrosion damage. No further action is required.
