## 4th District Court of Appeal (331)

3389 12th Street, Riverside, CA 92501

### Facility Condition Assessment

September 2015

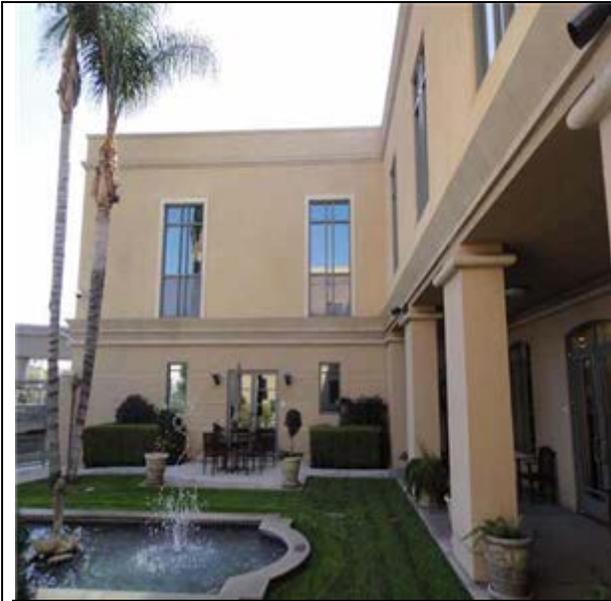
Item	Description
<b>B2011 Exterior Wall Construction</b>	B2011 - Exterior Insulating Finishing System (EIFS)
<b>Condition</b>	Fair
<b>Qty / UOM</b>	215 / CSF
<b>RUL (years)</b>	14
<b>Location</b>	Exterior Walls

Based on current condition and RUL, no further action is recommended.

B2011 - Exterior Insulating Finishing System (EIFS)

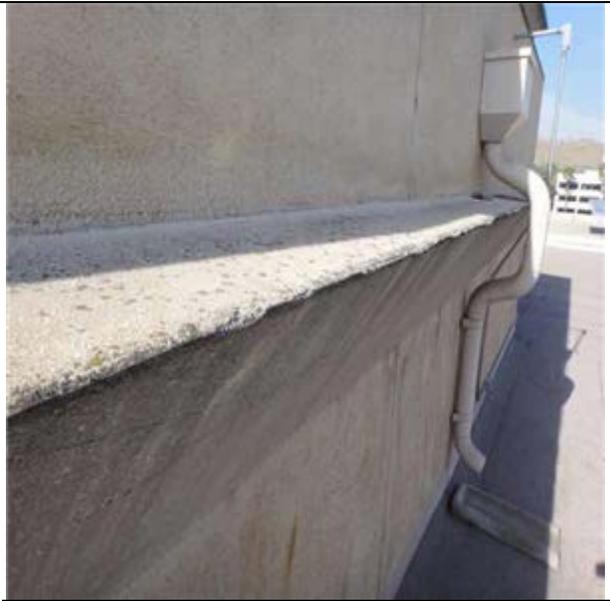
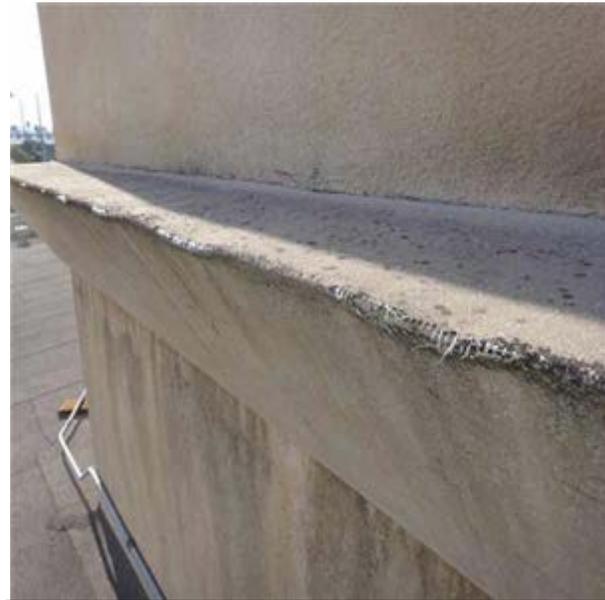
Item	Description
<b>B2011 Exterior Wall Construction</b>	B2011 Exterior Wall Construction
<b>Condition</b>	Poor
<b>Qty / UOM</b>	4 / CSF
<b>RUL (years)</b>	0
<b>Location</b>	Parapet Trim

Portions of the exterior insulation and finishing system (EIFS) located at the raised parapets were observed to be deteriorated, damaged, and exposed. Foam base material was visible. Based on current condition and RUL, replacement is recommended.

B2011 Exterior Wall Construction:- Damaged EIFS trim

B2011 Exterior Wall Construction :- Damaged EIFS trim

Type	Component Description	Qty / UOM	Unit Cost (\$)	Plan Type	Priority	Year	Expenditures (\$)
B2011	Replace B2011 Exterior Wall Construction	4.0 - CSF	718.4	IN - Beyond Rated Life	Priority 1	2015	2,874

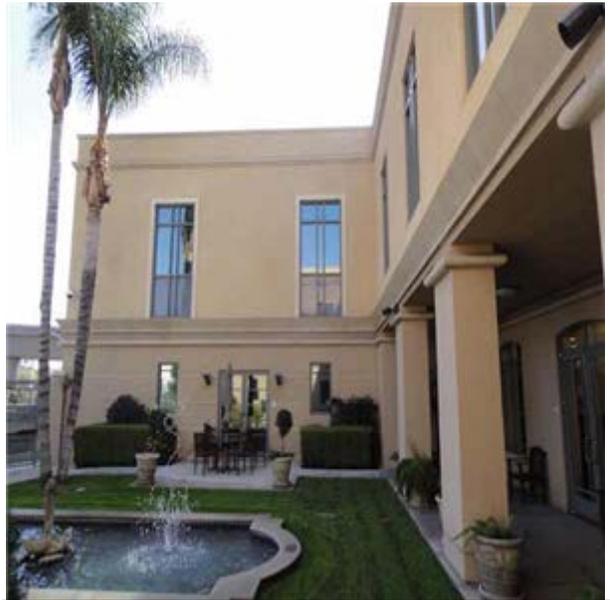
Item	Description
<b>B2011 Exterior Wall Construction</b>	B2011 - Exterior Wall Painting
<b>Condition</b>	Fair
<b>Qty / UOM</b>	21,500 / SF
<b>RUL (years)</b>	4
<b>Location</b>	Exterior Walls

Based on current condition and RUL, repainting the exterior walls is recommended during the assessment term.

B2011 - Exterior Wall Painting

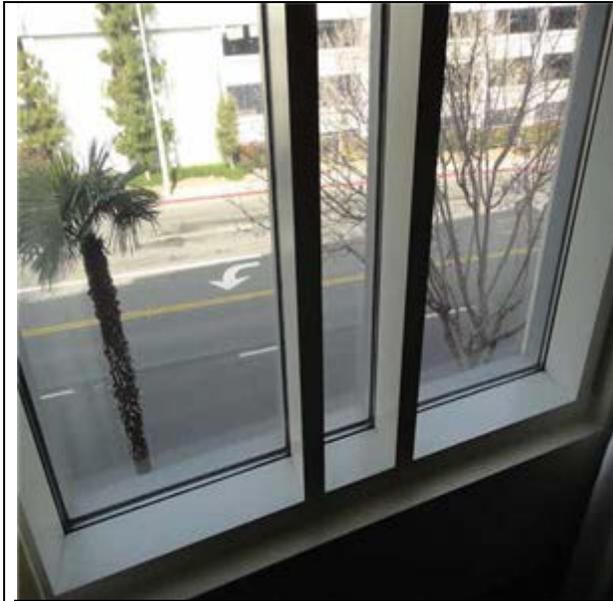
Item	Description
<b>B2021 Windows</b>	B2021 Aluminum Windows
<b>Condition</b>	Fair
<b>Qty / UOM</b>	84 / EA
<b>RUL (years)</b>	15
<b>Location</b>	Facility Windows
<b>Window Type</b>	Fixed
<b>Windows Material</b>	Aluminum
<b>Windows Glazing</b>	Double Glazed
<b>Window Operation</b>	Fixed

Based on current condition and RUL, no further action is recommended.

B2021 Aluminum Windows

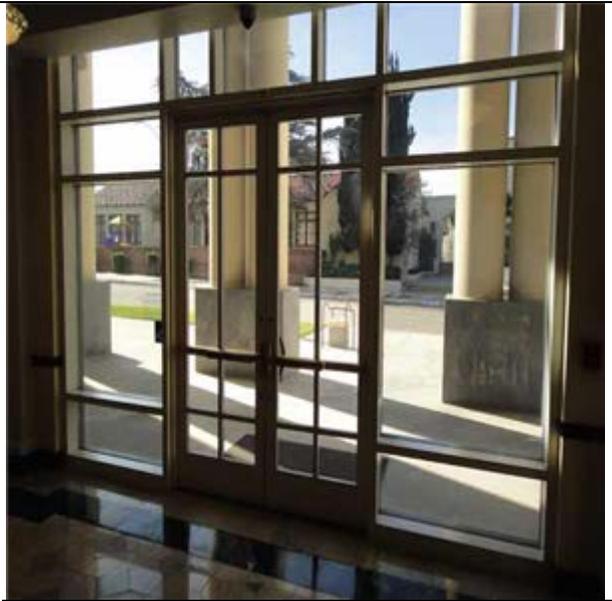
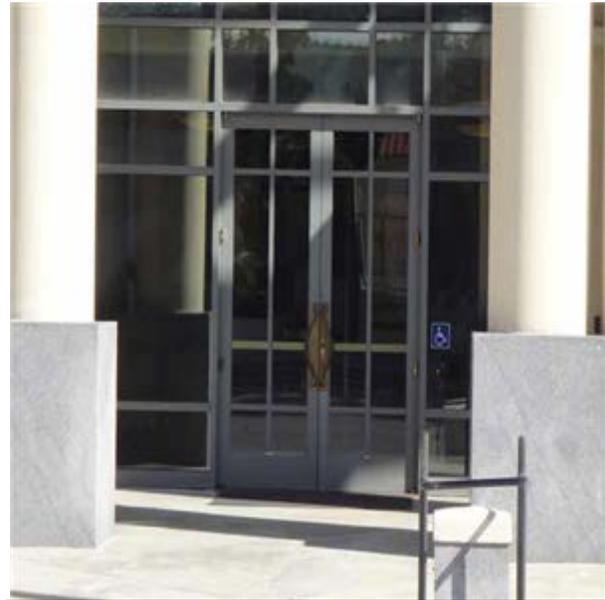
Item	Description
B2011 Exterior Wall Construction	B2031 - Glazed Doors & Entrances
Condition	Fair
Qty / UOM	6 / EA
RUL (years)	24
Location	Entrance Doors

Based on current condition and RUL, no further action is recommended.

B2031 - Glazed Doors & Entrances:- Store front wall

B2031 - Glazed Doors & Entrances

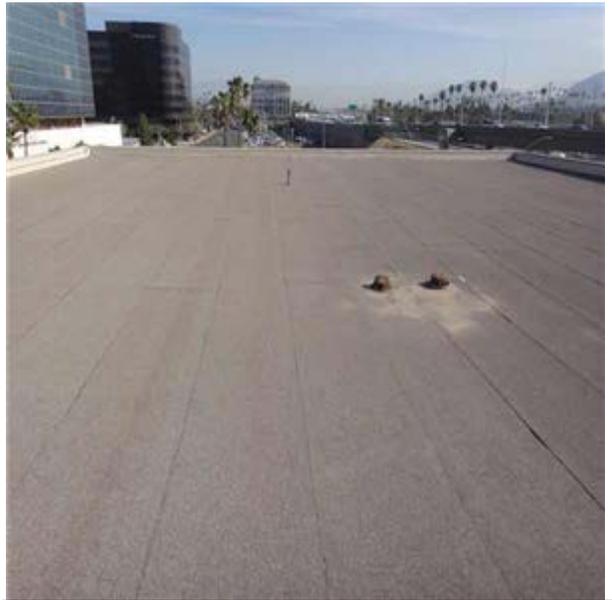
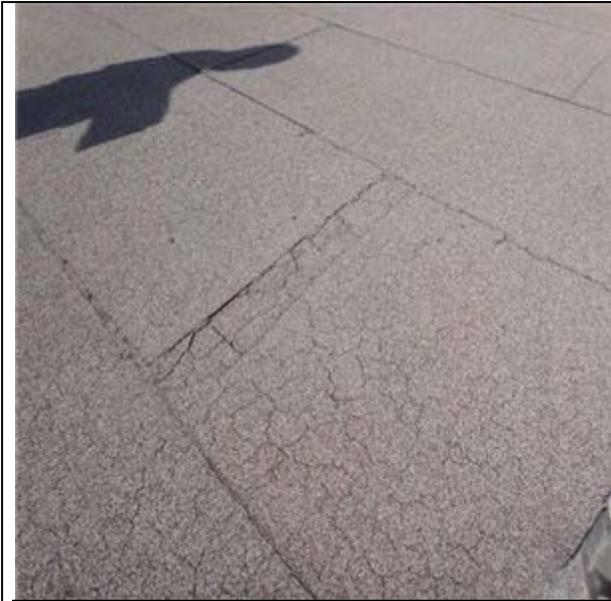
Item	Description
B3011 Roof Finishes	B3011 Built-Up Roofing
Condition	Fair
Qty / UOM	213 / SQ
RUL (years)	4
Location	Roof

Based on current condition and RUL, replacement is recommended during the assessment term.

B3011 Built-Up Roofing

Type	Component Description	Qty / UOM	Unit Cost (\$)	Plan Type	Priority	Year	Expenditures (\$)
B3011	Replace B3011 Built-Up Roofing	213.0 - SQ	1366.1	IN - Beyond Rated Life	Priority 3	2019	290,974

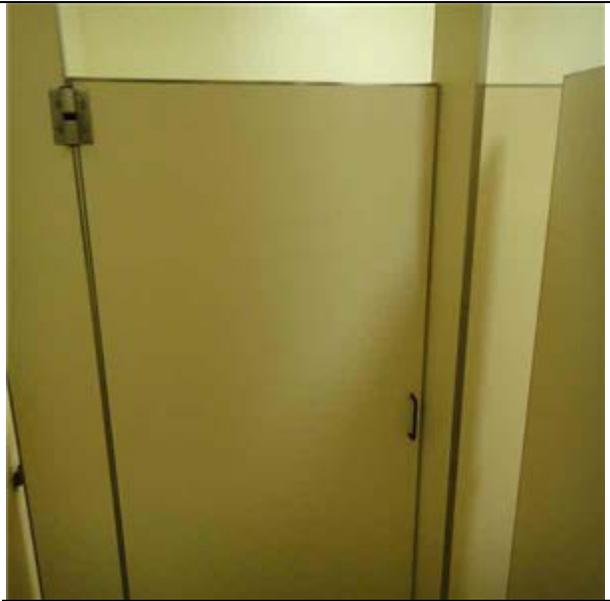
Item	Description
<b>C1014 Site Built Toilet Partitions</b>	C1014 - Toilet Partitions
<b>Condition</b>	Fair
<b>Qty / UOM</b>	2 / EA
<b>RUL (years)</b>	4
<b>Location</b>	First Floor Common Restrooms

The common area ADA accessible restroom stalls do not allow for the required 18 inch minimum clearance on the "pull" side of the door. Partition doors are recommended to be replaced/modified to allow for an inward swing of the doors, allowing for an 18 inch clear space.

C1014 - Toilet Partitions

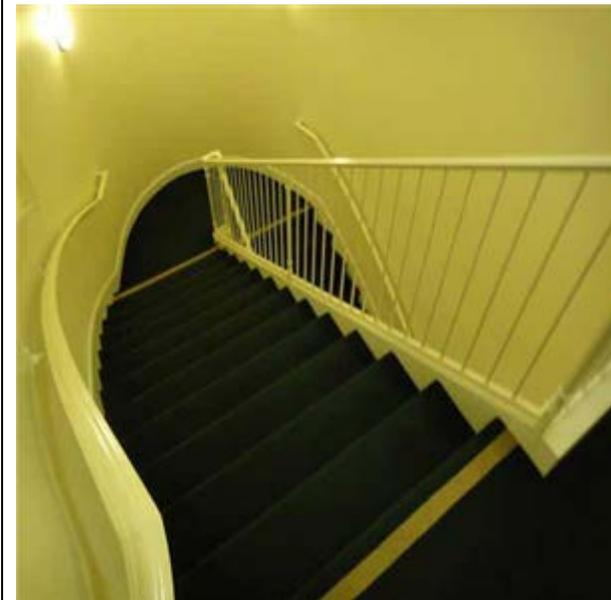
Item	Description
C2012 Curved Stairs	C2012 - Curved Stairs
Condition	Fair
Qty / UOM	600 / SF
RUL (years)	24
Location	Stairs
Stairs Frame	Wood
Stair Riser	Closed
Stair Treads	Wood
Stair Railings	Wood
Stair Soffit Finishes	Drywall
Stair Handrail Finishes	Painted

Based on current condition and RUL, no further action is recommended.

C2012 - Curved Stairs

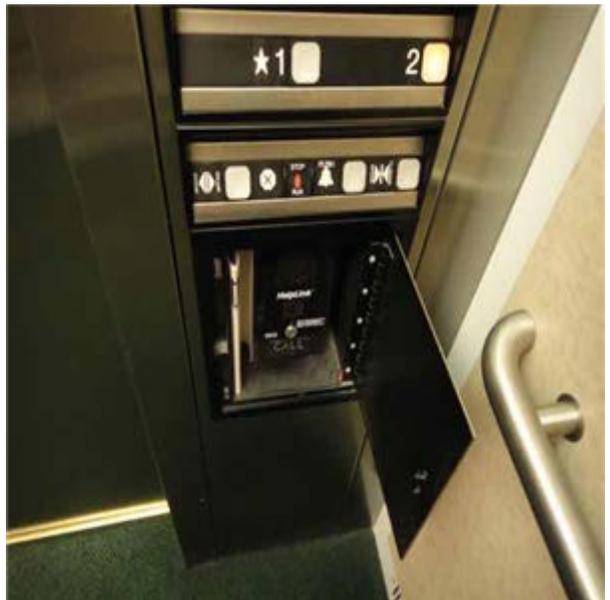
Item	Description
C3005 ADA Renovations	C3005 - ADA Renovations
Condition	Poor
Qty / UOM	1 / EA
RUL (years)	0
Location	Elevator

C3005 - ADA Renovations

Type	Component Description	Qty / UOM	Unit Cost (\$)	Plan Type	Priority	Year	Expenditures (\$)
C3005	Replace C3005 - ADA Renovations	1.0 - EA	3720.0	CC - Accessibility	Priority 1	2015	3,720

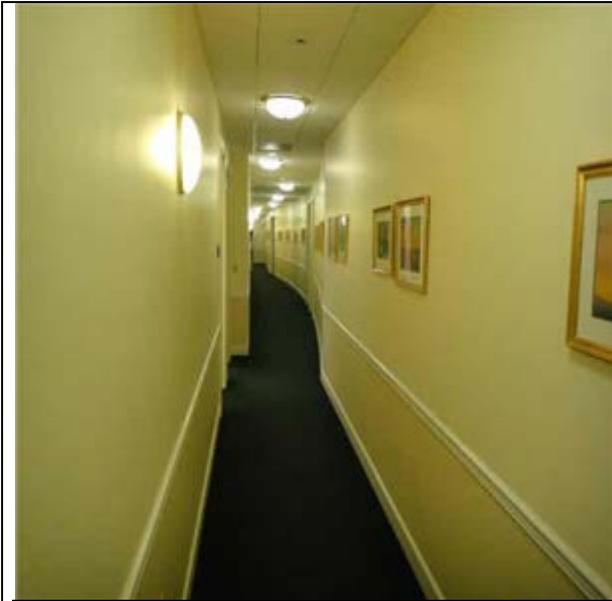
Item	Description
<b>C3012 Wall Finishes to Interior Walls</b>	C3012 - Paint Interior Walls, Drywall
<b>Condition</b>	Fair
<b>Qty / UOM</b>	63,000 / SF
<b>RUL (years)</b>	4
<b>Location</b>	Interior Walls

Based on current condition and RUL, repainting the interior walls is recommended during the assessment term.

C3012 - Paint Interior Walls, Drywall

Type	Component Description	Qty / UOM	Unit Cost (\$)	Plan Type	Priority	Year	Expenditures (\$)
C3012	Replace C3012 - Paint Interior Walls, Drywall	63,000.0 - SF	2.1	IN - Appearance	Priority 3	2019	134,366

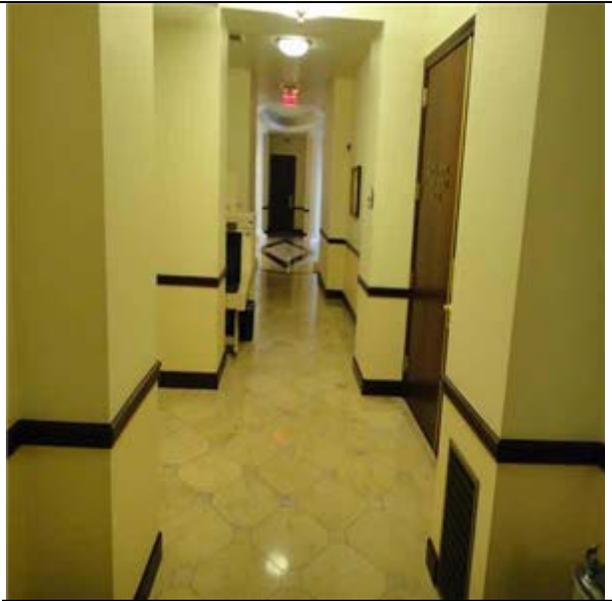
Item	Description
<b>C3024 Flooring</b>	C3024 - Marble Flooring
<b>Condition</b>	Fair
<b>Qty / UOM</b>	2,000 / SF
<b>RUL (years)</b>	34
<b>Location</b>	Interior Flooring

Based on current condition and RUL, no further action is recommended.

C3024 - Marble Flooring

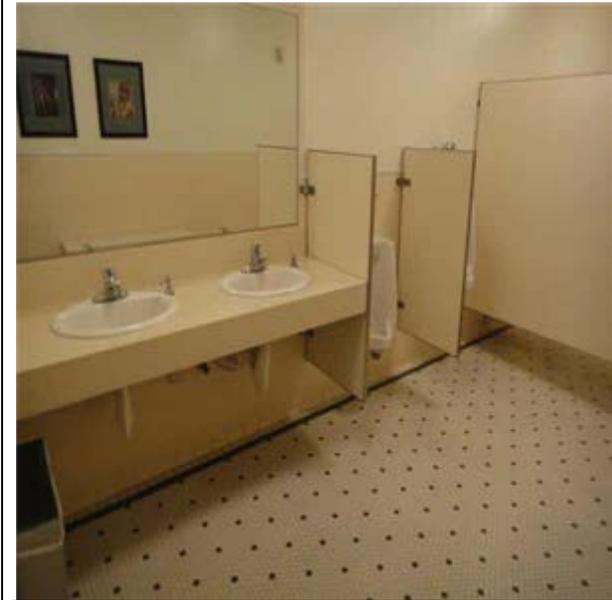
Item	Description
<b>C3024 Flooring</b>	C3024 - Ceramic flooring
<b>Condition</b>	Fair
<b>Qty / UOM</b>	4,200 / SF
<b>RUL (years)</b>	14
<b>Location</b>	Interior Flooring

Based on current condition and RUL, no further action is recommended.

C3024 - Ceramic flooring

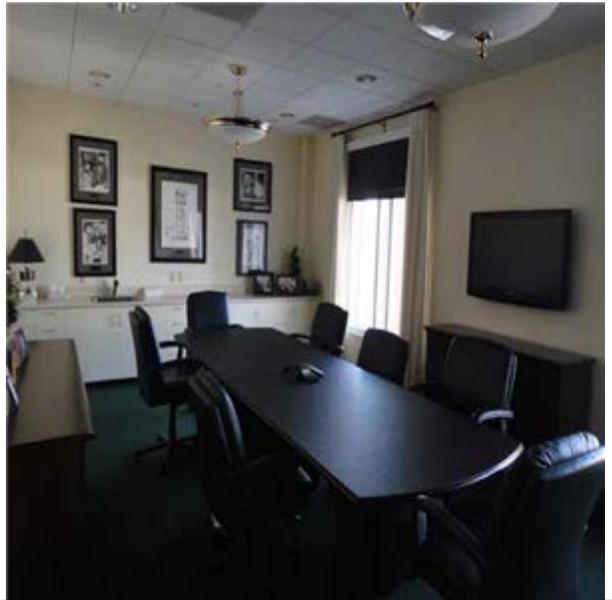
Item	Description
<b>C3025 Carpeting</b>	C3025 - Carpeting
<b>Condition</b>	Fair
<b>Qty / UOM</b>	3,620 / SY
<b>RUL (years)</b>	5
<b>Location</b>	Interior Flooring

Based on current condition and RUL, replacement is recommended during the assessment term.

C3025 - Carpeting

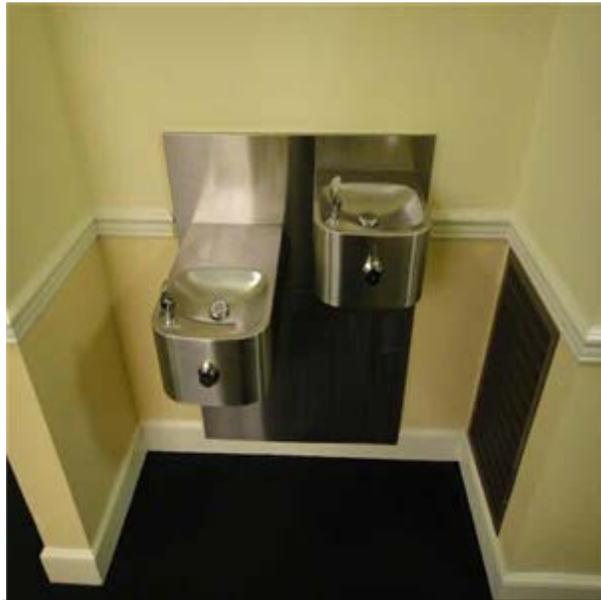
- Passenger elevator modernization in accordance with the State of California elevator report.
- Parking lot concrete curb replacement where damaged.
- The existing drinking fountains do not have accessible side actuators and do not meet Title 24 accessibility requirements.

Item	Description
D2018 Drinking Fountains and Coolers	D2018 - Drinking Fountains and Coolers
Condition	Poor
Qty / UOM	2 / EA
RUL (years)	0
Location	Interior Commons

D2018 - Drinking Fountains and Coolers

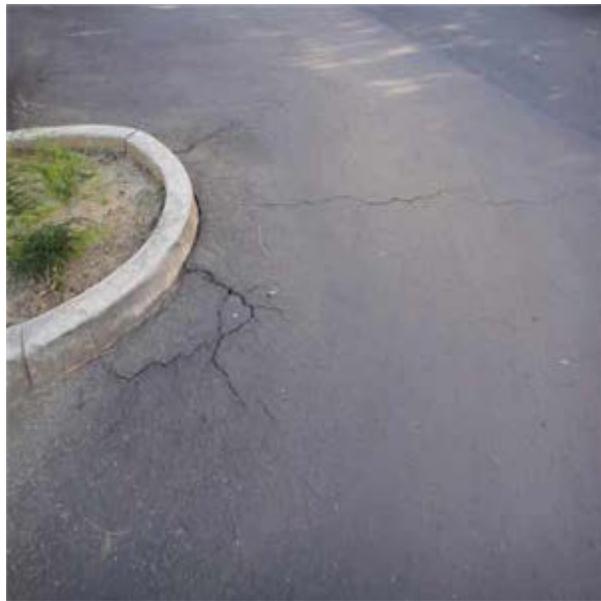
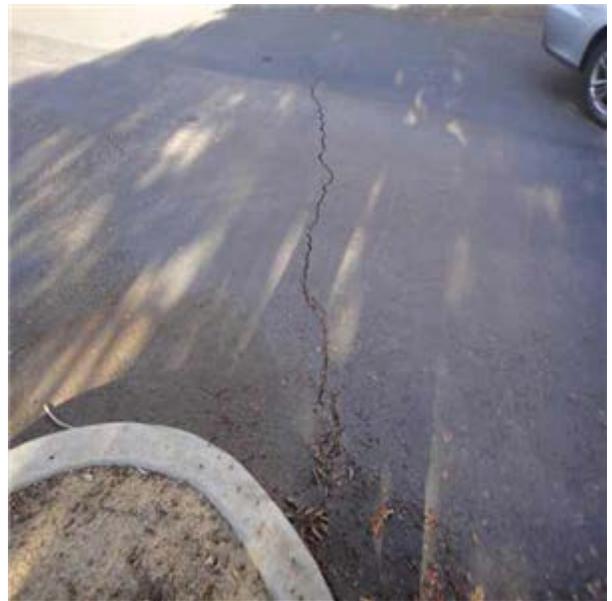
G2012 Asphalt Paving :- Asphalt paving cracks

G2012 Asphalt Paving:- Asphalt paving cracks

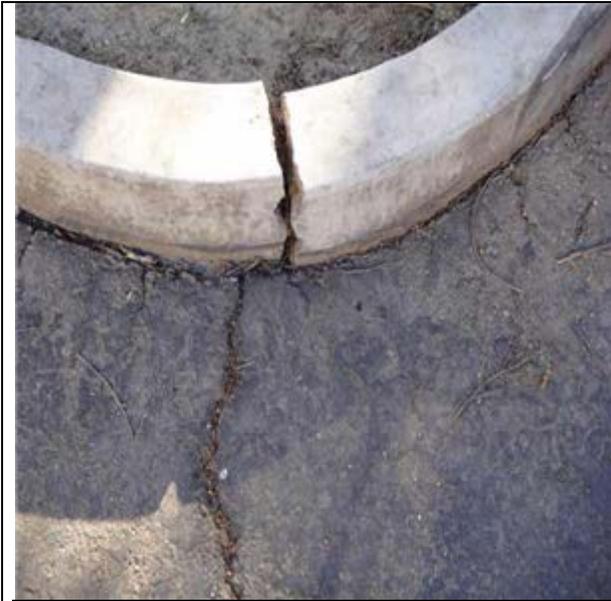
G2023 - Concrete Curbs :- Damaged curbing
