Van Nuys State Building (530)

6150 Van Nuys Boulevard, Van Nuys, CA 91401

Facility Condition Assessment

September 2015

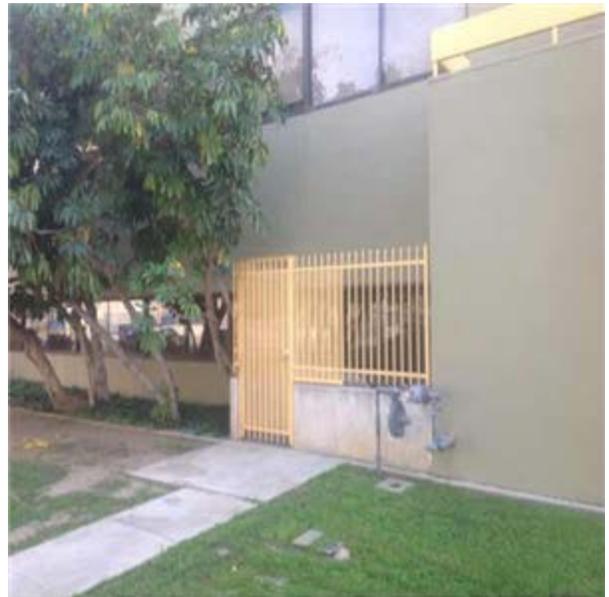
Item	Description
B1032 Concrete frame Structure	B2031 Cast-in-Place Reinforced Concrete Structural Frame
Condition	Fair
Qty / UOM	134,000 / SF
RUL (years)	19
Location	Parking Garage Structure

Based on current condition and remaining useful life (RUL), no further action is recommended.

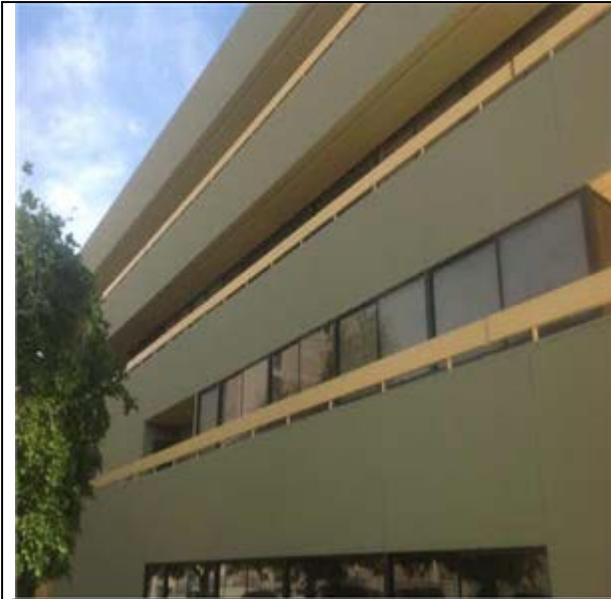
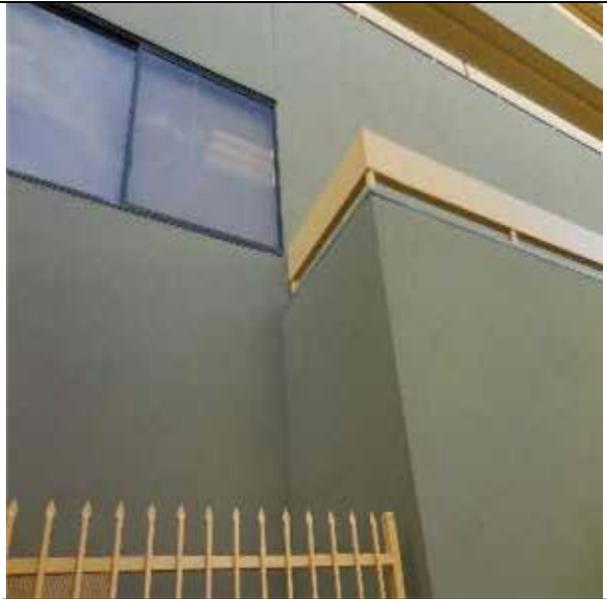
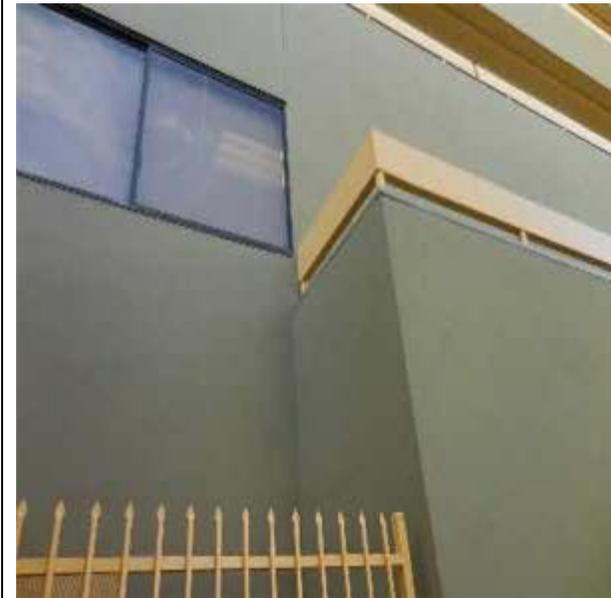
Item	Description
B2011 Exterior Wall Construction	B2011 Stucco Exterior Walls paint
Condition	Good
Qty / UOM	42,000 / SF
RUL (years)	9
Location	Exterior Walls

Based on current condition and RUL, repainting the exterior walls is recommended.

Type	Component Description	Qty / UOM	Unit Cost (\$)	Plan Type	Priority	Year	Expenditures (\$)
B2011	Replace B2011 Stucco Exterior Walls paint	42,000.0 - SF	3.3	IN - Appearance	Priority 4	2024	140,650

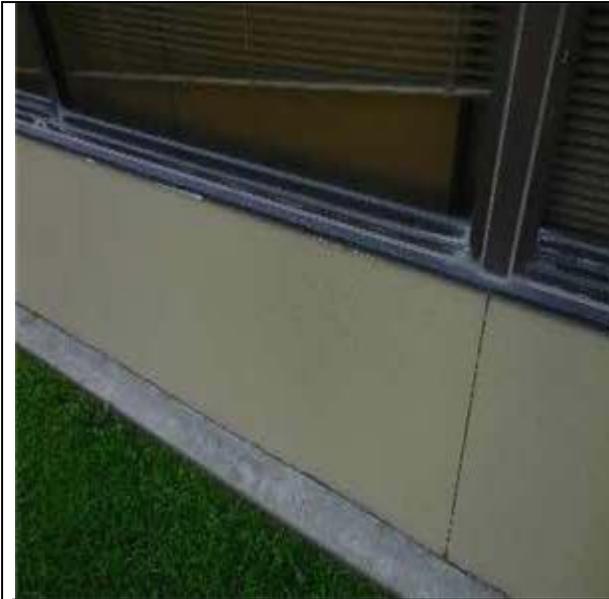
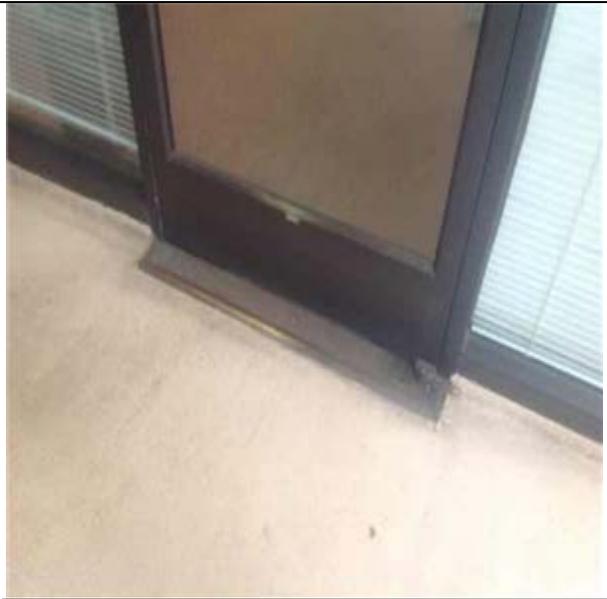
Item	Description
B2021 Windows	B2021 Aluminum Windows
Condition	Fair
Qty / UOM	135 / EA
RUL (years)	3
Location	Exterior
Window Type	Slider
Windows Material	Aluminum
Windows Glazing	Single Glazed
Window Operation	Manual

Based on current condition and RUL, replacement is recommended. This is a partial replacement of only those units which are in the most deteriorated conditions.

Type	Component Description	Qty / UOM	Unit Cost (\$)	Plan Type	Priority	Year	Expenditures (\$)
B2021	Replace B2021 Aluminum Windows	135.0 - EA	3594.5	IN - Beyond Rated Life	Priority 2	2018	485,258

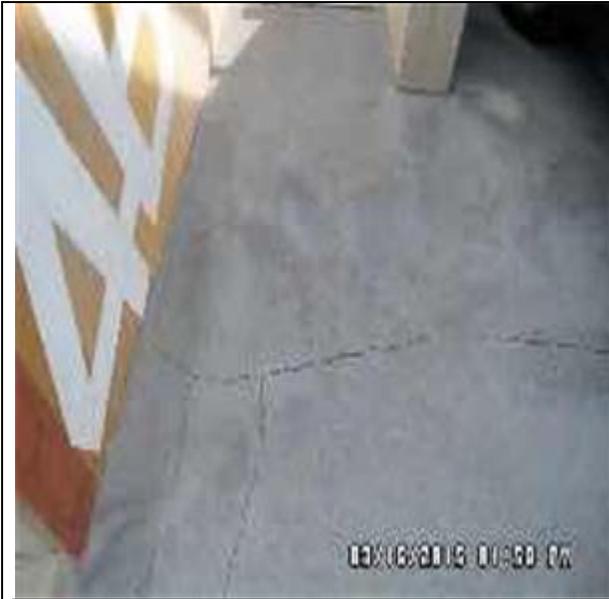
Item	Description
B3011 Roof Finishes	B3011 Built-Up Roofing
Condition	Fair
Qty / UOM	372 / SQ
RUL (years)	2
Location	Roof
Traffic Toppings and Pavings	Last layer appeared to be elastomeric

According to maintenance staff, roofing is likely original and has been overlaid with layers of fiberglass and elastomeric coatings over the years. Based on current condition and RUL, replacement is recommended.

Type	Component Description	Qty / UOM	Unit Cost (\$)	Plan Type	Priority	Year	Expenditures (\$)
B3011	Replace B3011 Built-Up Roofing	372.0 - SQ	1366.1	IN - Beyond Rated Life	Priority 2	2017	508,179

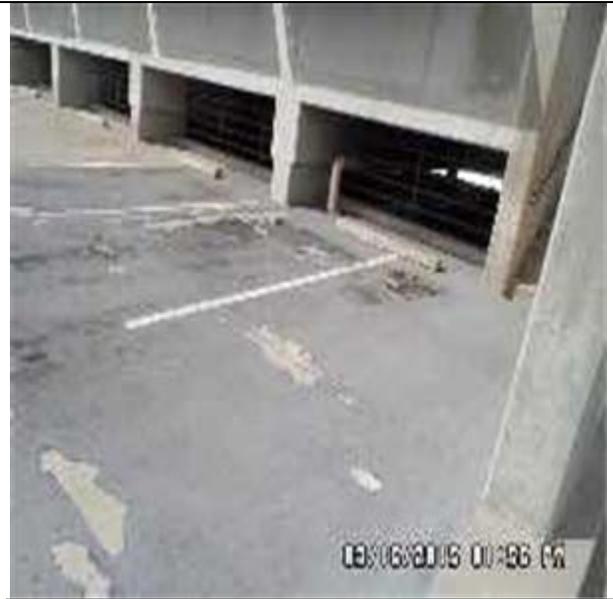
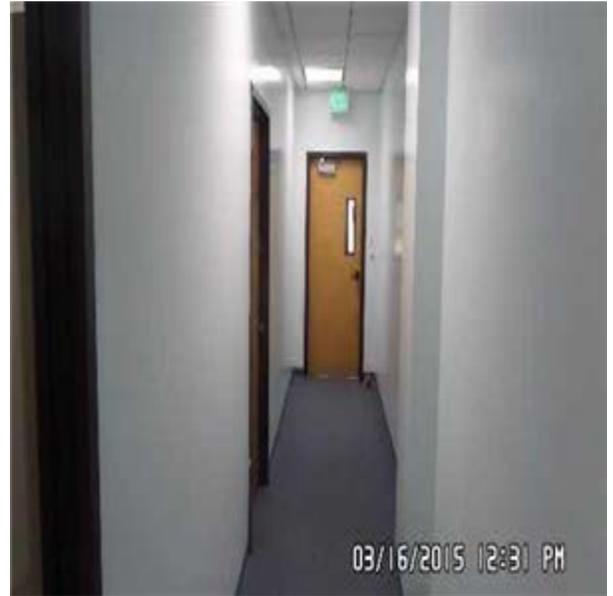
Item	Description
B3011 Roof Finishes	B3011 White Liquid-Applied Coating
Condition	Poor
Qty / UOM	22,000 / SF
RUL (years)	0
Location	Parking Garage Structure Roof

A significant amount of rainwater is infiltrating the parking structure through roof/upper level cracks. This entering water travels throughout the structure and ultimately pools at the lowest level. The moisture is also damaging exhaust fan ducting throughout. An elastomeric roof sealant should be applied to the roof/upper deck and along the open perimeters. Floor drains should be added along the perimeters to drain storm water appropriately (additional line item asset.) Based on the active water infiltration and condition, as well as zero years RUL, re-application is recommended.

Type	Component Description	Qty / UOM	Unit Cost (\$)	Plan Type	Priority	Year	Expenditures (\$)
B3011	Replace B3011 White Liquid-Applied Coating	22,000.0 - SF	8.8	IN - Beyond Rated Life	Priority 1	2015	194,594

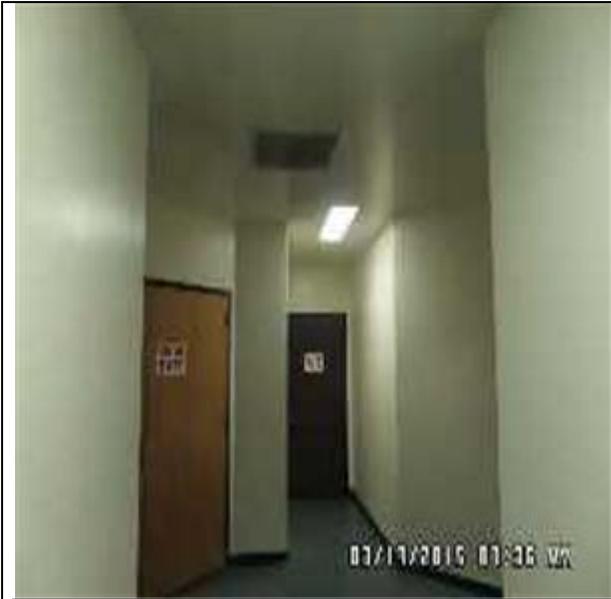
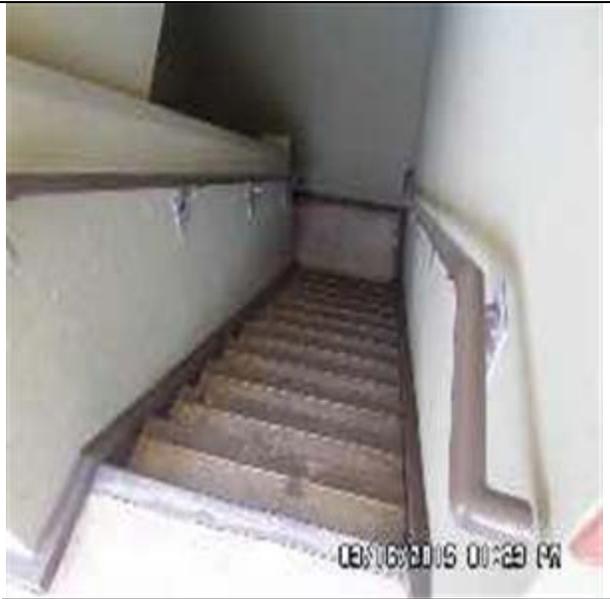
Item	Description
C1021 Interior Doors	C1021 Interior Doors
Condition	Fair
Qty / UOM	230 / EA
RUL (years)	15
Location	Interior Doors

Based on current condition and RUL, no further action is recommended.

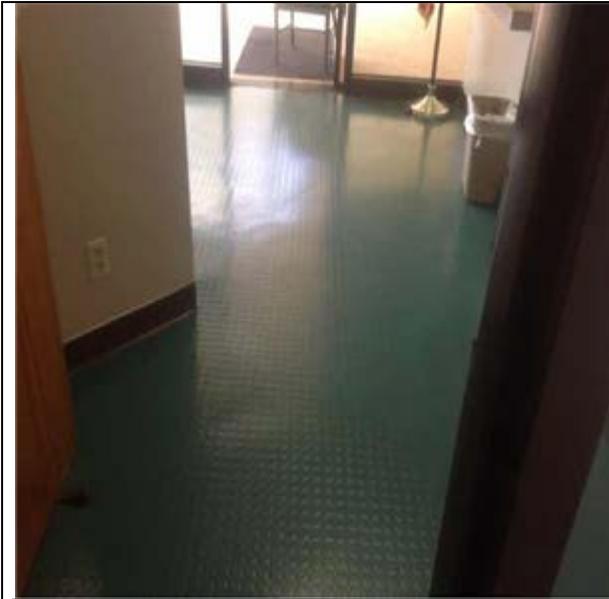
Item	Description
C3012 Wall Finishes to Interior Walls	C3012 Paint Interior Walls, Drywall
Condition	Fair
Qty / UOM	340,000 / SF
RUL (years)	4
Location	Interior Walls

Based on current condition and RUL, repainting the interior walls is recommended.

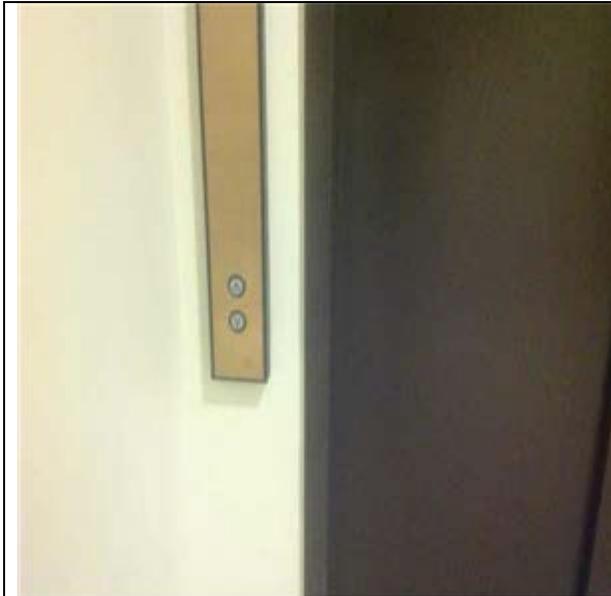
Item	Description
D1011 Passenger Elevators	D1011 Elevators and Lifts remove call buttons
Condition	Poor
Qty / UOM	6 / EA
RUL (years)	0
Location	Elevators

Type	Component Description	Qty / UOM	Unit Cost (\$)	Plan Type	Priority	Year	Expenditures (\$)
D1011	Replace D1011 Elevators and Lifts remove call buttons	6.0 - EA	8190.0	CC - Accessibility	Priority 1	2015	49,140
