East End Complex Block 225 (049)

1430 "N" Street, Sacramento, CA 95814

Facility Condition Assessment

June 2015

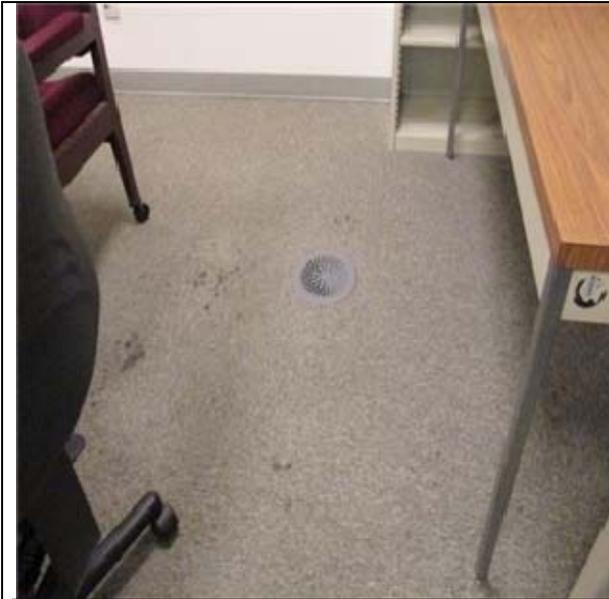
The top surface of the assembly of the floor air distribution system are round steel plates that are approximately 18 inches in diameter. According to the maintenance staff, the steel restricts regular floor finish cleaning methods because the water used can rust the steel or seep into the plenum and cause rust.

B1019 Under Floor Air Distribution(UFAD) :-
Underfloor distribution supply air vent

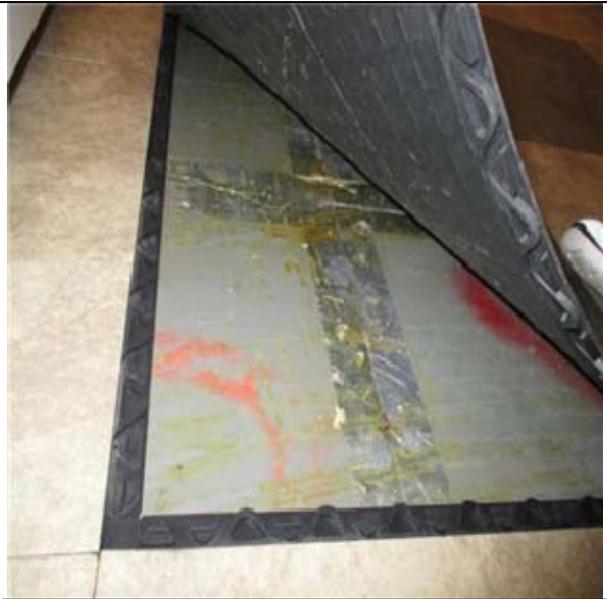
B1019 Under Floor Air Distribution(UFAD):- Joints
between the steel plates are sealed with duct tape.

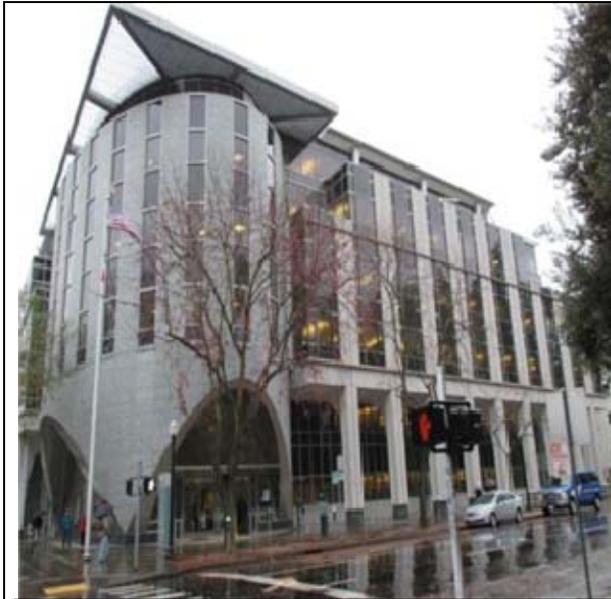
B2011 Curtain Wall Glazing

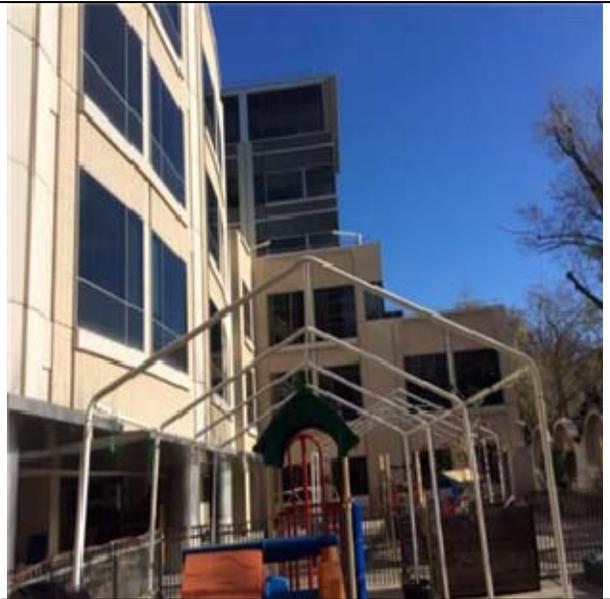
The aluminum windows are double glazed. The maintenance staff explained that the report of a window leak was attributable to wind-driven rain, and that investigation and attempts to correct it were in progress.

B2021 Windows

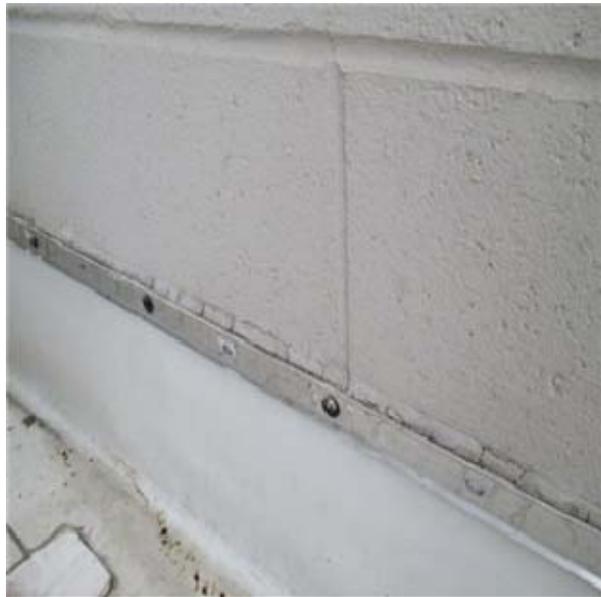
B3014 Flashings & Trim:- Failing sealant

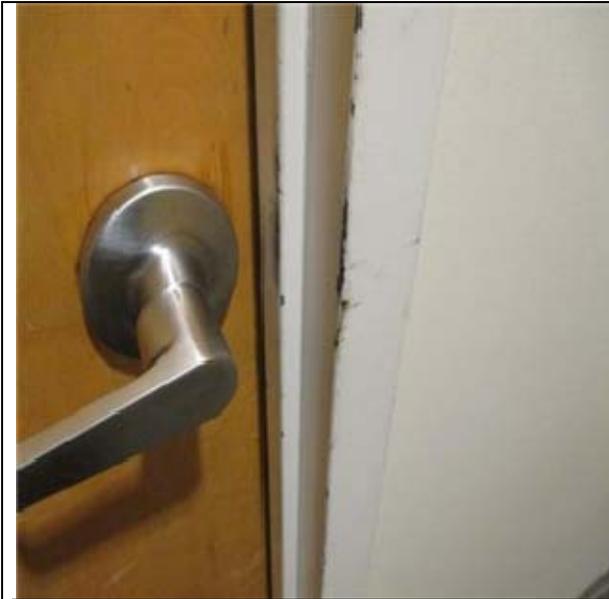
C1021 Fire Door, Wood, Flush, 60 Minute, Incl. Demo, with Hardware :- The spring has failed in this lever set

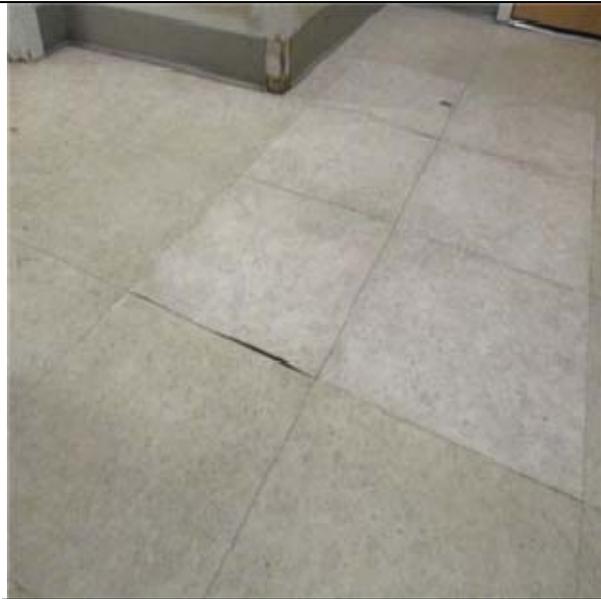
C3021 Epoxy Flooring:- Vinyl tile that has been replaced is lifting

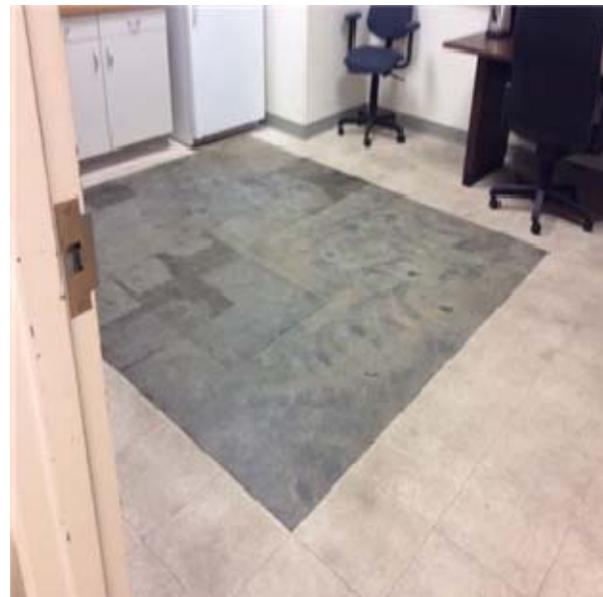
C3021 Epoxy Flooring :- A large area of vinyl has come up

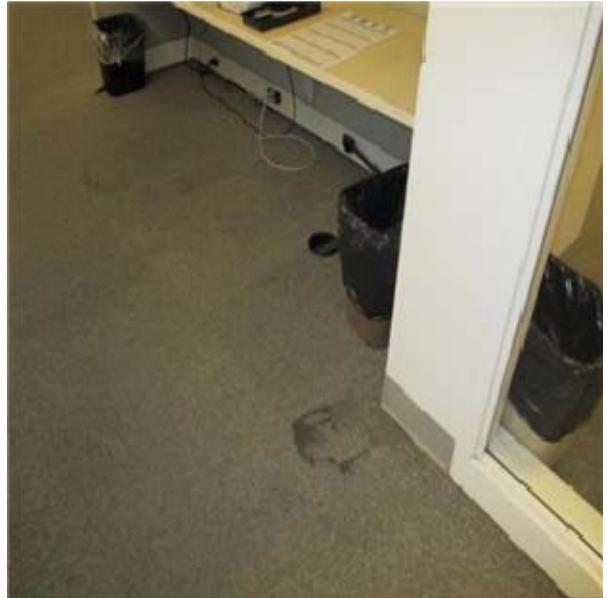
C3025 Carpet Tiles - Standard:- Condition of carpet

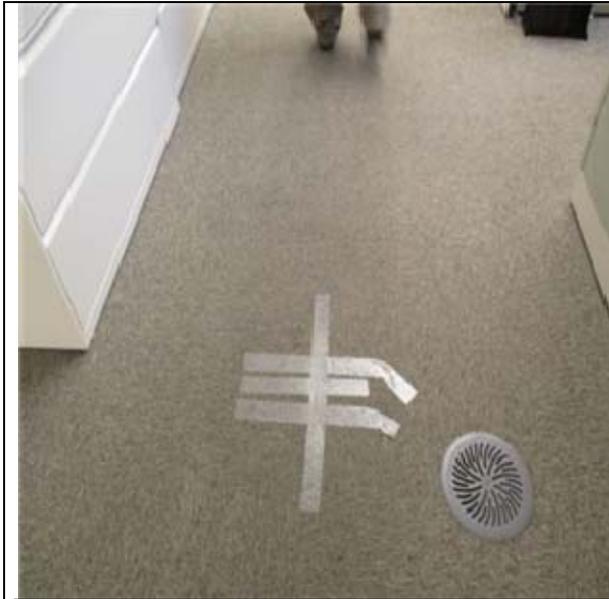
C3025 Carpet Tiles - Standard :- Seams coming loose

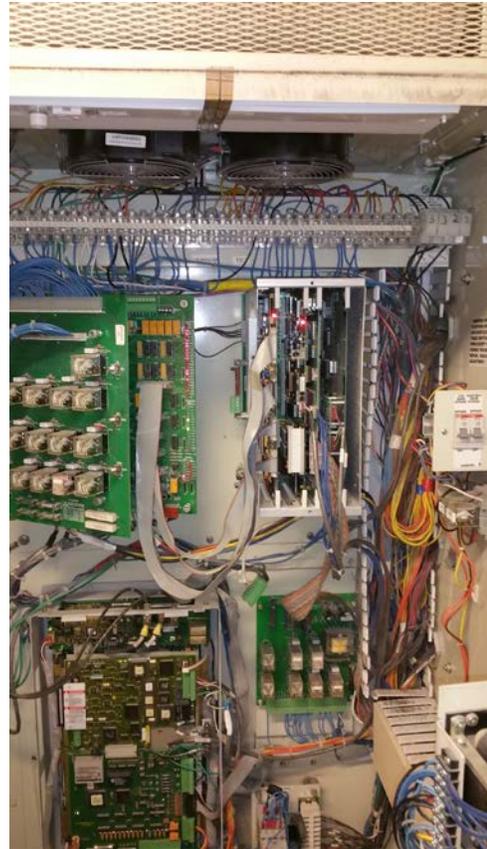
The controllers for were manufactured by Kone just after they purchased Montgomery Elevator in 2000. They are Miprom A/I. These particular controllers had a limited run and long term support is questionable.

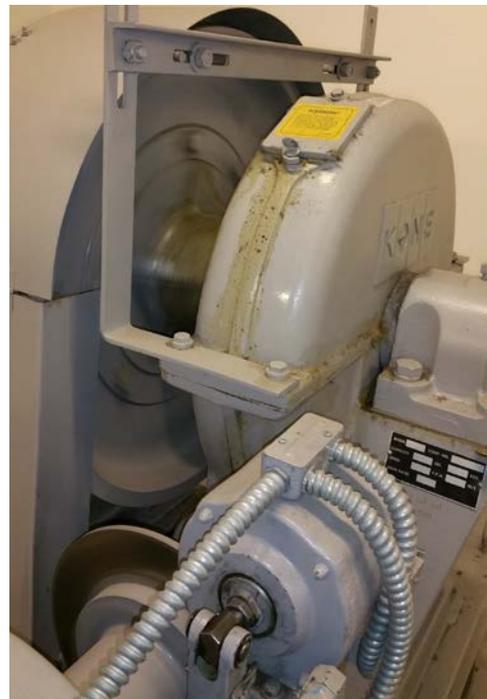
Elevators 1-5 and 7 have geared Hollister Whitney machines. Most the machines had minor oil leaks and some had enough that warrant changing the seals. These machines are generally in good condition and do not need updated anytime soon. Elevator 6 has a gearless machine manufactured by Kone.

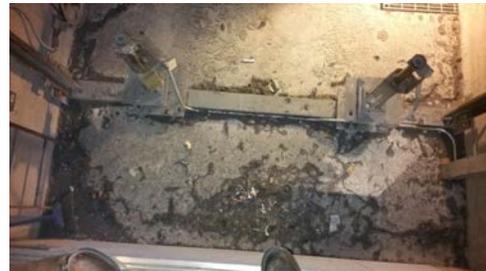
The pits were found to be dry but very dirty.

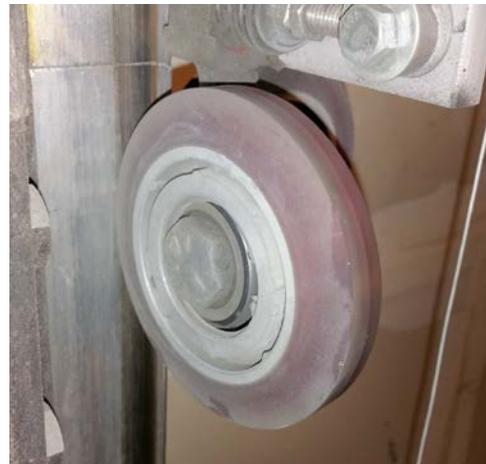
On both sides of the elevators and on the top and bottom roller guides keep the elevators riding up and down the steel guide rails. The counterweight rollers were noted to be in bad condition and need to be replaced immediately as part of the maintenance program.
