January 27, 2000

Re: Asbestos and Lead-Based Paint Survey, Orange County Fair, Cafeteria Building,
performed on January 4, 2000; HSA Project Number 00LA135

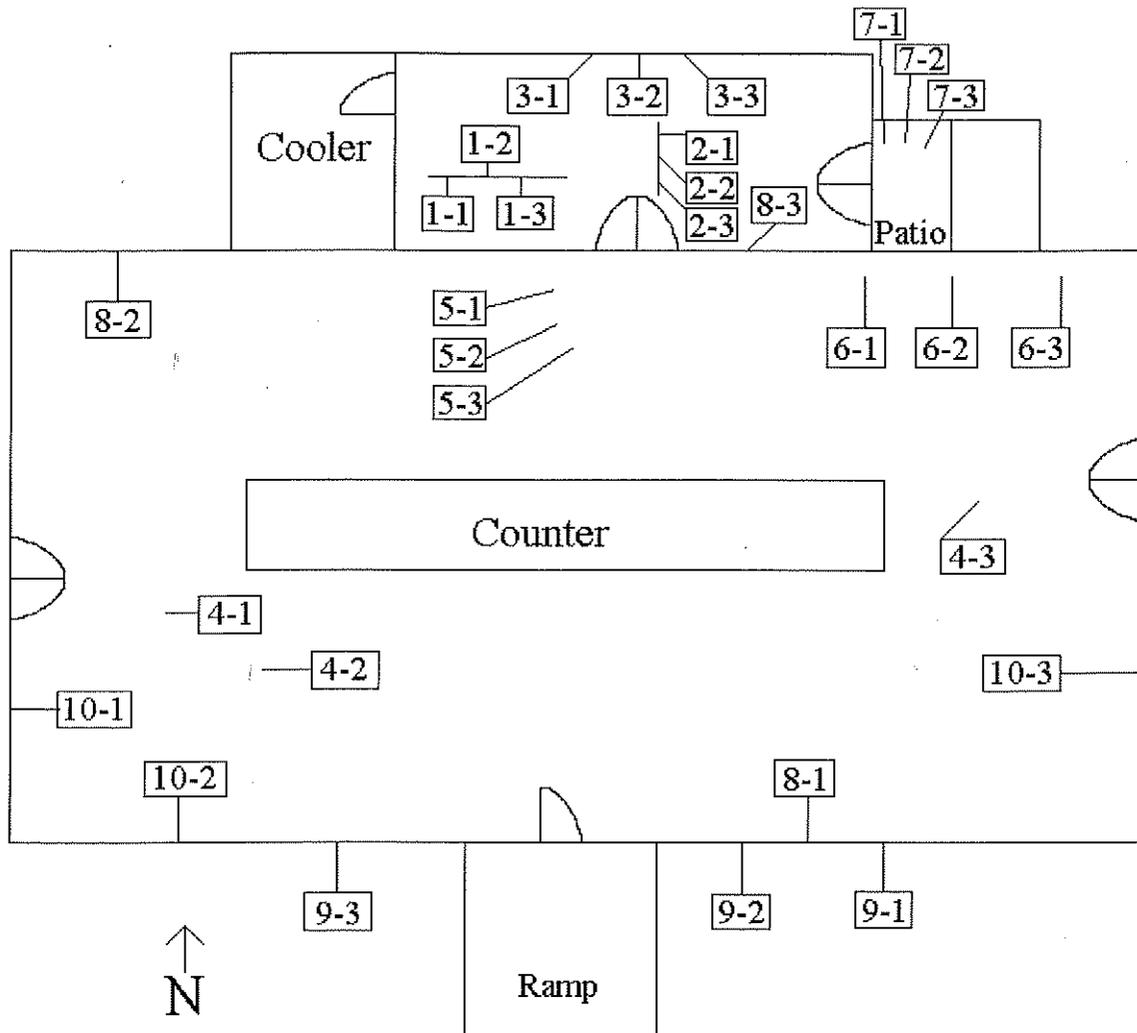
Figure 1

Kitchen Attic:

- 2" pipe insulation; and
- 4" pipe insulation.

Eating Area:

- Brown 9" X 9" floor tile and mastic.

Sample Number 00LA135	Location/Description (see Figures 1 & 2)	Asbestos Results Type and Percent (%)
0104 - 1-1	Attic Above Kitchen/2" Pipe Insulation	Chrysotile: 60%
0104 - 1-2	Attic Above Kitchen/2" Pipe Insulation	Chrysotile: 60%
0104 - 1-3	Attic Above Kitchen/2" Pipe Insulation	Chrysotile: 60%
0104 - 2-1	Attic Above Kitchen/4" Pipe Insulation	Chrysotile: 15% Amosite: 50%
0104 - 2-2	Attic Above Kitchen/4" Pipe Insulation	Chrysotile: 15% Amosite: 50%
0104 - 2-3	Attic Above Kitchen/4" Pipe Insulation	Chrysotile: 15% Amosite: 50%
0104 - 3-1	Attic Above Kitchen North Wall/Felt Paper	BLD
0104 - 3-2	Attic Above Kitchen North Wall/Felt Paper	BLD
0104 - 3-3	Attic Above Kitchen North Wall/Felt Paper	BLD
0104 - 4-1	Eating Area/9 x 9 Brown Floor Tile & Black Mastic	1. Tile: Chrysotile: 2% 2. Mastic: Chrysotile: 2%
0104 - 4-2	Eating Area/9 x 9 Brown Floor Tile & Black Mastic	1. Tile: Chrysotile: 2% 2. Mastic: Chrysotile: 1%

0104 - 4-3	Eating Area/9 x 9 Brown Floor Tile & Black Mastic	1. Tile: Chrysotile: 2% 2. Mastic: Chrysotile 1%
0104 - 5-1	Behind Counter Entrance to Kitchen/Tan Linoleum	BLD
0104 - 5-2	Behind Counter Entrance to Kitchen/Tan Linoleum	BLD
0104 - 5-3	Behind Counter Entrance to Kitchen/Tan Linoleum	BLD
0104 - 6-1	Behind Counter East End/Tan Linoleum	BLD
0104 - 6-2	Behind Counter East End/Tan Linoleum	BLD
0104 - 6-3	Behind Counter East End/Tan Linoleum	BLD
0104 - 7-1	Patio Off Kitchen/12 x 12 Tan Floor Tile & Brown Mastic	BLD
0104 - 7-2	Patio Off Kitchen/12 x 12 Tan Floor Tile & Brown Mastic	BLD

It is our understanding that the cafeteria is scheduled for demolition. Since there is greater than 100 square feet of ACM it will have to be removed by a state certified and registered asbestos abatement contractor in accordance with all local, state, and federal regulations prior to the demolition.

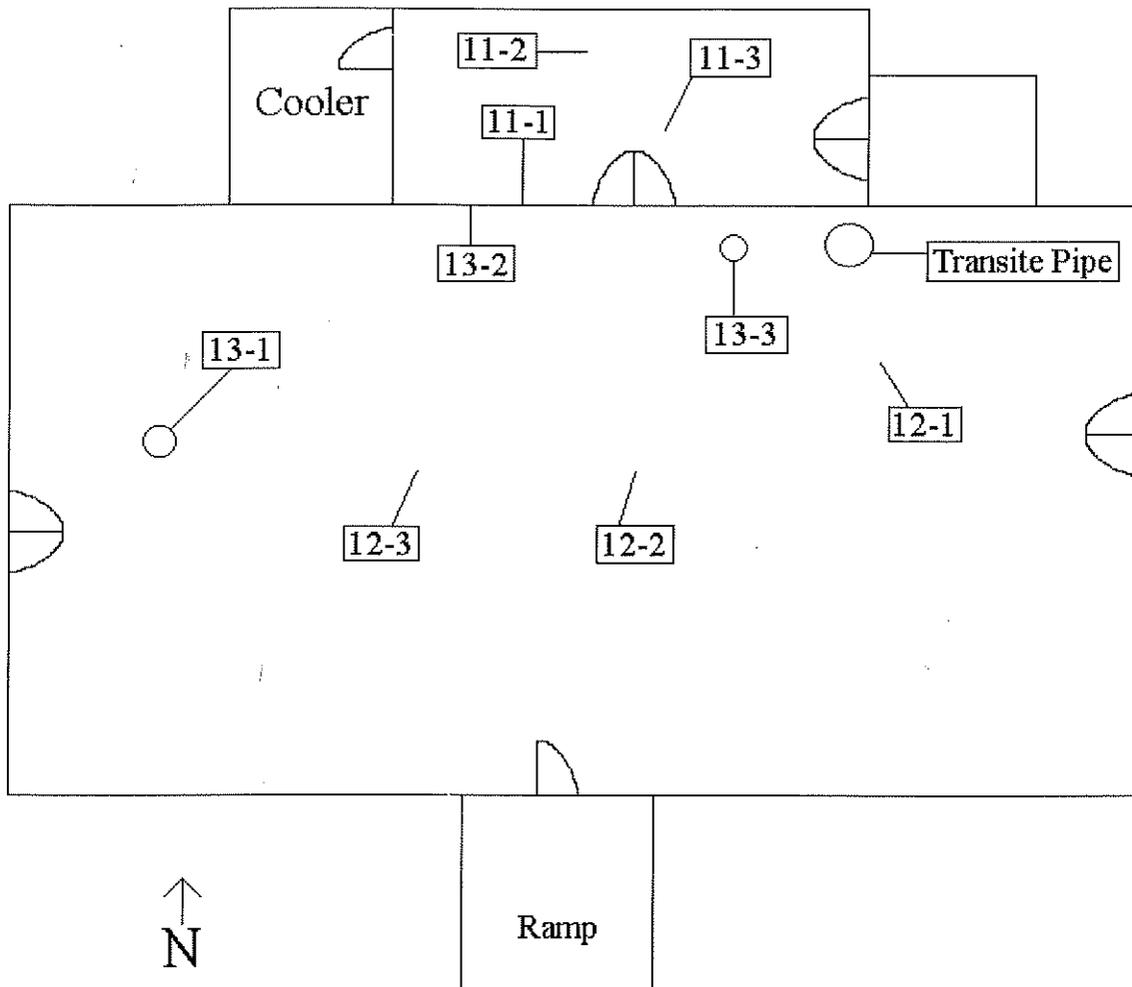
Figure 2

Exterior

- Black roof vent mastic.
- Stucco was determined to be ACCM via TEM analysis. The material must be removed by a licensed asbestos abatement contractor utilizing dust control measures. The material may be disposed as normal construction debris.

Sample Number 00LA135	Location/Description (see Figures 1 & 2)	Asbestos Results Type and Percent (%)
0104 - 7-3	Patio Off Kitchen/12 x 12 Tan Floor Tile & Brown Mastic	BLD
0104 - 8-1	South Upper Wall/Drywall Core	BLD
0104 - 8-2	South Upper Wall/Drywall Core	BLD
0104 - 8-3	South Upper Wall/Drywall Core	BLD
0104 - 9-1	Exterior South Windows/Window Putty	BLD
0104 - 9-2	Exterior South Windows/Window Putty	BLD
0104 - 9-3	Exterior South Windows/Window Putty	BLD
0104 - 10-1	Exterior West Side/Stucco	Chrysotile: 1% (.15% by TEM)
0104 - 10-2	Exterior West Side/Stucco	Chrysotile: 1% (.17% by TEM)
0104 - 10-3	Exterior West Side/Stucco	Chrysotile: 1% (.14% by TEM)
0104 - 11-1	Roof/Flat Rolled Grey/Roof Core	BLD
0104 - 11-2	Roof/Flat Rolled Grey/Roof Core	BLD
0104 - 11-3	Roof/Flat Rolled Grey/Roof Core	BLD
0104 - 12-1	Roof/Flat Rolled Grey/Roof Core	BLD
0104 - 12-2	Roof/Flat Rolled Grey/Roof Core	BLD
0104 - 12-3	Roof/Flat Rolled Grey/Roof Core	BLD

0104 - 13-1	Roof Vent/Black Mastic	Chrysotile: 8%
0104 - 13-2	Roof Vent/Black Mastic	Chrysotile: 10%
0104 - 13-3	Roof Vent/Black Mastic	Chrysotile: 10%
Standards		
EPA - ACM and ACBM		1.0
State of California - ACCM		0.1
Abbreviations: BLD = Below the limit of detection; < = less than; % - percent; EPA = Environmental Protection Agency; ACM = Asbestos Containing Material; ACBM = Asbestos Containing Building Material; ACCM = Asbestos Containing Construction Material

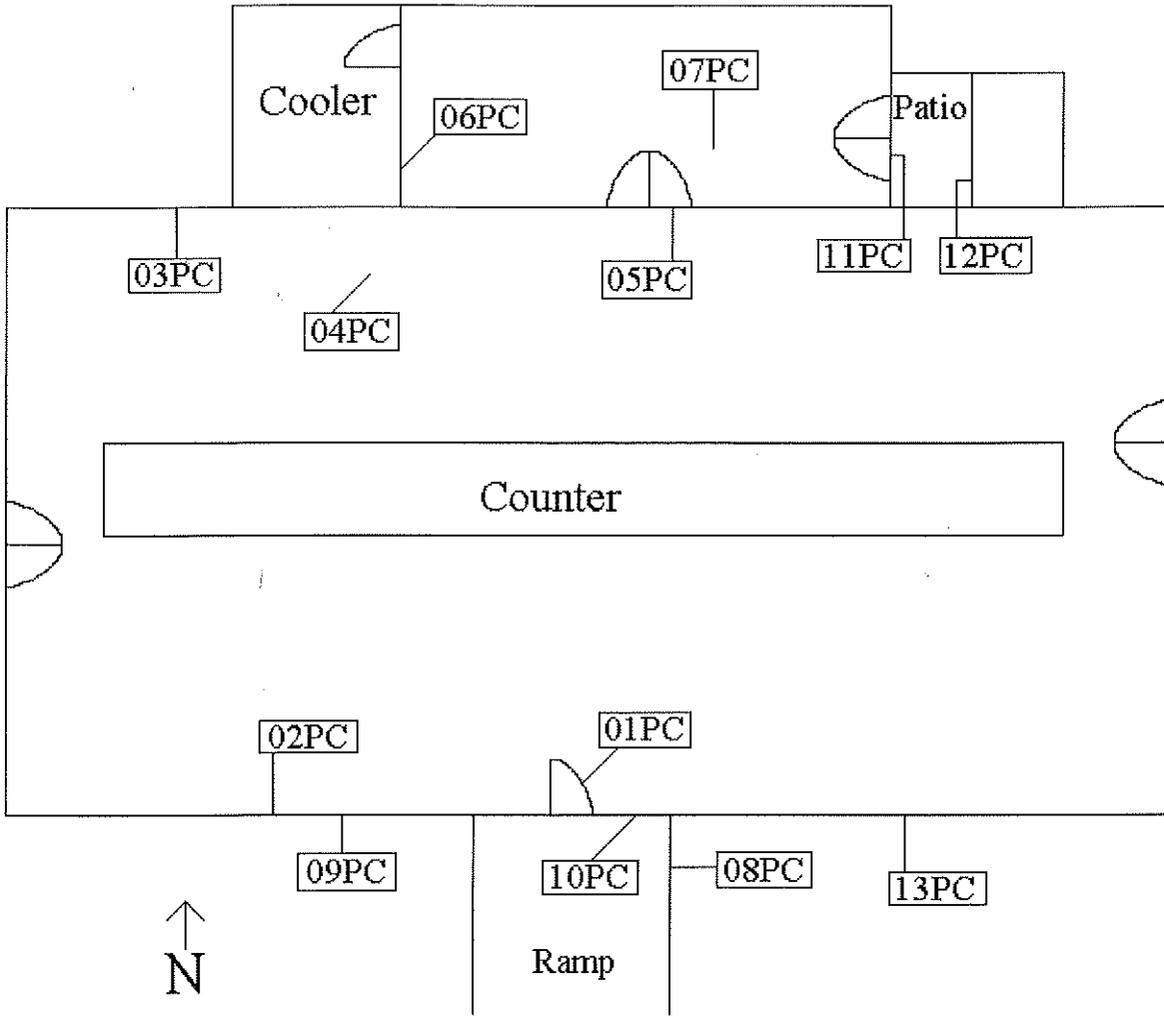
Figure 3

The green paint on the main entrance door and the exterior south side window was determined to be LBP. The green paint on the interior south upper wall, white paint on the interior north window, the off white paint on the interior ceiling above the counter, the tan paint on the exterior south side eave, and the tan paint on the stucco was determined to be LCP.

Sample Number 00LA135	Location/Description (See Figure 3)	Laboratory Results Lead WT%
0104 - 01PC	Front Door/Dark Green Paint	3.0
0104 - 02PC	Interior South Upper Wall/Green Paint	0.10
0104 - 03PC	Interior North Window/White Paint	0.093
0104 - 04PC	Interior Ceiling Above Counter/Off White Paint	0.022
0104 - 05PC	Interior/Kitchen Doors/Off White Paint	<0.01
0104 - 06PC	Interior Kitchen Walls/Off White Paint	<0.01
0104 - 07PC	Interior Kitchen Floor/Grey Paint	<0.01
0104 - 08PC	Exterior South Side Hand Rail/Dark Green Paint	0.01
0104 - 09PC	Exterior South Side Window/Dark Green Paint	0.53
0104 - 10PC	Exterior South Side Eaves/Tan Paint	0.23
0104 - 11PC	Exterior Door on Patio to Kitchen/White Paint	<0.01
0104 - 12PC	Exterior Patio Cover Frame/Flat White Paint	<0.01
0104 - 13PC	Exterior/South Wall on Stucco/Tan Paint	0.029
Standards		
Consumer Products Safety Commission		0.06
HUD Guidelines, June, 1995		0.5
Abbreviations: WT% = weight by percent; BLD = below the limit of detection; < = less than

LBP and LCP was also detected in the cafeteria. Orange County Fair is required to notify the demolition contractor that LBP and LCP was detected on the components listed above. The contractor is required to be in compliance with CCR Title 8, Section 1532.1. The waste

generated from the demolition of the LBP components will have to be tested prior to disposal to determine its hazardous waste classification, if any.
