## Junipero Serra Office Building (512)

320 West Fourth Street, Los Angeles, CA 90013

### Facility Condition Assessment

September 2015

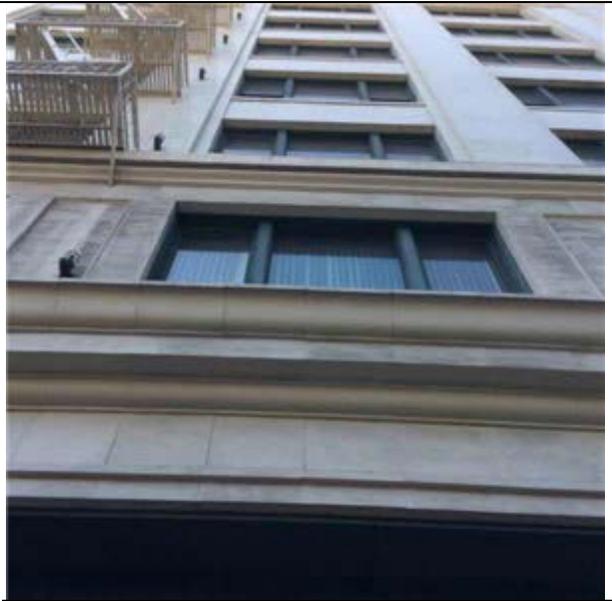
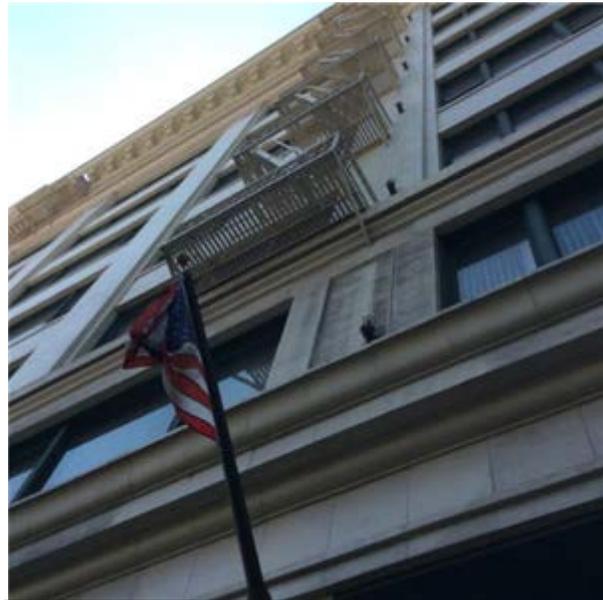
B2011 Concrete Exterior Walls

The exterior walls appear to be in fair condition, however, minor cracking was noted. Based on current condition and RUL, no further action is recommended.

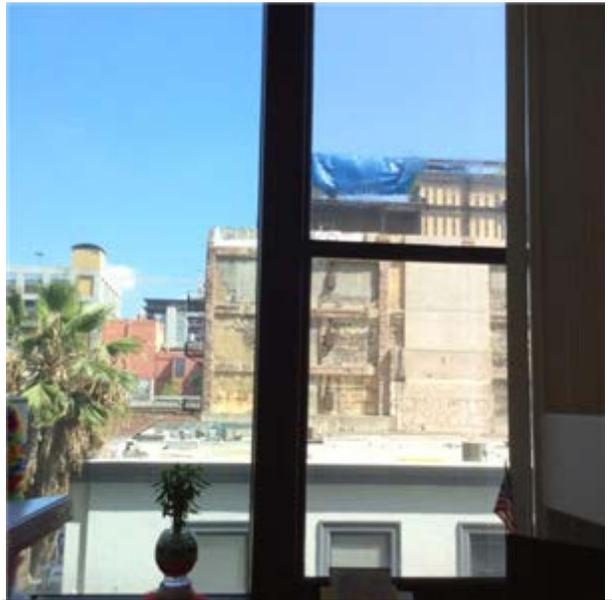
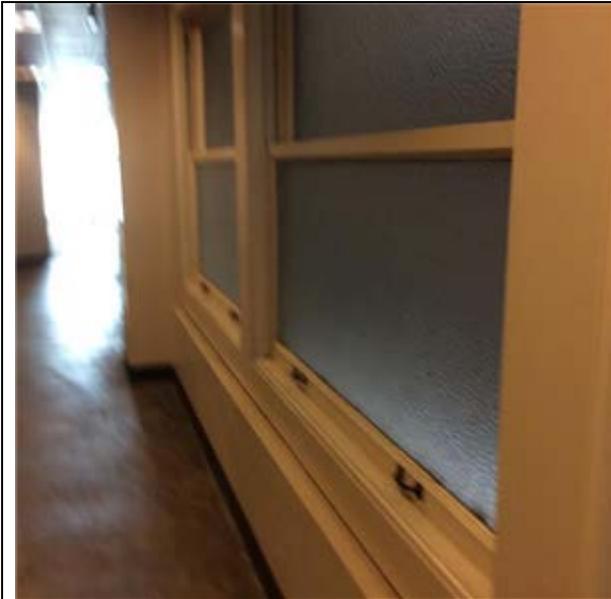
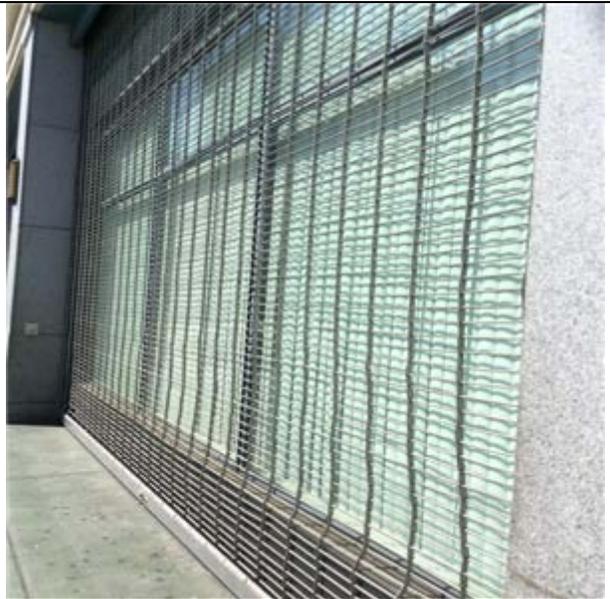
Based on current condition and RUL, replacement is recommended.

Type	Component Description	Qty / UOM	Unit Cost (\$)	Plan Type	Priority	Year	Expenditures (\$)
B2021	Replace B2021 Aluminum Windows	280.0 - EA	2652.8	IN - Beyond Rated Life	Priority 4	2024	742,783

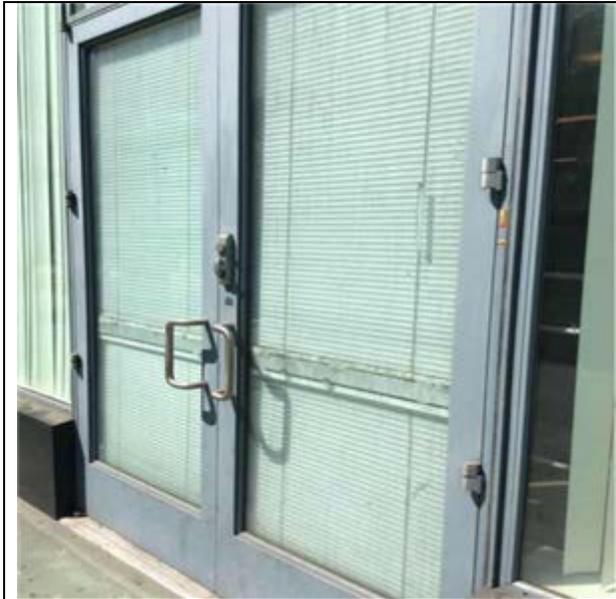
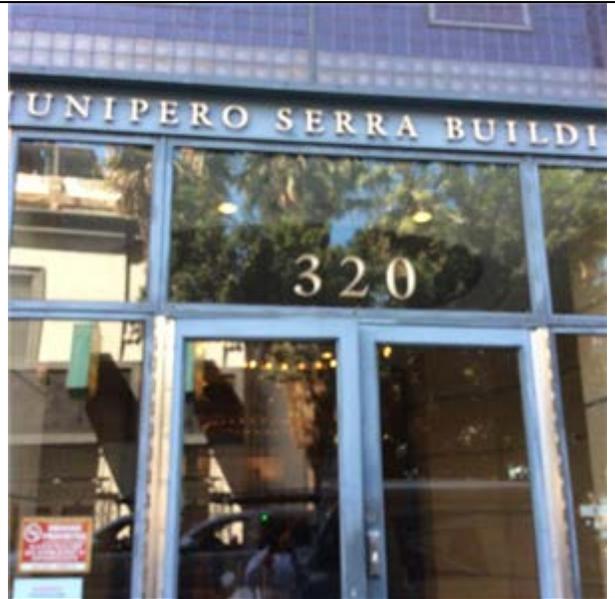
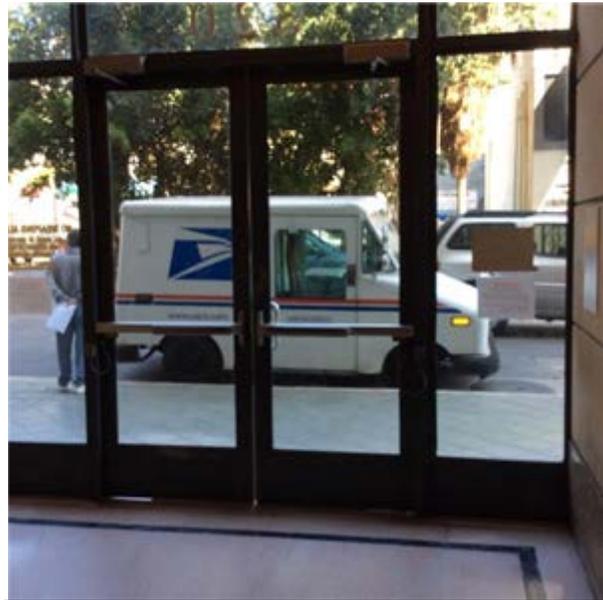
Based on current condition and RUL, replacement is recommended.

Type	Component Description	Qty / UOM	Unit Cost (\$)	Plan Type	Priority	Year	Expenditures (\$)
B2031	Replace B2031 Glazed Entrance Doors	6.0 - EA	3181.7	IN - Beyond Rated Life	Priority 2	2017	19,090

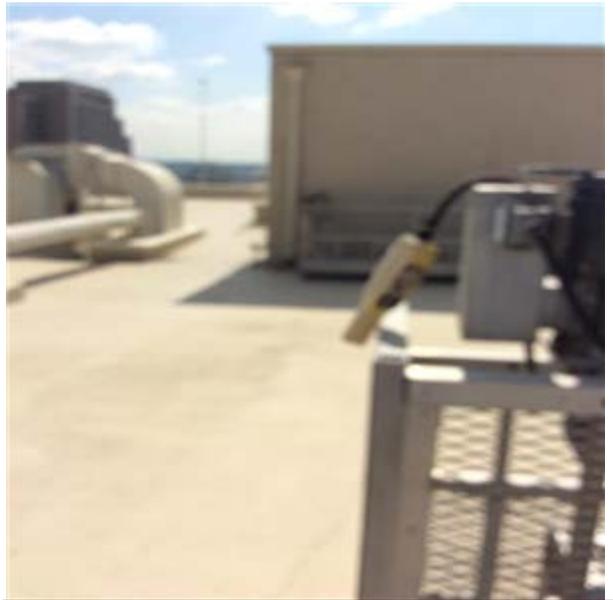
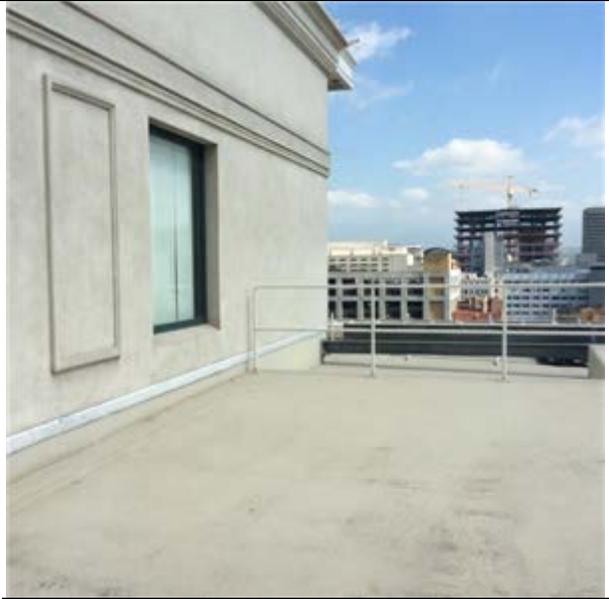
Based on current condition and RUL, replacement is recommended.

Type	Component Description	Qty / UOM	Unit Cost (\$)	Plan Type	Priority	Year	Expenditures (\$)
B3011	Replace B3011 Polyurethane Sprayed Roof, Encased	460.0 - SQ	2338.7	IN - Beyond Rated Life	Priority 3	2019	1,075,802

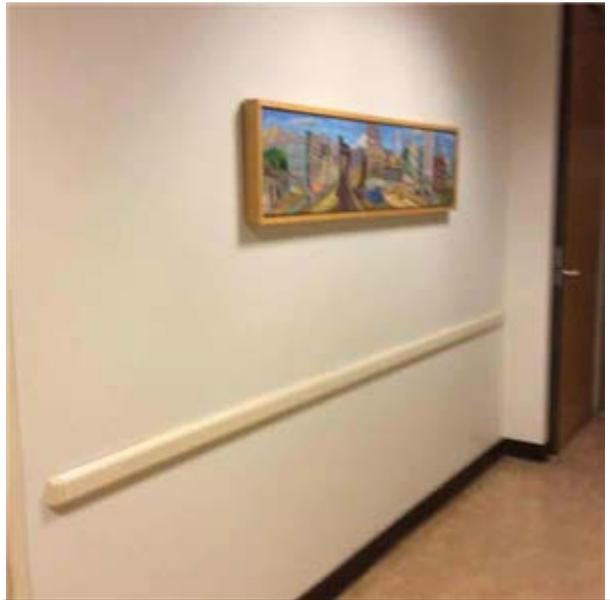
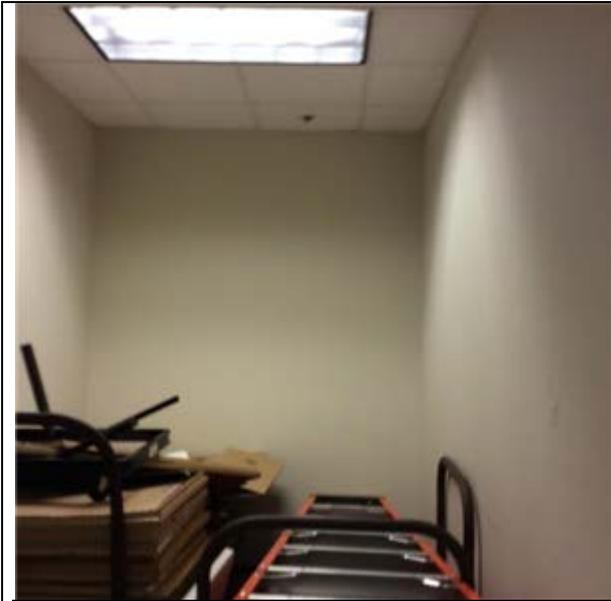
Based on current condition with noted interior wall staining and isolated peeling paint, as well as zero years RUL, repainting the interior walls is recommended.

Type	Component Description	Qty / UOM	Unit Cost (\$)	Plan Type	Priority	Year	Expenditures (\$)
C3012	Replace C3012 Wall Finishes, Interior Painting	295,000.0 - SF	2.7	IN - Appearance	Priority 2	2015	790,128

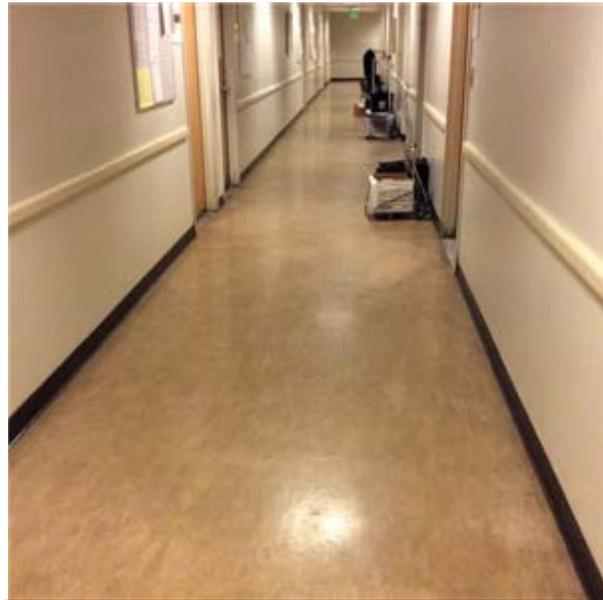
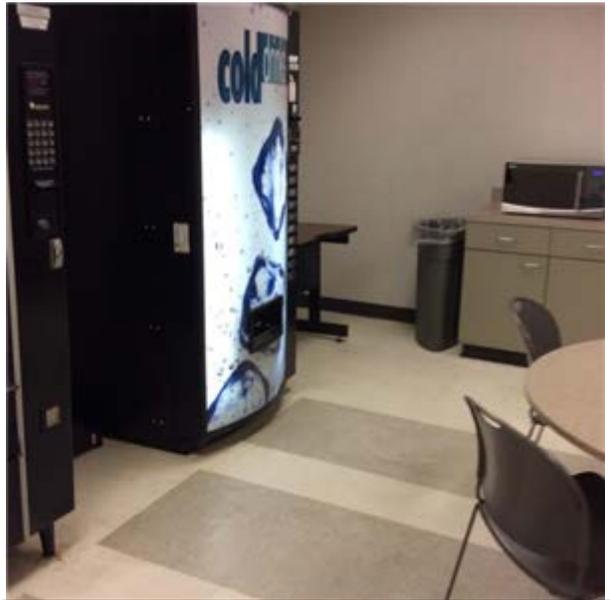
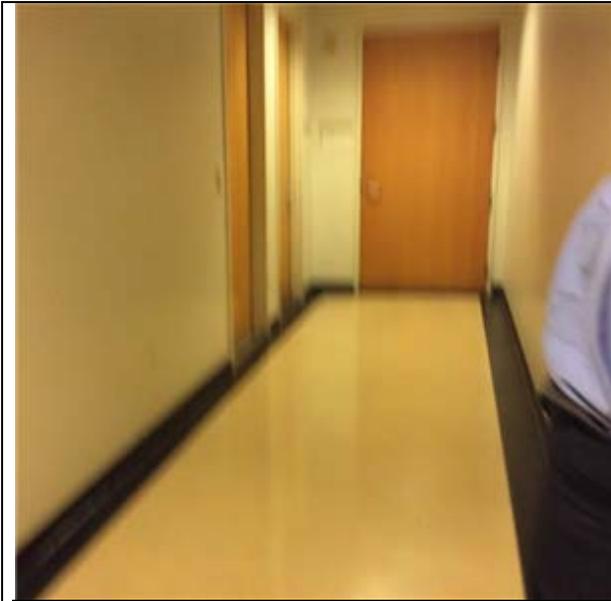
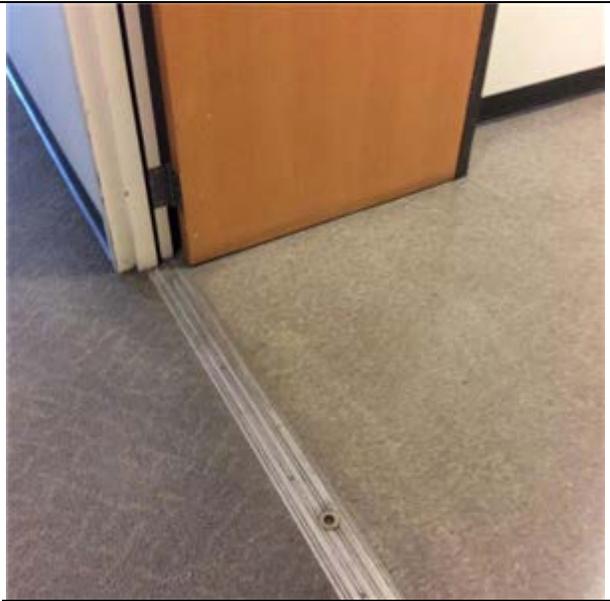
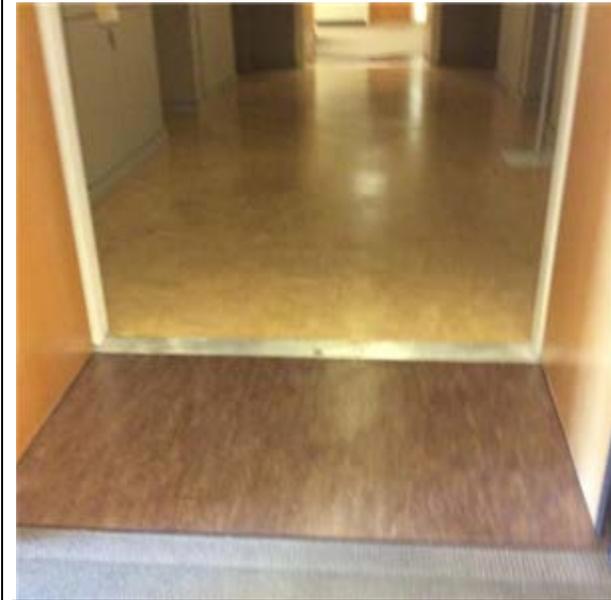
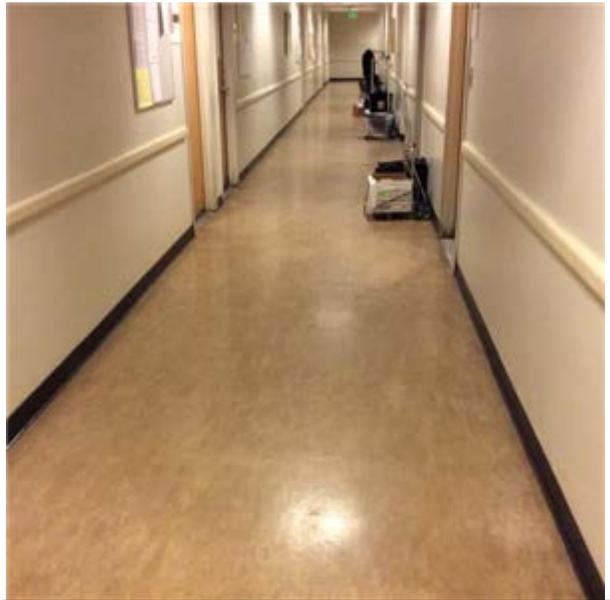
Based on current condition and RUL, replacement is recommended.

Type	Component Description	Qty / UOM	Unit Cost (\$)	Plan Type	Priority	Year	Expenditures (\$)
C3024	Replace C3024 Vinyl Tile	19,100.0 - SY	125.8	IN - Appearance	Priority 3	2017	2,402,402

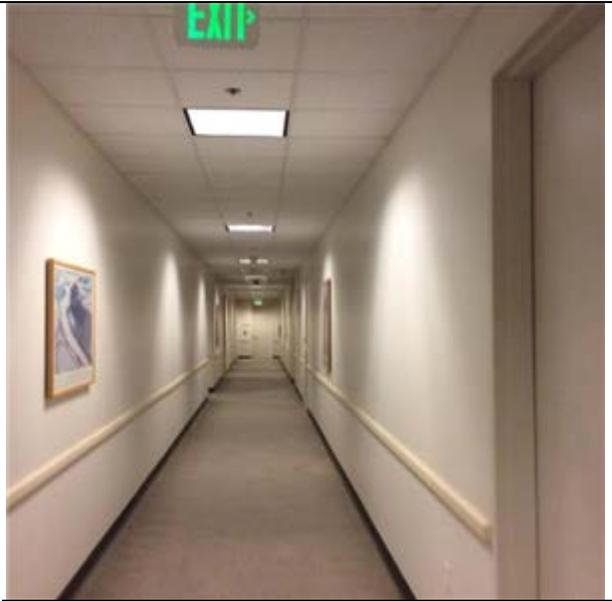
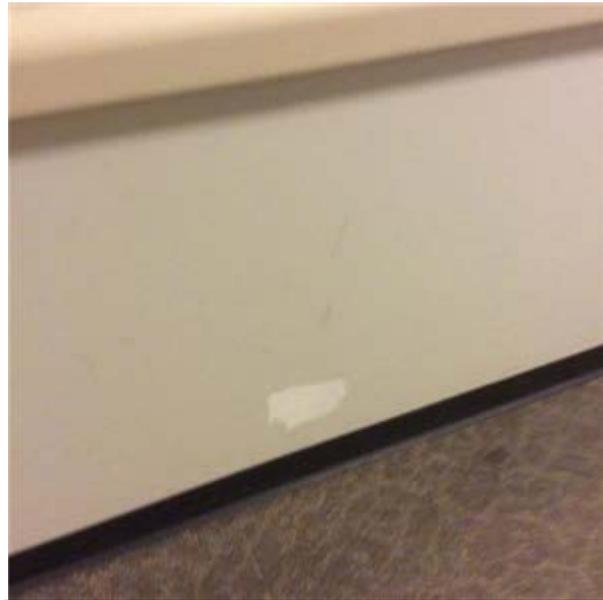
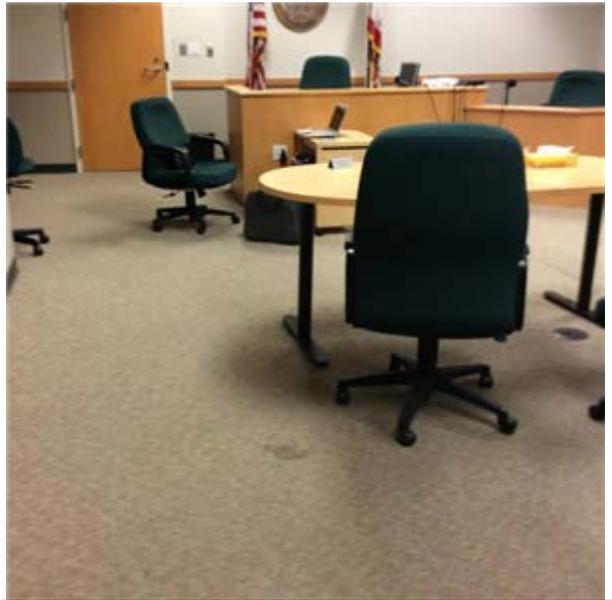
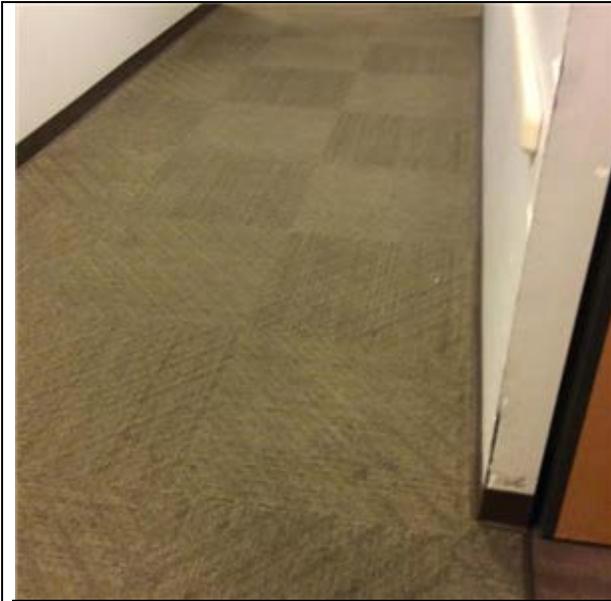
Based on current condition and RUL, replacement is recommended.

Type	Component Description	Qty / UOM	Unit Cost (\$)	Plan Type	Priority	Year	Expenditures (\$)
C3025	Replace C3025 Carpet Tiles - Standard	18,050.0 - SY	96.6	IN - Appearance	Priority 3	2018	1,743,731

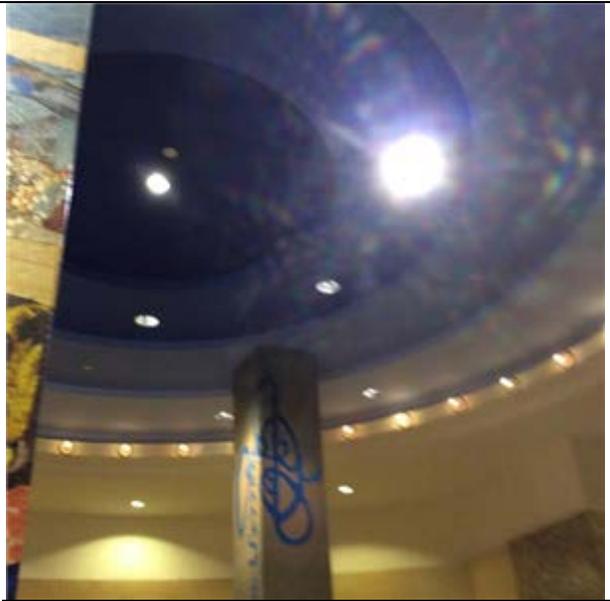
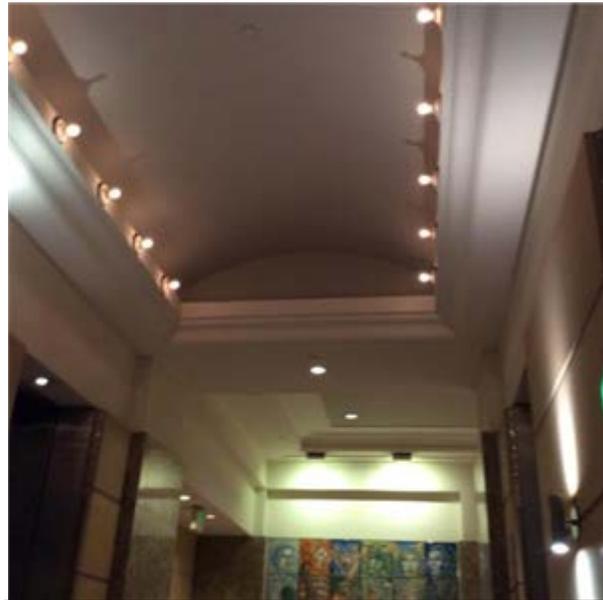
Based on current condition and RUL, repainting the interior gypsum board ceilings is recommended.

Type	Component Description	Qty / UOM	Unit Cost (\$)	Plan Type	Priority	Year	Expenditures (\$)
C3031	Replace C3031 Drywall – Painted Finished Ceilings	15,000.0 - SF	4.5	IN - Appearance	Priority 3	2019	68,076

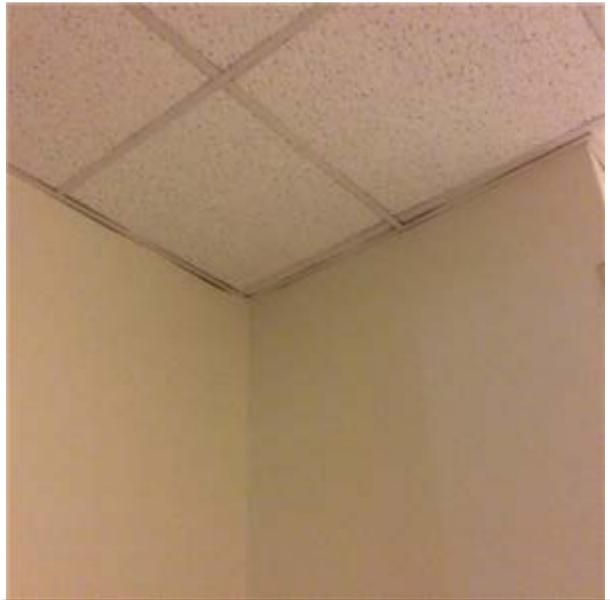
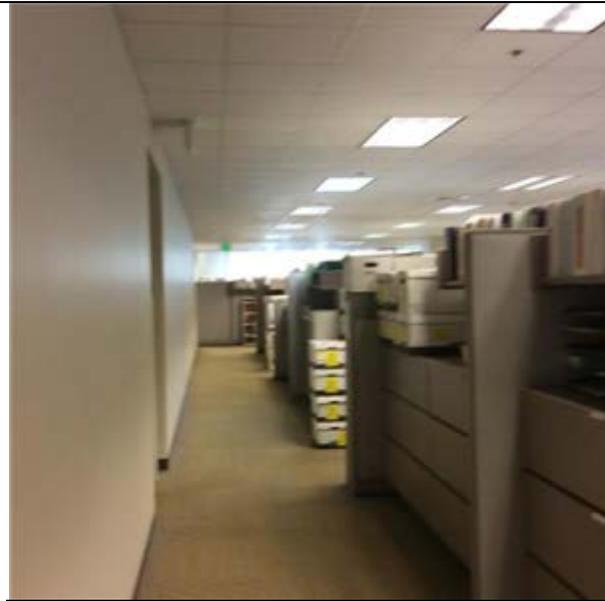
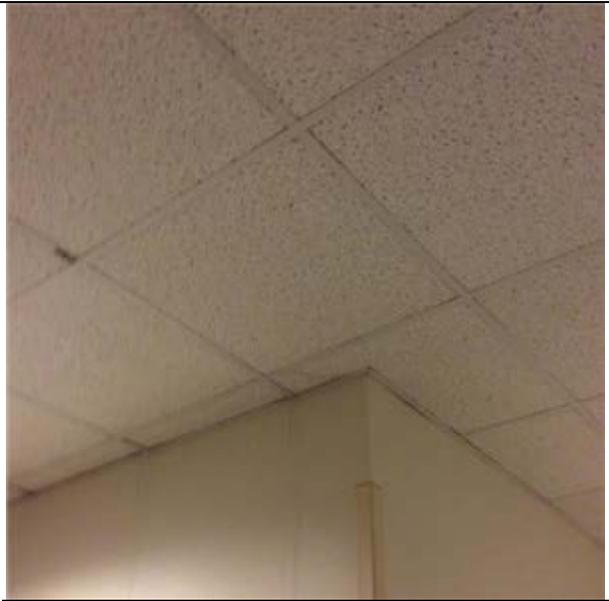
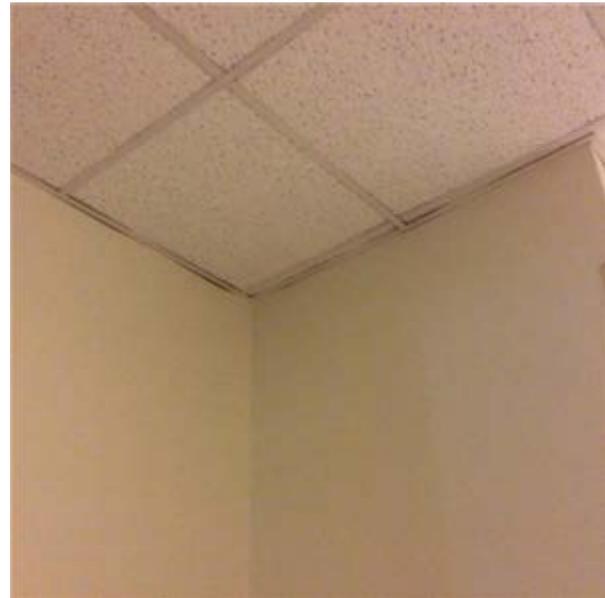
Based on current condition and RUL, replacement is recommended.

Type	Component Description	Qty / UOM	Unit Cost (\$)	Plan Type	Priority	Year	Expenditures (\$)
C3032	Replace C3032 Acoustical Ceiling Tile	3,100.0 - CSF	1201.6	IN - Appearance	Priority 3	2019	3,724,836
