Wadie P. Deddeh State Office Building (860)

4050 Taylor Street, San Diego, CA 92110

Facility Condition Assessment

September 2015

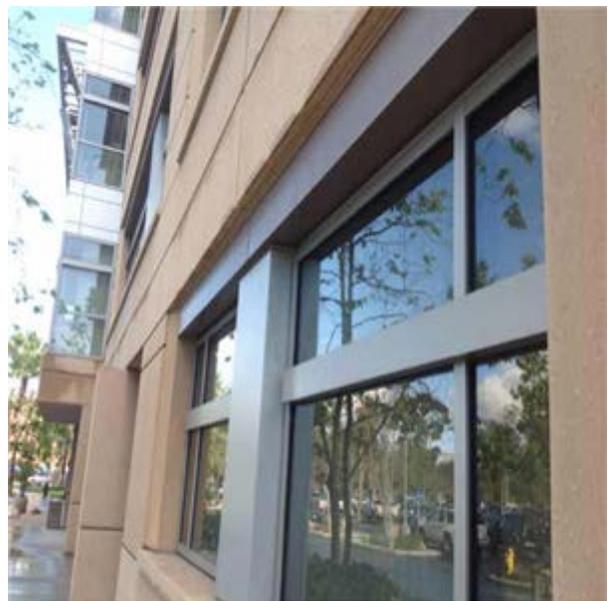
Item	Description
B2011 Exterior Wall Construction	B2011 Exterior Walls
Condition	Poor
Qty / UOM	2,000 / LF
RUL (years)	0
Location	Exterior Walls

Periodic water infiltration was reported at isolated gaps in the exterior finishing materials, and caulking/waterproofing is insufficient. An allowance for preventative maintenance at potentially problematic areas is recommended, as well as a lump sum amount to address those known areas of concern.

Type	Component Description	Qty / UOM	Unit Cost (\$)	Plan Type	Priority	Year	Expenditures (\$)
B2011	Replace B2011 Exterior Walls	2,000.0 - LF	23.3	OP - Maintenance	Priority 1	2015	46,592

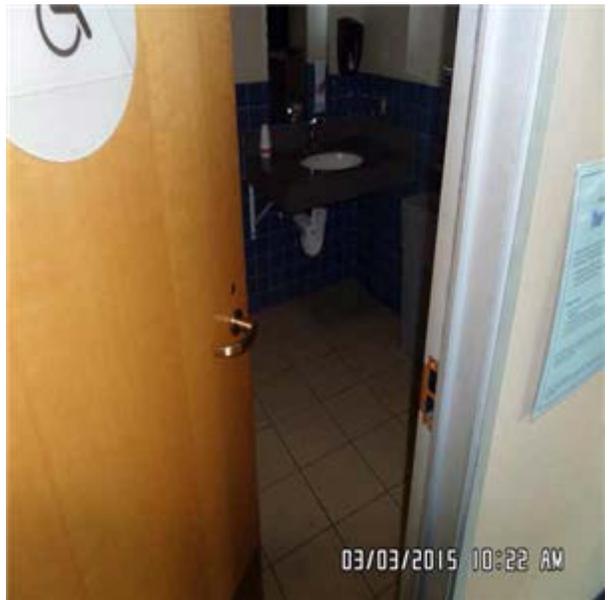
Item	Description
C1021 Interior Doors	C1021 Interior Doors- older
Condition	Fair
Qty / UOM	265 / EA
RUL (years)	21
Location	Interior Doors

Based on current condition and RUL, no further action is recommended.

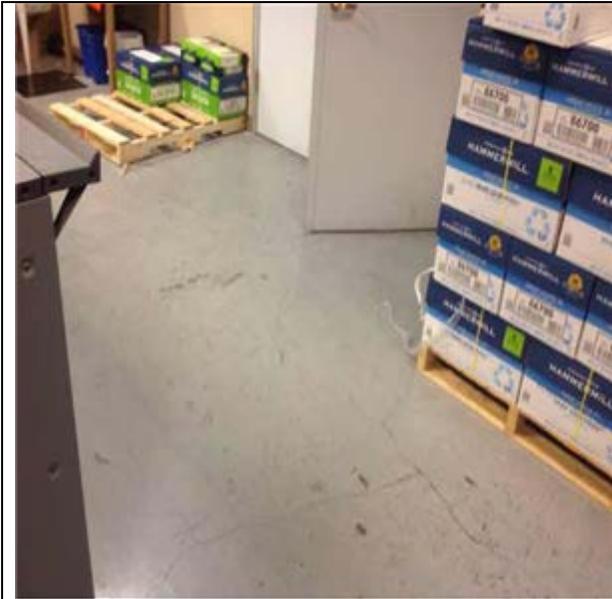
Item	Description
C3024 Flooring	C3024 Ceramic Tile
Condition	Fair
Qty / UOM	350 / CSF
RUL (years)	21
Location	Interior Flooring

Based on current condition and RUL, no further action is recommended.

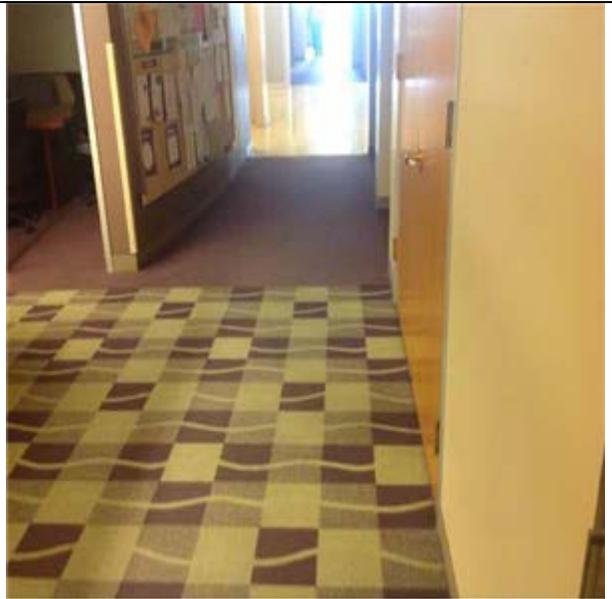
Item	Description
C3024 Flooring	C3024 Vinyl Tile
Condition	Fair
Qty / UOM	1,750 / SY
RUL (years)	9
Location	Interior Flooring

Based on current condition and RUL, replacement is recommended during the assessment term.

Type	Component Description	Qty / UOM	Unit Cost (\$)	Plan Type	Priority	Year	Expenditures (\$)
C3024	Replace C3024 Vinyl Tile	1,750.0 - SY	163.1	IN - Appearance	Priority 4	2024	285,424
