Ronald Reagan State Building (509)

Facility Condition Assessment

September 2015

Prepared for the State of California Department of General Services

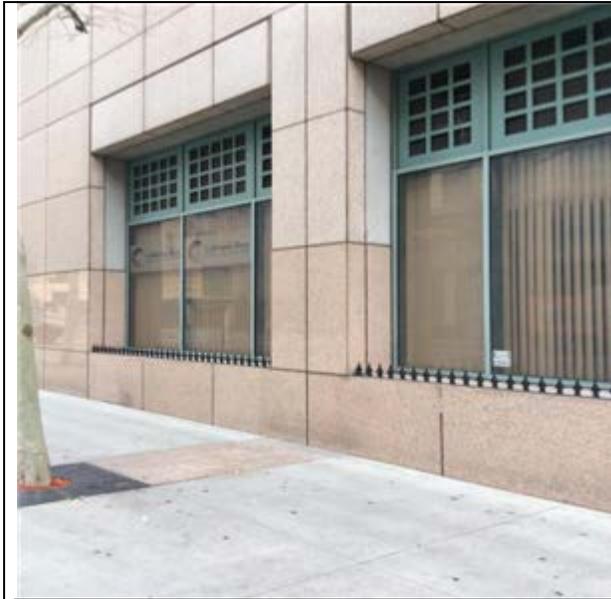
| Item | Description |
|---|---|
| Condition | Fair |

Based on current condition and RUL, replacement is recommended during the assessment term.

| Type | Component Description | Qty / UOM | Unit Cost (\$) | Plan Type | Priority | Year | Expenditures (\$) |
|---|---|---|---|---|---|---|---|
| B2021 | Replace B2020 Aluminum Storefront 10' Tall w/O Door | 620.0 - SF | 142.9 | IN - Beyond Rated Life | Priority 2 | 2017 | 88,579 |

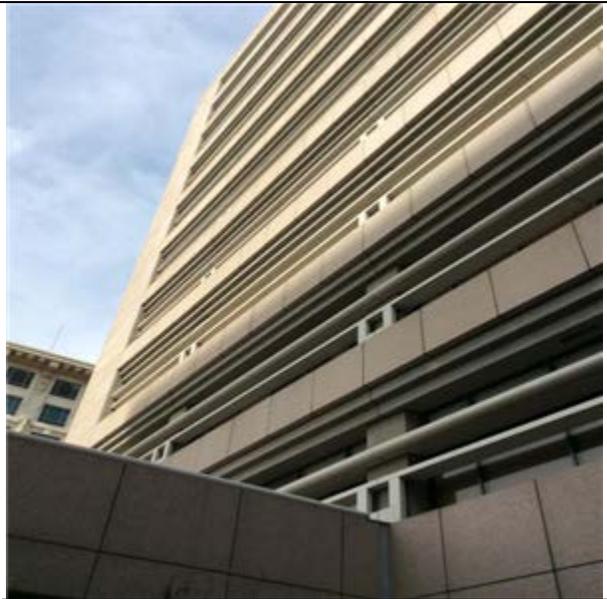
| Item | Description |
|---|---|
| Condition | Fair |

Based on current condition and RUL, replacement is recommended during the assessment term.

| Type | Component Description | Qty / UOM | Unit Cost (\$) | Plan Type | Priority | Year | Expenditures (\$) |
|---|---|---|---|---|---|---|---|
| B2021 | Replace B2021 Aluminum Windows | 850.0 - EA | 2652.8 | IN - Beyond Rated Life | Priority 2 | 2017 | 2,254,876 |

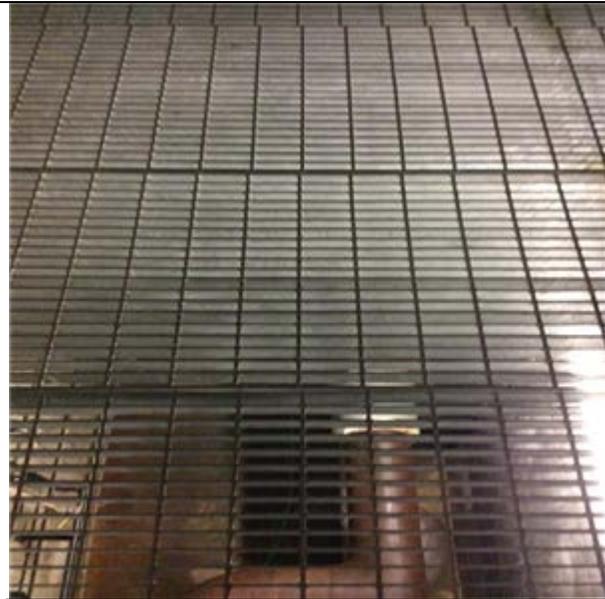
| Item | Description |
|---|--|
| Condition | Fair |

Based on current condition and RUL, replacement is recommended during the assessment term.

| Type | Component Description | Qty / UOM | Unit Cost (\$) | Plan Type | Priority | Year | Expenditures (\$) |
|---|--|---|---|---|---|---|---|
| B2034 | Replace B2030 Steel Rolling Overhead Door, Manual - 12' to 20' | 5.0 - EA | 9508.4 | IN - Beyond Rated Life | Priority 3 | 2021 | 47,542 |

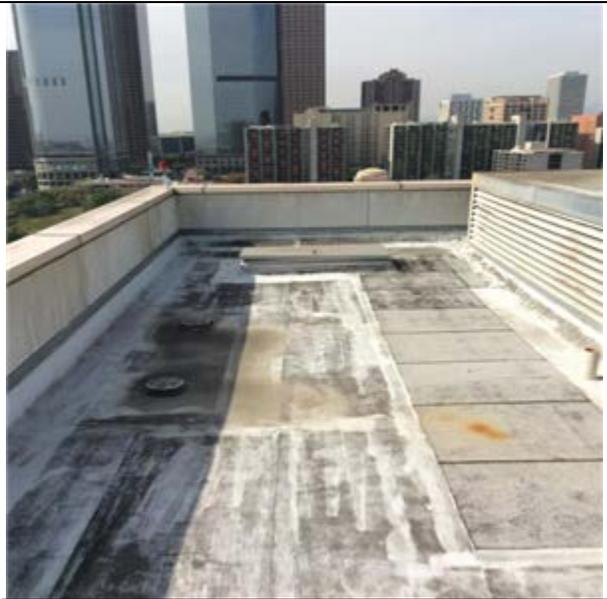
| Item | Description |
|---|---|
| Condition | Fair |

Based on current condition and RUL, replacement is recommended during the assessment term.

| Type | Component Description | Qty / UOM | Unit Cost (\$) | Plan Type | Priority | Year | Expenditures (\$) |
|---|---|---|---|---|---|---|---|
| B3011 | Replace B3011 Built-Up Roofing | 935.0 - SQ | 1366.1 | IN - Beyond Rated Life | Priority 2 | 2017 | 1,277,279 |

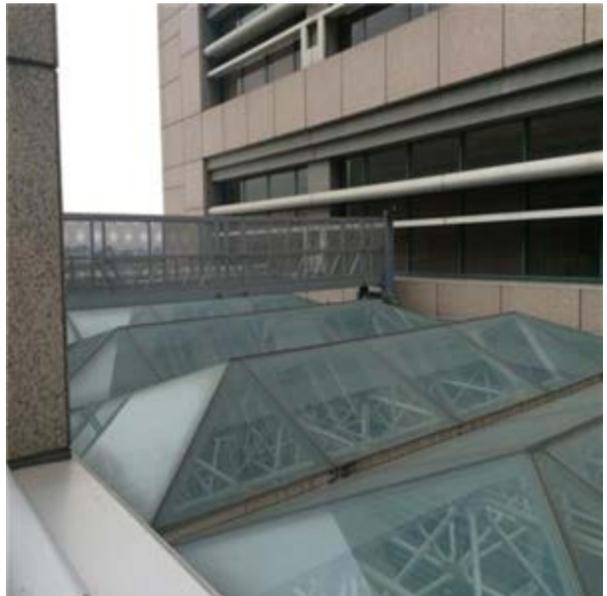
B3021 Skylight system

| Item | Description |
|---|---|
| Condition | Good |

The skylight system covers the atrium between the two towers. Caulking and gasket replacement will be required.

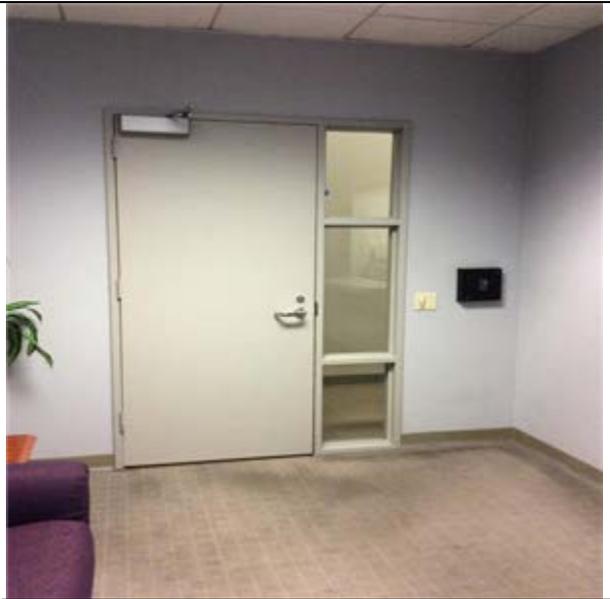
| Item | Description |
|---|---|
| Condition | Fair |

Based on current condition and RUL, replacement is recommended during the assessment term.

| Type | Component Description | Qty / UOM | Unit Cost (\$) | Plan Type | Priority | Year | Expenditures (\$) |
|---|---|---|---|---|---|---|---|
| C1021 | Replace C1021 Interior Doors | 440.0 - EA | 2403.1 | IN - Beyond Rated Life | Priority 4 | 2021 | 1,057,373 |

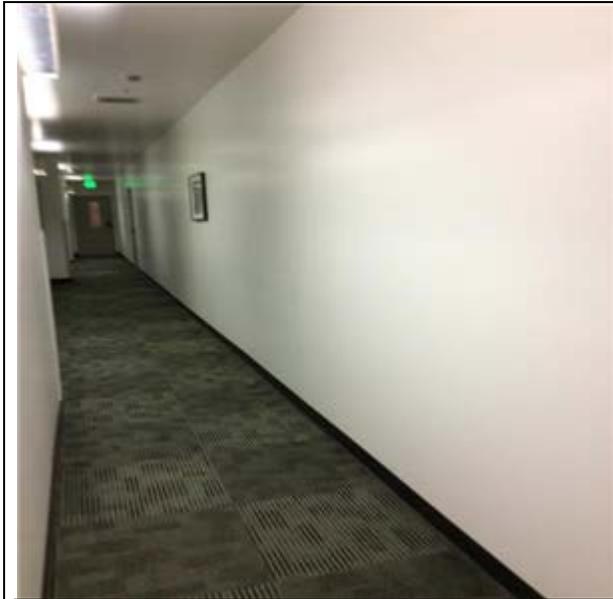
| Item | Description |
|---|---|
| Condition | Fair |

Based on current condition and RUL, the interior walls are recommended to be repainted during the assessment term.

| Type | Component Description | Qty / UOM | Unit Cost (\$) | Plan Type | Priority | Year | Expenditures (\$) |
|---|---|---|---|---|---|---|---|
| C3012 | Replace C3012 Paint Interior Walls, Drywall | 1,510,000.0 - SF | 2.1 | IN - Appearance | Priority 3 | 2017 | 3,220,528 |

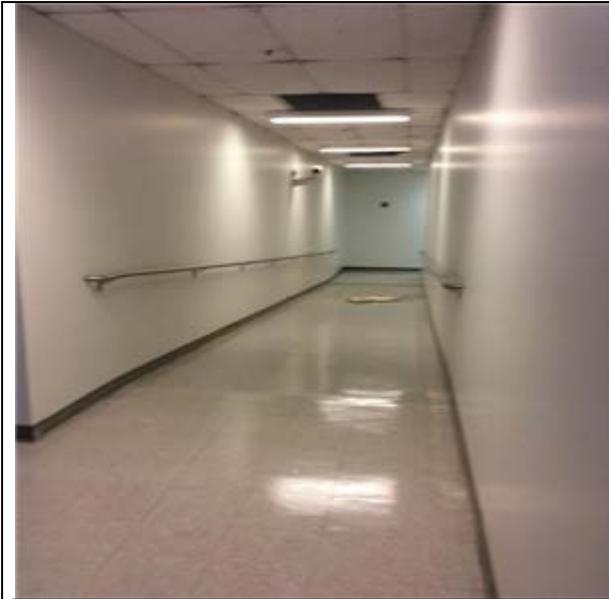
| Item | Description |
|---|---|
| Condition | Fair |

Based on current condition and RUL, replacement is recommended during the assessment term.

| Type | Component Description | Qty / UOM | Unit Cost (\$) | Plan Type | Priority | Year | Expenditures (\$) |
|---|---|---|---|---|---|---|---|
| C3024 | Replace C3024 Vinyl Tile | 12,840.0 - SY | 125.8 | IN - Appearance | Priority 3 | 2019 | 1,615,018 |

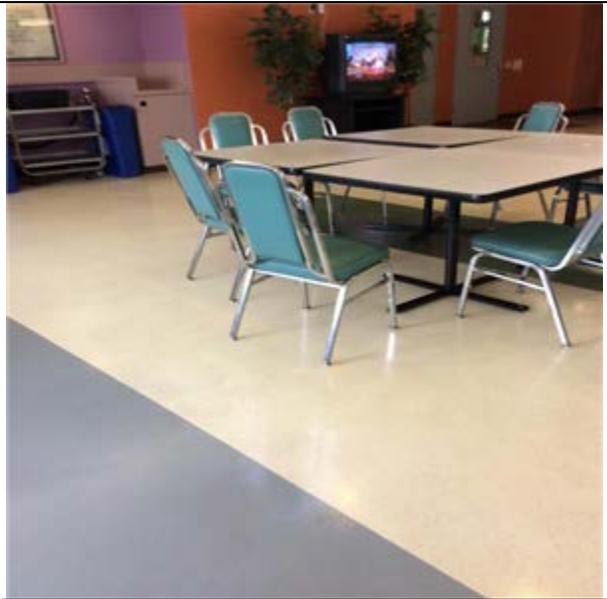
| Item | Description |
|---|---|
| Condition | Good |

Based on the RUL, replacement of sheet resilient flooring will be required during the reserve term.

| Type | Component Description | Qty / UOM | Unit Cost (\$) | Plan Type | Priority | Year | Expenditures (\$) |
|---|---|---|---|---|---|---|---|
| C3024 | Replace C3024 Sheet Vinyl | 1,460.0 - SY | 204.7 | IN - Beyond Rated Life | Priority 4 | 2021 | 298,829 |

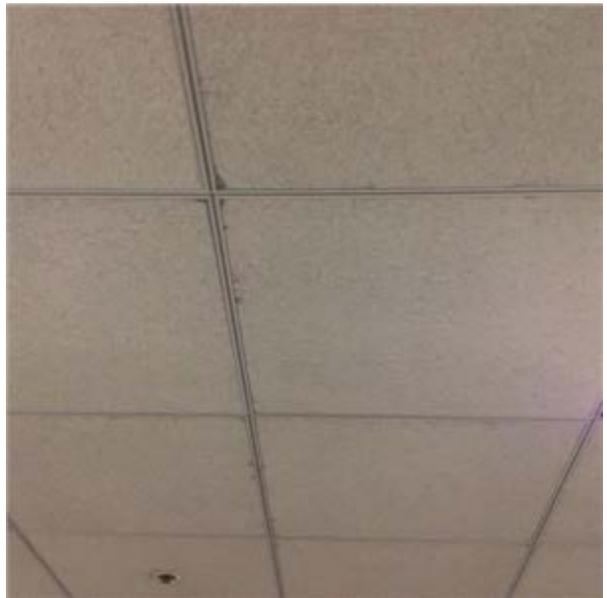
| Item | Description |
|---|---|
| Condition | Fair |

Based on current condition and RUL, replacement is recommended during the assessment term. Replacement of the fire sprinkler piping will require replacement of the ceiling tiles.

| Type | Component Description | Qty / UOM | Unit Cost (\$) | Plan Type | Priority | Year | Expenditures (\$) |
|---|---|---|---|---|---|---|---|
| C3032 | Replace C3032 Acoustical Ceiling Tile | 4,685.0 - CSF | 1201.6 | IN - Appearance | Priority 3 | 2017 | 5,629,309 |
