STUDY

Stockton EDD office building from southeast

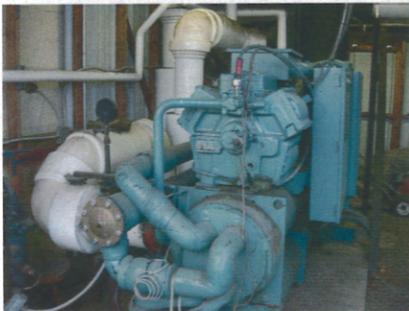
120 ton Chiller

The chiller, CH-1, has two compressors. One compressor, the south one, was replaced in 2009 with a rebuilt unit. This compressor has 56,936 starts and 8,960 hours or 6-1/3 starts per hour of use. The second compressor had the valves replaced by American Chiller Service three years ago and is presently in good shape. This second refrigeration circuit is low on refrigerant. This compressor has 22,685 starts and 2,112 hours or 10-3/4 starts per hour of use. This is an excessive number of starts per use for both compressors. American Chiller Service visited the site and provided an assessment of the chiller.

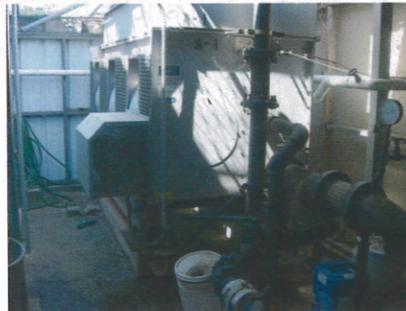
Cooling Tower, CT-1

The cooling tower, CT-1, overall is in good shape. There are 3 fans and 3 bearings. The center bearing of the three bearings need replacement. One of the three sets of fan blades are missing. The plastic drift eliminators have suffered

sun damage, become brittle and need replacement. ACS Cooling Tower Services visited the site and provided an assessment of the cooling tower.

- 1) Replace cooling tower.
- 2) Replace CHW and CW pumps.
- 3) Replace VFDs.
- 4) Provide new zoning reusing much of the duct.
- 5) Replace supply diffusers and return registers. Remove and reinstall lights and repair ceiling as required to perform the work.
- 6) Clean ducts if being reused.
- 7) Remove and replace ceiling as required for access to mechanical equipment and appurtenances being replaced.
- 8) Air balance HVAC system.
- 9) Replace chiller.
- 10) Replace both air handlers including removal of unused concrete pads from mechanical rooms.
- 11) Replace VAV boxes.

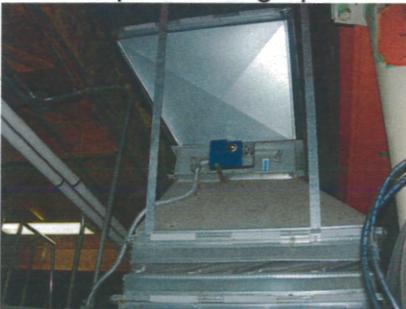
AH-1 is in bad shape. Both VFDs for SF-1 and RF-1 have been bypassed. SF-1 VFD caught fire at one point and has not been repaired or replaced. The return air fan, RF-1, is located adjacent/parallel to the air handler, AH-1. The RA (return air) duct wraps around the end of the unit and enters the air handler from the end. The OA (outside air) comes from a doghouse on the roof. The OA duct drops from above going through a damper. Drawings from the 1992 renovation show a 30"x62" OA duct and 30"x62" OA damper. Onsite measurements show a 31"x82" OA connection at AH-1 and a 21"x66" OA damper. The OA damper restricts the OA duct to less than 55% of its cross sectional area. The OA damper free area should equal the duct cross sectional area. When the RA damper is closed and the OA damper is open the OA is a restriction. In this damper arrangement the supply fan sucks the RA duct in. When the RA damper is open and the OA damper is closed, the return fan, RF-1, expands the RA duct out. In other words the return air duct entering AH-1 is expanding and contracting, as the dampers change positions.

AH-1 outside air restriction

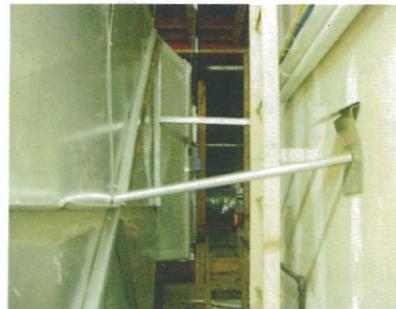
AH-1 external duct supports

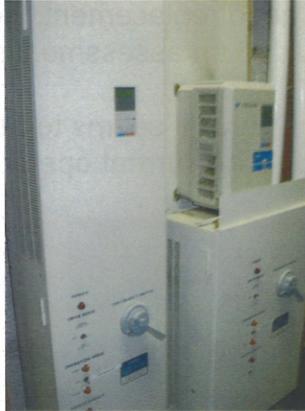
AH-1 VFDs have been bypassed because they are shot. Note the wall discoloration above SF-1 VFD in the photo below.

VFDs for RF-1 and SF-1, resp.

- 1) Add refrigerant to chiller to number 2 compressor circuit.
- 2) Replace chilled water 3-way valves.
- 3) Replace VFDs (disconnect and reconnect any electrical power.)
- 4) Replace EMS controls (disconnect and reconnect any electrical power).
- 5) Replace cooling tower fans, fan inlet rings, shaft, bearings, fan sheave, belts, and sheave bushings.
- 6) Replace cooling tower plastic honeycomb drift eliminators.
- 7) Replace AH-1 RA and OA dampers.
- 8) Replace RF-1 inlet shroud.
- 9) Reconfigure AH-1 RA duct and RF-1 support.
- 10) Repair/replace boiler controls.
- 11) Replace four exhaust fans.
- 12) Add wall returns to two second floor conference rooms and ceiling return to second floor office.

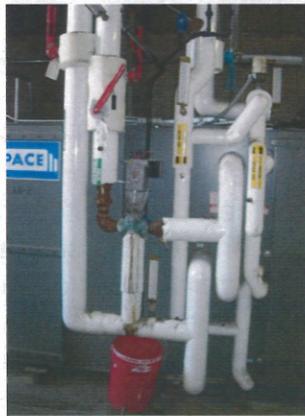
AH-2 piping

Note bucket for leaky CHW valve

Coils, both cooling and heating, in both units are in good shape based on temperature differentials. CHW three-way valves work, but leak on both units. Space heating hot water three-way valves on both units are in good shape.

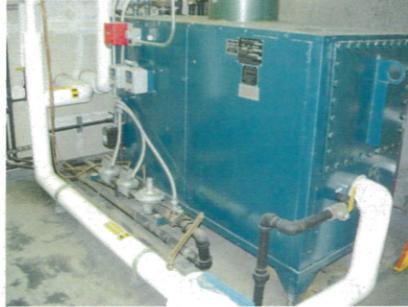
Boiler

The boiler was installed in 1992. Overall it seems to be in good shape. The controls work for a while, then quit. The current operational fix is to manually restart the boiler.

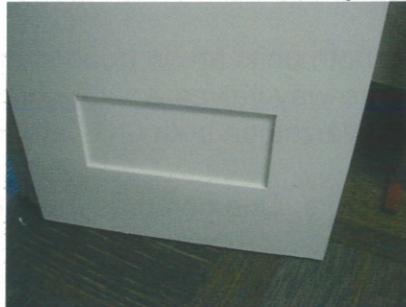
The second floor is conditioned by air handler, AH-1. Per drawing M1 of the 1992 renovation the supply ducts to this area were capped. Onsite investigation revealed that air was coming out of the supply diffusers and that there are no return registers in any of the three rooms on the second floor. The only return air register for this area is located in the stairwell. At one point there were returns in the doors but they have been sealed. It is assumed this was the result of a CSFM (California State Fire Marshal) requirement. The Building code allowed returns through doors and hallways in the era the building was built. Since then code updates have deleted this allowance. The net result for these areas of the building is, if the doors are closed, minimal space conditioning occurs.

Second floor door blocked return air

- 13) Relocate second floor thermostat to south meeting room.
- 14) Adjust zoning to separate public and employee use areas.
- 15) Air balance HVAC system.
