## Facility Hardship Program Project Examples

The Office of Public School Construction has provided the following as examples of projects that have been funded under the School Facility Program's Facility Hardship Program. The example languages provided are intended to illustrate information submitted with a request for funding. Inclusion or lack of inclusion, of this information verbatim does not guarantee a project is ineligible/eligible for funding. We encourage you to contact our staff for assistance.

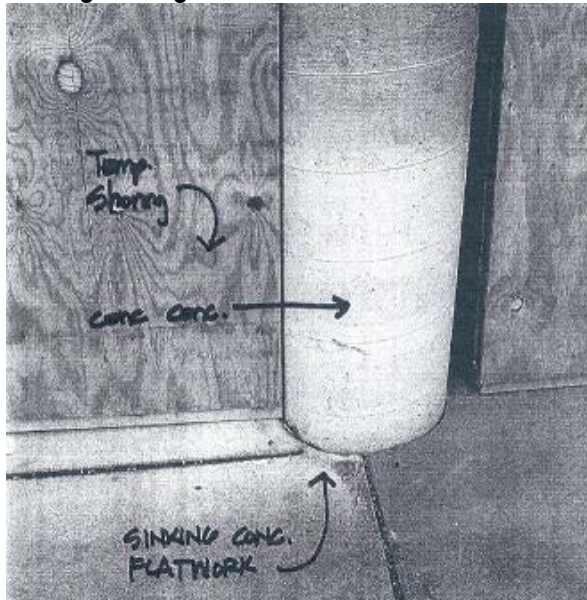
### Structural Deficiency Due to Ground Settling/Sinking

**Example of Language:** "The damage involved the settlement of the fill soils behind the retaining walls on either side of the amphitheater.... This combined with the natural deterioration of the wood shoring has caused the existing condition to become dangerous and even life threatening...."

**Example of Language:** "DSA has reviewed the reports regarding the specific structural deficiencies and has made a visit to the site. DSA concurs that portions of the Building B and exterior walkway as shown in the reports are no longer in compliance with the drawings approved at the time of construction. These deficiencies are such that the health and safety of the pupils is at risk and must be corrected. The DSA has reviewed the plans and specifications for this project and concur that the work in the plans is the minimum work required to mitigate the health and safety threat and gain DSA approval."

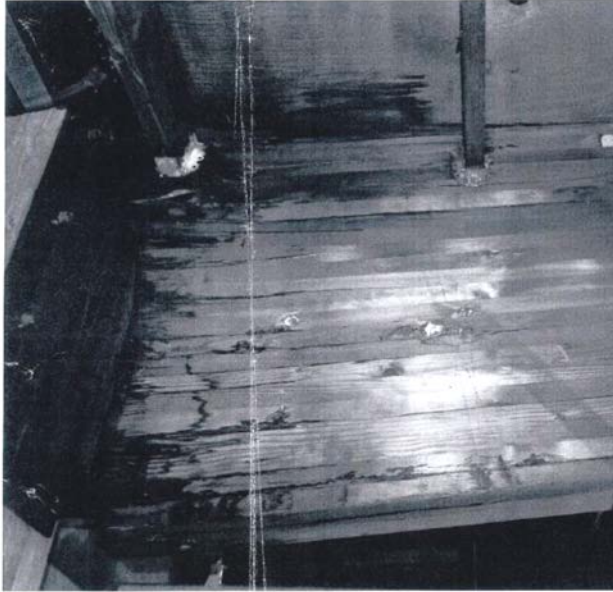
**Structural Deficiency Due to Water Damage**
**Industry Specialist:** Structural Engineer

**Example of Language:** “Two glu-laminated beams have experienced crushing, etc. at one end due to years of water intrusion from the roof.... As a result of the end damage, the bolting of the glu-laminated beam to the steel bucket can no longer transfer the out-of-plane seismic loads.... This could lead to a partial roof and wall collapse during a seismic event. Consequently, the compromised glu-laminated beam ends constitute a current life safety hazard....”

**Example of Language:** “DSA has reviewed the letter regarding the specific structural deficiencies and has made a visit to the site.... DSA concurs that the locker facilities in the gymnasium buildings, as mentioned in the letter, are no longer in compliance with the drawings approved at the time of construction. These deficiencies are such that the health and safety of the pupils is at risk and must be corrected. The DSA has reviewed the plans and specifications for this project and concur that the work in the plans is the minimum work required to mitigate the health and safety threat and gain DSA approval.”

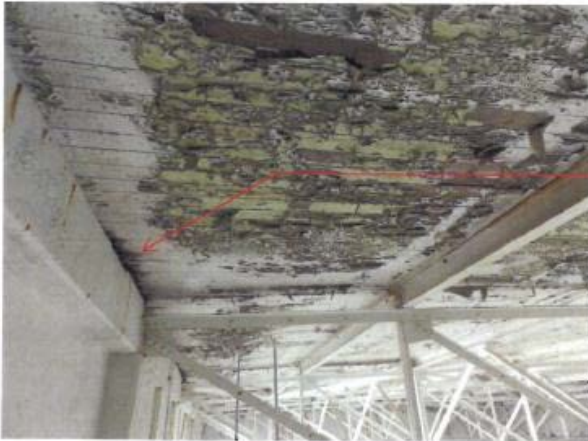
**Structural Deficiency Due to Dry Rot**
**Industry Specialist:** Structural Engineer

**Example of Language:** “While the framing and lateral force resisting system in its original, undamaged state appear to be in general conformance with requirements for existing school buildings...because of the damaged roof framing, the Pool Building is not safe for school use.”

For Hazard: “DSA concurs that portions of the Pool Building as shown in the report are no longer in compliance with the drawings approved at the time of construction. These deficiencies of the Pool Building are such that the health and safety of the pupils is at risk and must be corrected.”

For minimum remediation work: “In the review of the Facility Hardship Report, it was recognized that proposed repair work was designed and detailed to provide the minimum required work necessary to mitigate the structural deficiencies listed under the investigation reports and gain DSA approval.”

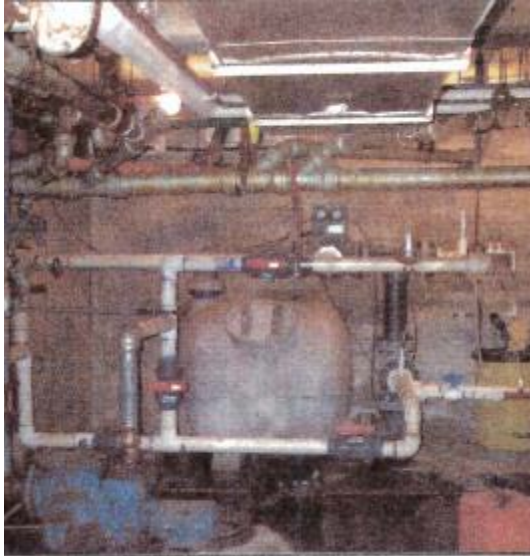
**Boiler System Installation** (to replace steam heating system previously provided through the city but no longer available)

**Example of Language:** “The existing mechanical system and hot water heating system is serviced by steam supplied by the local lumber company. In discussing this with company officials, it is clear that the steam service will be cut-off. Given the mountainous area of the school, without a heating source for the facilities, students will be at risk for serious health concerns relating to the cold temperatures. Therefore the system must be replaced at the earliest possible time to mitigate a health and safety threat to the students.”

**Example of Language:** As the County Public Health Officer I have verified the need for a new boiler and heating system for the school. For most of the school year, heat is necessary in (this) County to maintain a healthy environment for students.

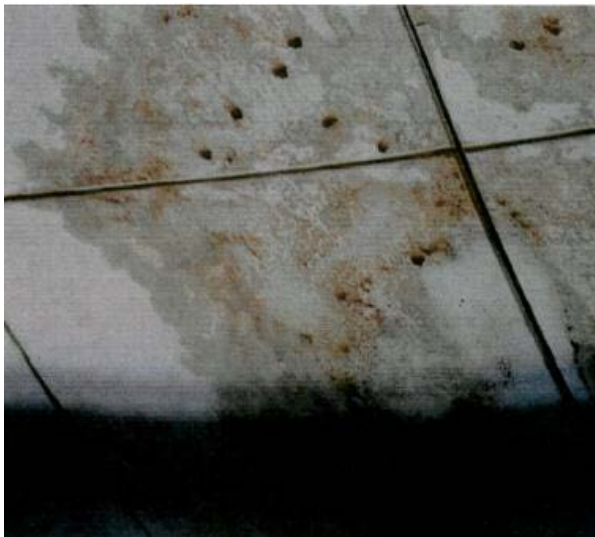
**Mold**

**Example of Language:** “Stachybotrys spores were detected in the indoor bulk samples collected from the site. Mold spores that which are found on the interior of a building which are not found on the exterior of a building are also cause for alarm.... The samples are elevated to a point that would justify taking action to not occupy the hallway, bathrooms, room 114 and the locker rooms without ...remediation. All areas should be placed under full containment guidelines.”

**Example of Language:** “The roof...has sagged considerably over the years and holds water...creating more leaks. These areas of excessive moisture intrusion are breeding places for mold and present serious health risks to the students and staff. The CDPH has review the reports provided by the Environmental Testing Professional and Structural Engineer and concur that the work as shown in the reports is the minimum work required to mitigate the health and safety threat.”

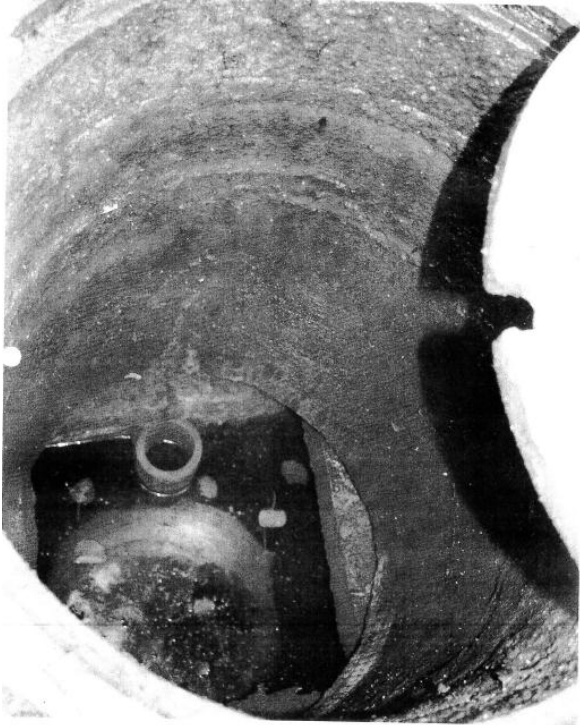
**Sewage Treatment**

**Example of Language:** “In overview the system has experienced complete failure and pumping costs are extremely high. Risk to the health and safety of the students have arisen from the surfacing effluvium....”

**Example of Language:** “Due to the safety issues caused by the surfacing sewage from your failed septic system, the County required the repair to be completed as soon as possible. The County has reviewed the provided plans for the repair work and concur that the work in the plans is the minimum work necessary to mitigate the health and safety threat.”
